Failure Investigation of WB-57 Aircraft Engine Cowling

Microscopy & Microanalysis 2014

Symposium P06 – Failure Analysis of Structural Materials
06 August, 2014

Failure Analysis of WB-57 Aircraft Engine Cowling

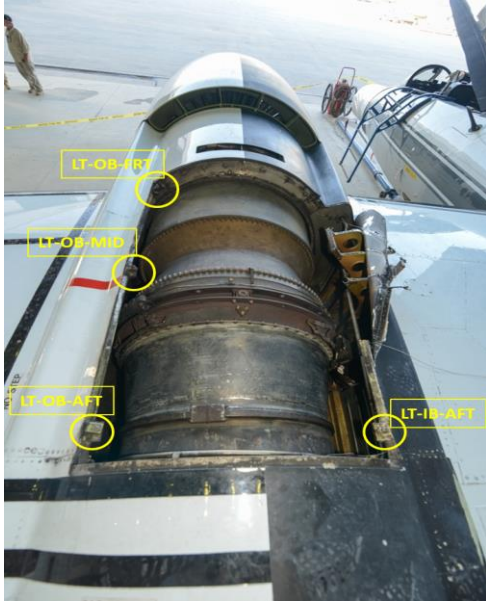
Each engine cowling panel is attached to the engine nacelle using six bushings made of 17-4 PH steel. The cylinder portions of four of the six bushings were found still attached to the aircraft (Fig 1). The other two bushings were lost with the panel. The other four bushings exhibited ratchet marks (multiple fatigue origins) which initiated in the sharp radius of the flange/cylinder fillet and were observed 300 degrees around the flange perimeter (Fig 2-3). Low stress, high cycle fatigue (HCF) was observed on the fracture surfaces of all four bushings^[2] (Fig 4).

Fig 1. WB-57 Aircraft Left Engine w/Missing Cowling. Location of four remaining bushings circled in yellow.

To improve the cowling panel joint design and enable return to flight, new cowling bushings with thicker flanges and a larger machined flange/cylinder fillet radius were installed on all cowling panels. In addition, a spacer was added to the joint to achieve the proper stack tolerance. Finally, a time change requirement for all cowling bushings was instituted.

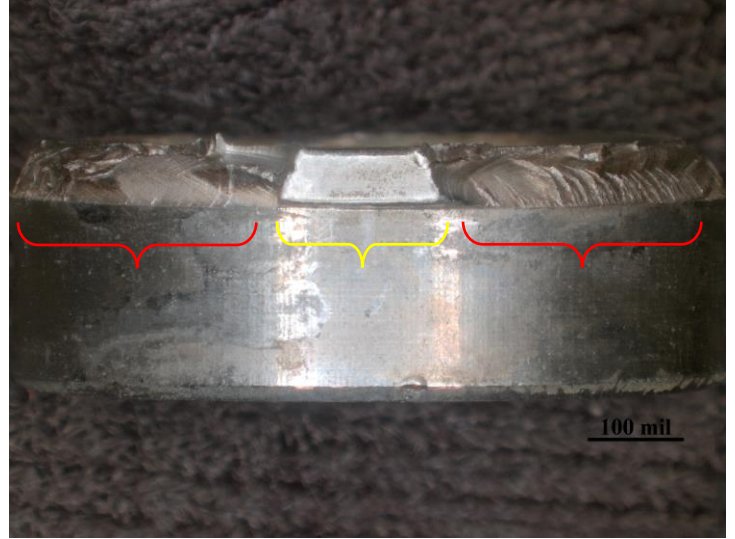
Fig 2. Photo of Failed Engine Cowling Bushing. Fatigue fracture zone in red, unfractured zone in yellow.

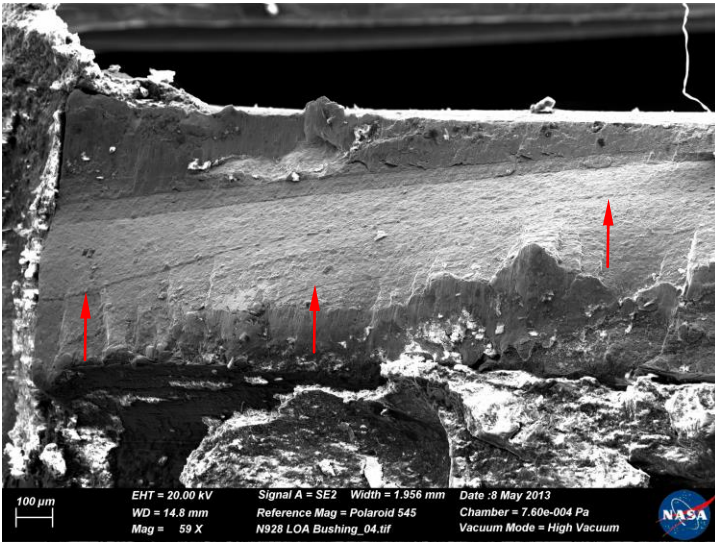
Fig 3. SEM of Failed Engine Cowling Bushing (ratchet marks at red arrows)

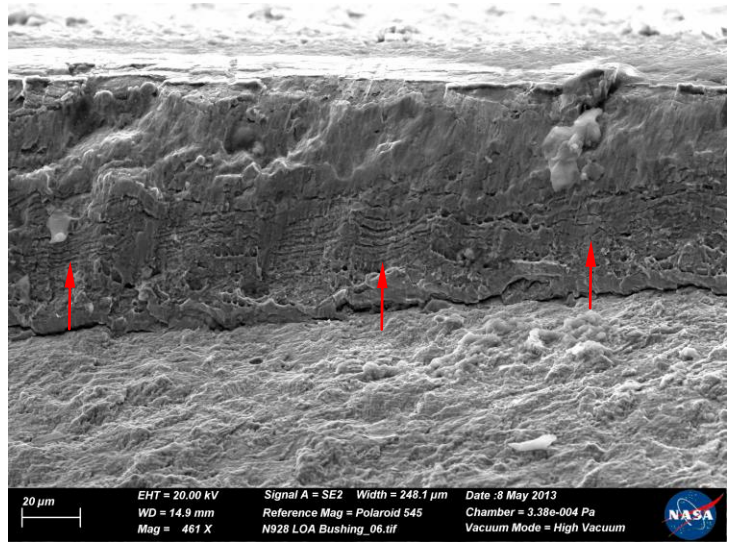
Fig 4. SEM Image of HCF Striations (red arrows)

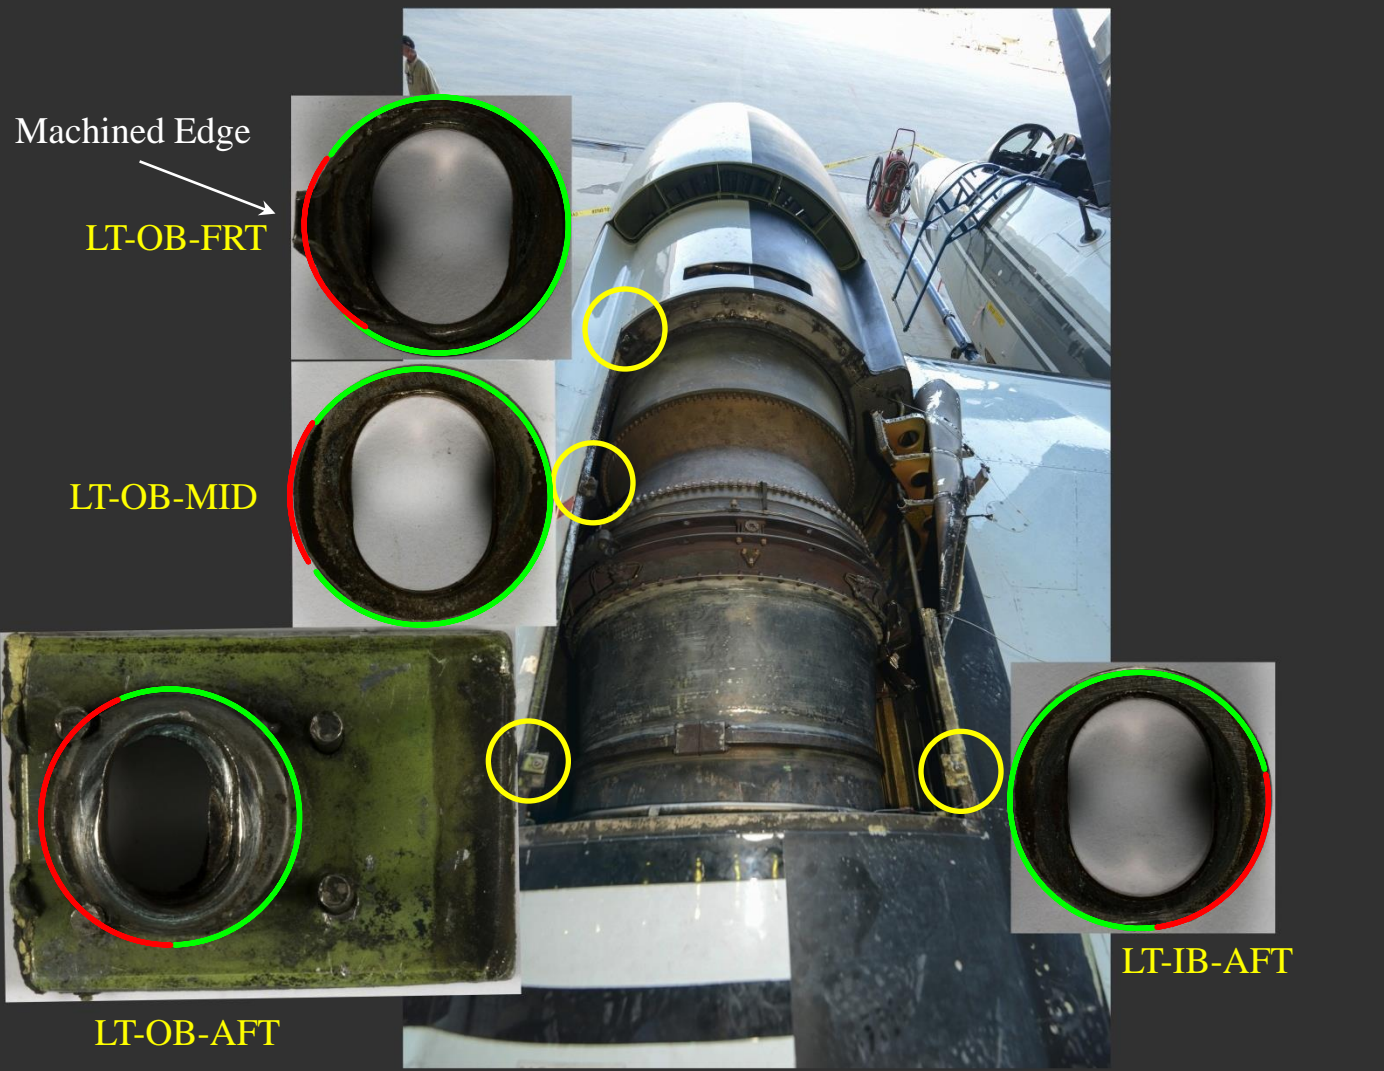
High cycle fatigue
Multiple initiation points

Overload fracture

Note: Mapping of crack type on bushing on PT-OB-FRT and PT-OB-AFT known due to noted bushing features. Mapping assumed for PT-OB-MID and PT-IB-AFT

Remaining 2 attachment fittings (PT-IB-MID, PT-IB-FRT) missing from aircraft.

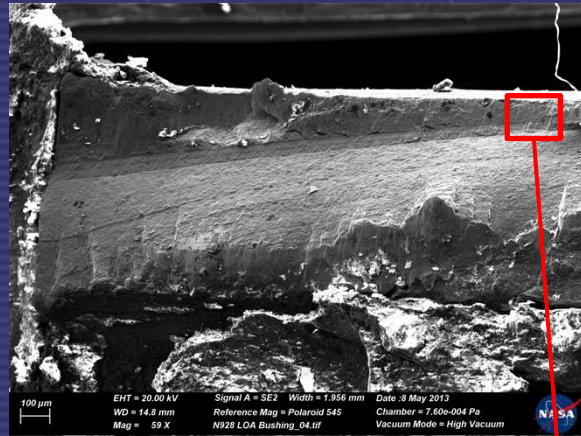
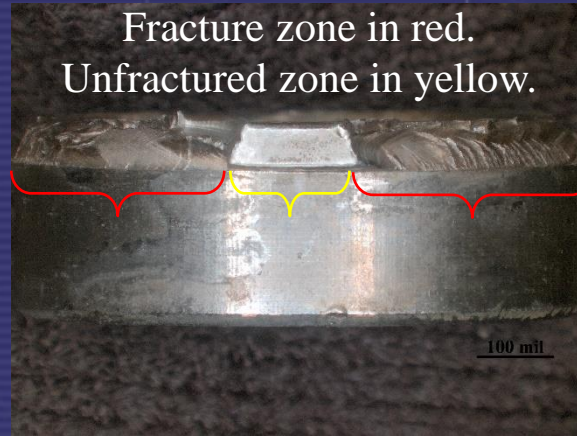
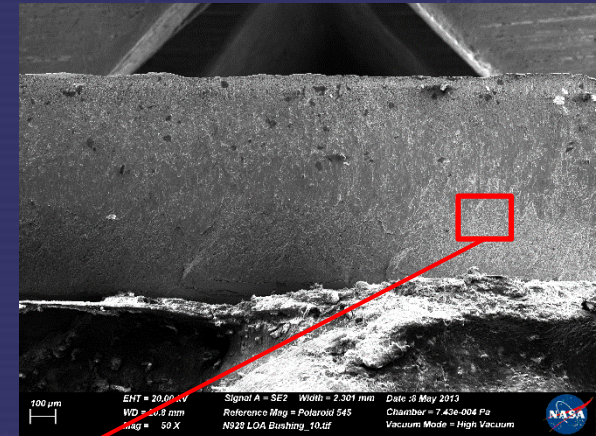
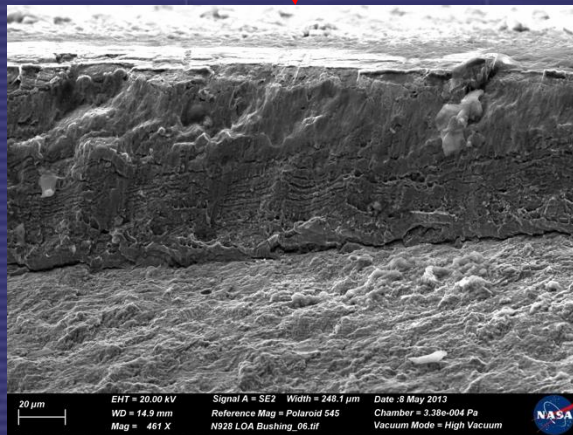
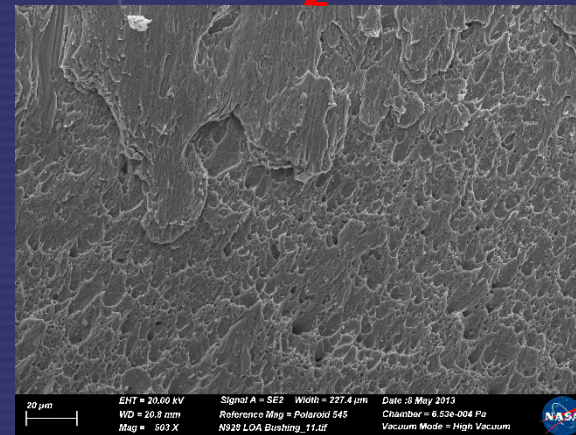
SEM Fatigue Micrograph - Port Outboard Front Bushing

Fatigue Zone

Overload Zone

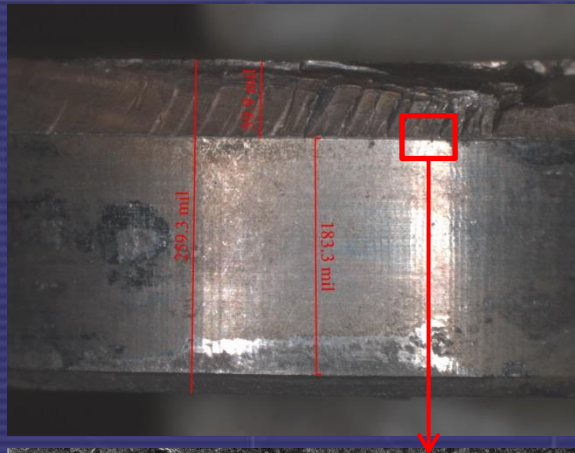
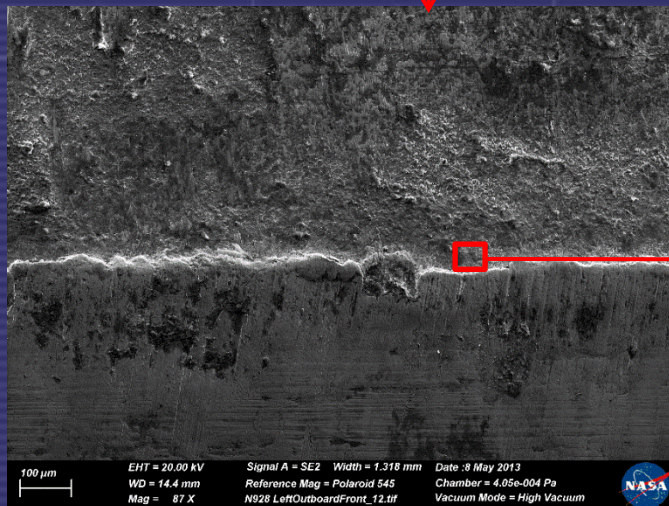
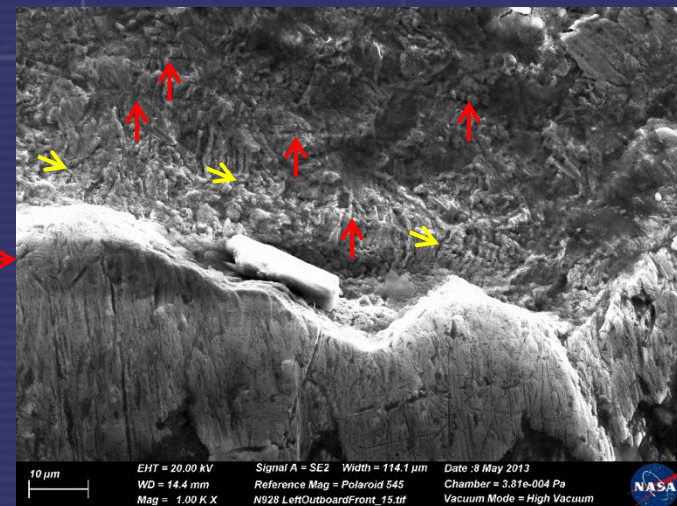
SEM Fatigue Micrograph - Port Outboard Front Bushing

Multiple origin fatigue initiated on the flange to cylinder radius. SEM micrographs of the fracture reveal **striations** (red arrows) and **tear ridges** (yellow arrows). All of the N928 bushings failed in a similar manner by low stress, high-cycle fatigue (HCF).

- **All four LT side cowling bushings submitted from N928 exhibited low stress, high-cycle fatigue.**
 - ❖ The multiple-origin fatigue initiated in the sharp radius of the flange/cylinder fillet and progressed across the flange thickness.

- ❖ Both the LT-OB-FRT and LT-OB-MID bushing exhibited ratchet marks (multiple fatigue origins) exceeding 300 degrees around the flange/cylinder fillet. Failure of the cowling door probably initiated at one of these two significantly fatigue cracked bushings.

- To improve the cowling panel joint design and enable return to flight, new cowling bushings with thicker flanges and a larger machined flange/cylinder fillet radius were installed on all cowling panels.
- In addition, a spacer was added to the joint to achieve the proper stack tolerance.
- Finally, a time change requirement for all cowling bushings was instituted.

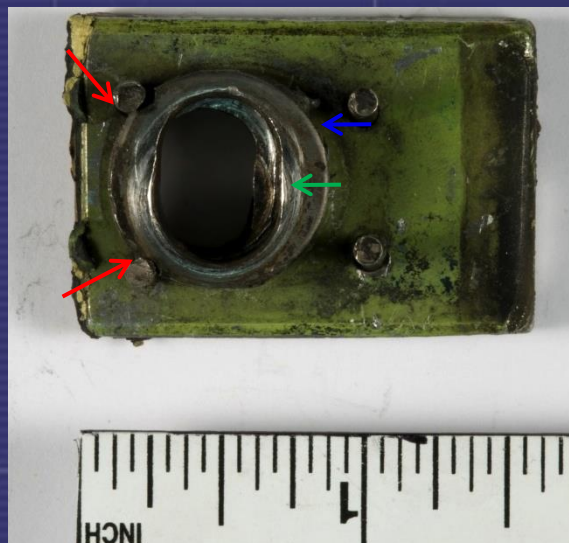
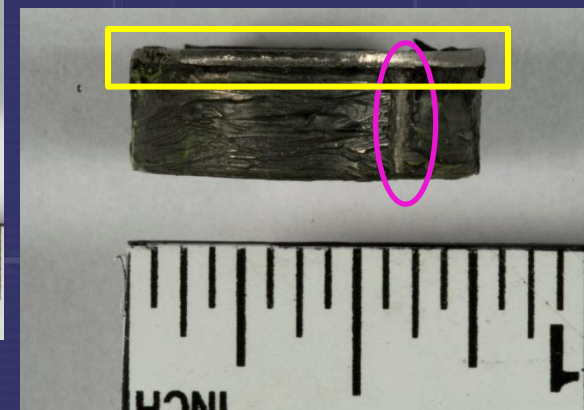
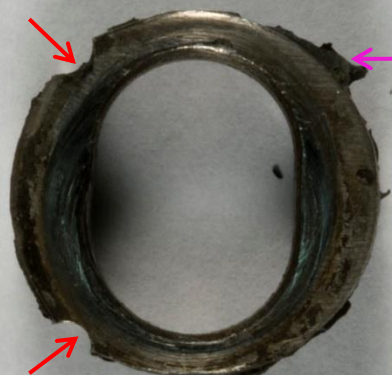
Left Outboard Aft Spacer

- Drilled holes are shown at the red arrows. The rivets on the right perfectly fit into the drilled holes.
- Fracture on bushing is shown at right photo in yellow box.
- The bushing was fractured from the flange. There is wear on top-side of bushing (green arrow), which is consistent with wear from the bolt head.
- The witness mark on the bushing (pink arrow and oval) resulted from contact with the top right rivet of center image when cowling was departing the aircraft.

- ❖ LT-OB-AFT bushing repair (6061-T6 spacer with 4 Monel 405 rivets) did not initiate the cowling door failure. However, with the spacer in place, the accompanying bolt was not long enough to achieve proper thread engagement.

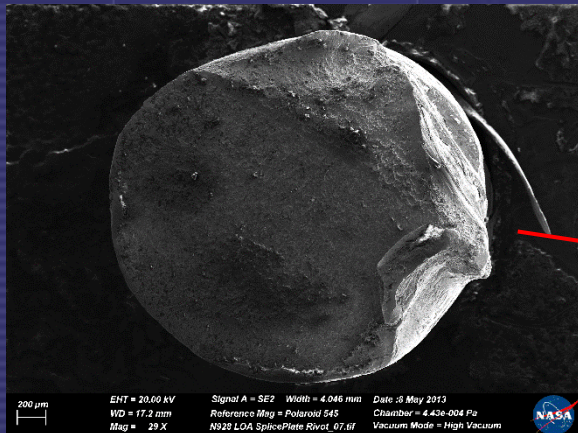
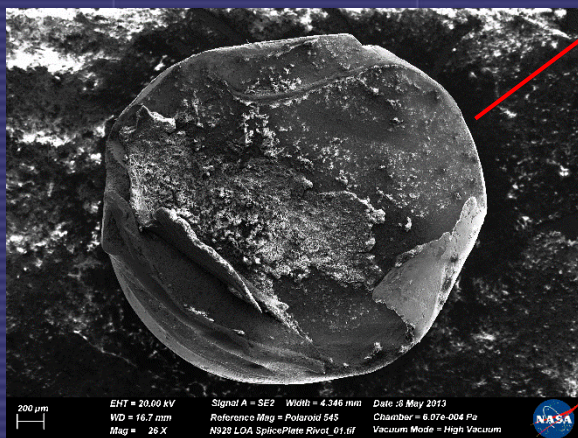
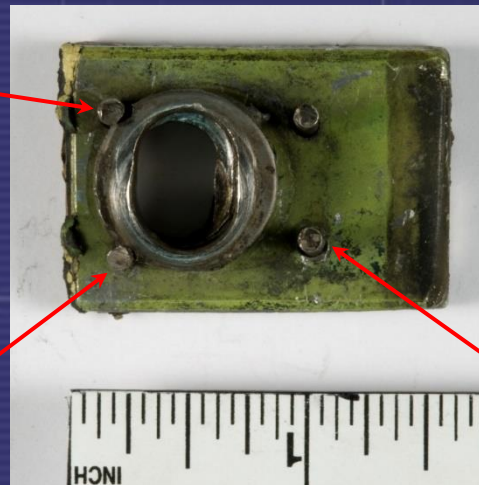
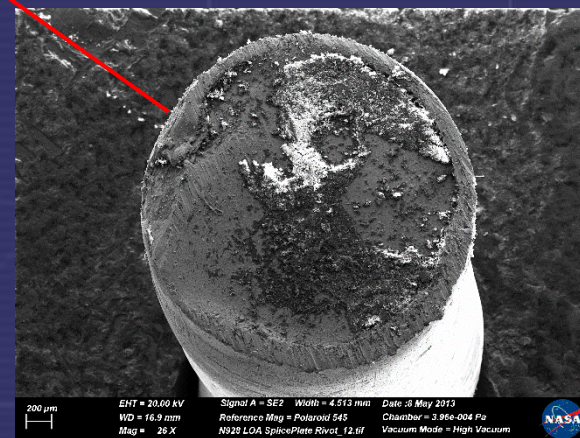
Spacer/Flange/Cowling Rivet Fracture Surface

- Monel 405 rivets
- Ductile failure fracture surface
 - No evidence of fatigue
 - Consistent with single overload event

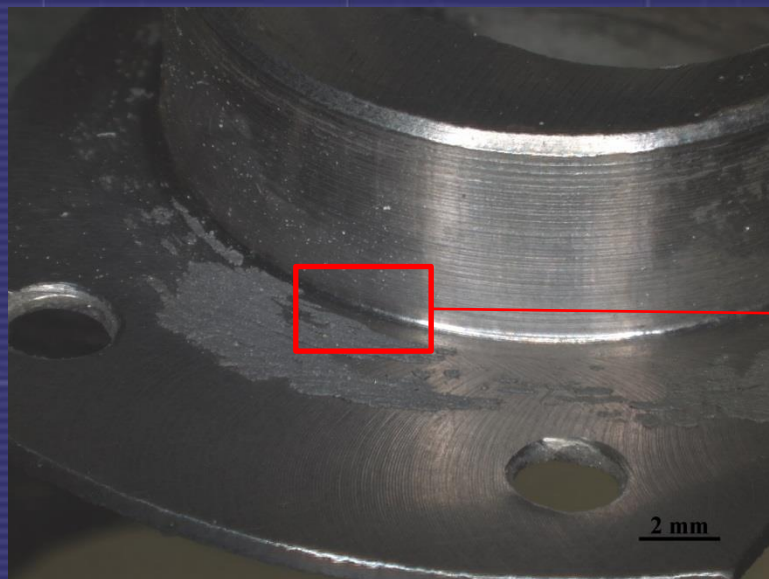
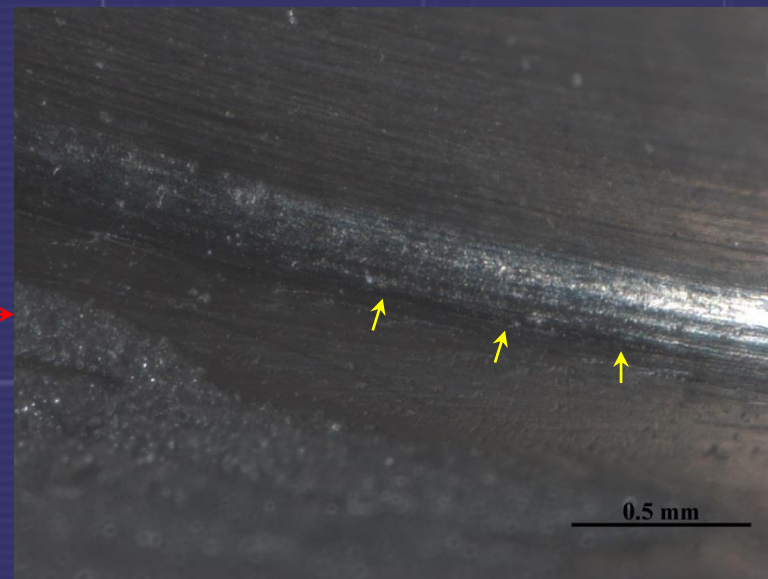
Stereomicroscope Images of A/C N928 RT Aft Outboard Bushing

Aft Outboard bushing contained wear and several crack-like features (yellow arrows) at the fillet.

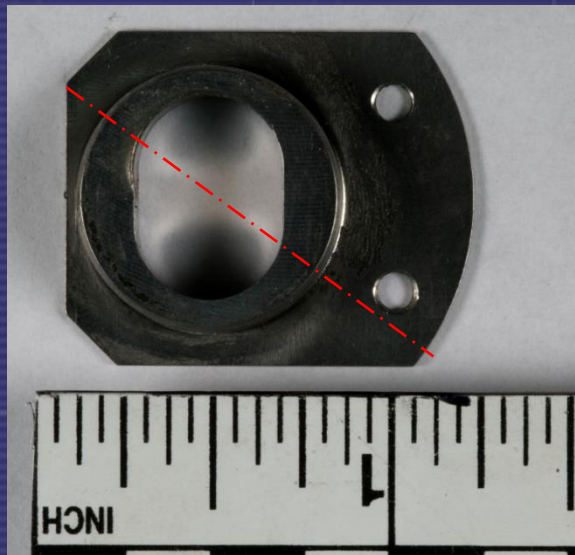
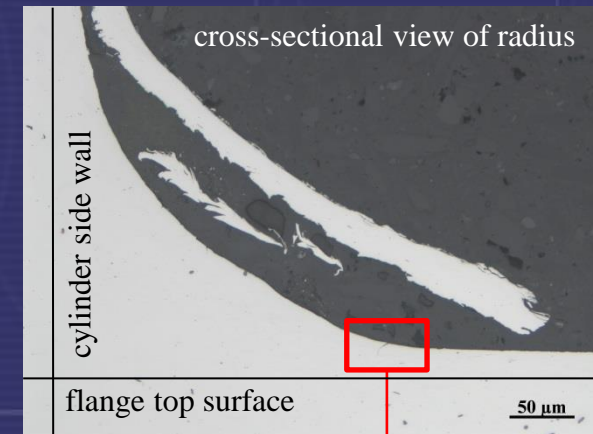
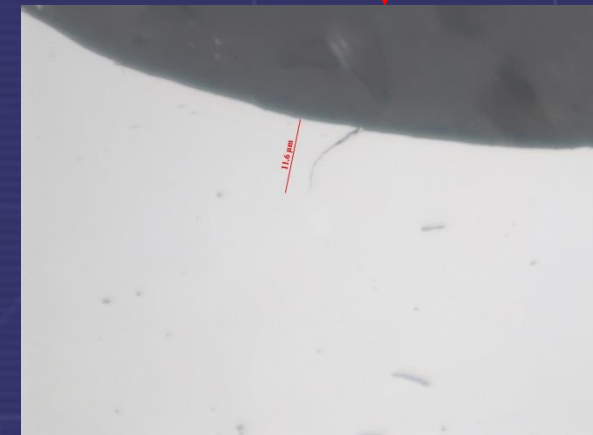
Metallography of A/C N928 (Incident A/C) RT Side (Non-Incident Side) Aft Outboard Bushings

Aft Outboard bushing was cross-sectioned to determine the depth of the crack-like features at the flange-to-cylinder radius. The feature was measured to have a depth of 12 microns (0.0005").

The shape of the crack is consistent with a fatigue crack emanating at a 45 degree angle down from the surface of the flange-to-cylinder radius and then changing direction to grow perpendicular to the flange top surface, propagating through the thickness of the flange.

- Five RT side cowling panel bushings were received intact. One bushing was damaged upon removal from panel.
- Bushings were NDE'd at EFD and on-site. No cracks were found.
- Upon viewing intact bushings under optical microscope, some bushings had crack-like features but source could not be determined non-destructively.
- Aft Outboard bushing was cross-sectioned and polished to view under Scanning Electron Microscope which revealed a 0.0005" long fatigue crack (well below NDE detection threshold).

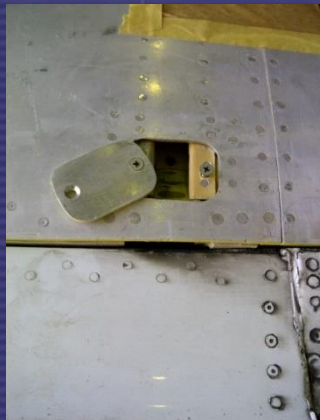
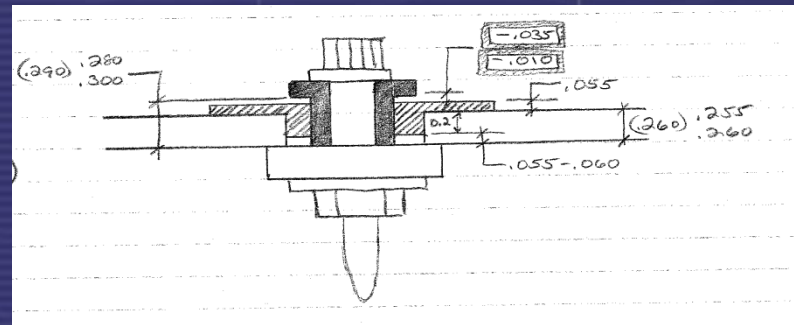
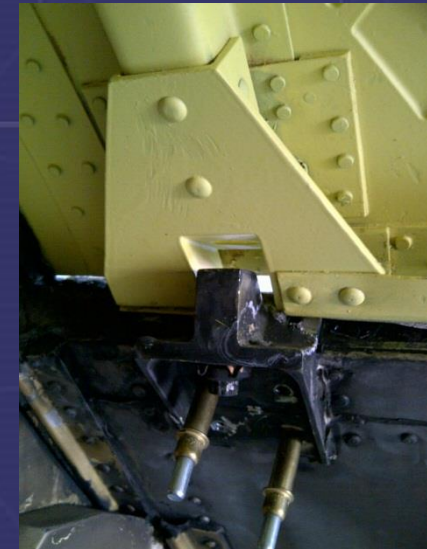
Bushing stress induced by cowling panel fit and joint stack up which varies panel-to-panel, joint-to-joint

Fatigue cracks were observed on both the left side incident cowling panel and the right side non-incident panel. Fatigue cracks on the incident side were much more extensive, likely due to differences in bushing stress caused by variations in panel fit and joint stack up.
