NASA/TM-2014-218538 (Corrected Copy)
NESC-RP-14-00957

A Comprehensive Analysis of the X-15 Flight 3-65 Accident

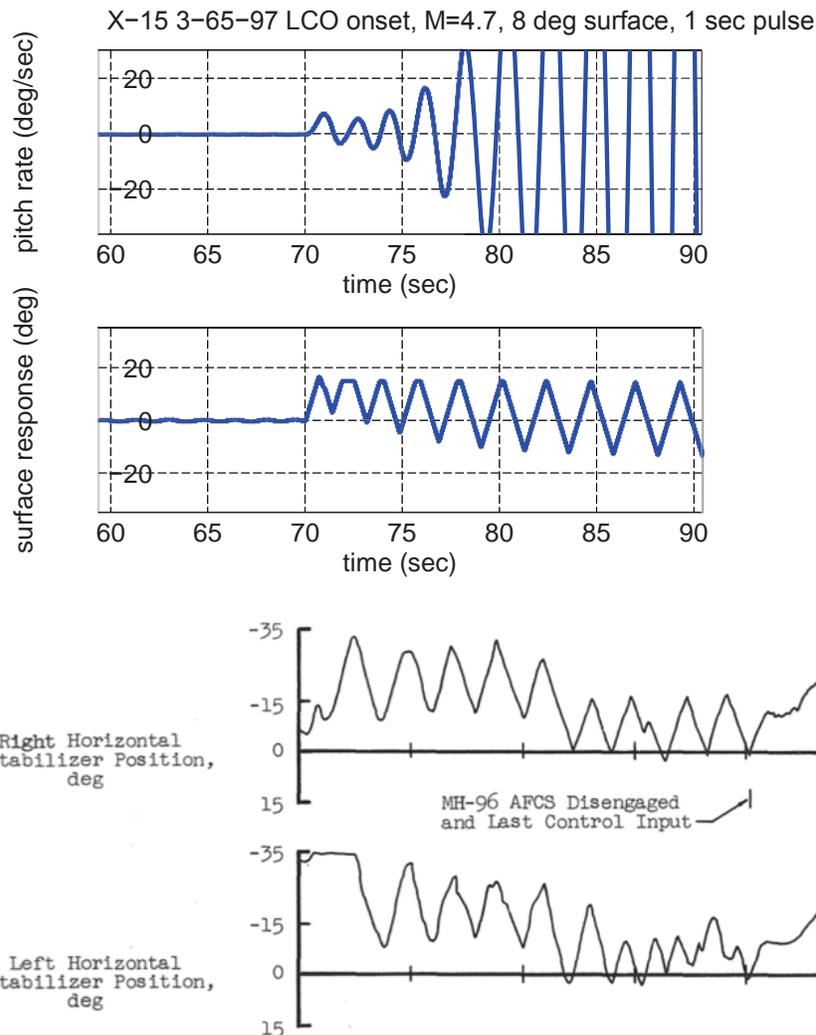
Figure 8.5-3. X-15 3-65 MH-96 Servo Actuator LCO (simulated) versus Flight Data

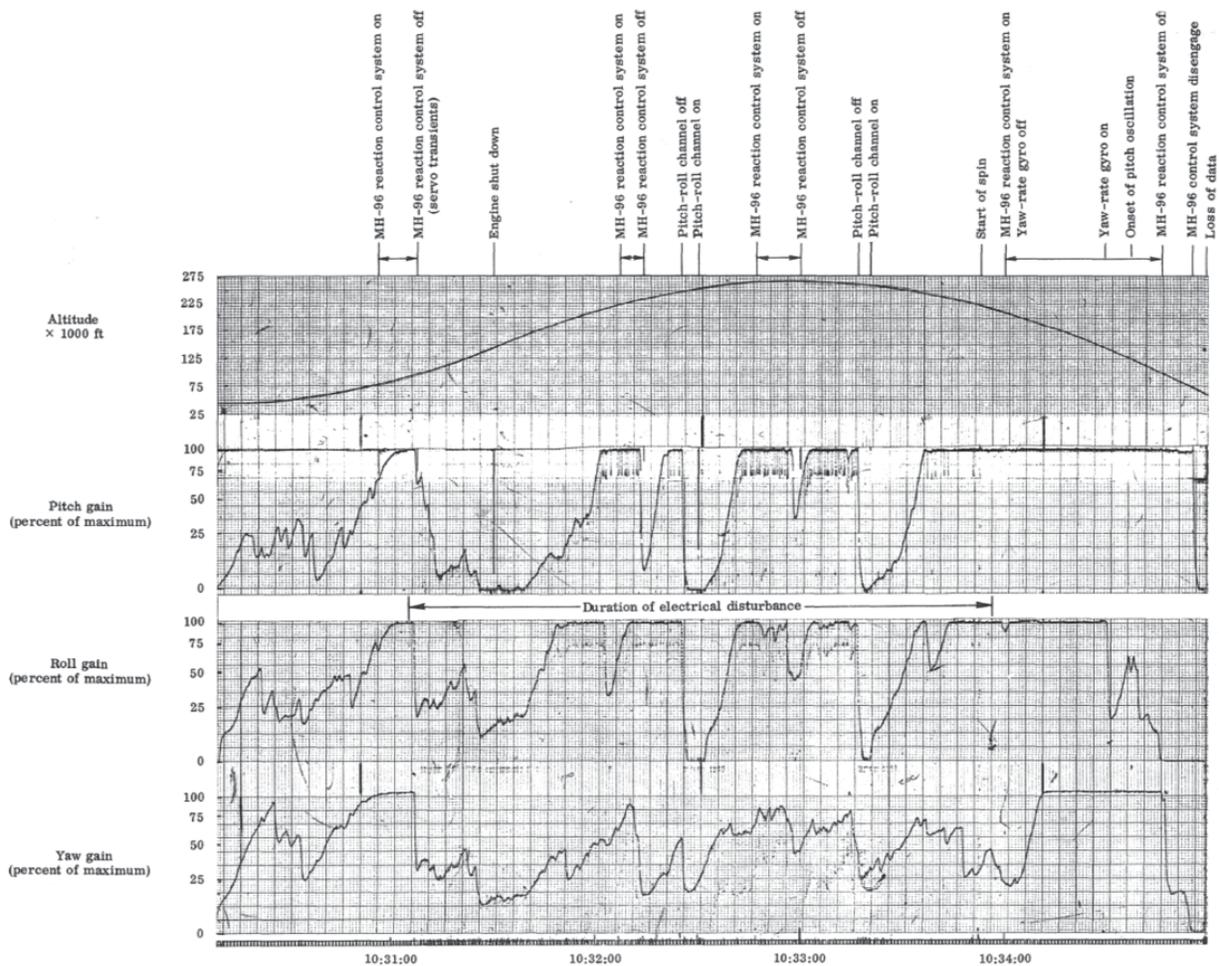
However, 14 seconds later, at 10:33:39 PST (MET + 211 seconds) and about 240,000 feet, the pilot reported that the aircraft control seemed “squirrely.” Twenty-two seconds later at 10:34:01 PST (MET + 233 seconds), the pilot said, “I’m in a spin.” Ground control did not acknowledge either of these transmissions. The pilot repeated, “I’m in a spin,” at 10:34:16 PST (MET + 248 seconds). At 10:34:17 PST (MET + 249 seconds), the flight controller said, “Say again.” At 10:34:17 PST (MET + 249 seconds), the aircraft was in descent at 184,000 feet with a velocity of 5,100 fps. The aircraft would begin to break apart 37 seconds later.

Figure 9.1-2. AFCS Gain Variation during Flight 3-65

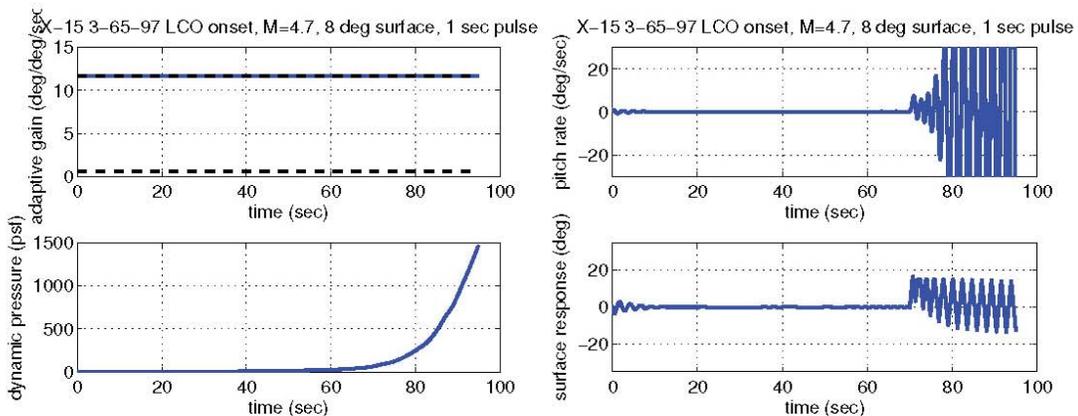
The adverse LCO appears in the anomalous entry due to saturation of the control surface actuators such that the short-period pitch mode of the aircraft is simultaneously excited during the period when the gain adaptation would otherwise be rapidly reducing system gain to compensate for the rapid increase in dynamic pressure (Figure A.15).

Figure A.15: MH-96 3-65 entry, pilot input

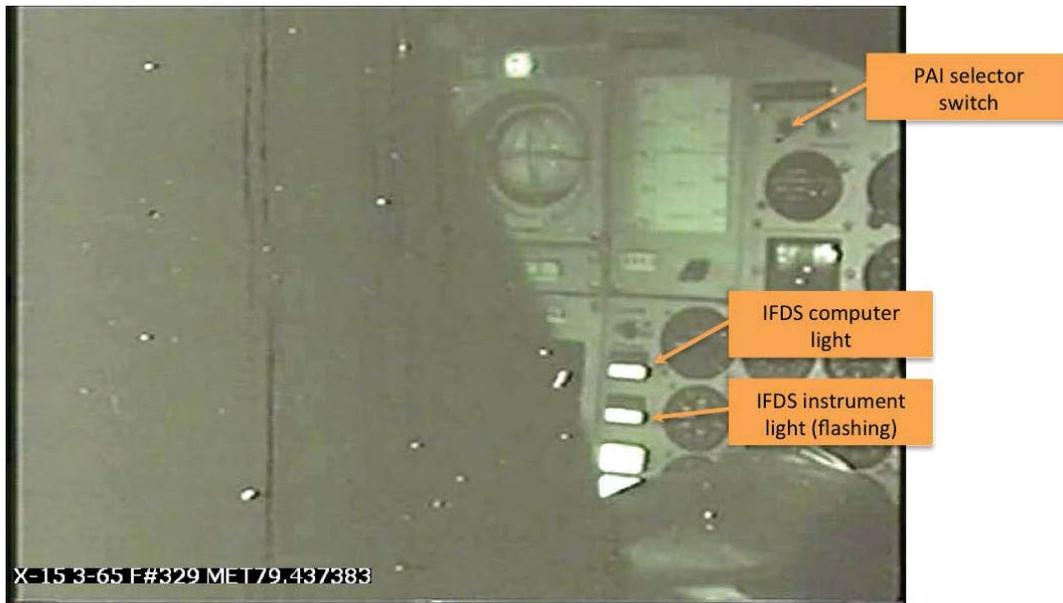
Figure B-10. Cockpit Film – Begin IFDS Malfunction (MET = 79 seconds, 10:31:27 PST)

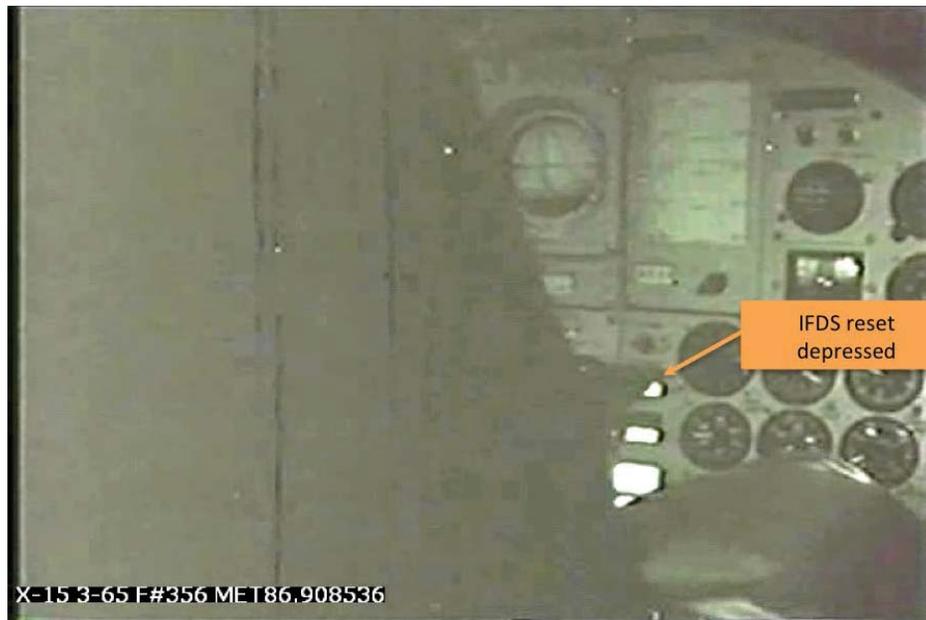
Figure B-12. Cockpit Film – Pilot Attempts IFDS Reset (MET = 87 seconds, 10:31:35 PST)

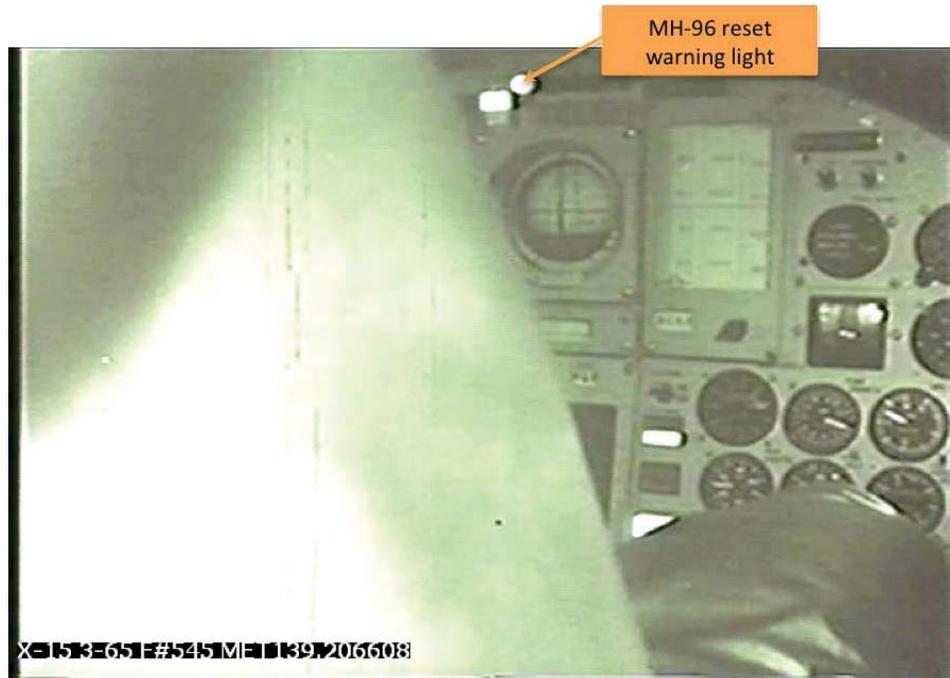
Figure B-14. Cockpit Film – One of At Least Two MH-96 Disengages (MET = 139 seconds, 10:32:27 PST)

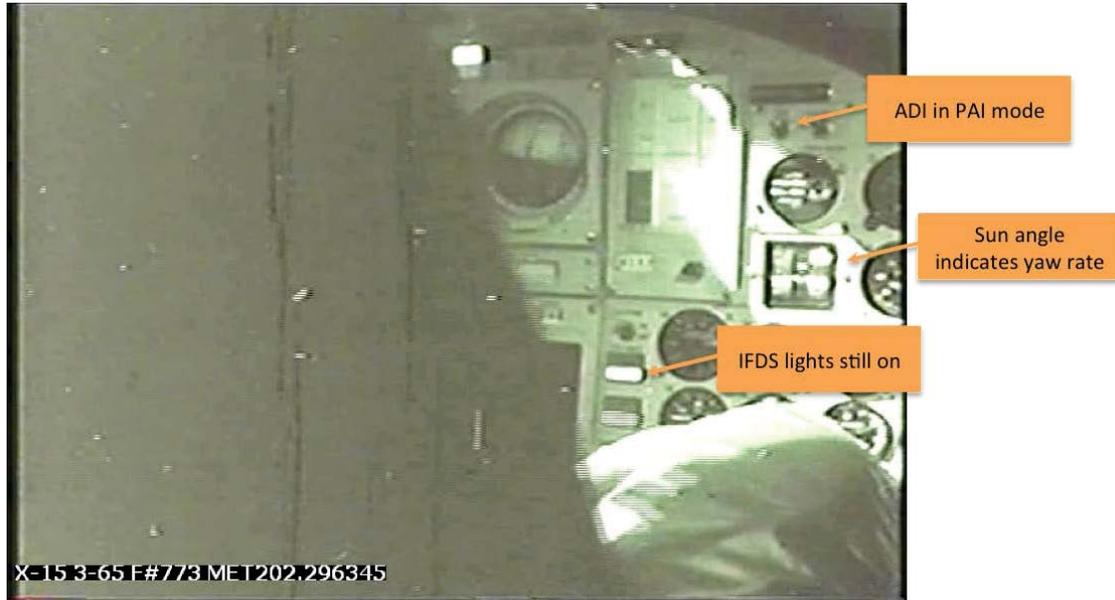
Figure B-16. Cockpit Film – Spin Entry (MET = 202 seconds, 10:33:30 PST)
