**A Historical Analysis of Crane Mishaps  
at Kennedy Space Center**

Crystal Wolfe

Kennedy Space Center

Date: 25 07 2014

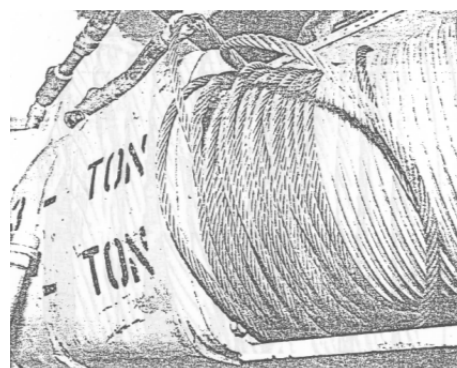
In 1989, the Indian government contracted to launch the INSAT-1D communications satellite on a Delta IV rocket at Cape Canaveral. During storage operations of a lid on an upper platform, the hook block of the 3-ton hoist was displaced approximately 14 degrees from the center of the hoist while the block was lifted without a load attached. This caused the wire rope to mis-spool around the drum, randomly overwrapping the wire rope (Fig. 4). Individual wires and then strands broke due to local interferences between the overlapping cables and the crane housing. The falling wire sections were caught by the debris shield above the hook and were not seen by technicians. During the next lowering operation, the broken section of the rope came off the spool causing the hook and debris shield assembly to fall and impact the top of the satellite. This caused \$10 million of damage to the spacecraft and delayed the launch by a year.

**Figure 4. Mis-spooled, spiraled and overwrapped wire rope on 3-ton hoist.**<sup>3</sup>

The primary cause of the accident was the side loading of the hoist while lifting the hook block. The manufacturer recommended a maximum fleet angle of 4 degrees, significantly smaller than the measured 14 degree offset. A contributing cause was improper training: operators had only been warned about side pulls with loads attached, not without. Additionally, lighting around the cable drum was inadequate to view the spooling operations from the hoist control pendant and the debris shield hid the initial indicators of rope failure.

Several lessons can be learned from this accident to prevent future mis-spooling incidents. The most important is that hooks should be centered under the hoist while lifting the hook block, regardless of whether a load is attached. Providing adequate lighting of the cable drum allows operators to watch the spooling operation. This includes considering potential lighting problems when redesigning platforms and supports. Hoists can also be equipped with enhanced safety features including hoist spooling bars, rope guides, or photocells to alert when a mis-spool occurs. These features are not required by current safety standards but greatly enhance the overall safety of the hoist.

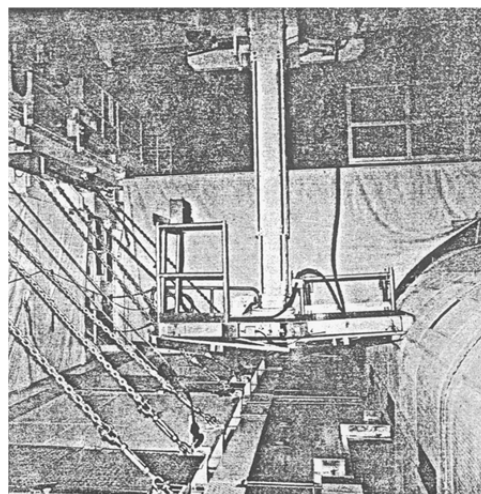
In 1985, during final closeout procedures for the orbiter Discovery, one of the Orbiter Processing Facility (OPF) Payload Bay Access Platforms failed. It fell from a stowed position, impacted chains supporting other work platforms, and pierced the protective blanket and payload bay door (Fig. 5). The falling platform struck a technician on a work platform below, bruising his shoulder and breaking his leg. This accident caused \$200,000 damage to the orbiter and platform and delayed the launch for three weeks.

Technicians had been trained to use the upper limit switch as a lift stopping point, which violated both OSHA and the NASA Lifting Standard safety rules. The upper limit switch on this particular platform was broken, which caused the telescoping structure to impact the supporting structure (two-blocking). This problem had been noted and the platform had been tagged out of service four days prior to the accident. Technicians mistook the tags for older tags and used the platform in the days leading up to the accident. Since the upper limit switch was broken, the technicians used the sound of the hoist to tell them when to stop. This two-blocked the hoist every time it was stowed. A linkage in the hoist eventually broke and failed when the platform was moved.

**Figure 5. Payload Bay Access Platform after accident.<sup>4</sup> Orbiter is on the right.**

The design of the telescoping tube system made it impossible to inspect the linkages in the hoist without disassembling the telescoping tube. After the accident, the remaining payload bay access platforms were disassembled for inspection and all of them showed signs of having been repeatedly two-blocked. As a result, the hoists and telescoping tubes were redesigned for easier inspection and safer operation.

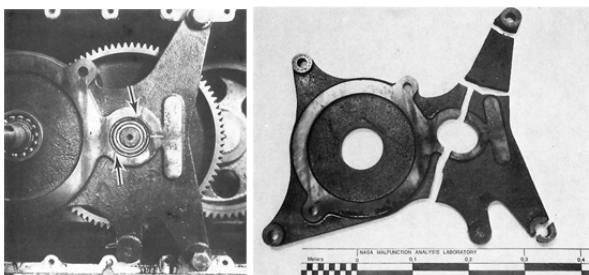
**Figure 6. Cracked Gear Case Spider.<sup>5</sup> Left: Spider inside crane. Right: Spider removed for inspection.**

While most two-blocking incidents cause an immediate accident, damage from two-blocking can also be hidden. Changes in the crane behavior and noise levels prompted a special gearbox inspection of the 40-ton crane in Hangar AF. A crack was discovered in a gear case spider (Fig. 6) and the spline on the end of the drum shaft was deformed (Fig. 7). It was determined that the damage was caused by overload, most likely due to a two-blocking incident that had occurred three years prior. At the time of the inspection, Space Shuttle Solid Rocket Motor segments were being handled using this crane.

After two-blocking has occurred, the entire hoist mechanism should be inspected for hidden damage. Proper lock-out/tag-out procedures should be followed to prevent further incidents until repairs can be made.

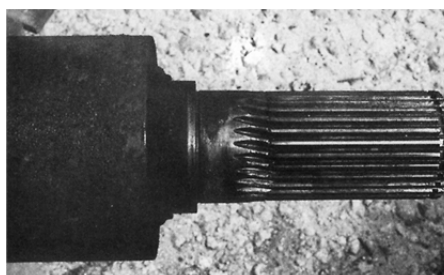
**Figure 7. Deformed drum shaft spline.<sup>5</sup>**

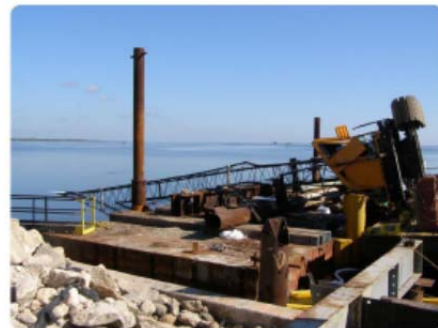
In 2010, a lattice boom mobile crane on a barge at the Jay Jay Railroad Bridge was setting pilings with a hydraulic driver. Several pilings had already been successfully placed on the south end of the barge. While placing a piling on the north-west end of the barge, the crane boom was lowered to avoid lifting the load over personnel and equipment. This increased the radius of the load very close to the maximum safe load radius. The load was swung clockwise toward the intended position. When it was perpendicular to the crane's crawler tracks, the crane began to tip. The operator was ordered to raise the boom to reduce the radius; however, he chose to lower the load using the hoist control instead in an attempt to safely lower the load onto a nearby barge. The load radius increased as the crane tipped further and the weight moved away from the crane. The barge also listed as the center of gravity of the crane moved, further exacerbating the tipping and the crane fell over (Fig. 8). The load fell into shallow water and the boom hit the pilings on the nearby barge. The operator sustained a minor laceration and the crane incurred \$100,000 damage.

**Figure 8. Overturned mobile crane on barge at Jay Jay Railroad Draw Bridge.<sup>7</sup>**

The primary cause of the crane overturning was exceeding the lift capacity of the crane. The crane operator was told at the site safety meeting the previous day that the load (including the hydraulic driver) was 9 tons. The weight of the hydraulic driver was miscalculated by the lift planner and the actual load was 10.5 tons. Due to this, the safe load radius of the crane was less than expected. NASA gave the contractor approval to conduct operations in accordance with the lift plans, but did not review them to the level required to realize the mistake in the load weight.

manufacturer load charts are not followed correctly. A key lesson is that lift planners should produce clear lift drawings that take into account multiple factors: safe lift restrictions based on load charts, reduced sling capacity due to angular displacement, and the location of the center of gravity of the load that is being lifted. A full understanding of the static and dynamic forces that occur during the lift is critical to keep the load safe.

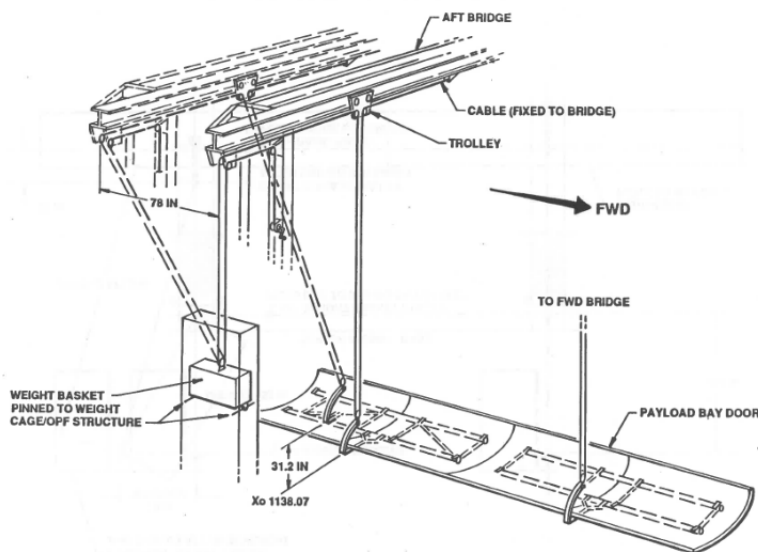
In 1990, an incident occurred in which the weight basket was left pinned to the weight cage. During the previous shift, preparations had been made to close the right payload bay door. The Zero-G fixtures had been installed on the right side of the orbiter and the inhibit switches on the crane bridge had been activated to prevent movement. Since the procedure was due to be completed by the following shift, the weight baskets were left pinned to the weight cages. On the next shift, a technician was assigned to perform work on a different area of the orbiter. This work was not part of the master schedule. During the walkdown, the technician only checked the left side of the Zero-G system, which was not hooked up to the bridge. The technician then turned off the inhibit switches and moved the crane bridge approximately 6 feet to the aft of the orbiter. This pulled on the Zero-G system and caused the weight

Figure 9. Diagram of Zero-G system attached to crane bridge showing deflection due to moving crane bridge.<sup>8</sup>

basket to jump off the track, breaking a pulley, fraying a cable, and deflecting the C-hook. The aft portion of the payload bay door was displaced upward 31 to 33 inches. The door was undamaged but required \$75,000 of analysis. The damaged fixtures required \$45,000 to replace and repair.

In the Payload Bay Door accident, the operating manual required a thorough walkdown and inspection of the bridge before moving. Performing complete walkdowns of the lifting area can significantly minimize load hang-ups. The lift area should be clear of hazards in all directions. The load should be free from constraints (bolts, pins, etc.) and observers should be used to alert the crane operator of other potential hazards. A good practice is to start lifting operations at slow speeds in case the load is accidentally constrained.

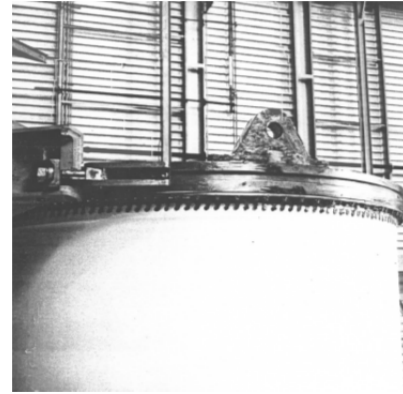
In November 1985, technicians were in the process of removing the pins from the lifting ring. There were 31 pins left to remove when the lead technician asked the crane operator to pick up the approximate weight of the lifting fixture (11,000 pounds) to aid in pin removal. The crane operator watched the load cell indicator while moving the hoist very slowly upward. About 85 seconds later, they heard a loud bang and the lifting ring jumped upward. The emergency stop on the crane was activated. The SRM clevis was damaged in multiple places with elongated pin holes and a piece of metal gouged out of the clevis. Two segmented ring segments were damaged: one with an elongated hole and the other with a broken corner.

The primary cause of the accident was removal of the ring being performed without following the approved procedure. The procedure prohibited crane movement until all shipping pins were removed. Apparently, the request to lift 11,000 pounds was an attempt to take the weight of the forward handling ring off the segment. This, along with not loosening the handling ring bolts, had become common practice to aid in pin removal. The 11,000 pounds was not calculated. It had been derived over several processing operations as the indicator on the load cell that best facilitated the pin removal.

**Figure 10. Handling ring installed on SRM segment.<sup>9</sup>**

As learned from the SRM Handling Ring mishap, crane operators should not rely on single indicators such as load cell readouts – multiple indicators including hook position indicators, hoist ammeter, and outside observers should be checked during lifting. The emergency stop operator should be close enough to the lift to be aware of potential problems and stop the lift if necessary.

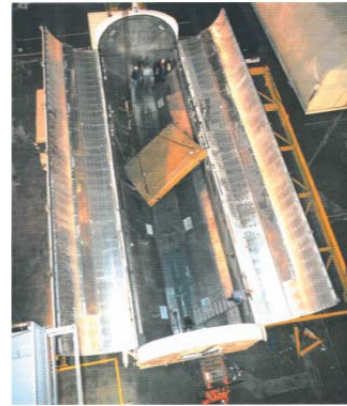
The Shuttle Payload Canister was damaged due to a crane component failure in 1989 (Fig. 11). The canister and test weight were used to load test lifting fixtures in the Payload Changeout Room at Pad A that had been recently modified. After validation, the test weight and canister were moved to the Vehicle Assembly Building (VAB) for removal of the test weight from the canister. Due to other operations in the VAB, a mobile crane had to be used to remove the test weight.

While removing the test weight, the crane was very close to its maximum safe lift radius due to miscalculations in the radius by the operators. After initially being lifted approximately 6 inches, the weight suddenly dropped back onto supports on the edge of the canister. No thorough analysis was conducted on the incident. The task leader was assured by other personnel that everything was okay and the lift continued. After the load was raised above the canister again, the operator swung the test load to the left toward the waiting trailer. The boom then spontaneously lowered rapidly. This boom run caused the weight to swing away from the crane, exceeding the safe lift radius and causing the crane to tip. The weight crashed into the payload canister, causing an estimated \$287,000 damage that took two months to repair.

**Figure 11. Dropped test weight in Payload Canister.**<sup>10</sup>

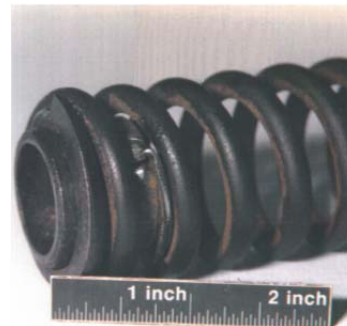
The investigation board determined that the primary cause of the accident was problems with the boom hoist brake. The brake release was not assembled properly: the spring retainer was missing and had been replaced with a thin flat washer. The washer failed and both the washer and the spacer were pushed inside of the spring (Fig. 12). This affected the ability of the brake release mechanism to actuate. Additionally, the boom hoist brake was misadjusted to the point where the boom hoist brake would not release when actuated. The boom hoist motor drove through the brake when raising and lowering the boom, causing wearing and heating of the brake. This caused reduced brake torque to the point where the brake finally slipped.

**Figure 12. Washer and spacer pushed inside spring.**<sup>10</sup>

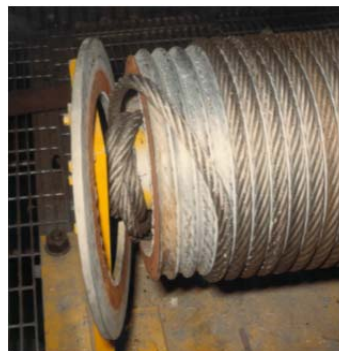
Visual examination of the winch system indicated that the drum flange came off of Winches #5 and 6. On both of these winches, the wire rope wrapped itself around the drum shaft (Fig. 13). The wire ropes then failed due to rapid tensile overload (shock load) caused by the load dropping and catching suddenly. This

**Figure 13. Separated end plate on Winch #6.**<sup>11</sup> Note cable wrapped on shaft.

happened when the drum flange came off and the rope jumped off the drum onto the drum shaft. Detailed examination by the Malfunction Analysis Branch determined that the weld on the drum and end plates displayed a “gross lack-of-penetration” and “numerous areas of lack of fusion.” The end plate weld on Winch #7 also exhibited cracking, but did not fully separate. Winch #8 suffered severe cracking in the housing of the drum gear box and motor.

The manufacturer contended that the end plates were never designed to support the side load created by overwrapping the cable on the drum. They stated that the drum was designed to support the original cable length of 36 feet without overwrapping.

All of the winches in this accident were replaced at the contractor’s expense. Other similar winches on the Mobile Launcher Platform were modified at NASA’s expense to support potential overwrapping. The wire ropes were also shortened to the original 36 feet specified.
