NASA Electronic Parts and Packaging (NEPP) Program

Effect of Preconditioning and Soldering on Failures of Chip Tantalum Capacitors

NEPP task 2014

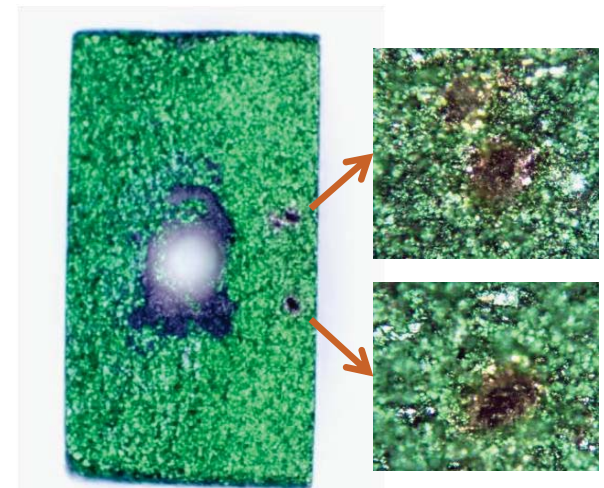
Top view (anode shoulder) of a stripped capacitor showing damaged sites

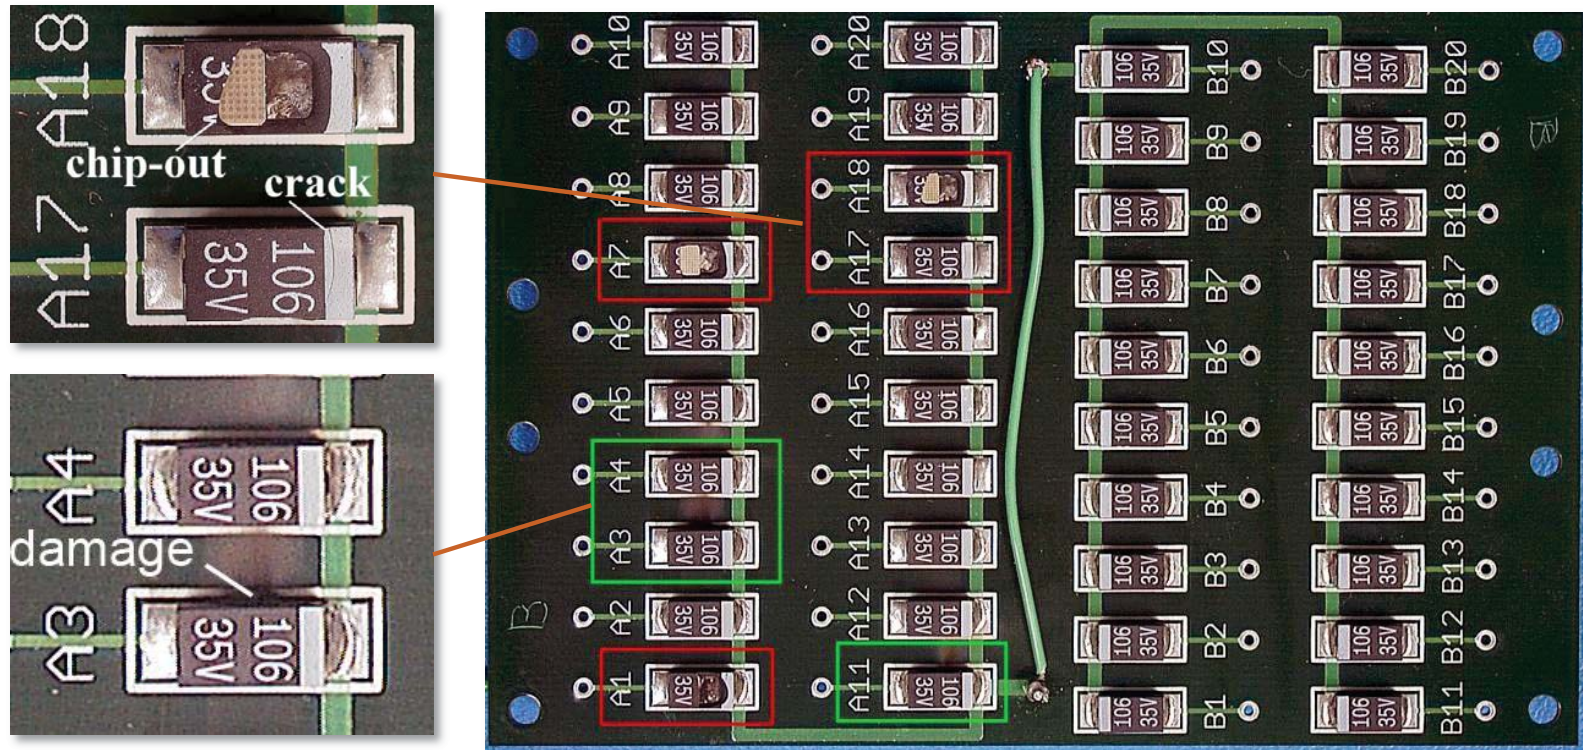
- ❑ Board B was populated with CWR29 capacitors that were preconditioned in humidity chamber (samples A1-A20) and reference parts (samples B1-B20).
- ❑ Cracks were observed on the top and at the bottom of the CWR29 capacitors.

- ✓ No case defects were observed after soldering.
- ✓ Case cracking and damage occur in 50% of CWR29 capacitors after SCT.
- ✓ SCT did not cause damage to CWR09 (reference) parts.

- ❑ Chip-outs and cracks in the case were not observed after soldering, but occurred after surge current testing in CWR29 capacitors preconditioned by moisture soak.

- This might indicate that case cracking is due to moisture remaining in the parts after soldering and overheating of the moisture containing MnO₂ layers by surge currents.

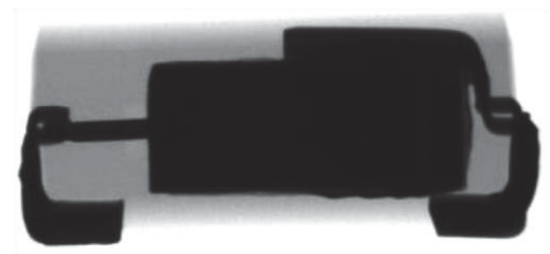
Typical X-ray view showing location of internal part of cathode terminal

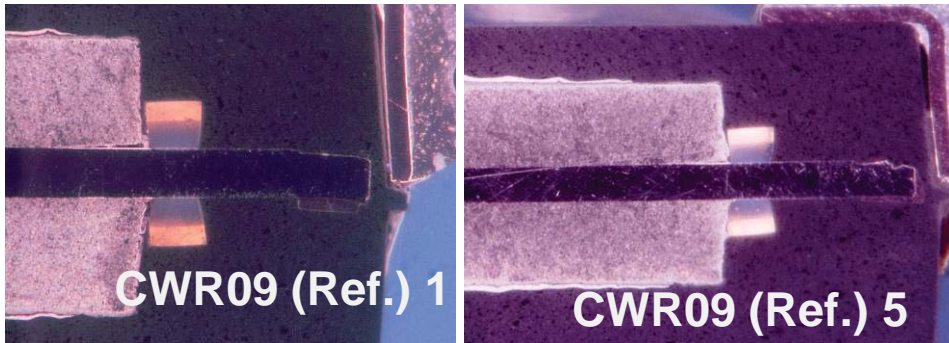
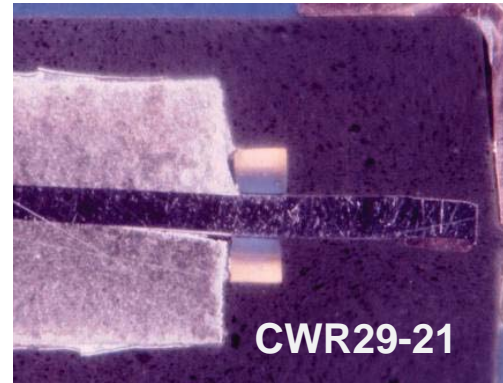
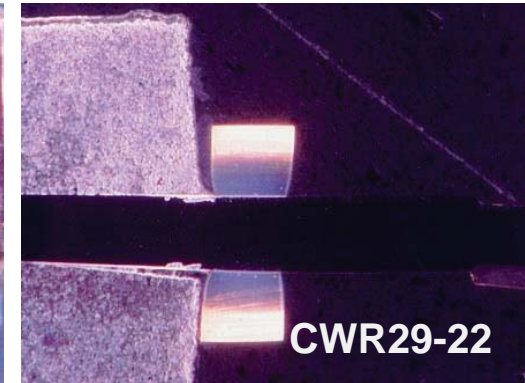
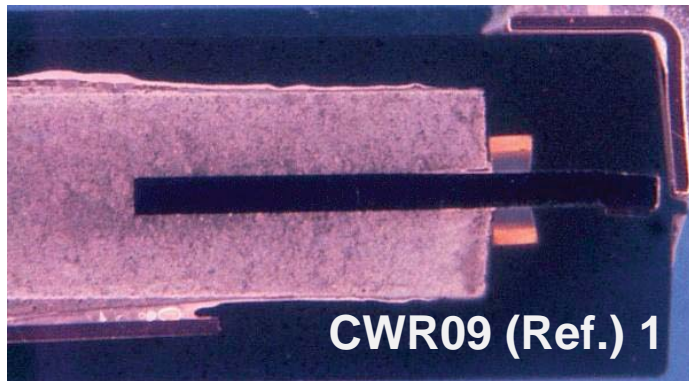
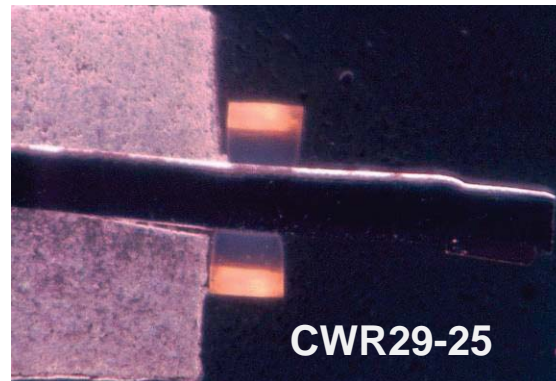
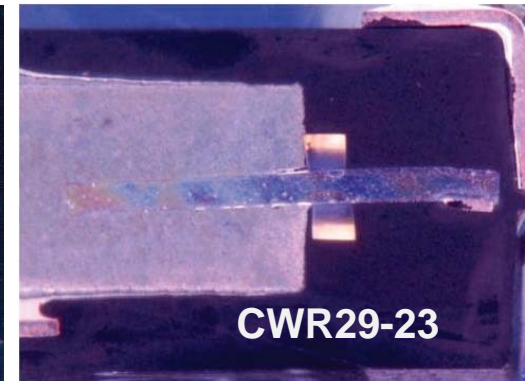
Results of Cross-Sectioning

Parts failed after reflow soldering have been cross-sectioned in small steps in the attempt to reveal damaged area.

- ✓ No substantial difference between CWR29 and reference parts.
- ✓ Delaminations between riser wires the slugs was observed in both part types.
- ✓ No obvious defects that might be associated with failures were detected.

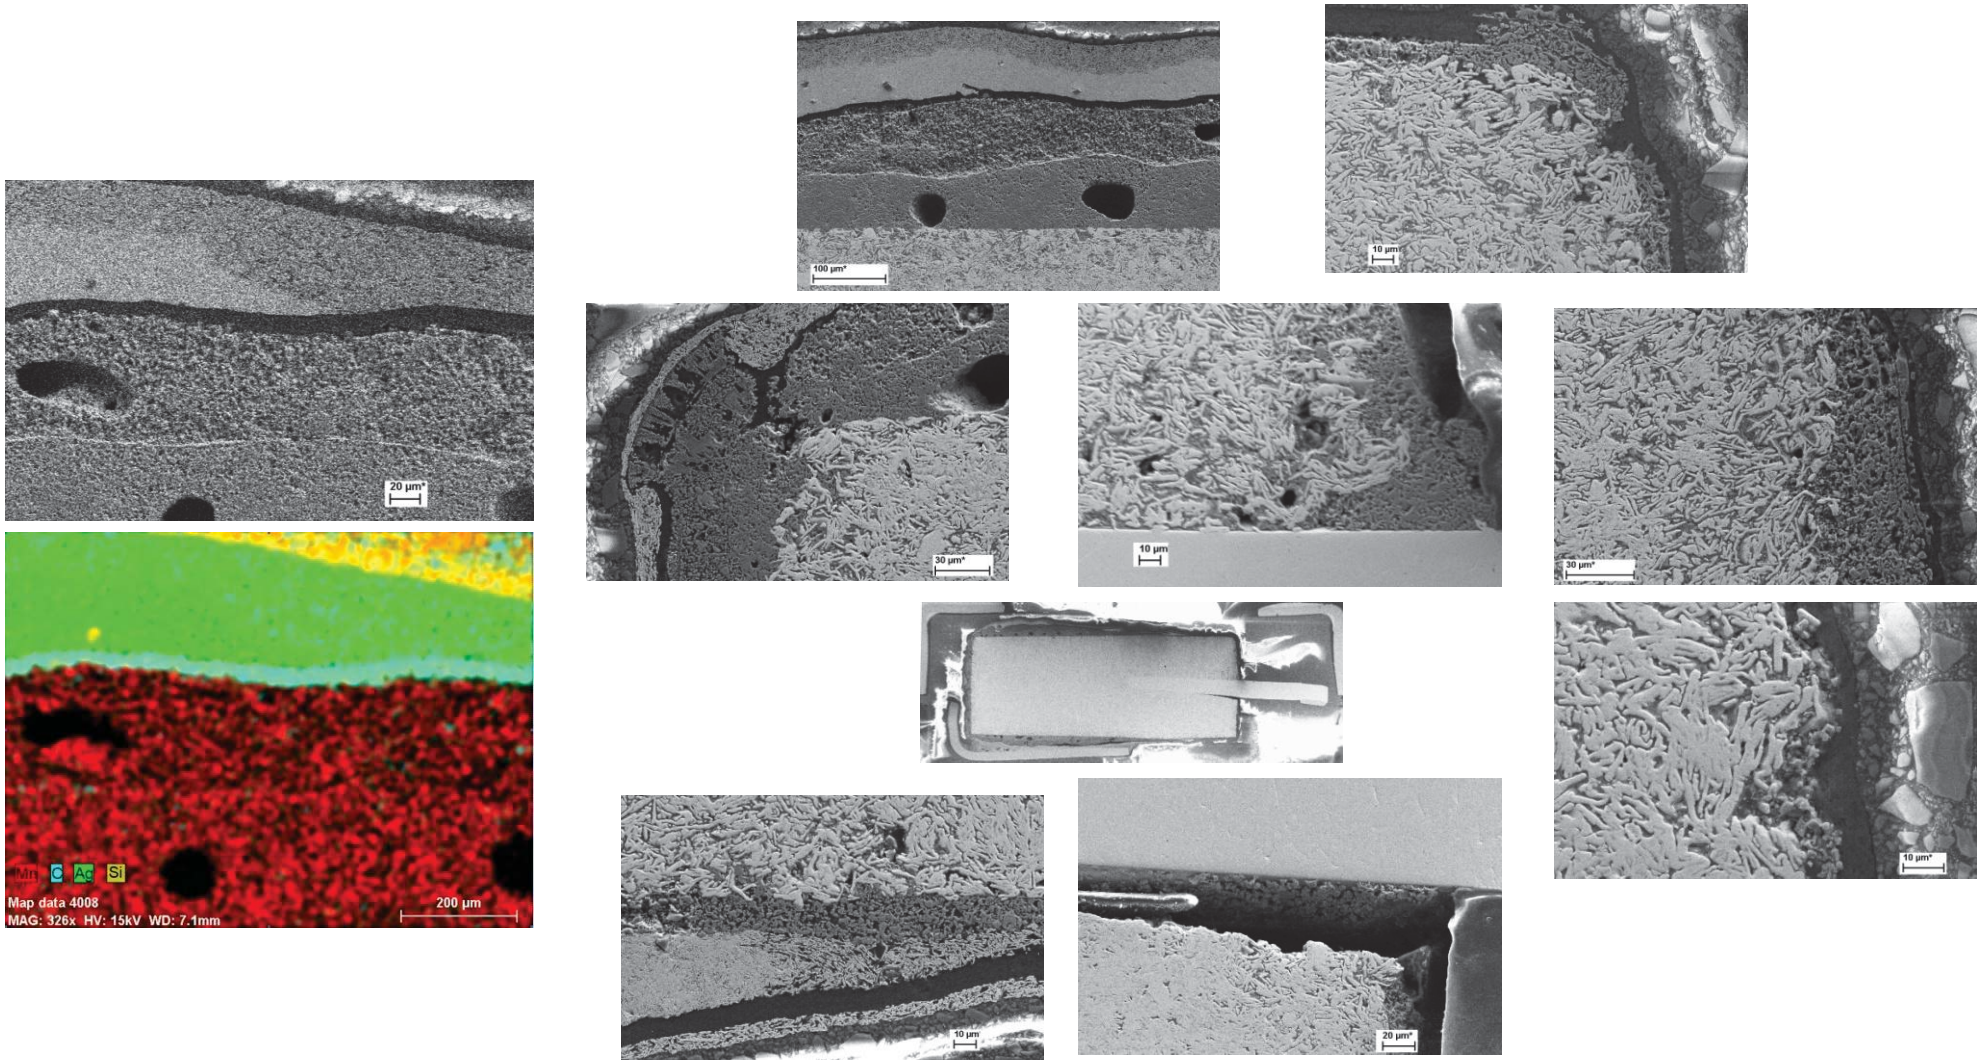
SEM Images and X-ray Mapping CWR29

- ✓ No anomalies observed, good coverage of the slug with MnO₂ and carbon.
- ✓ The riser wire shoulder had a thin layers of MnO₂ and carbon coatings.

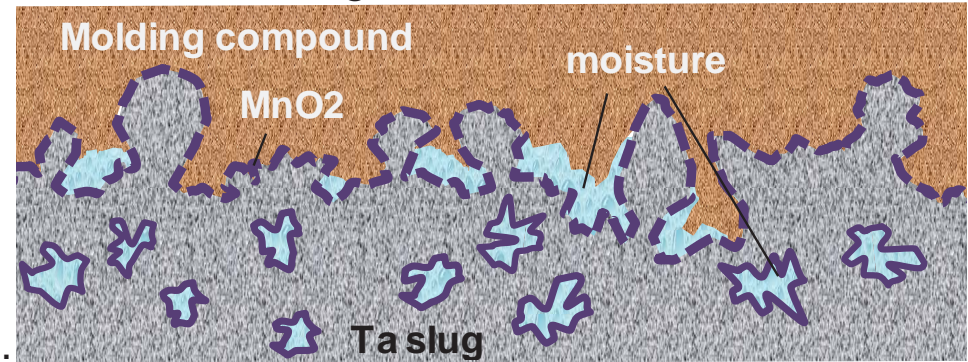
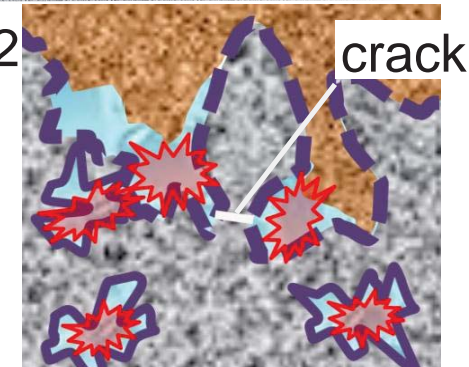
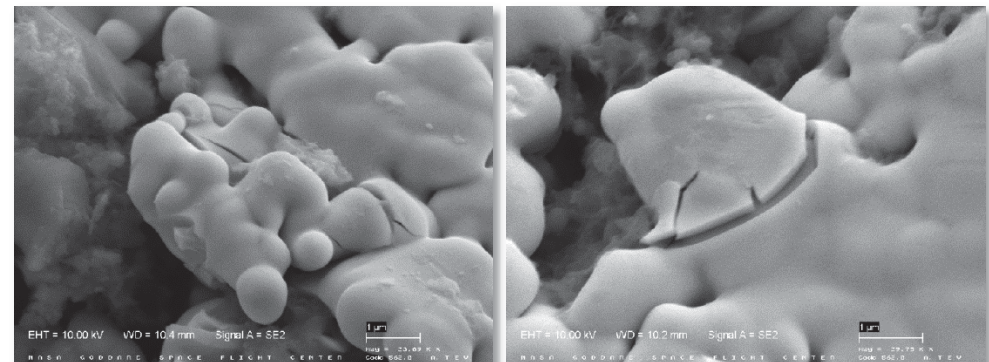
- ❑ During soldering, moisture condensed in cracks, pores, or MnO₂ evaporates rapidly creating high local pressure in the sponge-like structure of Ta anode and increasing delamination between MC and slug. When this pressure is applied to a mechanically weak site of the slug, a fracture of Ta₂O₅ dielectric occurs. This effect can be defined as internal popcorning.

Schematic of local popcorning that can cause cracking in Ta₂O₅ dielectric

Examples of cracks in the dielectric of 6.8uF 35V CWR11 capacitors

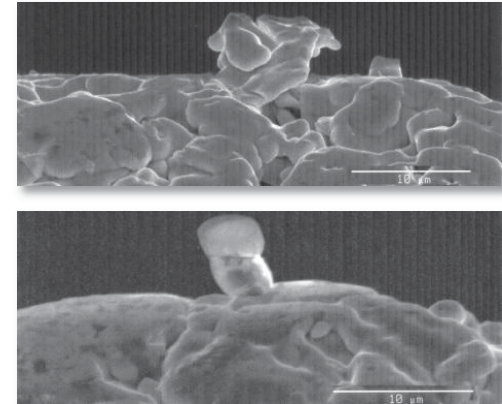
Example of weak sites on the surface of CWR11 capacitors

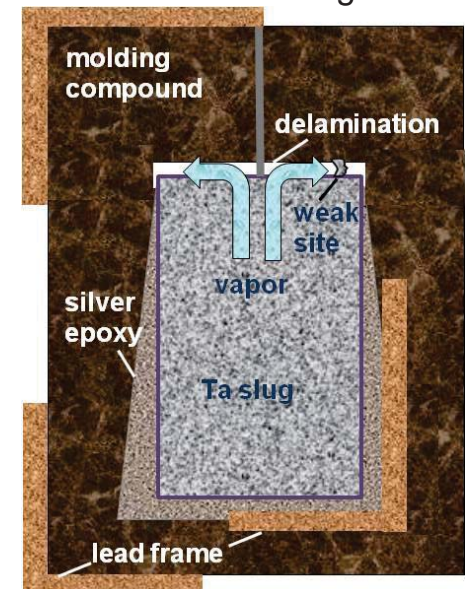
Schematic of popcorning-induced damage
