End-of-test Performance and Wear Characterization of NASA's Evolutionary Xenon Thruster (NEXT) Long-Duration Test

Rohit Shastry, Daniel A. Herman, George C. Soulas, Michael J. Patterson

NASA Glenn Research Center, Cleveland, OH 44135, USA

Presented at the 50th AIAA/ASME/SAE/ASEE Joint Propulsion Conference

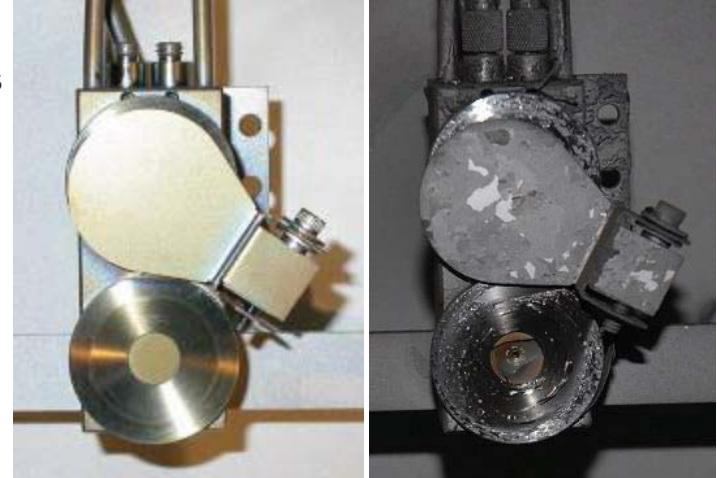
- Quartz crystal microbalance had failed after ~12.5 kh
 - Inspection revealed both crystals had shattered – crystals were replaced and QCM shutter was removed

- Staggered planar probes showed signs of shorting to ground, with permanent short observed at ~ 14 kh
 - Inspection revealed deposition on insulator between collector and guard ring, as well as coaxial cable short – cable was replaced and insulators cleaned

- Internal ionization gauge failed after ~ 6.5 kh
 - Inspection revealed probe clamp had failed, grounding probe grid – probe replaced with high-accuracy ionization gauge

- LED lighting for in-situ cameras degraded significantly between 30 – 40 kh
 - Inspection revealed damage to plastic diffusers – lights and/or diffusers were replaced

- Viewports on facility with backsputtered deposition were replaced
- An additional auxiliary flow line was placed at the chamber mid-length to facilitate pressure variation studies on thruster telemetry and performance

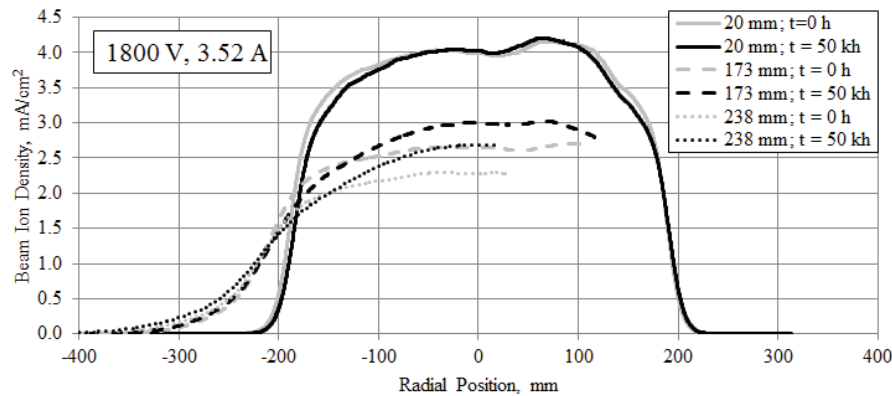
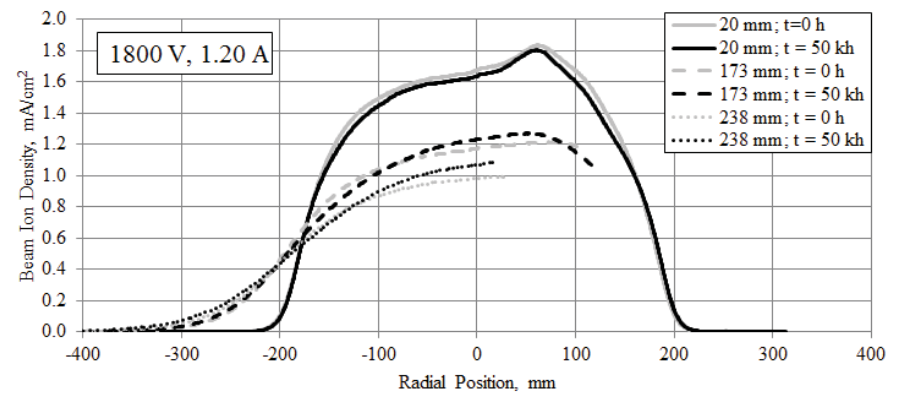
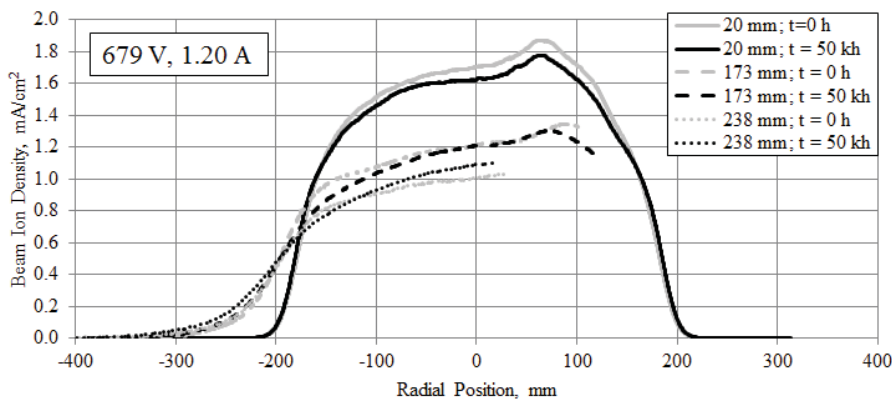
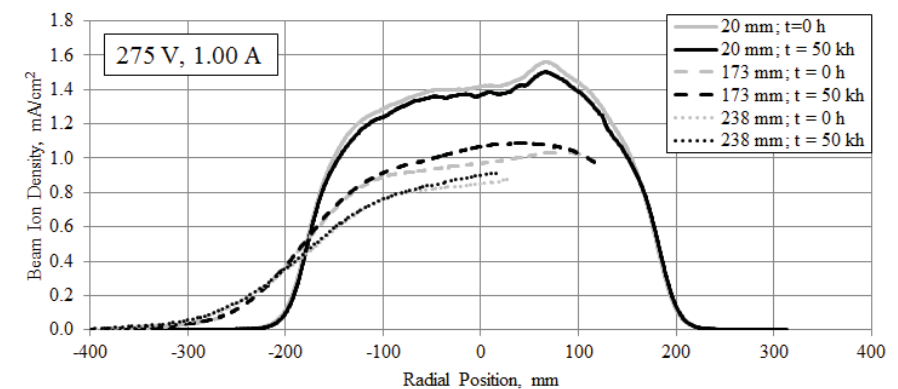
- Comparison of pre-test and end-of-test profiles indicate only minor changes to profiles 20 mm downstream of optics
- More significant changes observed at 173 and 238 mm, the cause of which is still being investigated
- Calculated properties, such as divergence angle, showed little change between 13 and 50 kh

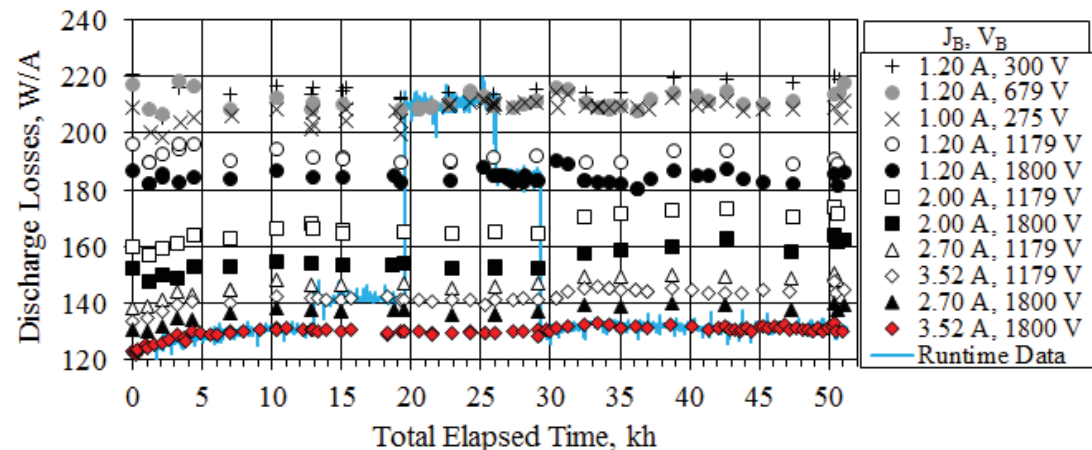
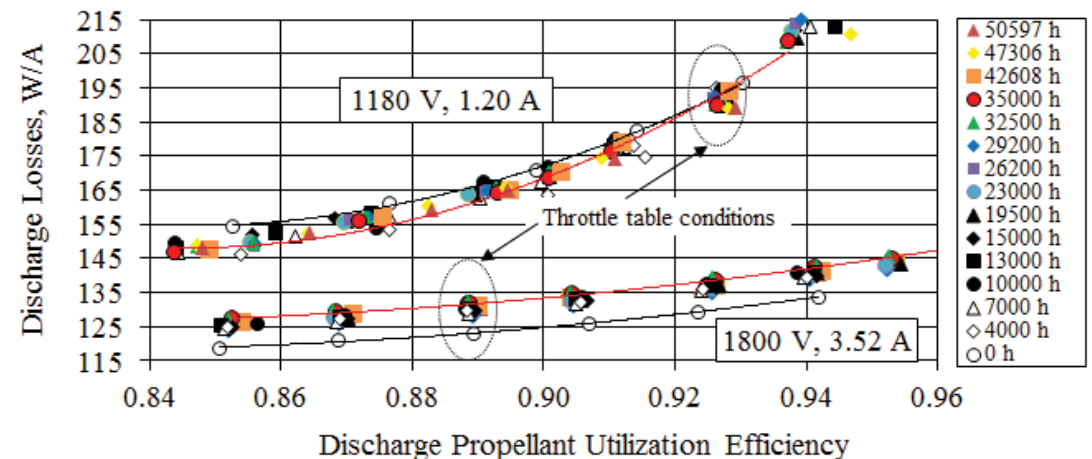
- Modest increases in discharge losses ($\leq 8\%$ across throttle table), primarily occurring in the first 10 kh of operation
- Increase primarily attributed to observed accelerator grid aperture chamfering, causing a drop in neutral density within the discharge chamber
- Negligible changes in discharge performance due to diagnostic repair process
- Discharge characteristics shift up (within first 10 kh) with no shape change, corresponding to rise in discharge losses and no magnetic circuit degradation

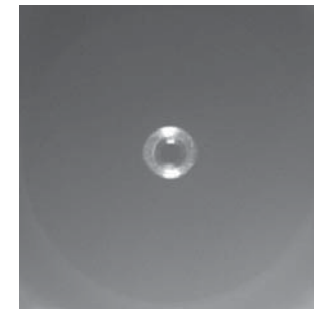
NEXT DCA @ 0 h

- In-situ camera images of NEXT discharge cathode assembly indicate minimal change ($< 5\%$) in cathode orifice diameter
- Decreasing trend in keeper orifice diameter over last 10-15 kh found to be likely due to camera lighting degradation – repaired lighting confirms minimal change ($< 5\%$)
- Change in cathode orifice chamfer diameter confirmed at $\sim 20\text{-}25\%$ increase over 51 kh
 - Post-test inspection is needed to confirm dimension and determine overall shape of chamfer
- Change to graphite keeper material has resulted in intact electrode even after 51 kh – excessive keeper erosion observed in NSTAR has been mitigated

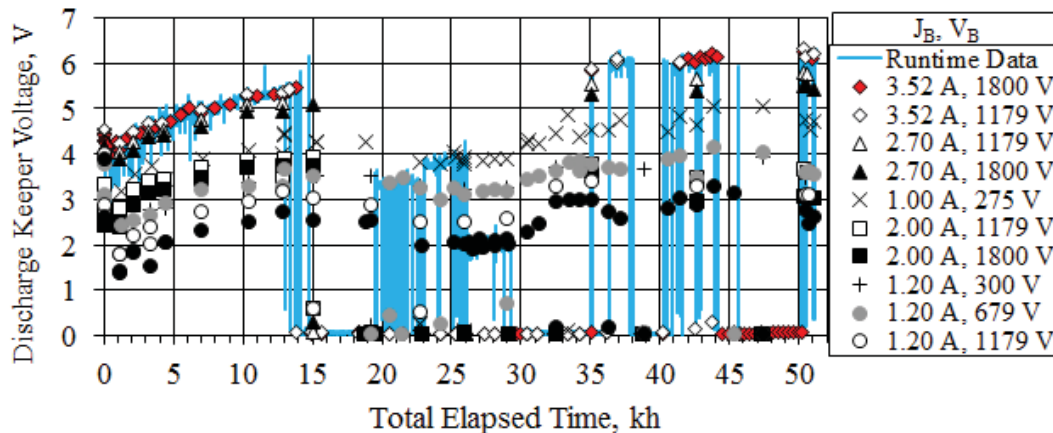
- Thermally-induced shorting has been observed between discharge cathode and keeper since ~ 14 kh
- Development of consistent short at ~ 48 kh, and its subsequent removal at ~ 50 kh, likely a result of anomalous pressure excursions (to ~ 300 mTorr) during facility regenerations
- This short has resulted in ignition times in excess of 10 minutes
- Determination of the root cause of this short is a critical task of the post-test inspection and analysis
- Methods to mitigate this issue and eliminate extended duration ignitions are actively being investigated

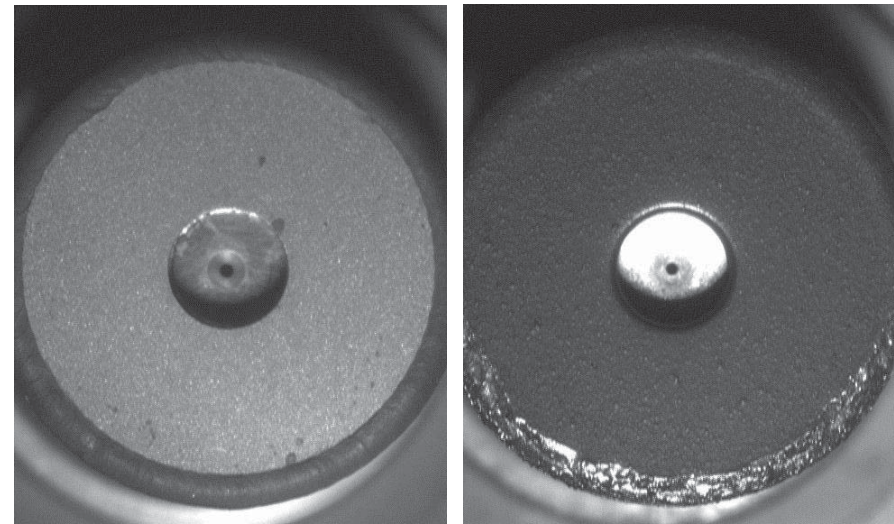
NEXT NCA @ 0 h

- Minimal cathode and keeper orifice diameter changes (<5%) over 51 kh of operation
- No observed clogging of neutralizer orifice despite 9.7 kh of operation at low power conditions
- Observed increase of 20% in cathode orifice chamfer
 - Dimension and overall shape needs to be measured in post-test analysis
- Performance degradation of neutralizer presently attributed to change in orifice geometry – needs to be measured in post-test inspection
 - In-situ camera can only measure minimum orifice diameter in profile

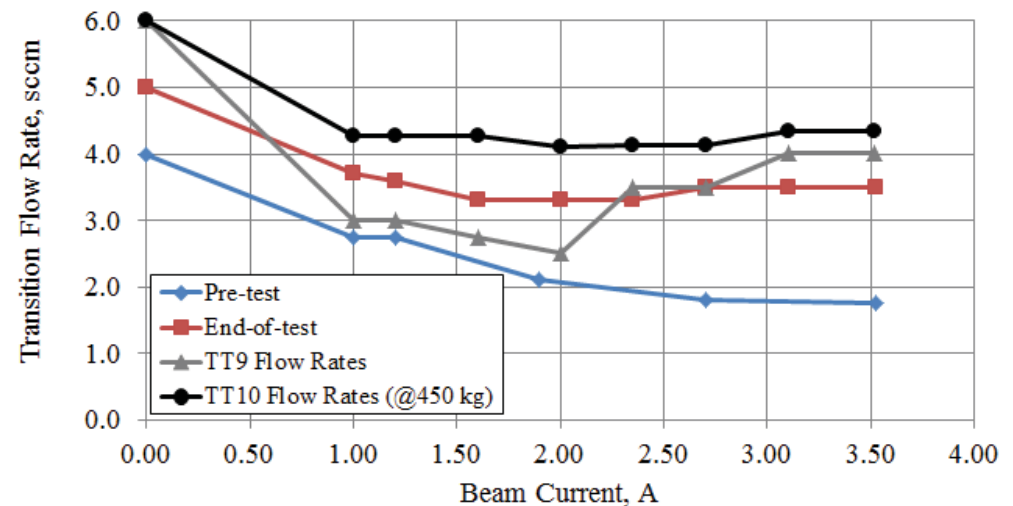
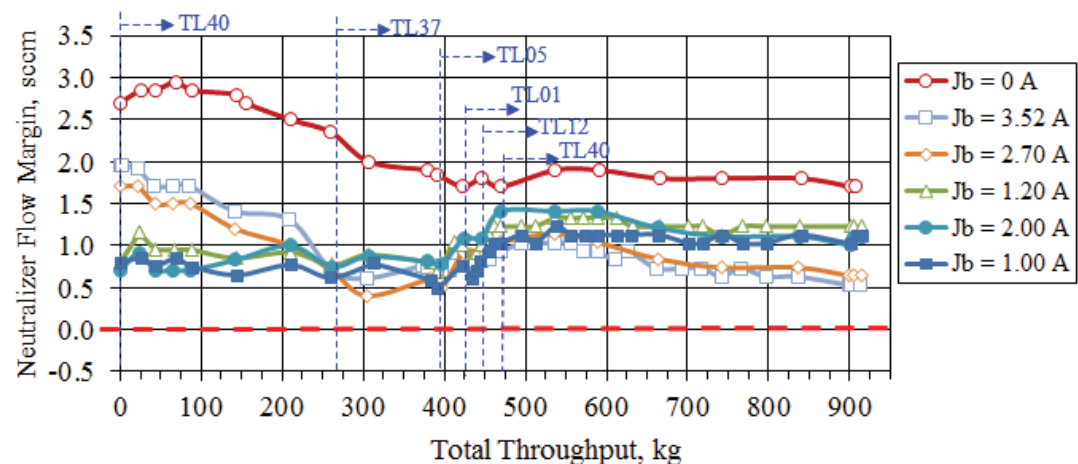
- Loss of flow margin observed, primarily during operation at $J_B = 3.52$ A during first 20 kh
- Inability to prevent transition to plume mode using TT9 flow rates, resulting in updated throttle table (TT10) which increases neutralizer flow rate with throughput to maintain flow margin
- TT10 maintains a minimum of 0.4 sccm margin over course of test across all beam currents
- Negligible changes in neutralizer performance after ~ 650 kg throughput
- Changes made to PM neutralizer in order to increase margin at lower beam currents where loss of margin was greatest
- TT10 results in loss of total efficiency due to increase in flow rate – what about modulating neutralizer keeper current?

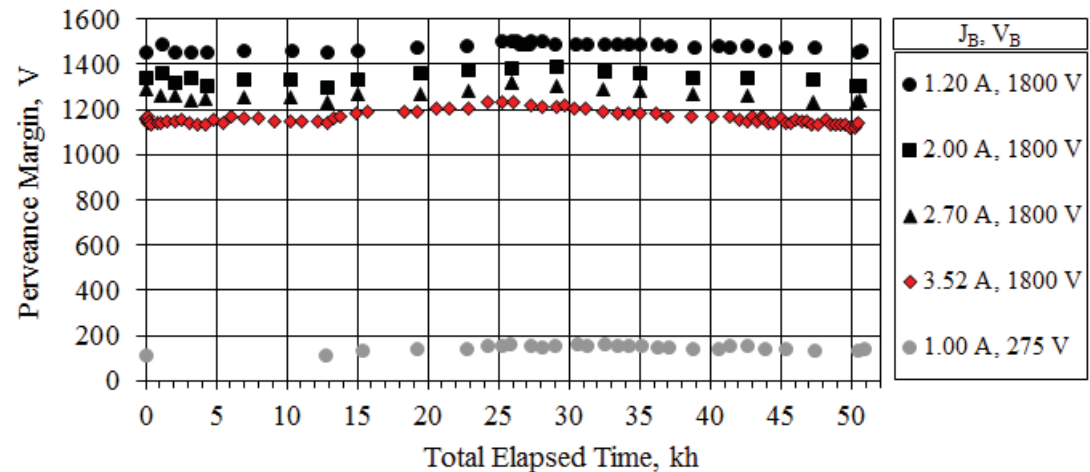
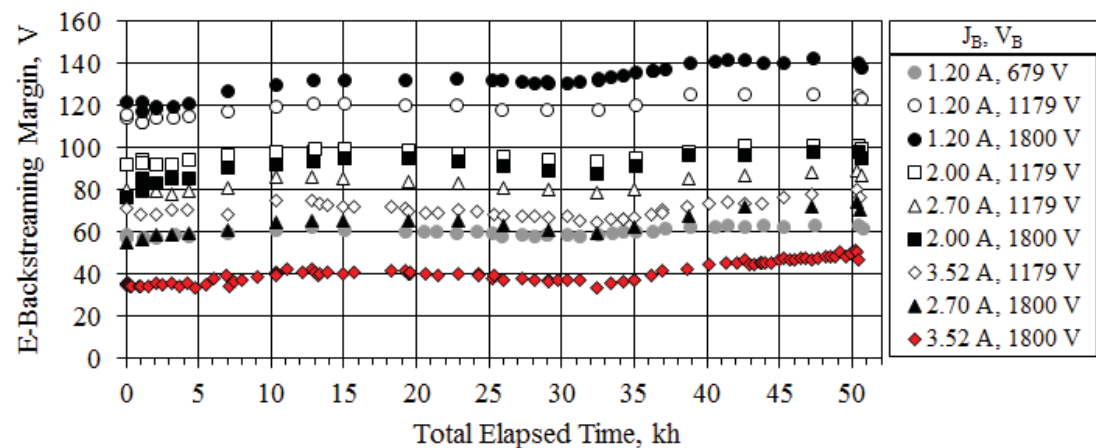
- No large changes in perveance margin or electron backstreaming margin over course of test
- Slight increase in perveance margin at beginning of test attributed to downstream chamfering of accelerator grid apertures, similar to NSTAR ELT
 - Decrease observed after 29.2 kh due to backspattered carbon partially filling in eroded sites
- Slight increases in electron backstreaming margin observed during extended operation at full power (6-13 V)
 - Could be due to increase in accelerator grid thickness due to backspattered carbon as well as slight deposits within accelerator aperture barrels
 - Changes to near-field plasma properties due to varying neutralizer flow margin could also be a factor

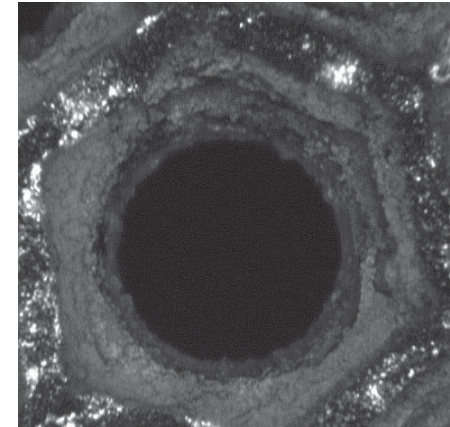
NEXT CRA @ 51,184 h

- Negligible change ($< 5\%$) in CRA cusp diameter over course of test
 - Partially responsible for no observed decrease in electron backstreaming margin
- Enlargement of accelerator apertures led to inability to prevent electron backstreaming at full power during NSTAR ELT (first failure mode of NSTAR)
- Downstream chamfering and pit-and-groove erosion also observed in final in-situ image of NEXT CRA

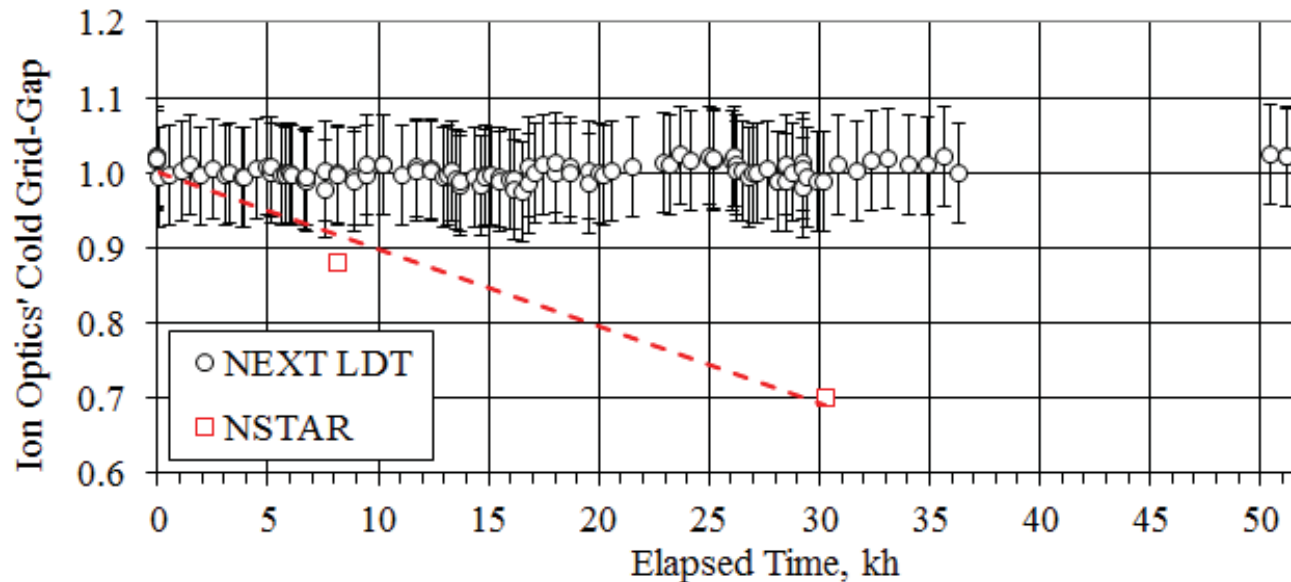
- Decrease in ion optics cold grid gap partially responsible for first failure mode of NSTAR
- Measured grid gap not available during 36-50 kh due to in-situ lighting degradation
 - Diagnostic repair allowed confirmation that cold grid gap has not changed over course of test
- Lack of change in grid gap and aperture cusp diameter has mitigated first failure mode observed during NSTAR ELT
- Presently first failure mode is expected to be penetration of pit-and-groove pattern through accelerator grid, causing loss of structural integrity of optics

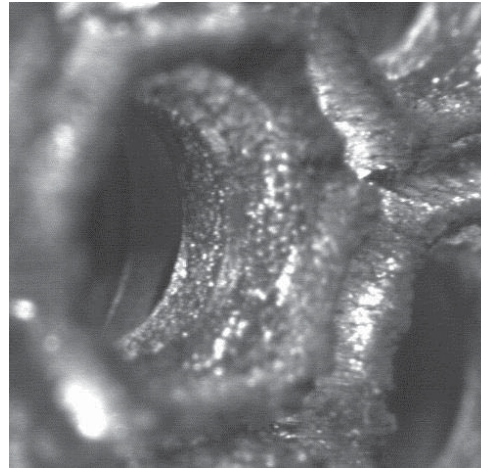
NEXT @ 19,520 h

- Groove depth measurements taken from 7.6 kh to 35.6 kh
 - Could not be obtained afterwards due to lighting degradation and groove shadowing
- Repair and augmentation of in-situ lighting allowed imaging of pit-and-groove pattern after 50 kh

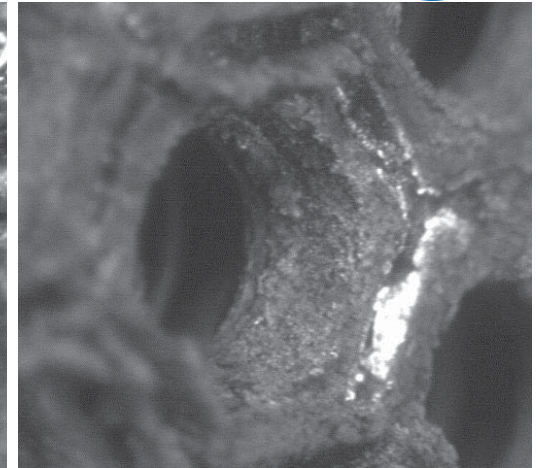
NEXT @ 50,453 h

- Pit and groove pattern is irregular around the aperture and varies from aperture to aperture
 - Three-dimensional, random nature of pattern indicates that cause cannot be modeled with simple modeling tools
- Presence of carbon deposits within pit-and-groove pattern, which was confirmed during initial inspection of the optics at atmosphere
- Detailed examination of thruster images indicate center of accelerator grid began to slowly change appearance ~ 36 kh – change could be caused by carbon deposits forming within pit-and-groove pattern
- Sectioning of grid and determination of final groove depth is critical to assessing first-failure mode and when carbon buildup began occurring

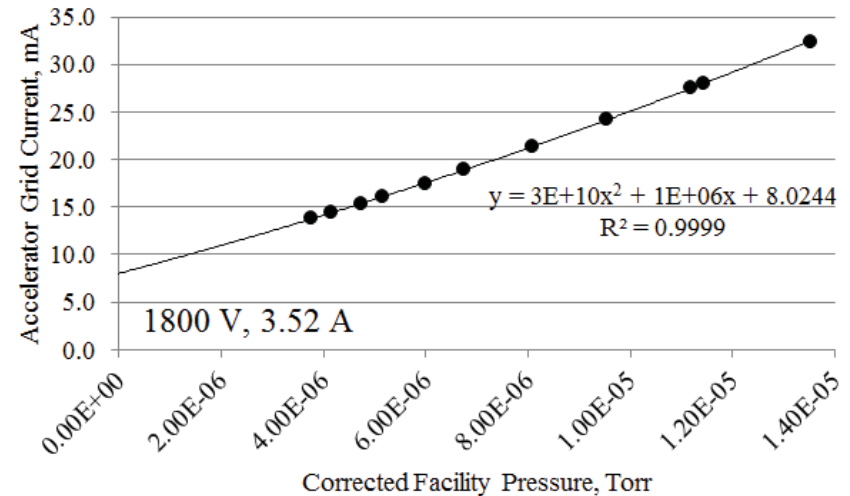
- Measuring telemetry at various facility background pressures allows extrapolation of values to zero-pressure, flight-like conditions
- Extrapolation was performed using linear and quadratic fit, and beam current was held constant by varying discharge current and main mass flow rate (all yielded similar results)
- Results indicate accelerator current is 35-75% higher during ground operation compared to zero-pressure conditions
- Modeling will need to be performed to determine impact on demonstrated lifetime on ground compared to flight
