# **Failure Analysis Results and Corrective Actions Implemented for the Extravehicular Mobility Unit 3011 Water in the Helmet Mishap**

**Water entered the Extravehicular Mobility Unit (EMU) helmet during extravehicular activity (EVA) #23 aboard the International Space Station on July 16, 2013, resulting in the termination of the EVA approximately 1 hour after it began. It was estimated that 1.5 liters of water had migrated up the ventilation loop into the helmet, adversely impacting the astronaut's hearing, vision, and verbal communication. Subsequent on-board testing and ground-based test, tear-down, and evaluation of the affected EMU hardware components determined that the proximate cause of the mishap was blockage of all water separator drum holes with a mixture of silica and silicates. The blockages caused a failure of the water separator degassing function, which resulted in EMU cooling water spilling into the ventilation loop, migrating around the circulating fan, and ultimately pushing into the helmet. The root cause of the failure was determined to be ground-processing shortcomings of the Airlock Cooling Loop Recovery (ALCLR) Ion Filter Beds, which led to various levels of

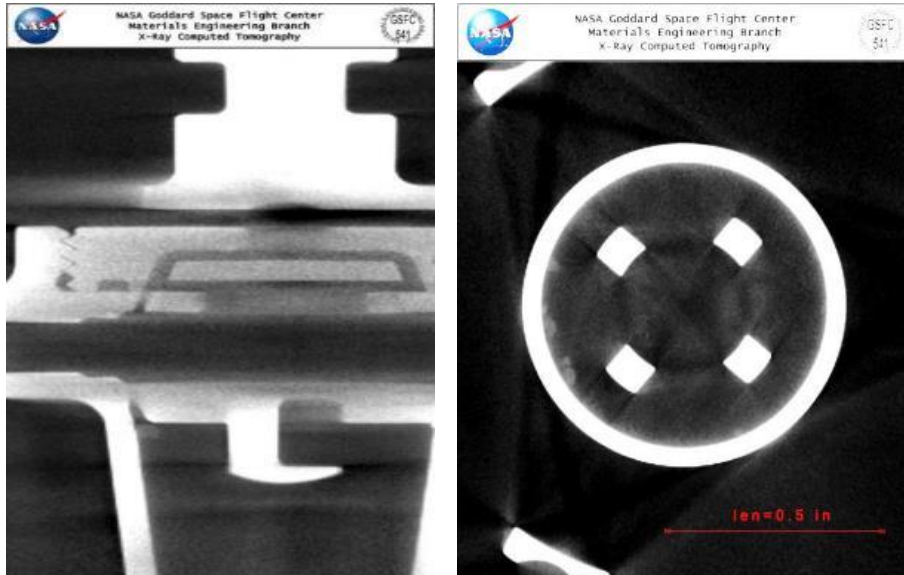
A receiving inspection was performed when the S/N 006 FPS assembly arrived at the United Technologies Aerospace Systems (UTAS) facility and the Item-123 FPS assembly was separated from the Item-127/128 Pump Inlet Filter. Both were repackaged and shipped to Goddard Space Flight Center for X-ray CT scans. The scans were primarily looking for mechanical assembly or component failure areas or gross contamination that may have caused the failure of the FPS to function properly. The result of the nondestructive evaluation showed no mechanical issues such as cracks or loss of a weld plug in the pitot that would result in the failure mechanism seen on orbit. However, both the X-ray CT scan and N-ray scan showed the presence of contamination within the drum of the separator. Figure 2 shows the contamination indications in the drum from the CT scans. The contamination appeared to be in and around the eight drum holes that feed the drum trough.<sup>3</sup>

**Figure 3: X-ray CT scan of FPS S/N 006 separator drum.**

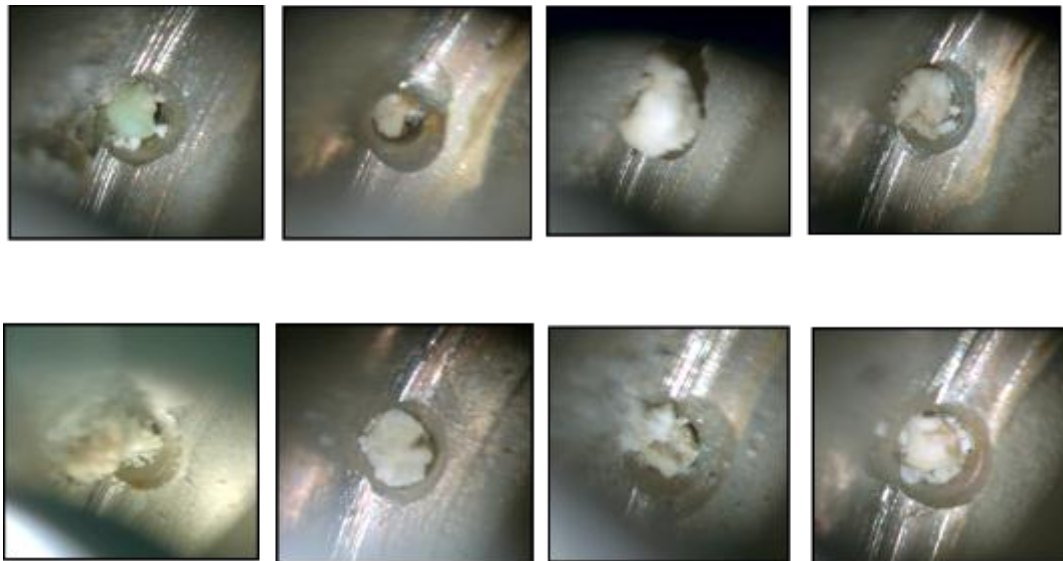
Upon return of the FPS, visual inspections identified contamination in all eight water separator drum inlet feed holes (Figure 3) and along the walls leading to the feed holes. Analysis showed the material to be primarily loosely bound silica, with zinc acetate, aluminum silicate, and aluminum oxide present as well. These constituents are all native to the EMU/Airlock system, but the quantity and location were out of family. The majority of the material was silica based.<sup>3</sup>

In operation of the EMU Transport Water Loop, small particles are filtered with a 20 micrometer filter prior to entering the water separator, which indicates the contaminant material either entered as very small particles that agglomerated in the separator or entered in solution followed by localized precipitation. Testing of EMU 3011's returned FPS (S/N 006) both with and without the drum-hole contamination confirmed that the blocked drum holes were the cause of the water in the helmet mishap.

**Figure 3. Blocked water separator drum holes.**

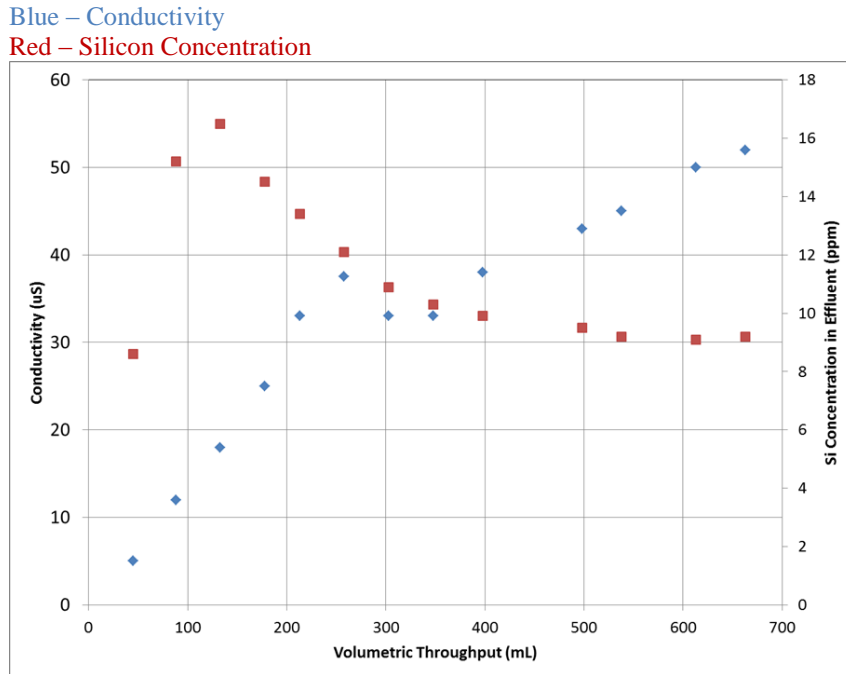
The free water (~60 mL) drained from ALCLR Ion Bed (S/N 1003) was found to have a relatively high dissolved silicon level (41 ppm) when compared to the others (< 1 ppm dissolved silicon), thus indicating that the ion exchange resin was saturated and unable to retain silicon in its common dissolved form, as ionic silicic acid. Furthermore, the acid/base extracts from the ALCLR Ion Bed S/N 1003 ion exchange resin was found to have relatively high chloride, sulfate, potassium, and silicon levels when compared to the data generated from the other four beds. Finally, when the ion exchange resin capacity test was done on the resin from ALCLR Ion Bed S/N 1003, it was found to have no remaining ion exchange capacity, and silicon immediately discharged from the ion exchange resin when capacity challenge sodium chloride was added (Figure 5). This was a stark difference from the other four Ion Beds, which all showed significant remaining ion exchange resin capacity (Figure 6).<sup>5</sup>

**Figure 5. Capacity test results—Ion Bed S/N 1003—no remaining capacity.**

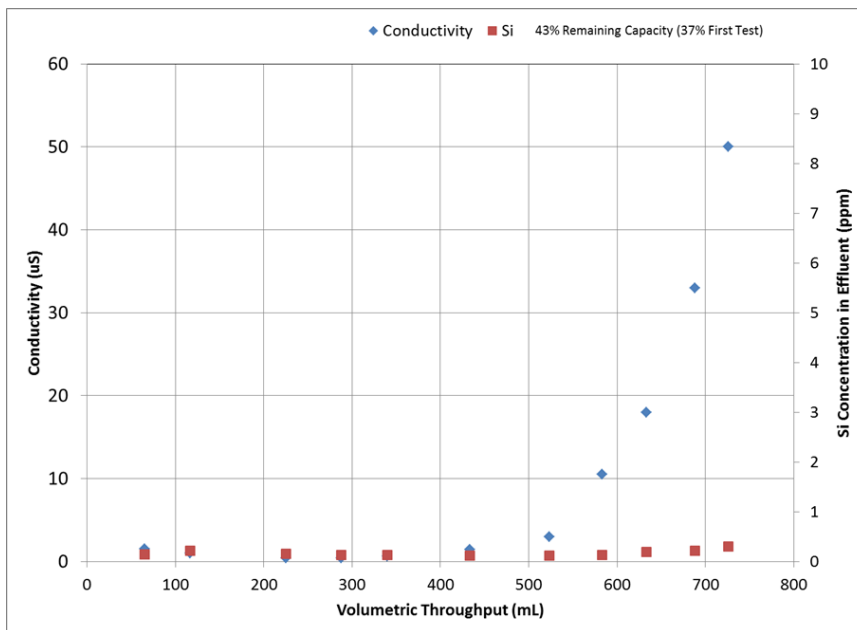
**Figure 6. Capacity test results—Ion Bed S/N 1013—significant remaining capacity.**

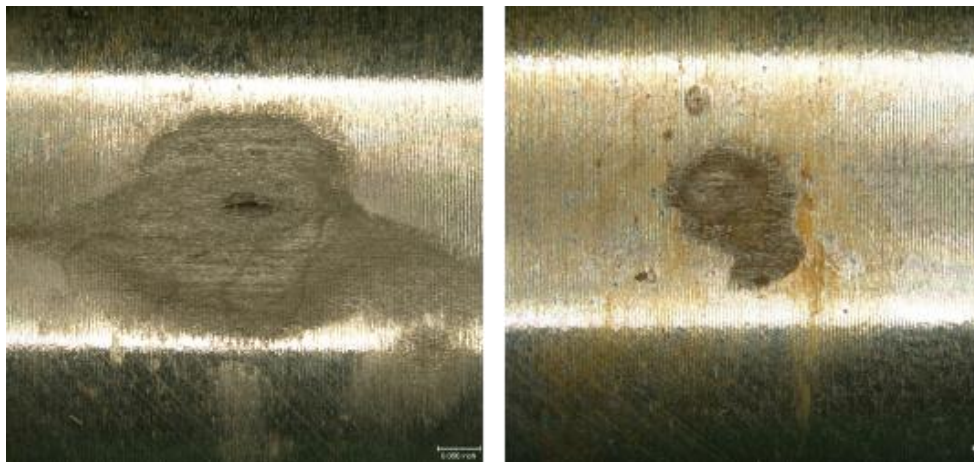
On December 26, 2013, “smudges and scratches” were noted on the exterior of the housings of the recently processed ALCLR filters, prompting an inspection. Further analysis of the hardware revealed that the housings were pitting and corroding, in some cases all the way through the housings (Figure 7).<sup>8</sup>

**Figure 7. Pitting and corrosion on the external surfaces of the ALCLR housings.**

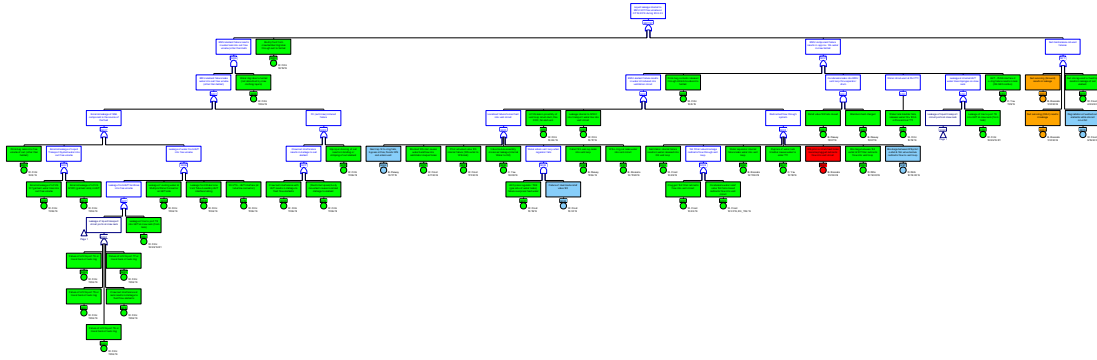
An action plan was created. This plan identified the investigative actions necessary to close each of the fault tree events. Actions included inspections, tests, analyses, documentation reviews, etc. Initially, each event on the fault tree was colored either yellow or orange, thus indicating that forward work was planned. Those events colored orange were given a higher priority, and closure rationale would be discussed in team meetings. Closure rationale was documented for each of the 44 basic events. The team evaluated the closure rationale to determine whether each basic event contributed to the failure. Events were colored green if technical information confirmed that the event was not a contributor. Events colored blue were determined to be non-contributors, but substantiated largely by engineering judgment. Contributors were colored red in the fault tree. Through evaluation of the closure rationale, the proximate cause was identified as “Water separator drum feed holes become plugged, redirects flow into vent circuit” (Figure 9).<sup>1</sup>

Figure 9. Fault tree.

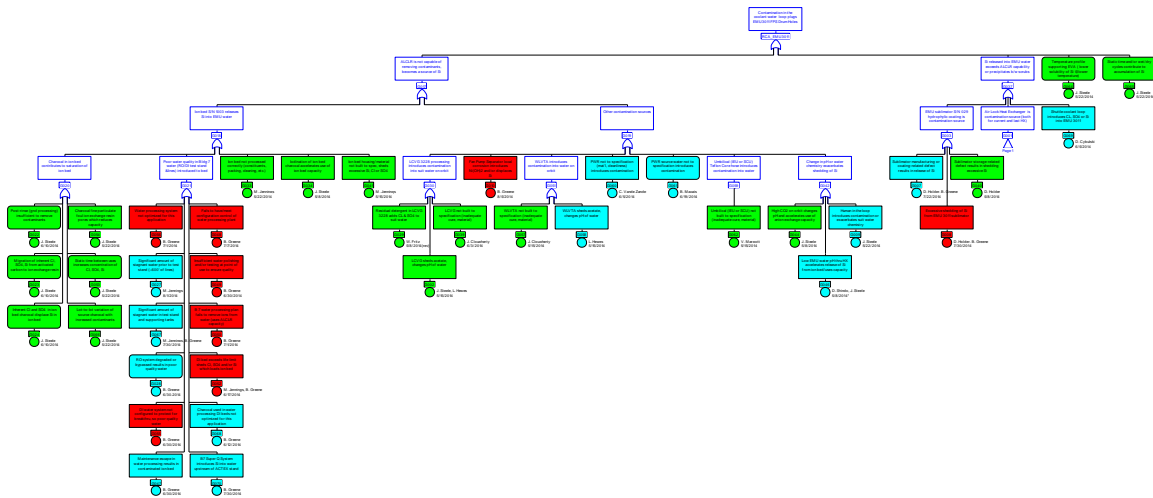
Once the proximate cause was identified, a causal tree was developed to include all potential causes of the proximate cause, and all the sources of the contamination in the coolant loop that plugged the water separator drum feed holes, and to determine the intermediate cause(s) (Figure 10). Sources of contamination included those resulting when the ALCLR components are not capable of removing contaminants and become a source of silicon (including ion bed S/N 1003, LCVG, Water Line Vent Tube Assembly, Payload Water Reservoirs, umbilicals, or changes to pH); silicon in the EMU water exceeds the capability or precipitates between scrubs (from sublimator hydrophilic coating, Space Shuttle coolant loop, or airlock heat exchanger); the temperature profile affects the solubility of silicon; or static time between wet-dry cycles contributes to the accumulation of silicon. Closure rationale was documented for each of the 42 potential causes, and was evaluated by the team. The findings (red events) and significant observations (identified by rounded corners on the description box) were determined by dispositioning each event.<sup>1</sup>

Figure 10. Causal tree.

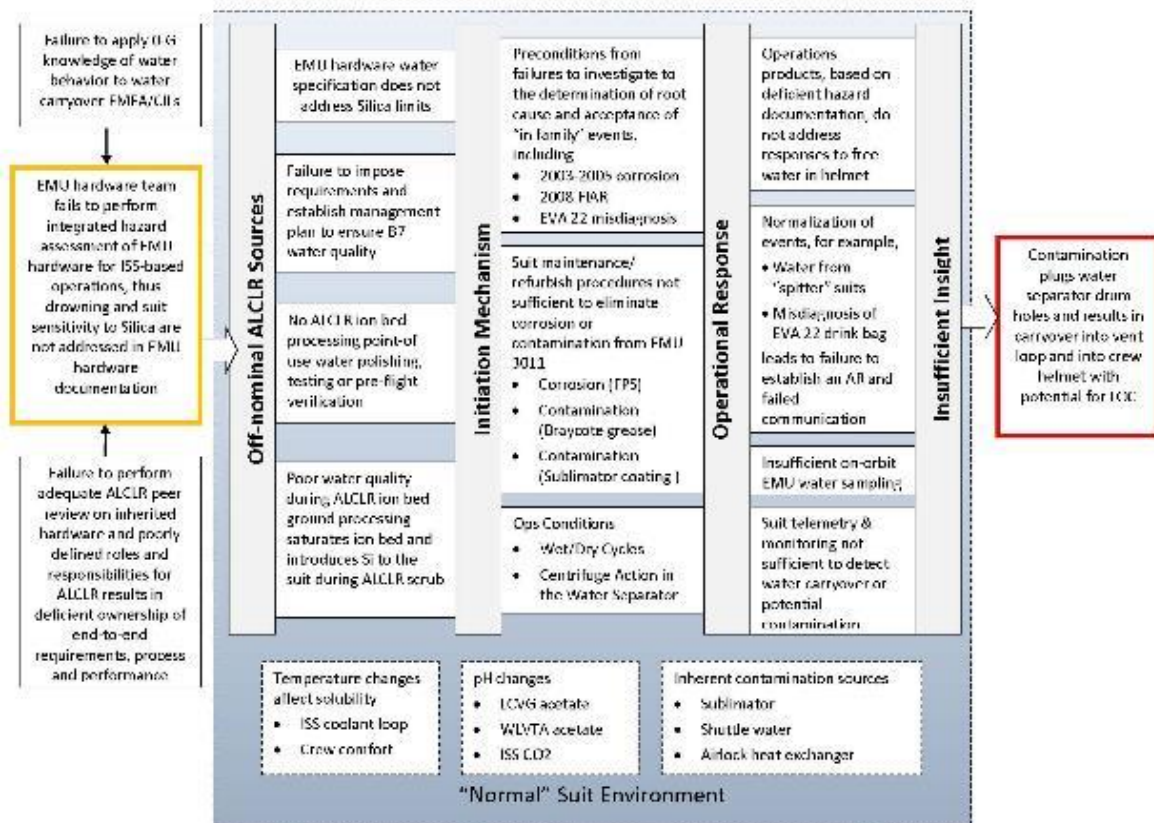
These findings and significant observations were then categorized by similarity of the causes as either an operational response, a response to water quality management, or an EMU hardware processing issue. Each finding and significant observation causal tree event was then mapped to these categories on a root cause determination matrix spreadsheet. The team then asked the “three whys”—a technique where the team asked why the event was allowed to manifest at least three times until an organizational factor was identified. Corrective actions were then identified for each root cause in a Corrective Action Plan (CAP) to ensure the failure would not be repeated. Finally, the high-level investigation results were documented in an event sequence diagram (Figure 11).<sup>1</sup>

Figure 11. Event sequence diagram.
