Solving Problems Caused by Small Micrometeoroid and Orbital Debris Impacts for Space-Walking Astronauts

E. L. Christiansen, D. M. Lear

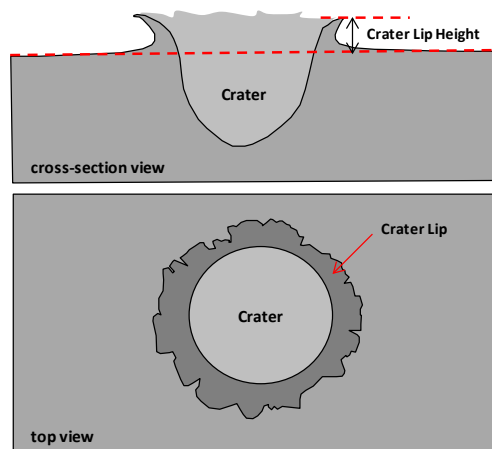
The external handrails used by the International Space Station (ISS) crew during extravehicular activity (EVA) are exposed to MMOD impacts that cause craters with raised edges, called “crater lips” (figure 1). These crater lips are often very sharp and represent an EVA cut-glove hazard. There have been several cases of craters reported to the ISS handrail team. For instance, the ARES HVIT group identified six craters on a single 13.7-in.-long handrail from an ISS pump module (PM) returned on the last Space Shuttle mission, STS-135. This PM handrail was exposed to MMOD impacts for 8.7 years. The largest crater on the PM handrail measured 1.85-mm diameter (outside) with a 0.33-mm lip height (figure 2). The size of the other five craters ranged from 0.12 mm to 0.56 mm in diameter, with crater lips that ranged from 0.01 mm to 0.08 mm high. Other MMOD craters have been observed on ISS handrails and EVA tools (figure 3).

Figure 1.— MMOD impact craters into metals typically exhibit raised sharp-edged “crater lips.”

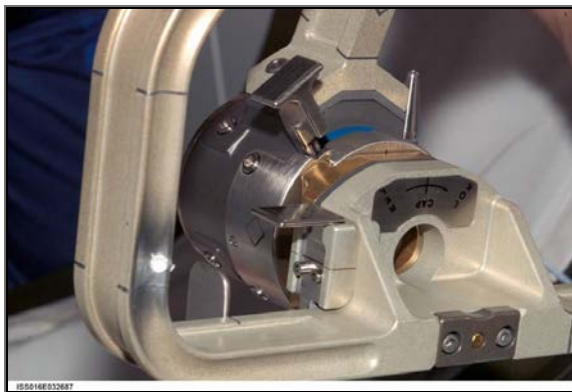
Figure 3.— Prior to STS-123 EVA, the ISS crew found a nearly 5-mm diameter crater on the EVA D-handle tool stored externally on ISS. Note that the detached spall from the side opposite the MMOD impact crater also has sharp edges. The D-handle is made of materials that are similar to those used in a typical ISS dog-bone handrail.
