Clearance Analysis of CTC2 (on ELC4) to S-TRRJ HRS Radiator Rotation Envelope

Donn Liddle

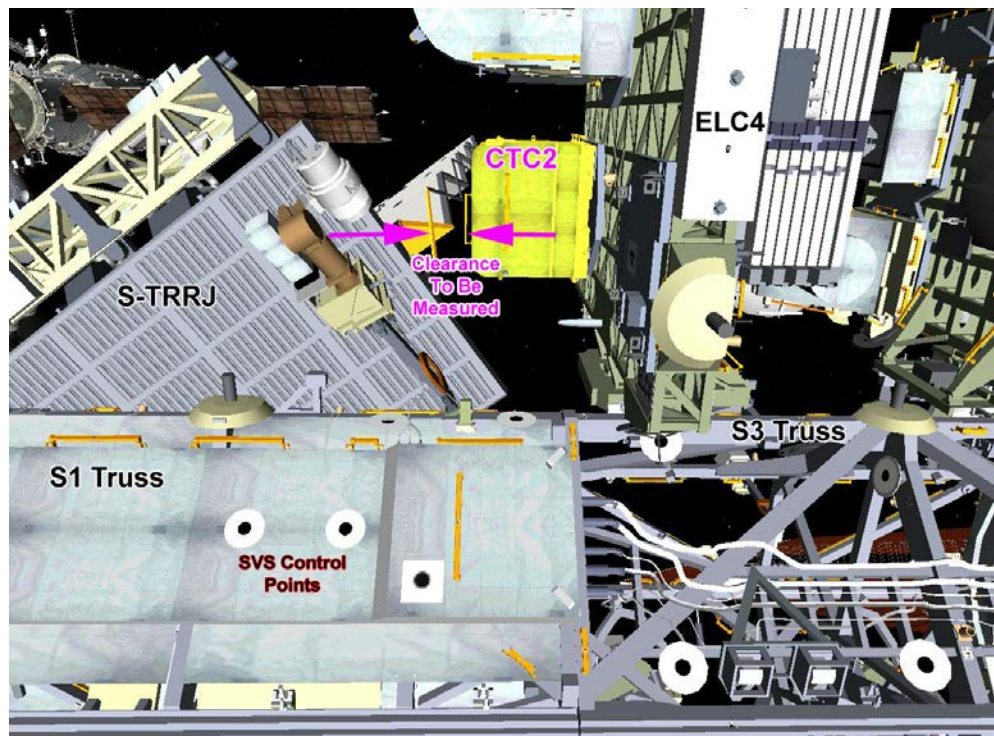
Figure 1.— CTC2 to S-TRRJ radiator clearance.

In response to the planned retirement of the Space Shuttle Program, International Space Station (ISS) management began stockpiling spare parts on the ISS. Many of the larger orbital replacement units were stored on the Expedite the Processing of Experiments to Space Station (EXPRESS) Logistics Carriers (ELCs) mounted on the end of the S3 and P3 truss segments, immediately outboard of the Thermal Radiator Rotary Joints (TRRJ) and their attached radiators. In an August 2009 computer-aided design (CAD) assessment, it was determined that mounting the Cargo Transport Container (CTC) 2 on the inboard face of ELC4 as planned would create insufficient clearance between the CTC2 and the rotational envelope of the radiators when the TRRJ were rotated to a gamma angle of 35.0 degrees (see figure 1). The true clearance would depend on how

the Unpressurized Cargo Carrier Attachment System (UCCAS) was mounted to the S3 truss and how the ELC4 was attached to it. If the plane of the UCCAS attachment points were tilted even slightly inboard, it would significantly change the clearance between CTC2 and the Starboard TRRJ (S-TRRJ) radiators. Additionally, since CTC2 would be covered in multilayer insulation (MLI), the true outer profile of CTC2 was not captured in the CAD models used for the clearance assessment. It was possible that, even if the S-TRRJ radiators cleared CTC2, they could snag the MLI covering. In the fall of 2010, the Image Science and Analysis Group (ISAG) was asked to perform an on-orbit clearance analysis to determine the location of CTC2 on ELC4 and the S-TRRJ radiators at the angle of closest approach so that a positive clearance could be assured.

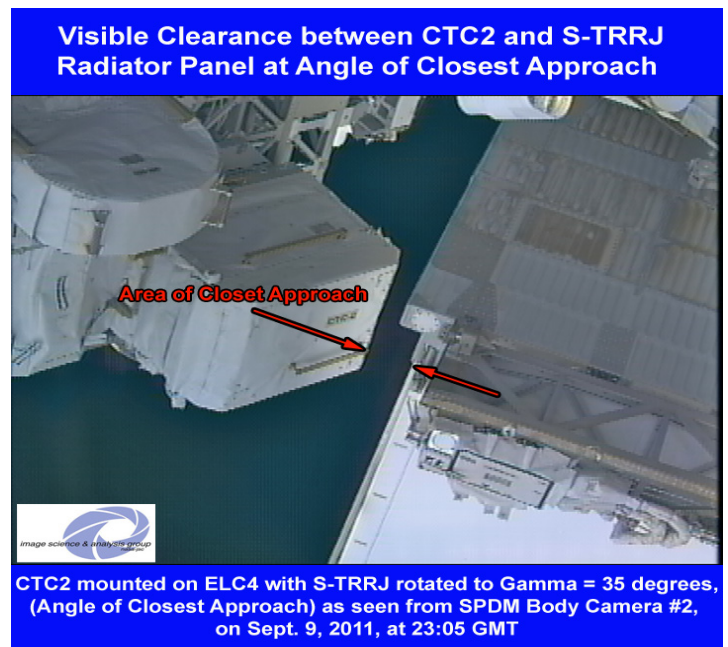
Figure 4.— Clearance between CTC2 and S-TRRJ Radiator

CTC2 was installed on ELC4, and the images required to support the photogrammetric clearance analysis were acquired on September 9, 2011. Additionally, an edge-on image of CTC2 and the S-TRRJ radiator at the angle of closest approach was obtained to immediately prove positive clearance (see figure 4).

“The combined measurement showed a clearance of 10.84” between the radiator and the CTC-2 (a bit better than expected). When we account for worst case conditions (worst possible thermal effects + worst on-orbit loads + uncertainty in our measurements & models) we still show an analyzed clearance of 7.89” (again, the best clearance we’ve seen).”

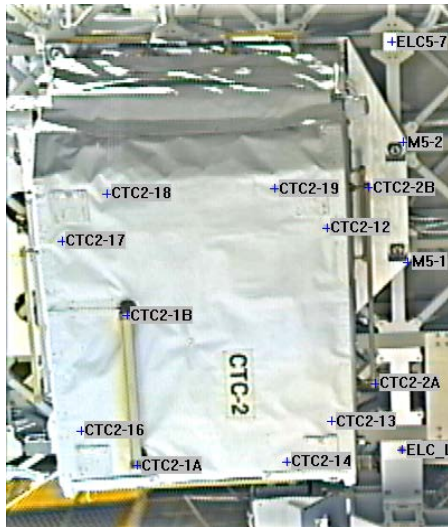
Figure 5.— Point measured on the inboard face of CTC2.

Out of about 86 images collected, the best 50 were selected for use in the analysis process. These images, the camera parameters, and 9 SVS control targets were used to compute coordinates for 20 points distributed across the inboard and forward face of CTC2, as shown in figures 5 and 6.
