Analyzing an Aging ISS

R. Scharf

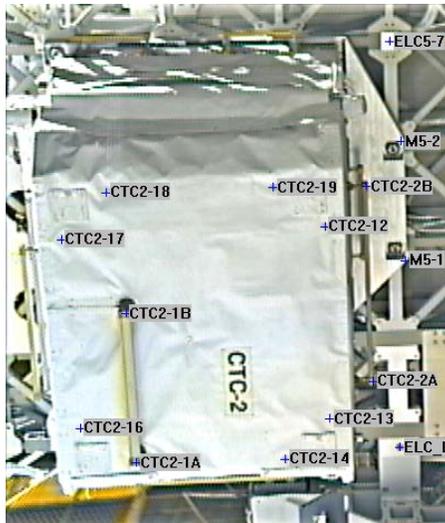
Figure 5.— Point measured on the inboard face of CTC2.

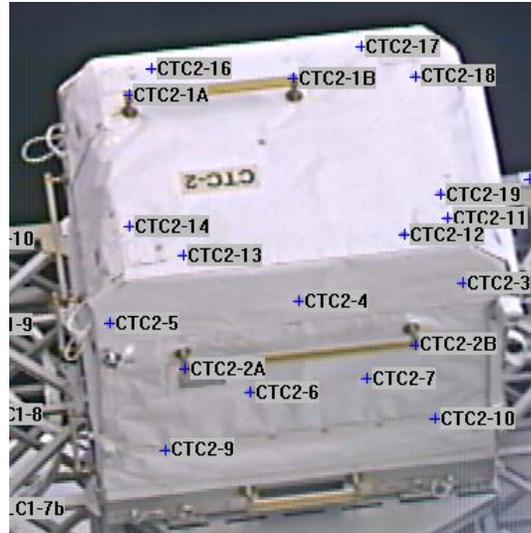
Figure 6.— Point measured on the forward face of CTC2.
