Development Testing and Subsequent Failure Investigation of a Spring Strut Mechanism

Abstract

The NASA Engineering and Safety Center (NESC) and Lockheed Martin (LM) performed random vibration testing on a single spring strut development unit to assess its ability to withstand qualification-level random vibration environments. Failure of the strut while exposed to random vibration resulted in a follow-on failure investigation, design changes, and additional development tests. This paper focuses on the results of the failure investigations referenced in detail in the NESC final report [1] including identified lessons learned to aid in future design iterations of the spring strut and to help other mechanism developers avoid similar pitfalls.

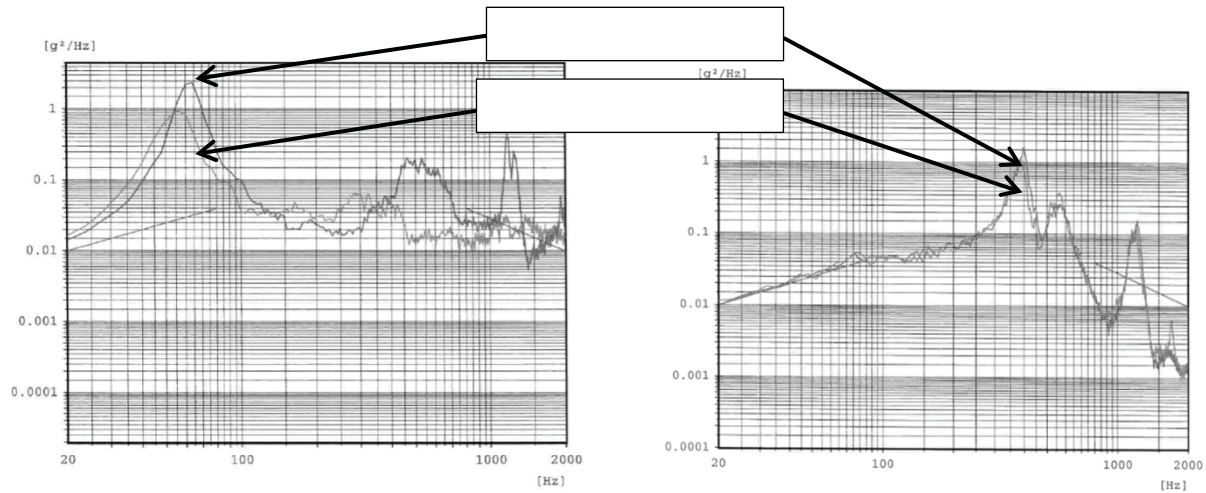
applied in both Z- and X-axes. A borescope was used after testing in each axis to qualitatively assess the magnitude of internal wear and provide a comparison from axis to axis. For the Z- and X-axis testing, the hardware was exposed to the target levels with no significant (i.e., operation-inhibiting) damage observed and thus deemed successful.

Figure 5. Typical Pre- and Post-Qualification MWS Differences (Z-axis [left]; X-axis [right])

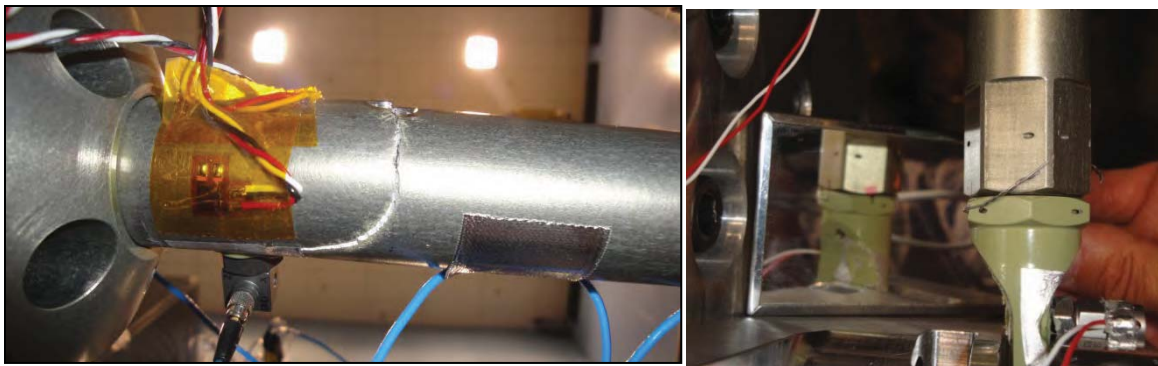
The Y-axis was anticipated to be the worst environment for the hardware. MWS and acceptance levels were completed in the Y-axis. However, during the qualification level test, a distinct change in the sound and response produced by the hardware was observed 27 seconds into the full level qualification run. A lack of clear visual failure indicators coupled with ill-defined criteria for test stoppage resulted in continuation of the testing to the full duration (3 minutes). Upon completion of the test, the NESC team found the secondary piston had failed at the aft tooling hole and the lockwire restraining the forward lug from rotating had failed (Figure 6). Due to the failure of the spring strut hardware, no further random vibration testing could be completed and the hardware was taken back for investigation and performance testing. Note that even though the test hardware incurred a failure, the testing was ultimately considered successful because it flagged design deficiencies before they were encountered late in the test and verification cycle.

Figure 6. Structural Failure of Secondary Piston at Aft Tooling Hole [left]; Lockwire Failure at Forward Lug [right]

Prior stress and fracture analyses did not include the tooling holes, and the secondary piston was not considered fracture critical. Large structural margins in this analysis deemed the secondary piston satisfied the definition of a 'low risk' component and were subsequently classified as non-fracture critical. These prior analyses were based on flight load factors found to be inadequate and inconsistent with the EFT-1 flight configuration. After the secondary piston failure, an updated fatigue analysis was performed accounting for the off-nominal secondary piston rotation to quantify the Cumulative Damage Index (CDI) using Rayleigh's distribution and Miner's Rule for response to the base input Power Spectral Density (PSD). In summary, the analysis results showed exceedance of the secondary piston fatigue life capability at the tooling hole ($CDI = 1.519 > 1.0$) when subjected to Y-axis qualification levels in a maximum bending condition. After the failure, the spring strut was evaluated by LM and Marshall Space Flight Center (MSFC) failure analysis groups with both groups concluding the structural failure occurred at the aft-most secondary piston tooling hole initiated in fatigue followed by ductile overload. The opposite side of the failed tooling hole also showed the beginnings of fatigue cracking.

Due to the rotation, strut tooling holes, nominally in the neutral bending axis during the Y-axis vibration test, were placed in maximum bending. Once the fatigue life capability at the tooling hole was exceeded, the secondary piston failed by crack growth and overload.

The NESC team was kept apprised of the redesign activities by the MPCV CM subsystem management team. LM made design changes intended to prevent loosening of the threaded parts and eliminate fatigue initiation sites, then retested the strut. These changes included an increase in the size of the secondary locking patches, quantity and diameter of lockwire, and preload at the end fitting joints (50 percent of F_{ty}). Additionally, the tooling holes were removed and a new retention tool design was devised. Once the initial redesign effort was complete, LM began with the Y-axis test, which was the worst case and the axis in which the secondary piston failed. Shortly after reaching qualification levels, the strut suffered another failure. This time, the forward lug fractured at the secondary piston interface. A subsequent investigation by LM determined fatigue failure was the cause and that the corrections made appeared to be working up to the point at which the testing was stopped. The LM retest had reused a majority of the hardware from the original test unit (including the forward lug) without a residual life assessment. Analysis revealed the fractured rod end had exceeded its fatigue life capability. Gapping in the joint between the rod end and the secondary piston exacerbated the problem.

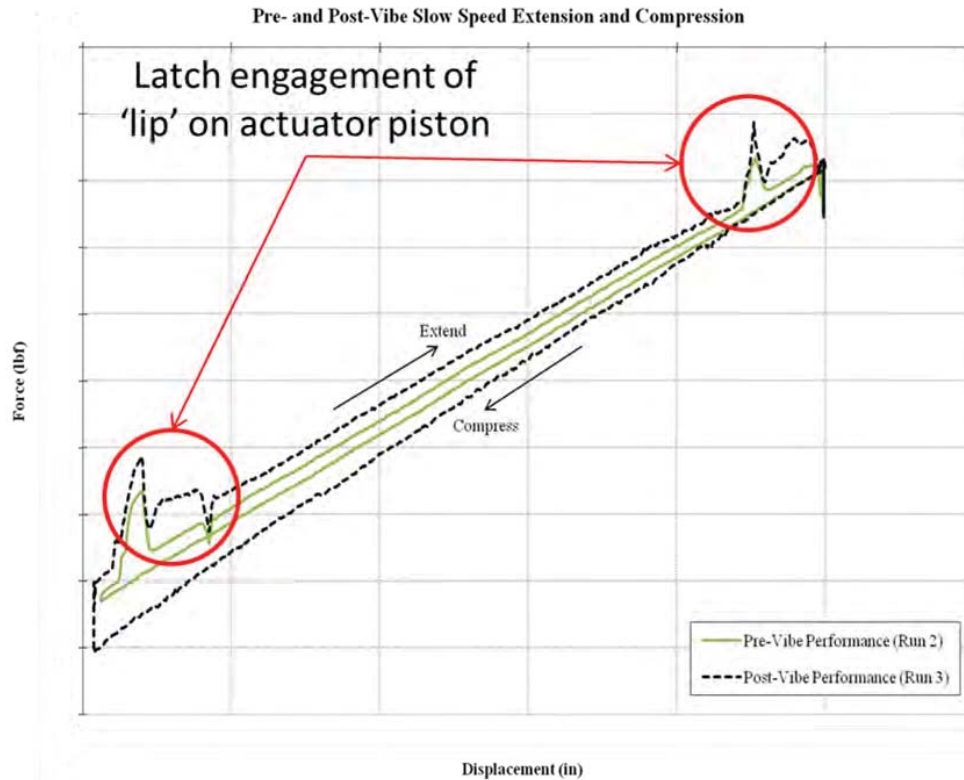
After failure during the random vibration testing, the strut was returned to the performance testing facility with a truncated secondary piston to remove the failed portion of the strut. Using a cupping interface, post-vibe performance deployment tests were performed with the strut assembled in the load frame. The post-vibration performance test served primarily to assess whether there were any large excursions from the nominal force-deflection curve. These excursions could be indicative of significant damage to the spring strut sliding surface. The post-vibration performance test satisfied the nominal expected end of travel force of $165 \text{ N} \pm 27 \text{ N}$ ($37 \pm 6 \text{ lbf}$) and resulted in nominal engagement of the anti-back travel latches. Force versus displacement within the expected tolerance yielded acceptable force margin based on the next high assembly assumptions and calculations. A comparison of the pre- and post-random vibration performance test is shown in Figures 8.

Figure 8. Force versus Displacement Plot for Slow Speed Extension

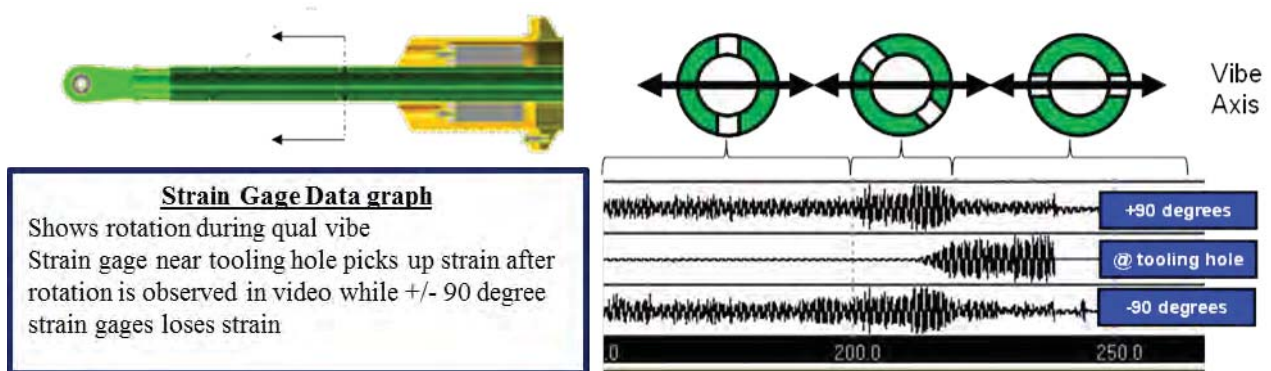
- 1. Test Video and Strain Gauge Data:** Immediately after application of the qualification levels, the SM side assembly (aft cap, actuator housing, and forward cap) rotated clockwise (looking SM to umbilical side). Lagging this rotation, the secondary piston was observed to rotate counterclockwise. Inspection of data from strain gauges mounted on the secondary piston and visual indicators of mounted accelerometers indicated a rotation of approximately 90 degrees. Strain gauge data with indicators of tooling hole orientation relative to the Y-axis applied load can be found in Figure 10. Approximately 27 seconds after application of qualification levels (242 seconds) there was a noticeable decrease in noise and strut dynamic response. No noticeable damage was observed, so the test was continued to the full duration at 395 seconds.

Figure 10. Strain Gauge Data and Strut Rotation

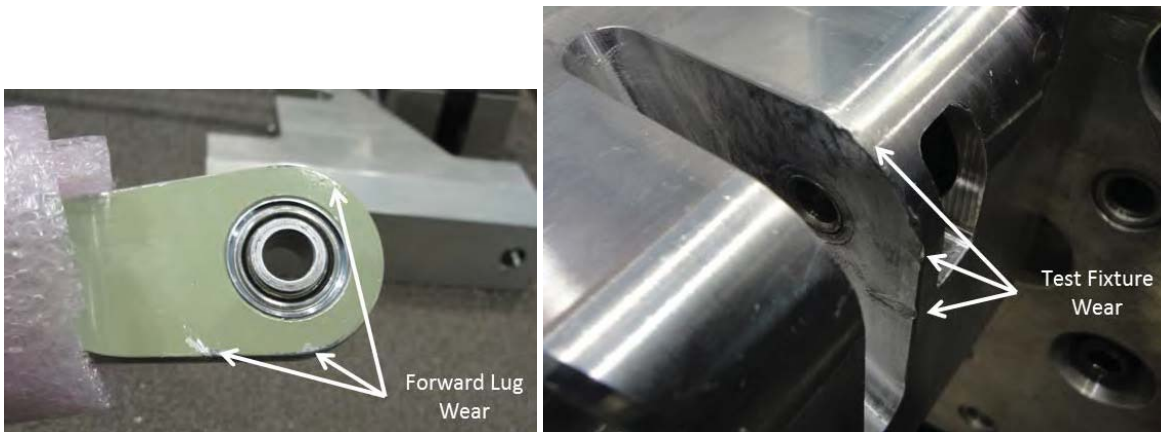
7. **End Fitting Rotational Offset:** Indications of wear are evident on the end fittings and adjoining clevises (Figure 11). Contact due to misalignment/rotational offset would have imparted a force off-axis from the strut and induced a torque applied to the end fittings. If the force was sufficient to overcome resistive elements of the joint, then the end fittings could have tightened or loosened. Loosening at the forward strut interface would have permitted an applied torque to more easily rotate the secondary piston relative to the forward lug.

Figure 11. Wear Post-Vibration Testing (Forward Lug [left]; Test Fixture [right])

During vibration testing there was contact between the aft cap and SM side actuator bracket and the forward lug and test fixture, with significant wear observed during post-test inspection. This produced a constraint and source of induced reaction force off-axis from the strut. The strut design also permitted a CG offset due to a combination of sliding contact interfaces, machining tolerances, non-axisymmetric nature of select piece parts, elastically buckled spring, and gravity loads as installed in the random vibration test fixture. The design also did not include an alignment feature integral to the strut, therefore forward lug and aft cap strut end fitting alignment was not guaranteed and permitted rotational misalignment between the two rod ends.
