ISS Ammonia Pump Failure, Recovery, and Lesson Learned – A Hydrodynamic Bearing Perspective

Robert J. Bruckner* and Richard A. Manco II**

Abstract

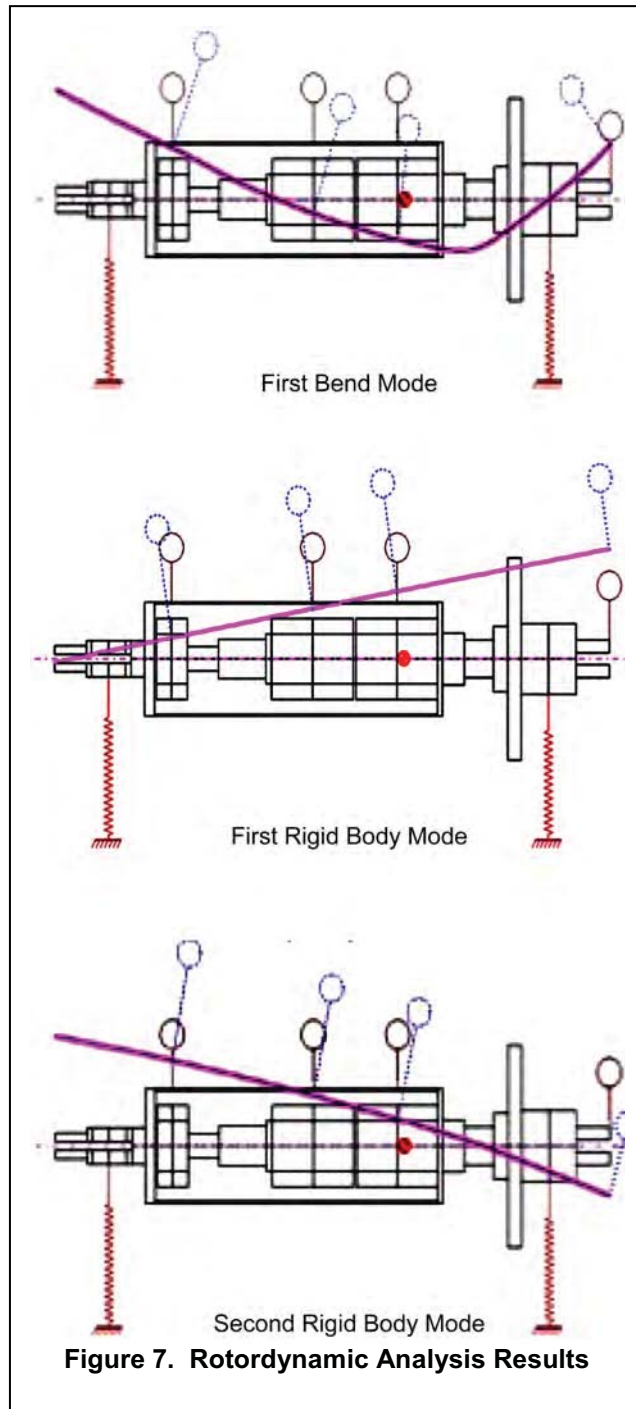
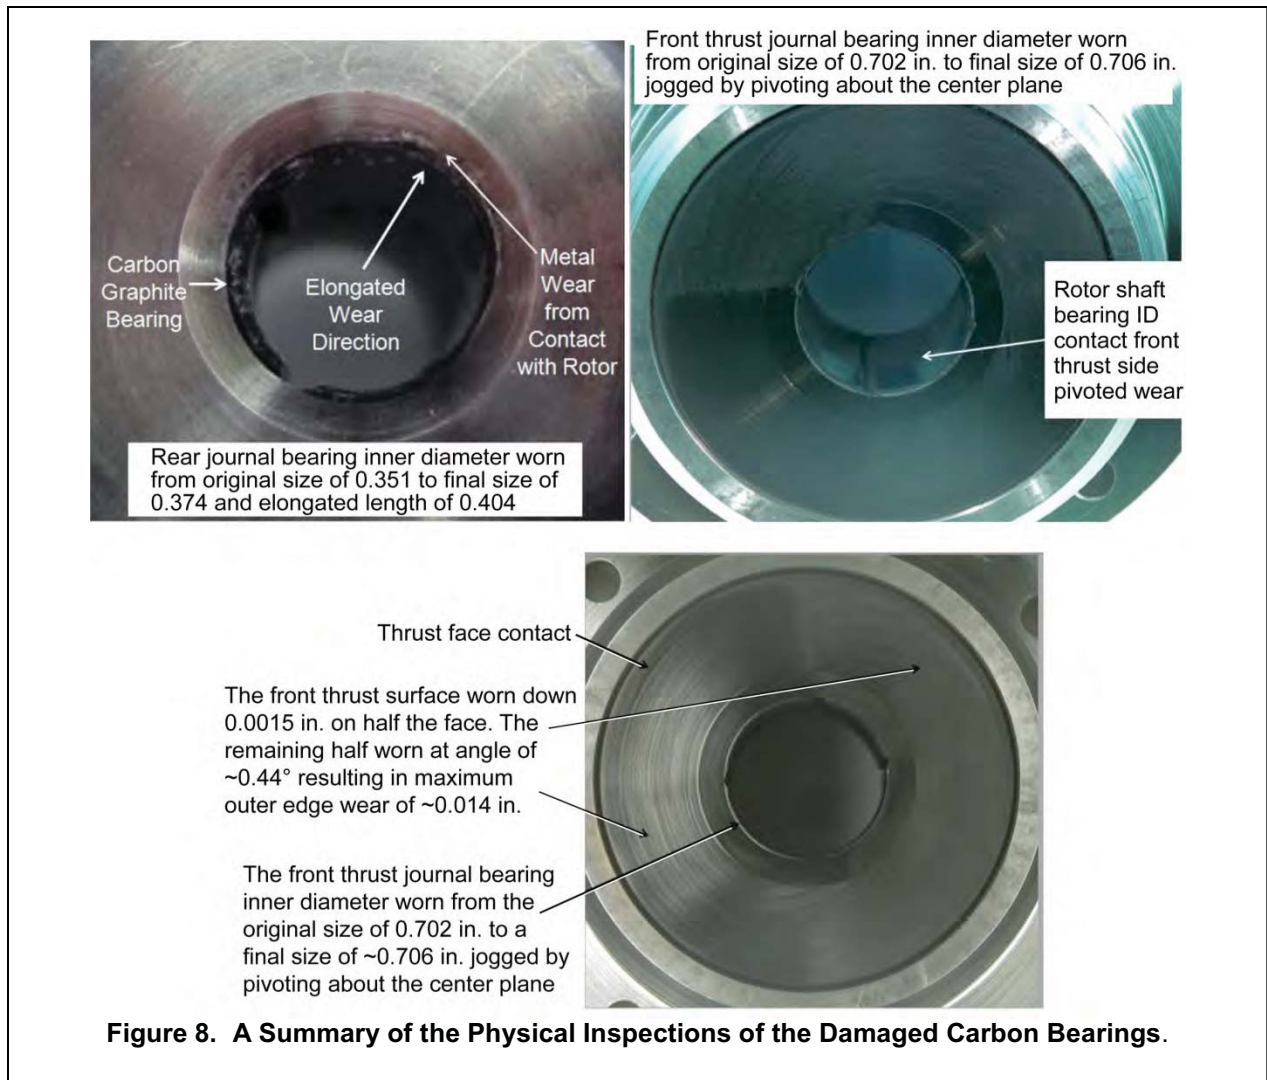
Figure 8. A Summary of the Physical Inspections of the Damaged Carbon Bearings.

The pump module was returned from orbit in 2011 on the final Space Shuttle mission, STS-135. After post-flight processing and ammonia decontamination were completed, a comprehensive inspection procedure was conducted on the returned hardware. This inspection covered electric power and controls, material microscopy and crack progression analysis, debris analysis, x-ray, ultrasound and visual examinations of the physical hardware. The electrical and control systems were deemed to be in acceptable condition given the long-term exposure to ammonia. No evidence was found to further pursue these components as the root cause. The most significant finding was severe wear of the carbon bearings at all three bearing locations, two journals and one thrust bearing. The most severe wear occurred at the rear journal bearing. An additional significant finding was that the wear was organized in a manner that indicates an angular misalignment. In other

words, a specific load acting in a specific direction on the rear bearing was the most likely root cause. Typically, in high speed rotating machinery the expectation is that wear would occur throughout the circumference of the bearing either in a cylindrical or conical shape. However, in this case the wear was concentrated in one quadrant and mainly on one bearing. Again, this is a strong indication a specific static force was acting directly on the rear bearing.

Both the front and the rear journal bearings used in this pump utilize axial grooves machined into the carbon sleeves. These grooves serve to disrupt the half frequency whirl flow pattern and delay the transition to turbulence in the fluid film. A detriment to bearing performance caused by this feature is to weaken the load capacity of the bearing when the load is oriented on or near one of these grooves. This orientation can reduce bearing load capacity by 55% compared with an orientation where the load is well-centered on the pad. During the assembly procedures of the pumps, no control measures were put in place to dictate the orientation of these grooves. Therefore this is a truly random variable, which may or may not become significant depending also on the orientation of the additional imposed loads. Physical inspections of the failed hardware revealed that the rear bearing wear was concentrated at one of these axial grooves. In fact, the wear was so severe that the 1.5-mm-deep groove was no longer a visible feature and the wear had gone deeper than the bottom of the groove. The evidence strongly implies that the orientation of the load on a groove is a major contributing factor to the failure of the ammonia pump. However, the load orientation only serves to diminish the load capacity, a force acting in this specific direction must be present to overload the bearing and cause the damage.

A unique feature of the secondary flowpath on the failed ISS ammonia pump was the single lubricant feed supply hole to the rear bearing. In addition to having just one supply hole to the rear bearing the lubricant was directed radially toward the shaft extension aft of the bearing. This is in contrast to the notional pump shown in Figure 3. Examination of the right side of this figure shows that the lubricant to the rear bearing is canted toward the rear endplate of the motor, not toward the shaft, and that there are symmetric supply holes to the rear bearing. This design practice ensures that no net force is imposed on the rear bearing due to the lubricant supply and secondary flowpath of the motor. However, the design that was implemented on the failed ammonia pump permitted a radial load to be imposed on the rear bearing due to the jet force of the lubricant feed. An analysis was conducted on the magnitude of this force as a function of pump rotational speed. The results of this analysis are cross-plotted on Figure 6 and show that this force can overload the 7.5 micrometer load capacity limit of the bearing at 12500 rpm. Furthermore, the finding of the physical inspections revealed that the wear on the rear bearing was in the direct opposite direction from the lubricant feed hole. There are two strong indications that the lubricant jet force on the rear bearing was the root cause of the bearing failure and initiated the damage to the rear bearing carbon. First, the load margin analysis showed that the jet force alone could overload the rear bearing at 12500 rpm without considering the additional effects of the previous four factors providing additional bearing loads or reduced capacity. Second, the wear pattern was consistent with a uni-directional load causing a static angular misalignment, which is the expected manifestation of the single jet force aft of the rear bearing.

Verification was needed to confirm the hypothesis that the lubricant jet force on the rear bearing served as the root cause for the ammonia pump failure. While analysis of the bearing capacity, analysis of the magnitude of the lubricant jet force, and the findings of the physical inspections were consistent with this fact, experimental validation of the analyses was needed to run the issue to ground. To this end, a flow visualization experiment of the rear bearing lubricant feed geometry was conducted. Still pictures of the lubricant jet characteristics at 11000 rpm and 15000 rpm are shown in Figure 9. In these experiments water was used to simulate the anhydrous ammonia in order to match the kinematic viscosity between the two fluids. In the flow visualization blue dye was added to the lubricant jet in order to distinguish between the fluid in the jet and the fluid resident in the aft bearing pocket. The pictures clearly show a change in the character of the jet force between the low speed operating point of 11000 rpm and the high speed operating point of 15000 rpm. At the low speed point, the jet is slow to emerge from the feedhole and diffuses into the surrounding fluid. These characteristics are consistent with a low imposed jet force. By contrast, at the high-speed condition the jet remains organized and coherent up to the point of impact with the shaft extension. This characteristic is consistent with a significant jet force imposed on the shaft and rear bearing. Because the bearing load capacity increases linearly with rotational speed but the jet force increases with the square or cube of shaft speed, a crossover point can be identified at which the rear bearing margin goes negative. Once the bearing margin goes negative, solid surface contact occurs and wear damage of the carbon bearing begins to accumulate. This initial damage changes the geometry of the bearing, which in turn predisposes the rotor-bearing system to angular misalignment in this direction. These flow visualization experiments provided verification that the lubricant jet force initiated damage to the rear bearing and contributed to the premature failure of the pump. In order to restore operational life of the remaining pump modules, procedures were modified to limit maximum speed to 12500 rpm, minimize changes to pump speed, and minimize start-stop cycles on the pump.

- Maintain an axially symmetric journal bearing design
- Ensure that cylindrical rigid body modes dominate over conical modes
- Perform vertical testing to unmask dead weight loading effects
- Perform qualification tests that quantitatively validate bearing performance
- Perform qualification tests that quantitatively validate rotordynamic performance
- Maintain ground assets to experimentally probe and verify in-space anomalies
