Space Shuttle Stiffener Ring Foam Failure Analysis, a Non-conventional Approach.

Philip M. Howard

NASA

Materials Science Division

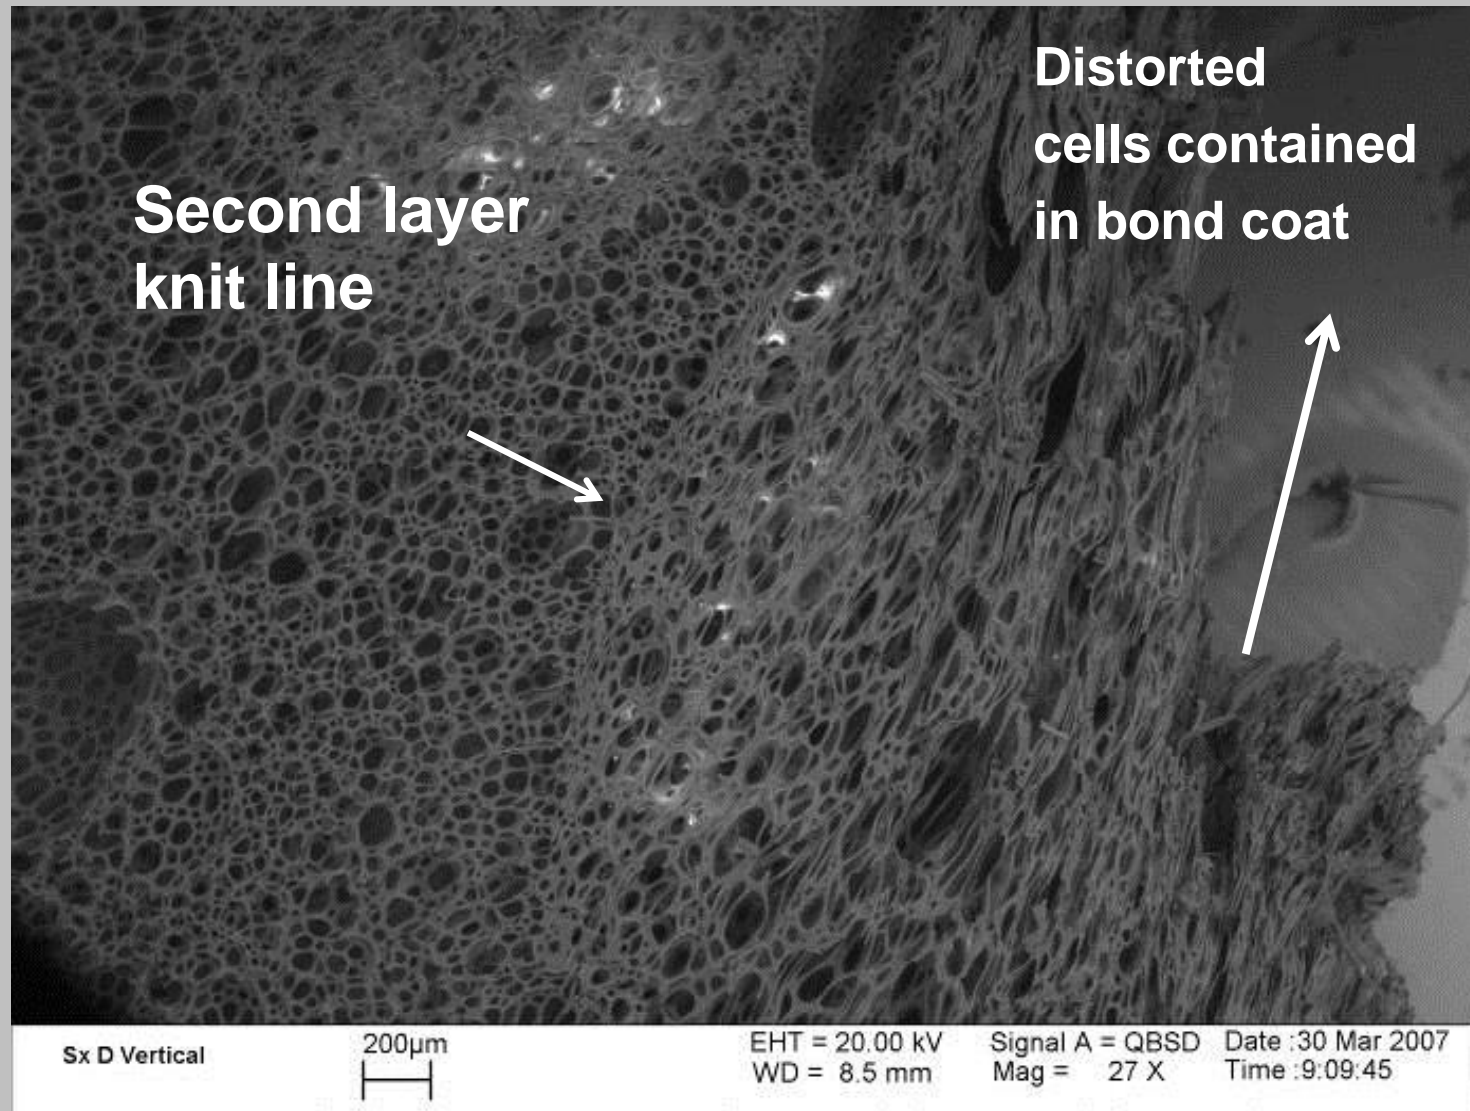
Cross Section of SRB Foam Failure

Chief SRB Engineer –we have never looked at foam like this

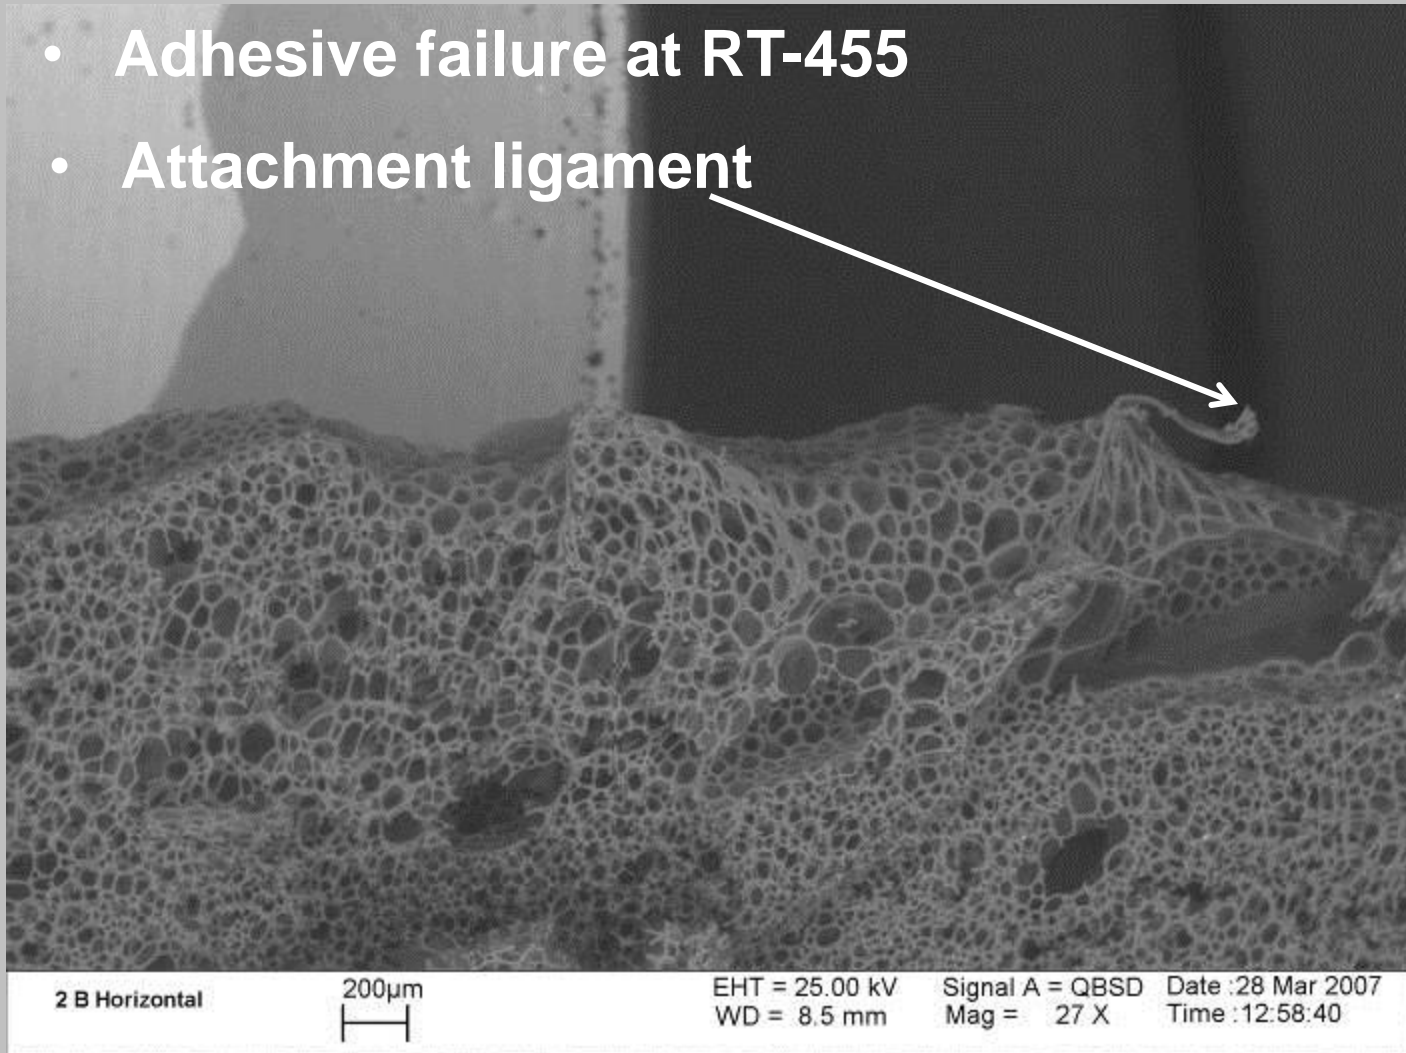
SRB Foam Failure

- Adhesive failure at RT-455
- Attachment ligament

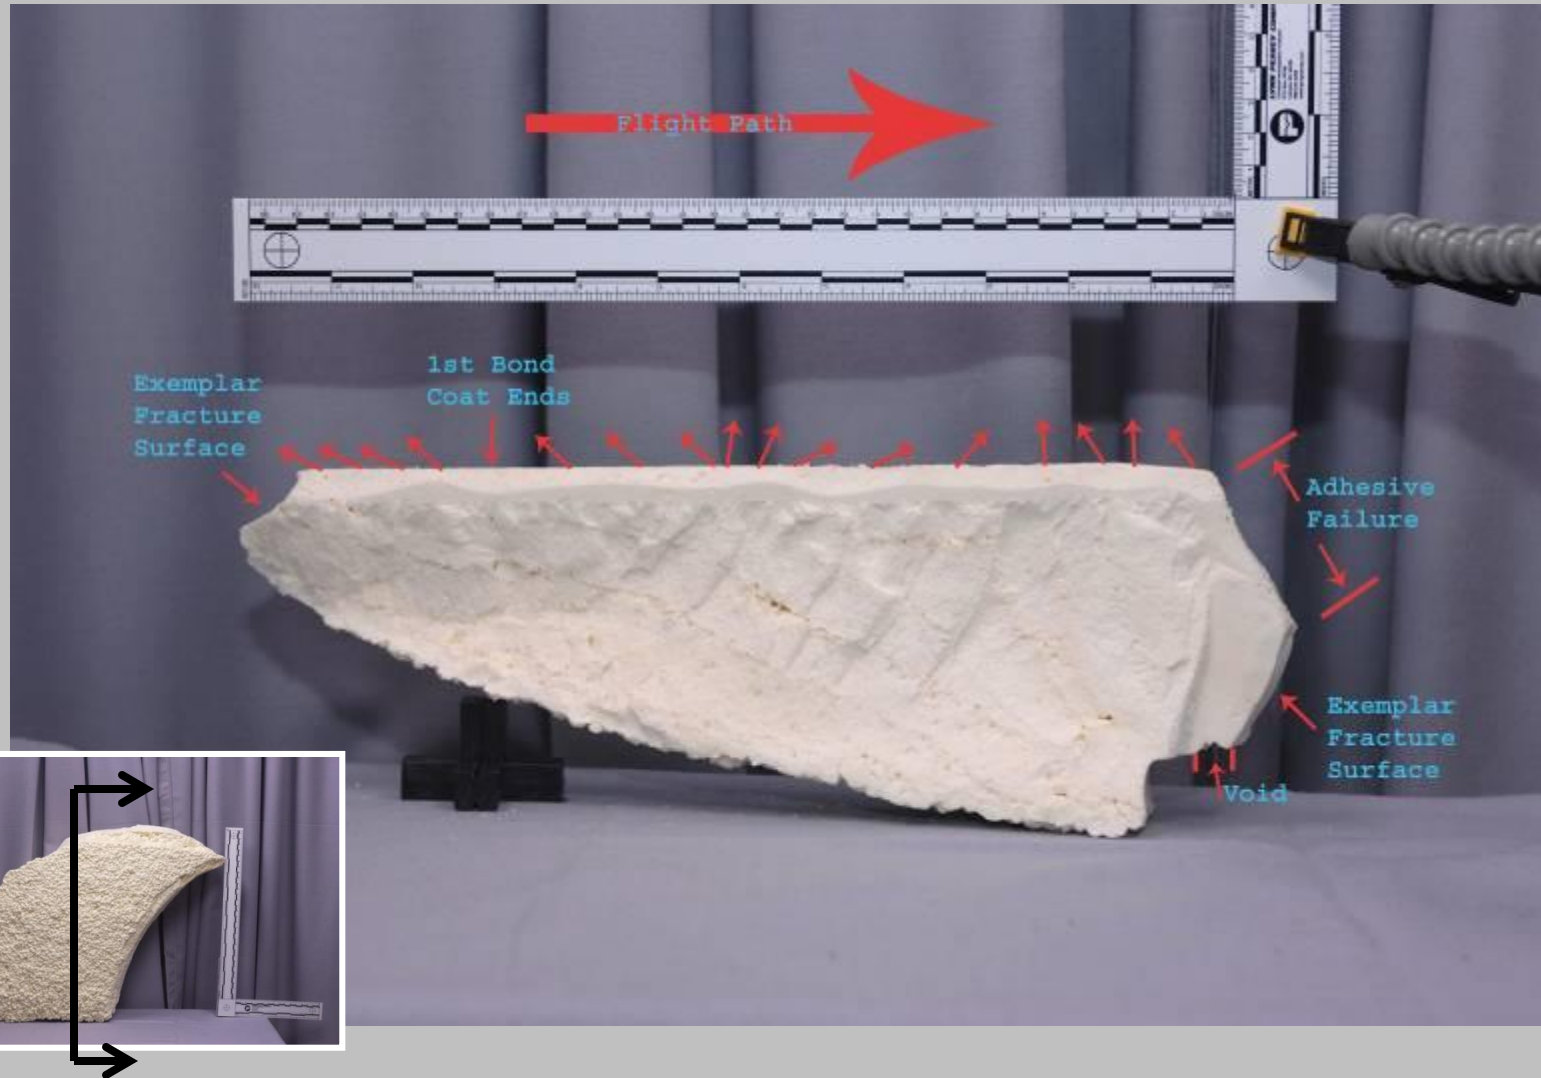
SRB Foam Failure

The foam bond coat displayed two modes of failure:

- >80 percent application failed
- Cohesive failure was observed due to severely deformed foam cells in the bond coat
- Adhesive failure was observed at the RT-455 Epoxy interface.

The observed morphology indicates that the bond coat was not fully cured before other forces were applied, e.g. the expansion forces of the second coat distorted the bonding cells.

- Develop spray hardware to apply micro bond layers ($< 1/8''$ layers)
- The bond coat should be allowed to completely dry/cure
Never apply over wet uncured layers
- Smaller Soup can (1/2 inch) inspection plugs for SEM analysis should be developed

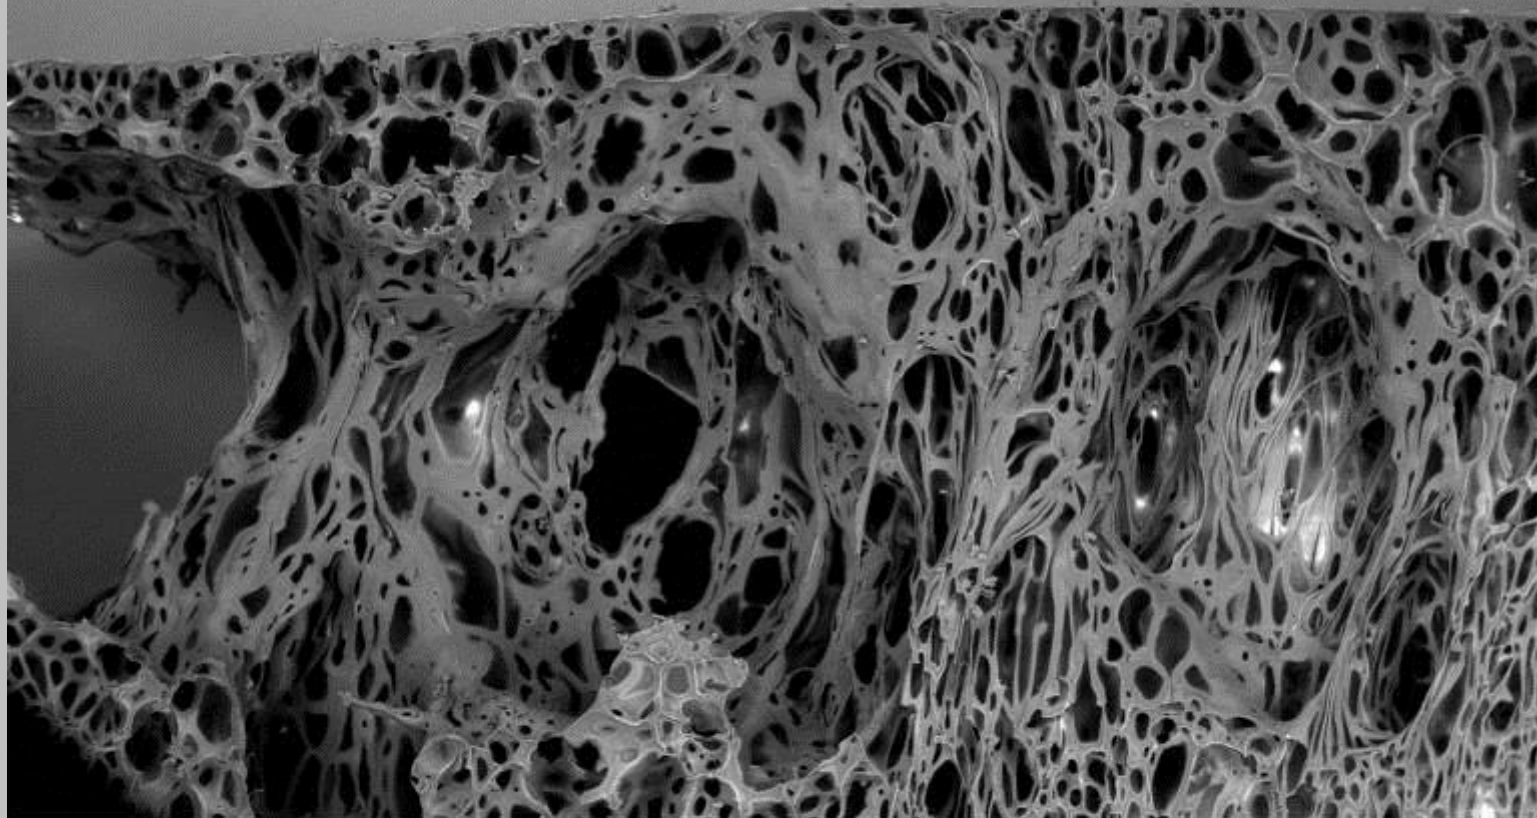
MSL-2007-0134
1

•30 % adhesive failure
