Title ELECTRON MICROSCOPY ABRASION ANALYSIS No. Copies Required 30Page 1 of 1

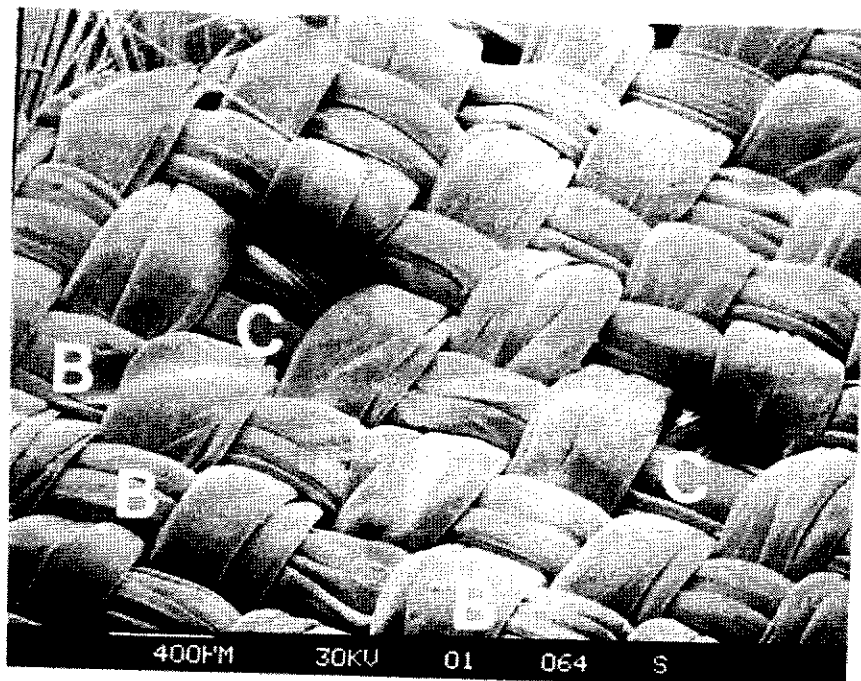
Figure 13

Sample: 1  
View: Front  
Condition: New  
Ref: 400 microns  
Mag: 33x

This is a representative view of the front face of new Orthofabric. Notice the characteristic wide, smooth, ribbon-like appearance of the Gore-Tex fibers. Although new, there is some random pitting (B) on the Gore-Tex fibers, possibly from manufacturing or weaving processes. The Nomex fiber bundles (C) are visible in the small depressions of the split, basket weave which occur after every third Gore-Tex fiber. These depressions are a possible route for dust to travel from the front face to the back of the fabric. (Disregard the cut fibers in the upper left hand corner; this photograph was taken near the edge of the SEM specimen.)

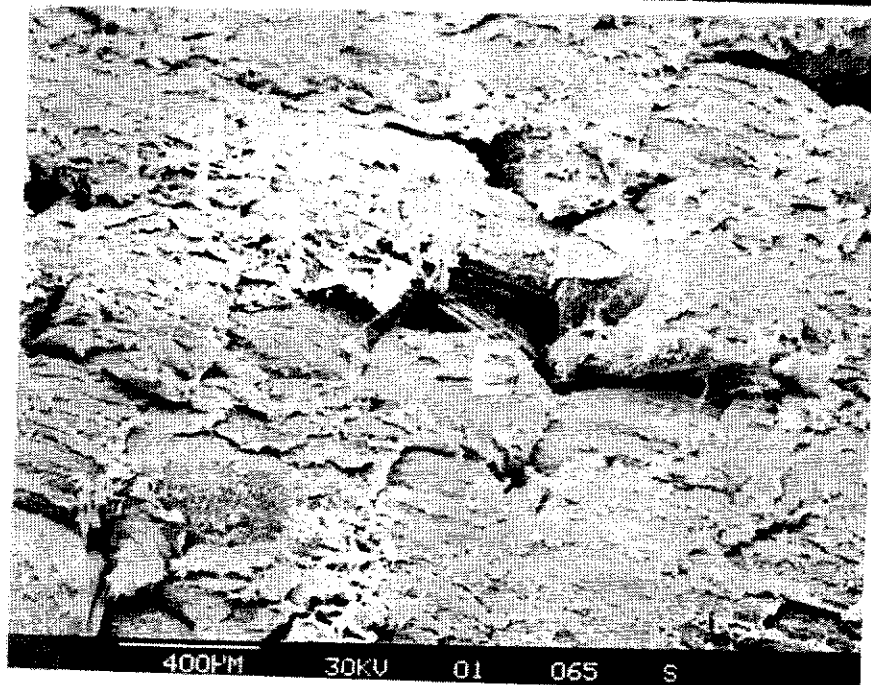
Figure 15

Sample: 1  
View: Front  
Condition: Cleaned  
Ref: 400 microns  
Mag: 47x

The ultrasound cleaning procedure did remove a large portion of the dust and loose fiber debris that remained on the sample. The Gore-Tex fibers are shredded and heavily damaged. It is still difficult to distinguish the original weave pattern as the tattered fragments lay over each other. However, the Nomex fibers (E) appear intact and there is no visible loose debris or dirt in the depression.

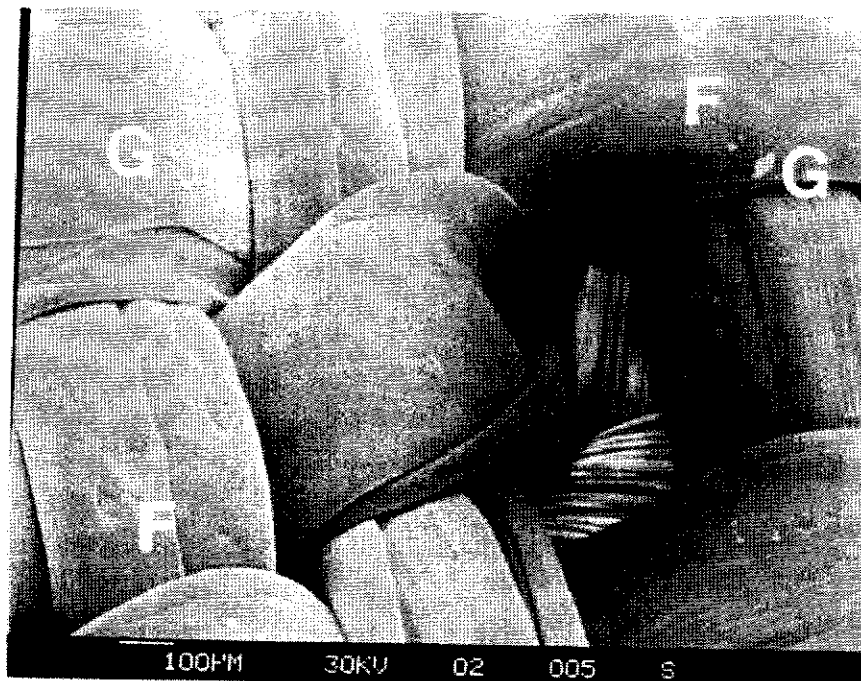
Sample: 1  
View: Front  
Condition: New  
Ref: 100 microns  
Mag: 50x

This micrograph gives a closer look at new Orthofabric. The random pits (F) and surface damage of the Gore-Tex fibers are more easily seen at this higher magnification. Small particles (G) on the Gore-Tex fibers are most likely pieces of dirt that got on the fibers or fabric during the weaving process or during handling. This micrograph is a good illustration of the depression in the weave where the Nomex fiber bundles show through to the front face of the fabric. There is room in the depression for dust to migrate through the fabric; however, the Gore-Tex weave appears fairly tight with little room in the interstices for dust to travel through.

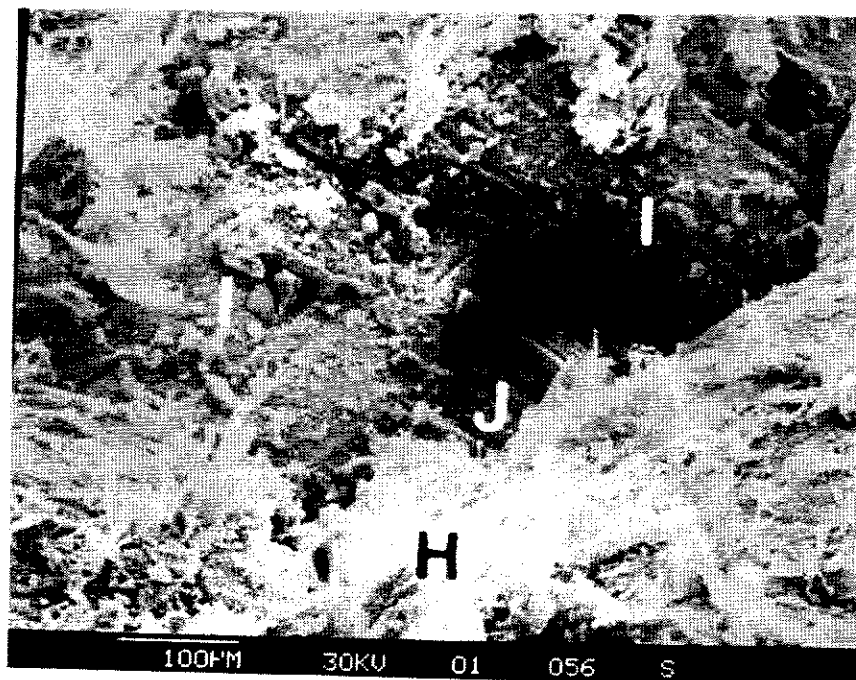
Figure 17

Sample: 1  
View: Front  
Condition: Tumbled  
Ref: 100 microns  
Mag: 150x

There is a significant amount both fiber debris (H) and abrading particles (I) present on the front face of the Orthofabric sample after tumbling. As with Figure 14, it is difficult to distinguish the Gore-Tex fiber weave, although the Nomex bundles (J) are visible in the center of the micrograph. The Gore-Tex has been heavily damaged by the tumbling procedure, whereas the Nomex fibers do not appear to be abraded.

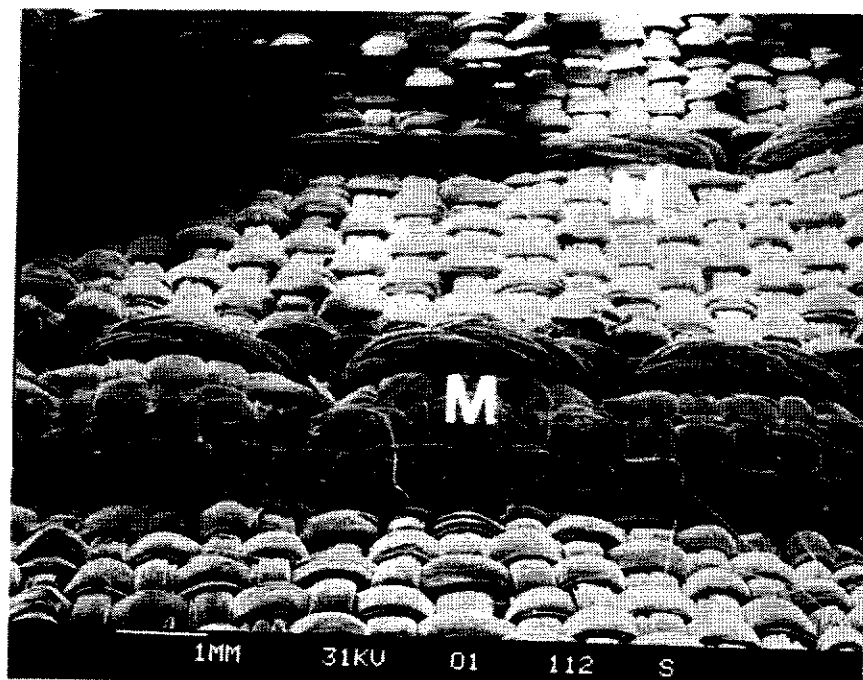
Sample: 1  
View: Front  
Condition:  
Seam, New  
Ref: 1 mm  
Mag: 11x

This micrograph illustrates how a new seam appears when viewed from the front face of the sample. The fabric is joined as follows - one piece is folded under and secured with two parallel seams (M) to a second piece of fabric. In addition to dust migration paths through the interstices of the weave and through depressions in the weave, the seam construction offers two other migration paths. Dust could migrate by following the Nomex thread from the front to the back of the fabric through the needle holes and/or by penetrating the gap between the two pieces of fabric.

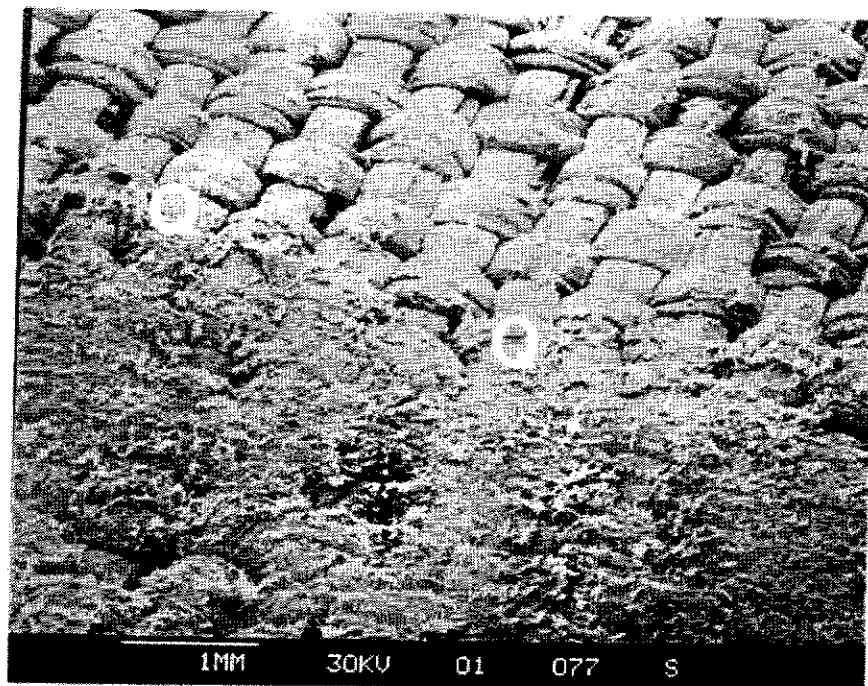
Sample: 1  
View: Front  
Condition:  
Fold, Tumbled  
Ref: 1 mm  
Mag: 17x

A fold (Q) on the front face of this specimen of tumbled Orthofabric is clearly distinguished by the difference in abrasion seen by the two sides. The fibers on one side of the fold show hardly any abrasion, whereas the other side is so heavily abraded that the weave is indistinguishable. Most of the fibers on the top side are intact and there is an even distribution of small dust or fiber debris particles covering the fibers. The bottom side shows the characteristic heavy abrasion seen in previous figures 15, 17 and 18 where the Gore-Tex fiber surface has been shredded. The abrasion seen in this micrograph appears worse than that of the previous photos; this is probably due to the lower magnification of the micrograph which could exaggerate the extent of the damage.

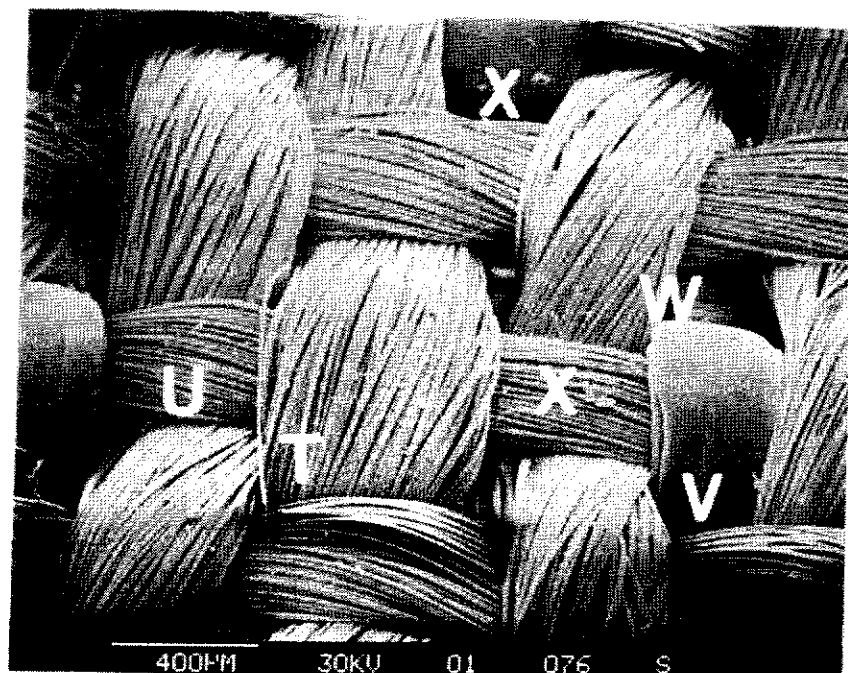
Sample: 1  
View: Back  
Condition: New  
Ref: 400 microns  
Mag: 48X

All three fibers, Gore-Tex, Nomex and Kevlar are visible on the back face of Orthofabric. In this micrograph, the bundles of thicker fibers are Kevlar (T) while the bundles of thinner fibers are Nomex (U). The broad Gore-Tex fibers (V) are woven through to the back face every third fiber just as the Nomex bundles were on the front face, creating a large gap in the weave (W). There is a small amount of particles (X) on the new fabric; as with the front, these are most likely pieces of dirt that got on the fabric during the weaving process or during handling. The fiber weave on the back face is much looser than on the front face; there is more room in the interstices of the weave for dust migration.

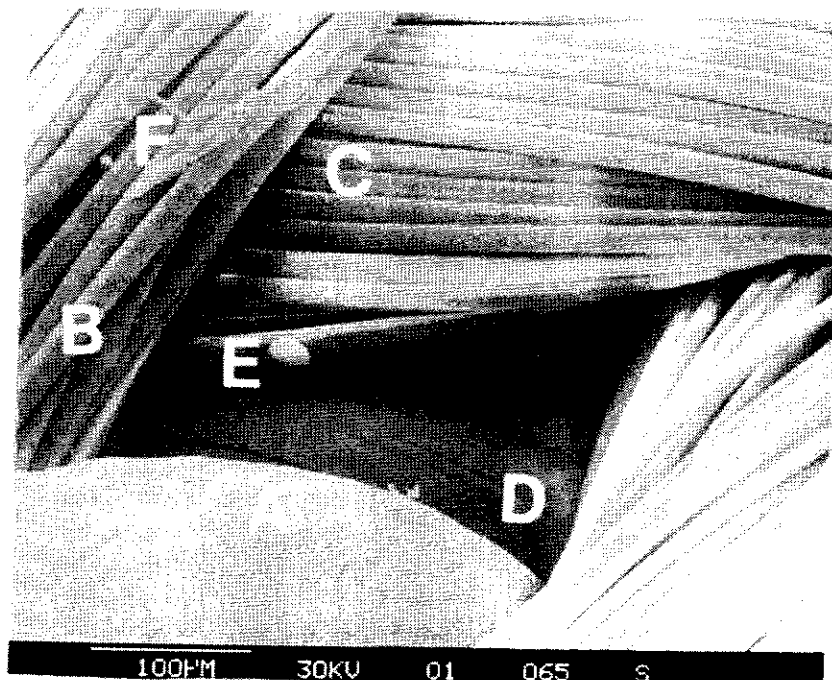
Sample: 1  
View: Back  
Condition: New  
Ref: 100 microns  
Mag: 200x

This micrograph is a close-up of the gap between the new Gore-Tex (A), Kevlar (B) and Nomex (C) fibers in the weave on the back face. The gap is nearly 300 $\mu$ m across and an average of 90 $\mu$ m wide. The front face Gore-Tex weave can be seen through the gap (D). A foreign dirt particle (E) can be seen clinging to the Nomex bundle at the edge of the gap. The Kevlar fiber bundle (B) has experienced some particulation (F) of one fiber through either handling or manufacturing processes.

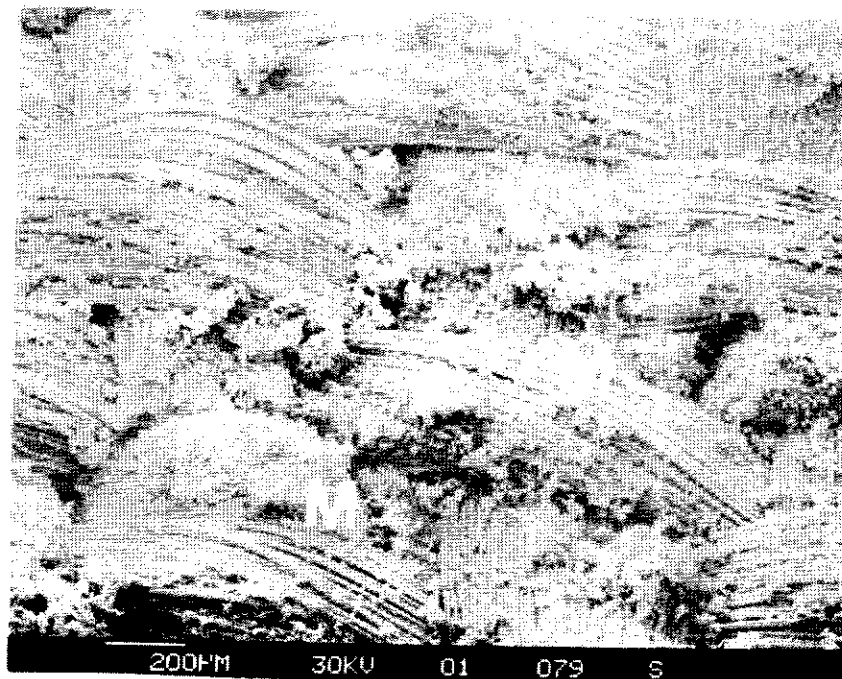
Sample: 1  
View: Back  
Condition:  
Fold, Tumbled  
Ref: 200 microns  
Mag: 50x

Unlike the front face of the fold shown in Figure 22, there is no clear distinction where the fold is in this view from the back face. Both sides of the fold are covered with a thick, even layer of dust simulant that practically hides the weave pattern. The dust has completely filled the gaps in the fabric weave (M). There is much more dust on the back of this fold than there was on the representative back face, tumbled area of fabric seen in Figure 26.

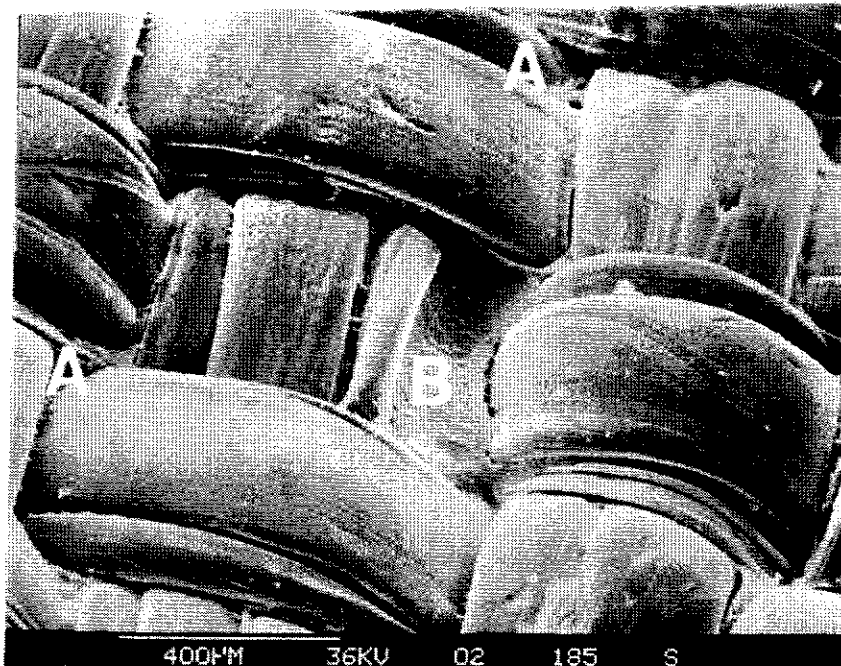
Sample: 2  
View: Front  
Condition: New  
Ref: 400 microns  
Mag: 75x

This is a representative view of the front-face of new, coated Orthofabric. The Gore-Tex weave is the same as that of the uncoated fabric. The difference in appearance is due to the back-face coating saturating through to the front which fills up the interstices of the weave (A). Notice that the Nomex fiber bundles are no longer visible; the depression in the weave (B) where these fibers would normally show through has been completely filled with the coating. Two dust migration routes that were identified for regular Orthofabric are through the interstices of the weave and through the depression in the weave. As seen in this micrograph, both of these routes are blocked on this sample due to the coating. There is some random pitting on the new Gore-Tex fibers, possibly from manufacturing or weaving processes.

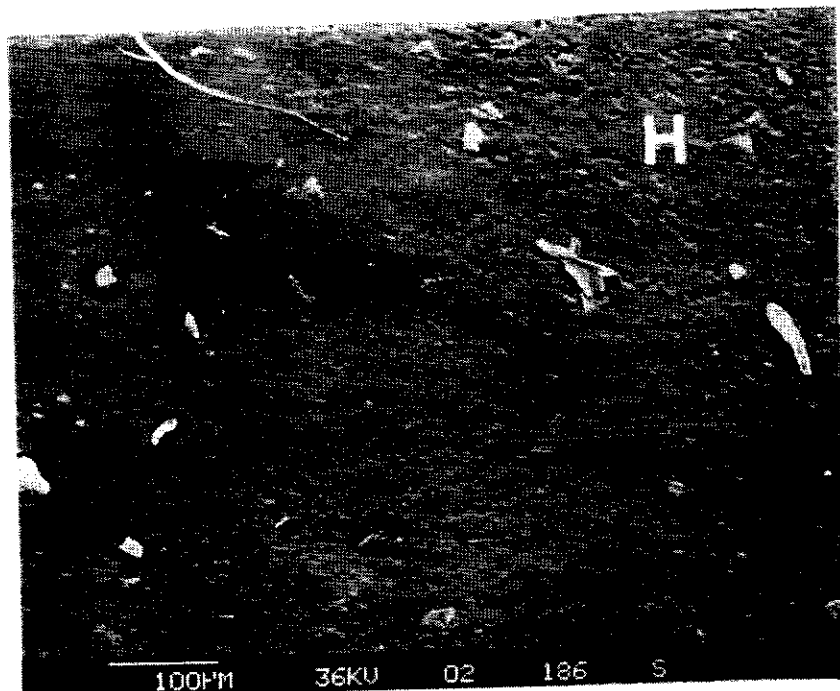
Sample: 2  
View: Back  
Condition: New  
Ref: 100 microns  
Mag: 130x

No features of the back face Orthofabric weave (illustrated in Figure 28) are visible beneath the 10 mil. silicone coating. The surface of the new coating is fairly smooth; however, there are small pits (H) and several foreign particles randomly located on the specimen. Both the pits and foreign particles are most likely from fabric manufacturing or handling process.

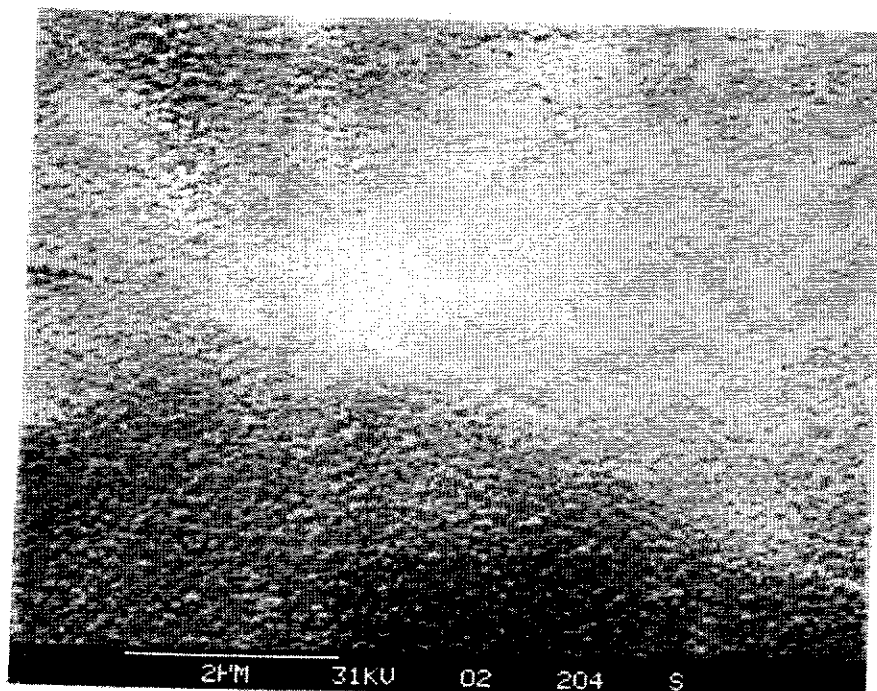
Sample: 2  
View: Back  
Condition: New  
Ref: 2 microns  
Mag: 14,700x

This micrograph is a close-up (14,700x) view of the new silicone coating on the back face of Orthofabric. (Notice that this is one of the highest magnification micrographs seen so far in this study.) The coating is very smooth. Disregard what appears to be a bump under the surface of the coating in the center of the micrograph. This is an anomaly caused by the heat of the SEM electron beam focusing on the sample.

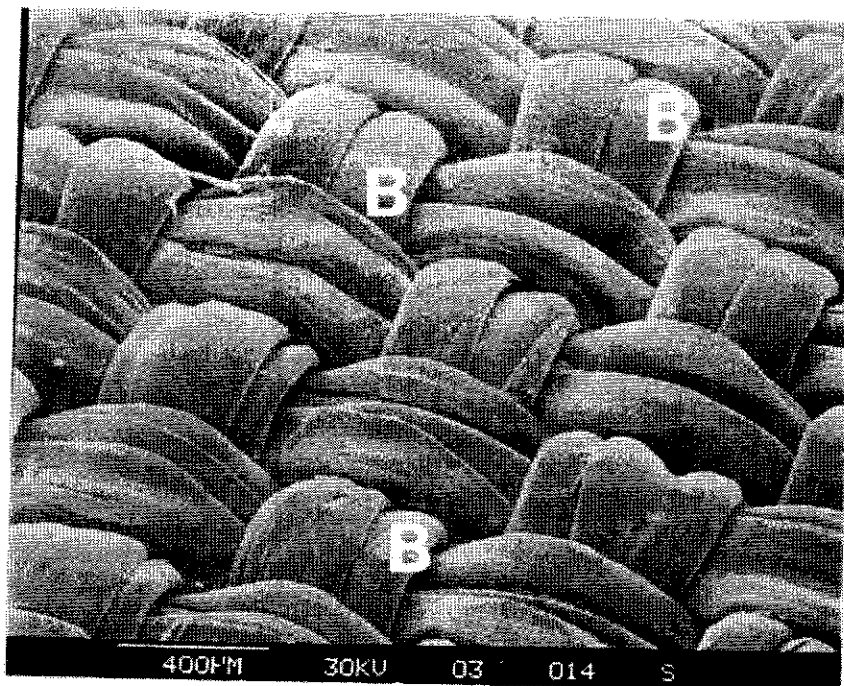
Sample: 3  
View: Front  
Condition: New  
Ref: 400 microns  
Mag: 50x

This is a representative view of the front face of the new Gore-Tex fabric. Notice the characteristic plain weave design of the familiar Gore-Tex fibers. The weave looks a lot like that of Orthofabric with the exception of the depressions where the Gore-Tex and Nomex fibers crossed. The weave is fairly tight, although there may be enough room in the interstices of the weave (B) for the lunar dust stimulant particles to penetrate the fabric. Again, there is random pitting on the new fibers from manufacturing or handling processes.

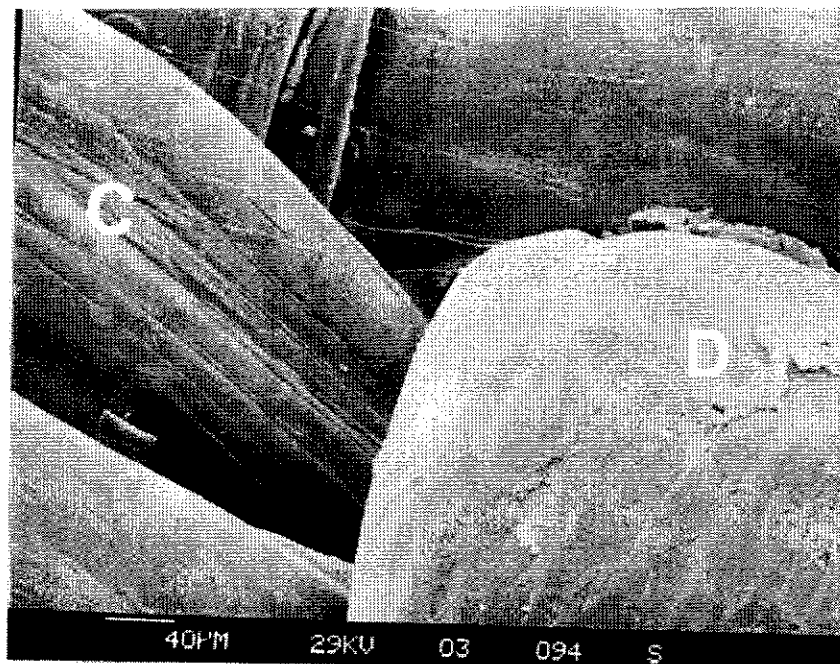
Sample: 3  
View: Front  
Condition: New  
Ref: 40 microns  
Mag: 210x

This micrograph illustrates the interstices of the front face Gore-Tex weave. There is little room for dust migration. Notice the parallel grooves (C) that run along the grain of the fiber; they are characteristic of new, expanded PTFE and are inherent to the material. The surface damage at (D) probably occurred during manufacturing. These features of new Gore-Tex fibers are noticeable at magnifications such as this (40 $\mu$ m).

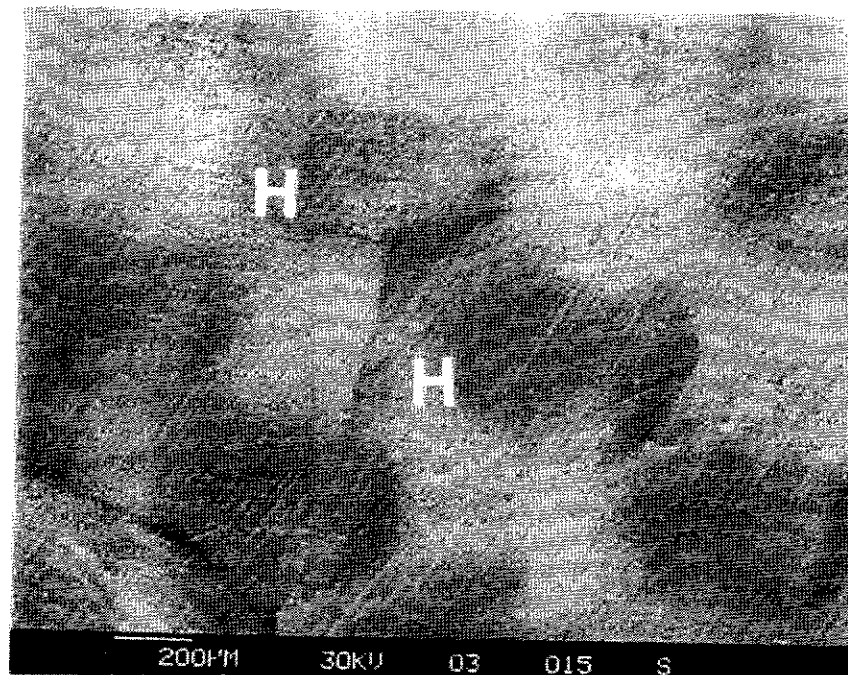
Sample: 3  
View: Back  
Condition: New  
Ref: 200 microns  
Mag: 50x

The laminate on the back face of the new Gore-Tex fabric is very smooth. The shadow-like, dark areas (H) on the surface indicate the weave beneath the 2 mil. laminate. There are very few pits or surface scars present from manufacturing or handling.

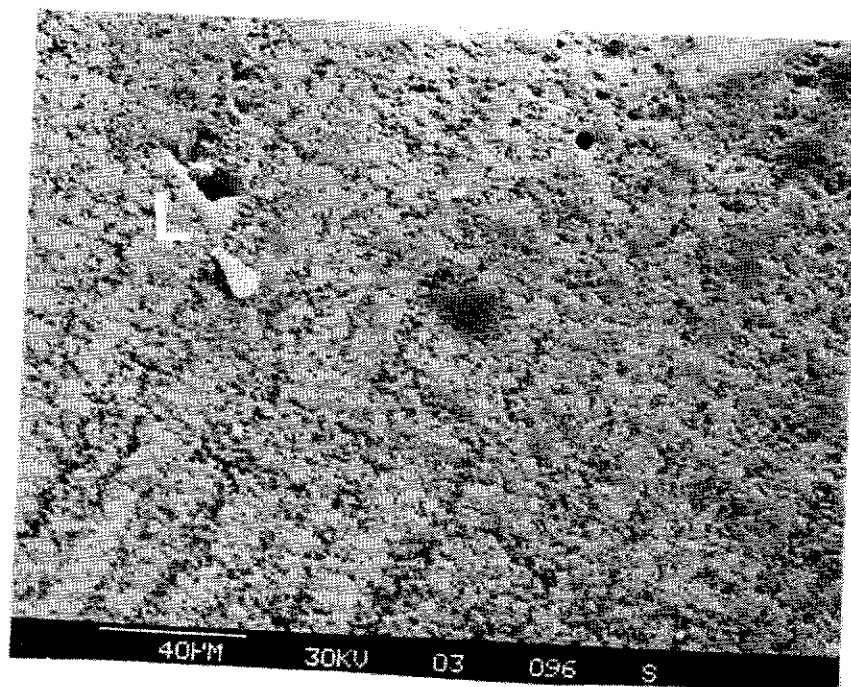
Sample: 3  
View: Back  
Condition: New  
Ref: 40 microns  
Mag: 490x

A closer look (490x) at the back face of the fabric reveals that the new laminate is essentially a membrane that resembles a dense, fishnet-like structure. There is a pattern of holes in the membrane. These holes are approximately 2-5 $\mu$ m which is too small for the lunar dust simulant particles to penetrate from the front face. The large hole (L) most likely occurred during manufacturing or handling.

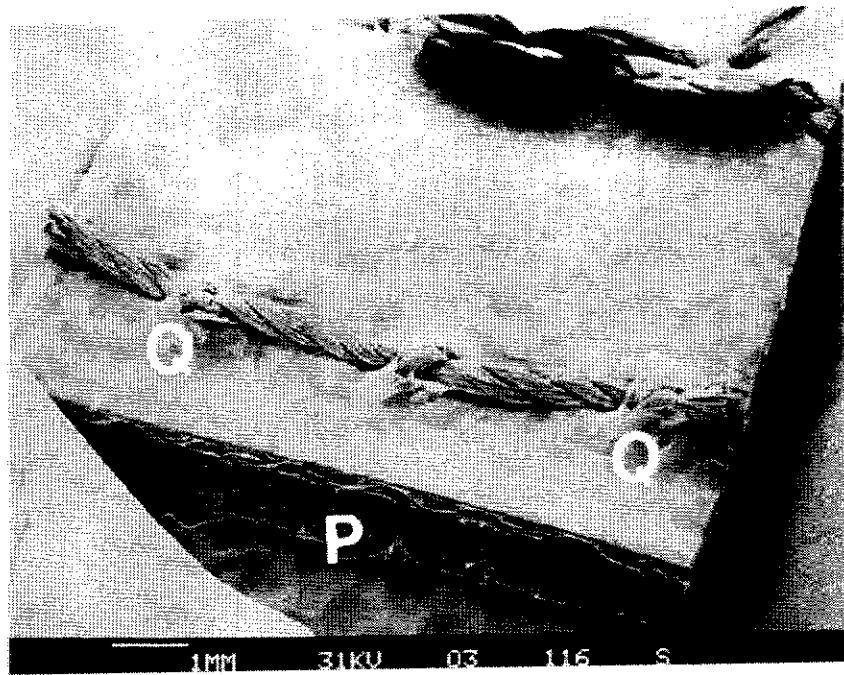
Sample: 3  
View: Back  
Condition:  
Seam, New  
Ref: 1 mm  
Mag: 8x

Here is a representative back face view of a new seam. Notice the smooth laminate which seals the Gore-Tex weave. As previously mentioned, there is a large gap (P) between the two pieces of fabric that are joined at the seam; this is the primary migration route of the lunar dust simulant particles from the front to the back of the fabric. Additional routes for particle penetration are the needle holes (Q) which pierce the back face laminate.

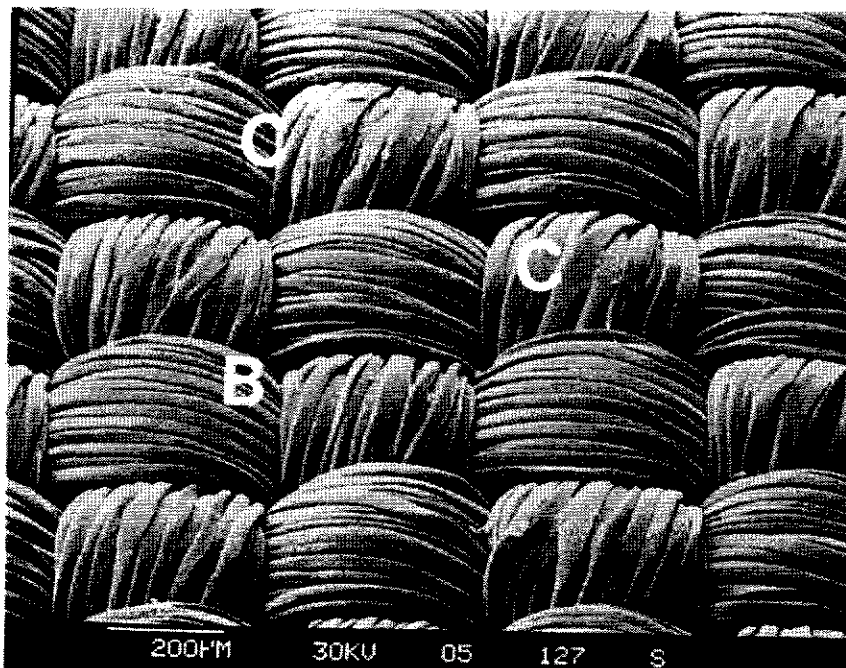
Sample: 5  
View: Front  
Condition: New  
Ref: 200 microns  
Mag: 77x

This is a representative view of the front face of new T162. The teflon fibers are smooth and have the ribbon-like appearance of the Gore-Tex fibers in Samples 1-4. However, unlike the two fiber Gore-Tex yarns (see Figure 16), the T162 yarns consist of many fine fibers. The characteristic plain weave is tight with little room in the interstices (B) for dust migration. There are a few fibers that are flattened (C); this damage occurred either during manufacturing or handling processes.

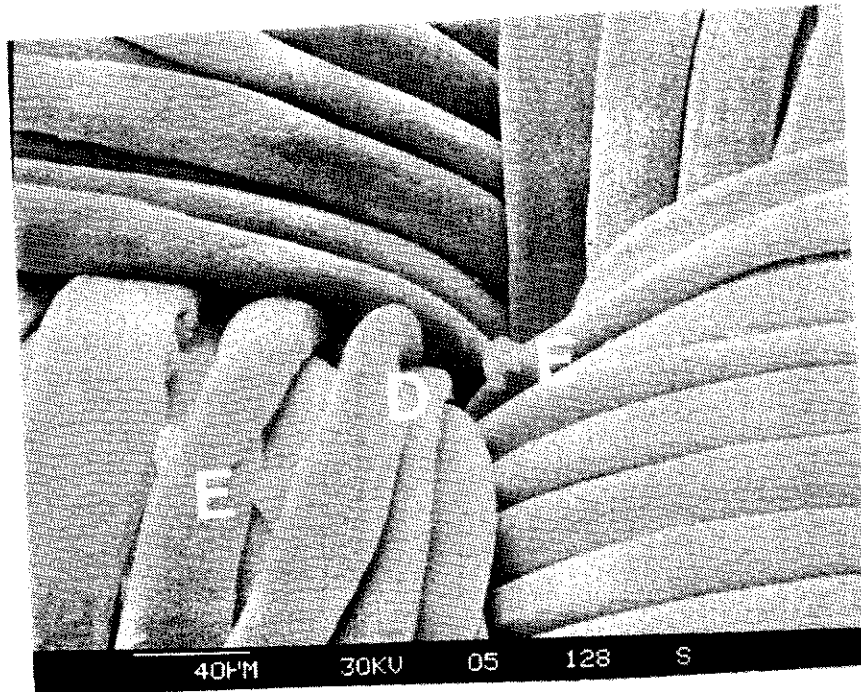
Sample: 5  
View: Front  
Condition: New  
Ref: 40 microns  
Mag: 380x

There is a 20 $\mu$ m gap (D) between the woven T162 yarns; this is a large enough path for small lunar dust simulant particles and fiber debris to travel through. Notice the smooth, thin, flat fibers of the fabric. There is little damage to this new specimen; the only anomalies are small pieces of fiber debris (E).

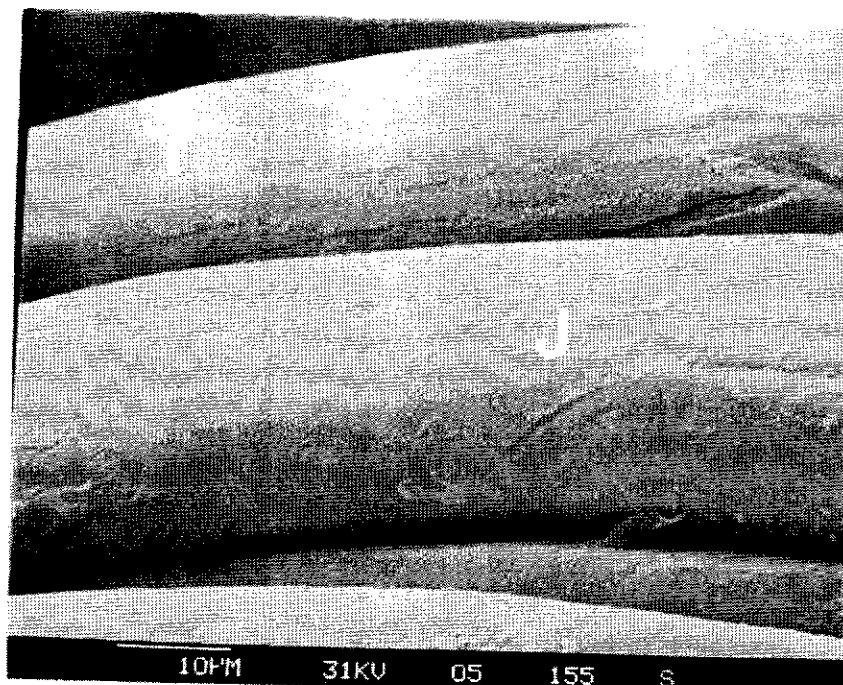
Sample: 5  
View: Front  
Condition: New  
Ref: 10 microns  
Mag: 1400x

Here is a close look (1400x) at four individual fibers in a T162 yarn. The fibers are very smooth. The surface grooves (I) of the new fibers are not as deep as the scars on the new Gore-Tex fibers (Sample 3 Figure 61). The other surface damage (J) is due to manufacturing and handling processes.
