Evidence of Processing Non-Idealities in 4H-SiC Integrated Circuits Fabricated With Two Levels of Metal Interconnect

Abstract. The fabrication and prolonged 500 °C electrical testing of 4H-SiC junction field effect transistor (JFET) integrated circuits (ICs) with two levels of metal interconnect is reported in another submission to this conference proceedings[1]. While some circuits functioned more than 3000 hours at 500 °C, the majority of packaged ICs from this wafer electrically failed after less than 200 hours of operation in the same test conditions. This work examines the root physical degradation and failure mechanisms believed responsible for observed large discrepancies in 500 °C operating time. Evidence is presented for four distinct issues that significantly impacted 500 °C IC operational yield and lifetime for this wafer.

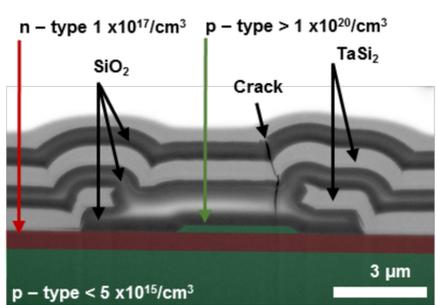
Fig. 1. Cracking sometimes occurs where metal 1 and metal 2 overlap the gate.

Crack Formation Induced Fail-Open of Top Metal Interconnect. The focused ion beam (FIB) cross-section shown in Fig.1, illustrates an example of dielectric and metal cracks that caused topmost metal conductive interconnect traces to electrically fail open. Devices close to the wafer center (roughly < 1 cm) did not exhibit this problem as the misalignment in this region was insufficient to result in such overlap/distortion. Misalignment and cracking grew more severe with increasing radial distance from the wafer center, consistent with rotational misalignment of the bottom metal mask pattern to the substrate n-mesa pattern during fabrication. Such cracks are not observed on other kinds of topology, such as where the lower TaSi₂ trace edge ends over the flat SiC region on the left side of Fig. 1. Cracking is also not observed on the large bond pad edge cross-section shown in Fig. 2. The measured resistance vs. time between adjacent connected bond pads plotted in Fig. 2 demonstrates desired minimal change in conduction properties (in part due to absence of crack features) over 4800 hours of 500 °C electrical testing time. Since it is related to misalignment, this cracking problem should be solvable by improved alignment and/or design rules with larger misalignment tolerances so as to prevent overlapping of lower metal edges with mesa features.

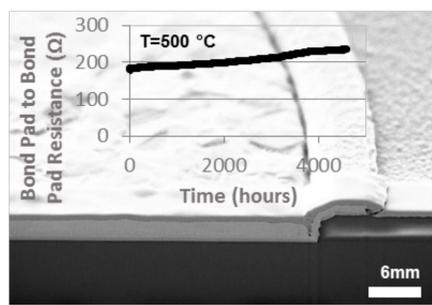
Fig. 2. By design, cracking did not occur around the oxide on bond pads. There was 32% increase in pad to pad resistance over 4800 hours.

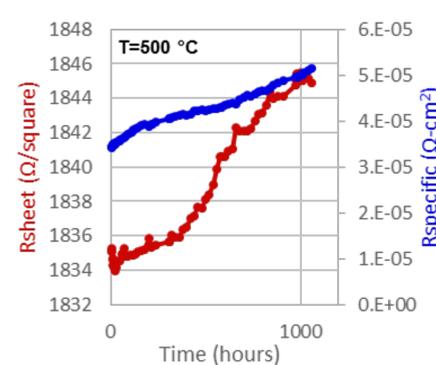
Fig. 4. < 1% variation in R_{sheet} , but 50% increase in $R_{specific}$

Device Resistance Degradation. Fig. 4 plots sheet resistance (R_{sheet}) and specific contact resistance ($R_{specific}$) extracted from prolonged measurement of a packaged 500 °C transmission line method (TLM) test device of the source/drain implant for over 1000 hours. R_{sheet} changed less than 1% while $R_{specific}$ changed 50%. This suggests a degradation in the contact area or metal while the high-dose SiC implanted sheet resistance is stable. The 500 °C testing time evolution of transistor parameters for a JFET in a NOT circuit are shown in Fig. 5. The threshold voltage (V_T) changes less than 2% over 2000 hours. Transconductance (g_m) and the on-state current (I_{DSS}) decrease with time at temperature while on-state resistance R_{DS} increases, which is qualitatively consistent with the Fig. 4 trend. Data discontinuity shown in Fig. 5 at 1000 hours corresponds to a brief temperature cycle to 25 °C and back. Most of the drift in R_{DS} recovered during this cycle. It is important to note that the recovery of R_{DS} seems inconsistent with contact oxidation or metal trace failure mechanisms that would be irrecoverable. Delamination of the contact area has not been seen in focused ion beam (FIB) cut cross-section images of similar devices on the wafer. Therefore, the root physical cause (or causes) of this degradation remains under investigation at this time.

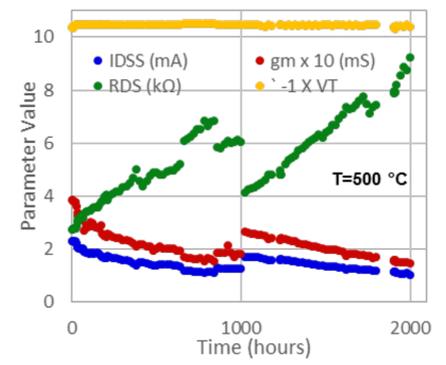
Fig. 5. < 2% variation in V_T . Note changes from thermal cycle to RT at 1000 hours.

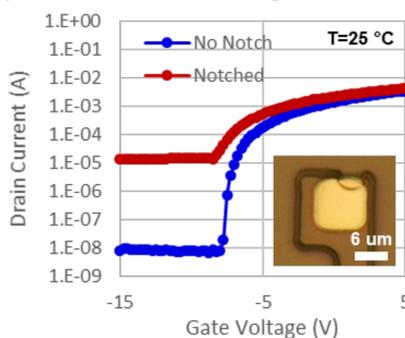
Fig. 3. JFET turn off leakage with and without a notch in the p-gate mesa.

Gate mesa with a notch that is not fatal at room temperature but decrease it's 500 °C durability do to thin SiO₂.

Gate-to-Channel Leakage/Short From Notching of Gate Etch Mask Metal. These notches arose from non-uniform oxidation/peeling along the edges of the gate etch mask during a prolonged unplanned storage of the sample in room air. When the second dry (n-mesa) etch was conducted, the notched regions did not sufficiently protect the p⁺ SiC from removal, which then exposed underlying n-mesa regions in areas where contacts to p⁺ gates were subsequently deposited. Fig. 3 inset shows where a p⁺ gate contact overlaps such a notch. This allows the deposited metal p⁺ gate contact to also form a parasitic electrical contact to the underlying exposed n-channel epilayer, including along the vertical etched sidewall of the n-epilayer. While not a complete short circuit at T = 25 °C, turn-off characteristics of “notched” JFETs are undesirably orders of magnitude larger than notch-free devices (Fig. 3). While not directly measured at high T, the leakage mechanisms of metal-semiconductor contacts/diodes are known to increase with anneal time and exponentially with T [2]. Therefore, this parasitic leakage is surmised to contribute to rapid failure of circuits at 500 °C. The degree of notching (and thus the degree of leakage) varied across the wafer. Very few devices with more than 10 gate fingers were free of notches. Notches have not been observed in any process runs before and after this wafer whose processing time between the gate and mesa etches have been a week or less, and were shipped to vendors in vacuum boxes.

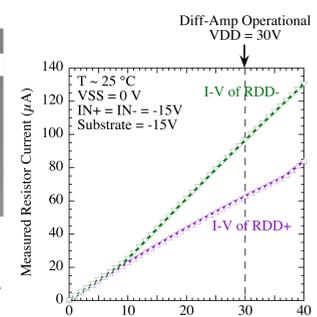
Fig. 7. Applied Resistor Voltage (V)

Parasitic Circuit Imbalance Induced by Mobile Ion Contamination. Differential amplifier circuits rely on well-balanced circuit legs (i.e., transistors and/or resistors) to operate. Resistive load differential amplifier ICs (including 2-stage op-amps which were also used as sense-amps for test memory ICs) were fabricated and electrically verified as operational at room temperature with expected gains. However, on all ICs custom-packaged for high temperature testing, these differential-based amplifiers all rapidly failed as they were heated past 200 °C. A packaged diff-amp (Fig. 6) underwent bias-temperature stress measurements while directly measuring “balanced” resistors RDD⁺ and RDD⁻ (highlighted with colored dashed lines) IV characteristics. Fig. 7 shows an example of the resistor IV imbalance measured after +30V 200 °C positive bias stress of the V_{DD} metal trace, while Fig. 8 shows that the imbalance is mostly eliminated following a subsequent -18V 300 °C stress applied to the V_{DD} metal trace. This reversible bias-temperature-time stress behavior is consistent with reversible mobile ion contamination phenomenon well-known to be detrimental to metal-oxide-semiconductor (MOS) devices [3]. Subsequent surface analysis detected sodium (Na) on the surface of wafer samples.
