The Evolution of Failure Analysis at NASA's Kennedy Space Center and the Lessons Learned

Failure in LEO: the Solar Alpha Rotary Joint (SARJ):

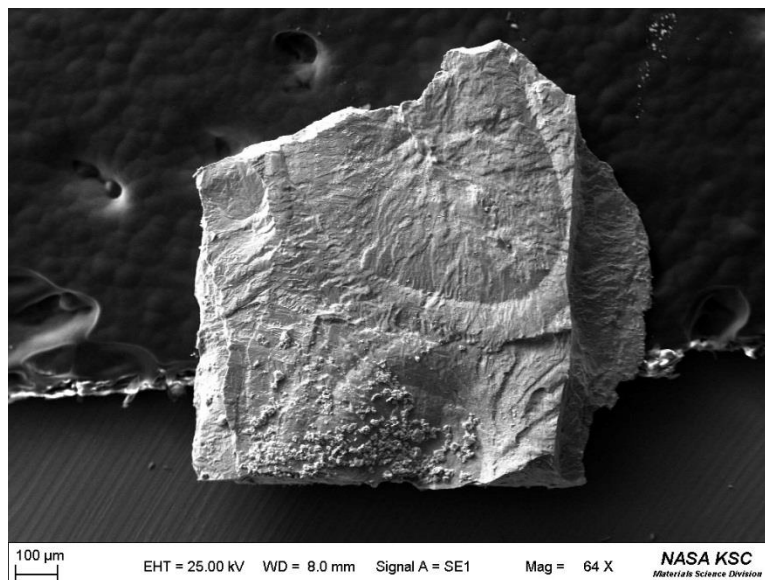
SEM observation of the debris revealed the clues that started to tell the story about what had happened to the SARJ race ring. The machine markings on some of the larger fragments were again confirmed via the SEM and when one of these fragments was flipped over, fracture features were revealed. The debris shards displayed classic evidence of Hertzian contact stress failure, with fracture paths parallel to the outer surface [14]. These fracture features were relatively brittle in nature, resembling a progressive failure with crack arrest marks clearly evident (Figure 7). Niobium-rich precipitates, verified via EDS and typical for this alloy, appeared at the subsurface initiation sites of the fractures.

Figure 7. SEM micrograph of a larger starboard SARJ chip showing subsurface crack initiation at Nb-rich precipitates and crack arrest marks. Credit: T. Long & C. Wright/NASA KSC

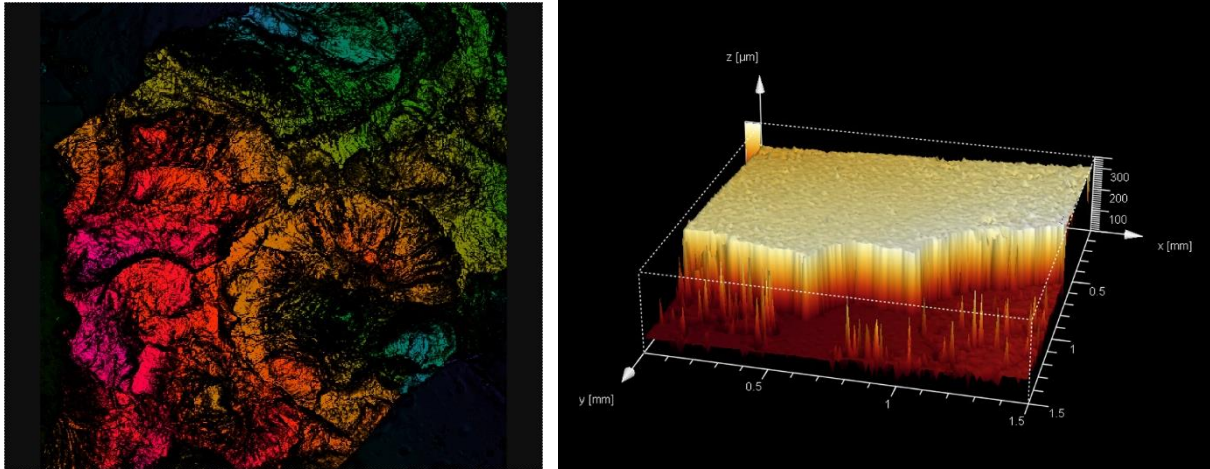
Laser confocal microscopy (Figure 8) and metallography were both used to characterize the thickness of the debris, which indicated that the debris generation was limited to the nitride case. However, M&P engineering was concerned by the observation of extrusion-like damage and

agglomerated fine particulate, which indicated that further damage was occurring and failure of the race ring could be exacerbated by the presence of this debris.

Figure 8. Laser confocal microscopy was utilized to non-destructively measure the thickness of the starboard SARJ debris. Credit: C. Wright/NASA KSC

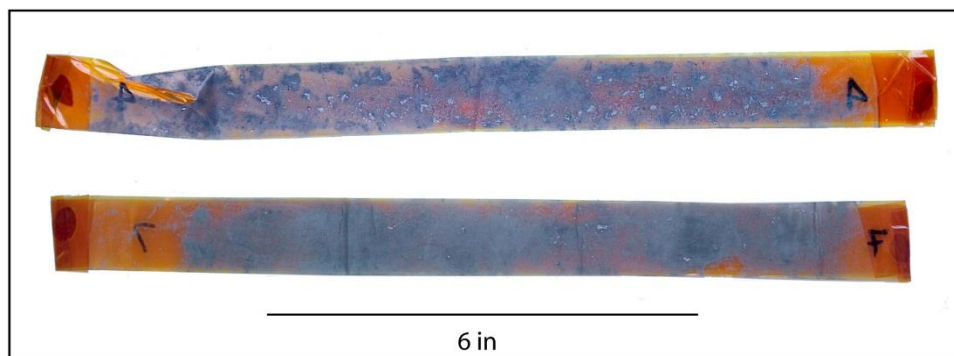
Figure 10. Photograph of two representative SARJ sample tapes from the Expedition 16 spacewalks showing a dust-like fine debris covering the majority of the adhesive tape surface as well as some larger fragments that were evident when visually inspected. Credit: P. Marciniak/NASA KSC

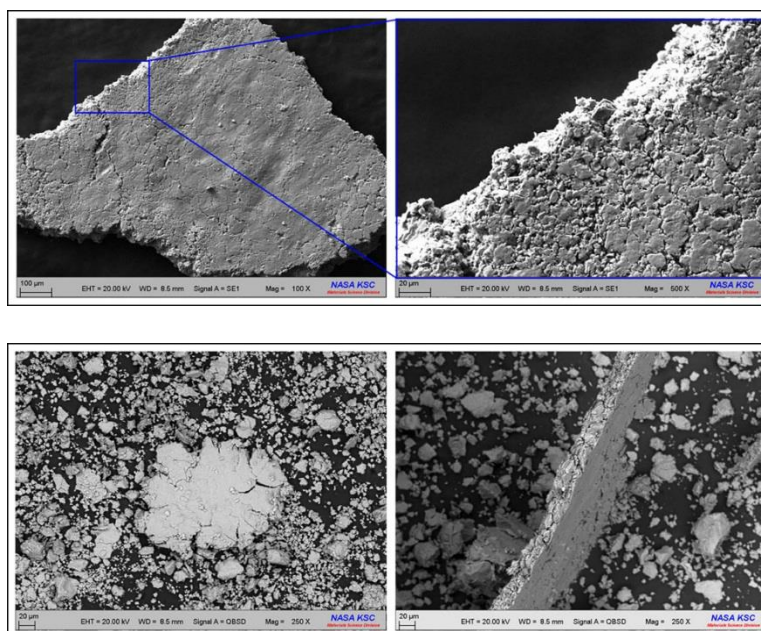
Figure 11. Representative SEM micrographs of agglomerated (top) and extruded (bottom) SARJ particles from Expedition 16 EVA. Credit: C. Wright/NASA KSC

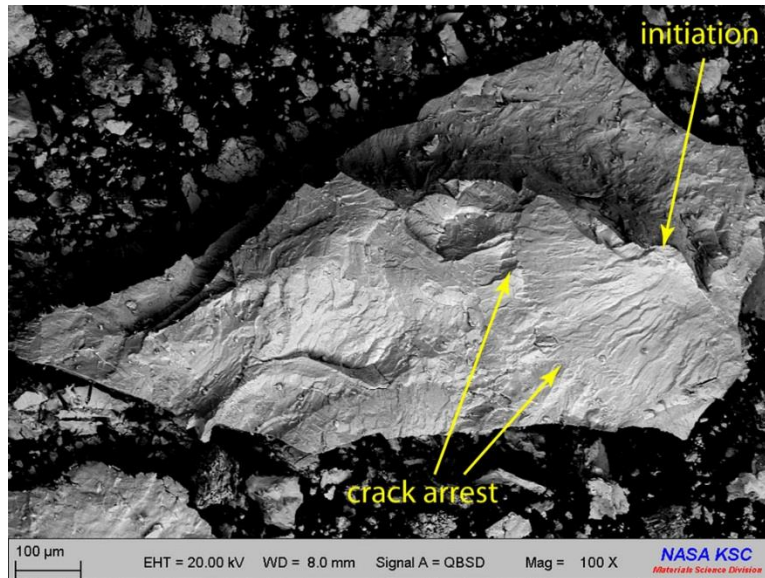
Figure 12. Fracture features of the Expedition 16 EVA samples were similar to those from the original STS 120 samples, with subsurface crack initiation and crack arrest marks. Credit: C.

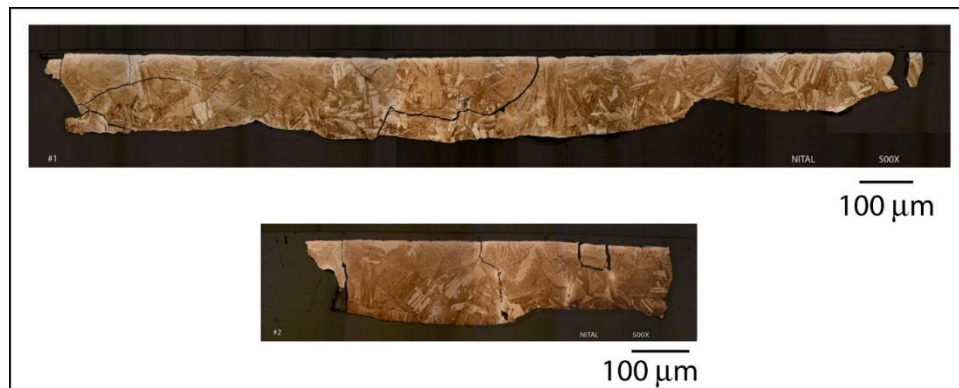
Figure 13. Etched starboard SARJ fragment showing transgranular crack propagation and fracture within the nitride case of the 15-5 PH race surface. Credit: P. Marciniak & B.
