Advanced Space Suit PLSS 2.0 Cooling Loop Evaluation and PLSS 2.5 Recommendations

John Steele¹, Greg Quinn²
UTC Aerospace Systems, Windsor Locks, CT 06096-1010

Colin Campbell³, Janice Makinen⁴, Carly Watts⁵, and David Westheimer⁶
NASA Johnson Space Center, Houston, TX, 77058

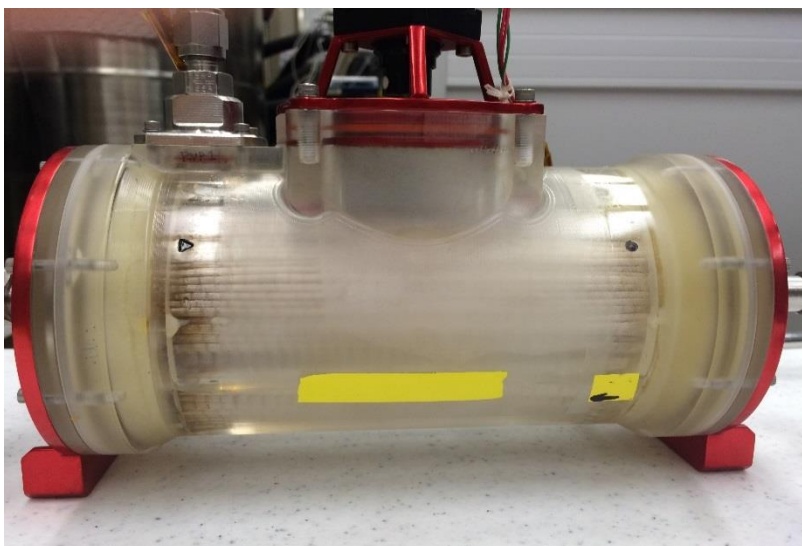
Figure 8. PLSS 2.0 SWME

Discoloration on either side of the SWME bundle was observed as shown in Figure 8. Swabs of the darkened areas were taken to identify the cause.

The darkened areas were identified as primarily inorganic in nature, with the primary constituents being silver and iron, with lesser amounts of aluminum, iron, nickel and copper observed (see Figure 9). Counter-ion elements such as oxygen, fluoride, phosphorous and sulfur were also observed, suggesting that these darkened areas are accumulations of inorganic precipitates. Why these suspect precipitates would collect in the observed pattern (inlet and exit) of the SWME bundle) are unknown.

At the time of this writing, an investigation was underway to determine the cause of a leak from the SWME. The primary cause of the leakage was determined to be a ruptured membrane fiber. A potential secondary cause may have been the loss of hydrophobicity in the fibers. While the cause of the ruptured fiber was most likely not due to water quality issues, the change in the wetting properties of the membrane may have been a result of either chemical or biological activity in the water loop. Further destructive evaluations are planned for this hardware to continue to evaluate the wetting behavior of the membranes.

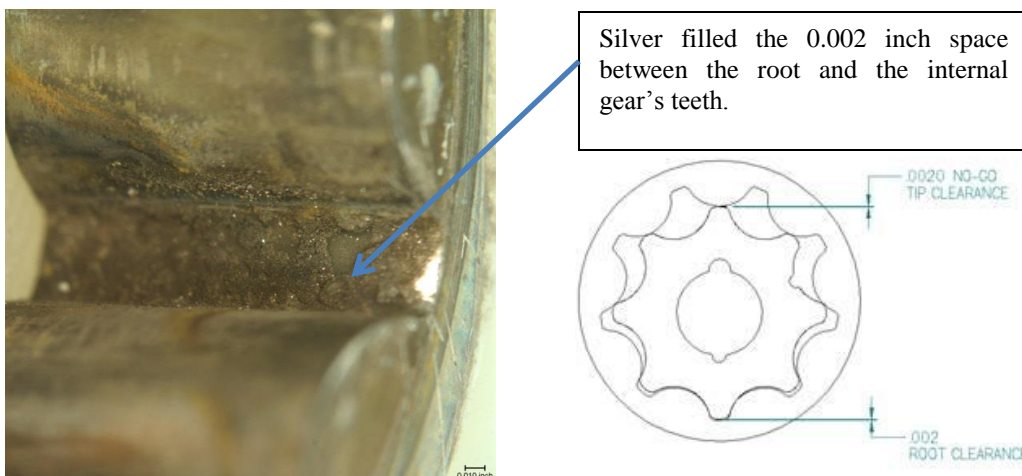
Figure 9. External Gerotor With Silver Deposits in the Root

The failure investigation ruled out electrical and power issues, as well as internal corrosion. Excessive wear was not observed. Cascon's experience with their gerotor pumps indicates that failure of the Stellite teeth and the silicon carbide plates on their own was unlikely, and the voids on the gears were not caused by cavitation. The most likely cause of failure was determined to be external contamination, which was evident throughout the pump. Plating of silver within the roots of the gerotor created interference between the gear and rotor generating repetitive, compressive stress. These compressive stresses either created excessive torque on the motor, or resulted in the fracture of the inner gerotor teeth. The fractured material then would have wedged in between the inner and outer gears and caused the pump to seize (Figure 9).

The root cause of PLSS 2.0's pump failure is believed to be the deposition of silver within the pump. The source of the silver could have been upstream galvanic interaction with stainless steel given the amount of deposited silver that was observed throughout the system. It is also possible that silver was attracted to the stellite wetted material in the gerotor given the galvanic potential between silver and stellite, though that could not be confirmed. The Deposition of silver precipitates could have been exasperated by the presence of surface biofilm based on the hydrocarbon presence finding, but that could not be confirmed. Silver built up everywhere, including in the roots of the outer gerotor in thicknesses that would have filled the 2 mil clearance between the inner and outer gerotor. resulting loads within the pump would have become significant and caused a jam between the gerotors in any one of several ways. Another possible, but much less likely cause of the pump failure is external debris being ingested by the pump and jamming it. However, there is no direct evidence that external debris actually entered the pump.

After approximately 300-hours of operation, the Cascon gerotor pump ceased up and had to be replaced. A disassembly and examination of the pump 6-months after the failure ruled out electrical and power issues as well as internal corrosion. Excessive wear was not observed. The most likely cause of the failure was found to be contaminants/precipitates in the water loop, specifically silver-rich precipitates coupled with a non-volatile organic material. It appeared that a collection of silver-rich particles or plated material within the roots of the gerotor created interferences between the gear and the rotor, generating repetitive compressive stress. The compressive stresses either created excessive torque on the motor or resulted in the fracture of the inner gerotor teeth. The fractured material would have then been prone to wedge in between the inner and outer gears, causing the pump to seize. The root cause of PLSS 2.0's pump failure, therefore, is believed to be the deposition of silver within the pump. The source of the silver could have been upstream galvanic interaction with stainless steel given the amount of deposited silver that was observed throughout the system. It is also possible that silver was attracted to the stellite wetted material in the gerotor pump given the galvanic potential between silver and the elements of stellite, though that could not be confirmed. The Deposition of silver precipitates could have been exasperated by the presence of surface biofilm based on the hydrocarbon presence finding, but that could not be confirmed. Silver built up everywhere, including in the roots of the outer gerotor in thicknesses that would have filled the 2 mil clearance between the inner and outer gerotor. The resulting loads within the pump could have become significant and caused a jam between the gerotors in any one of several ways. As with the SWME bundle, this occurrence indicates that the pump is prone to failure due to water loop precipitates and/or plating products.

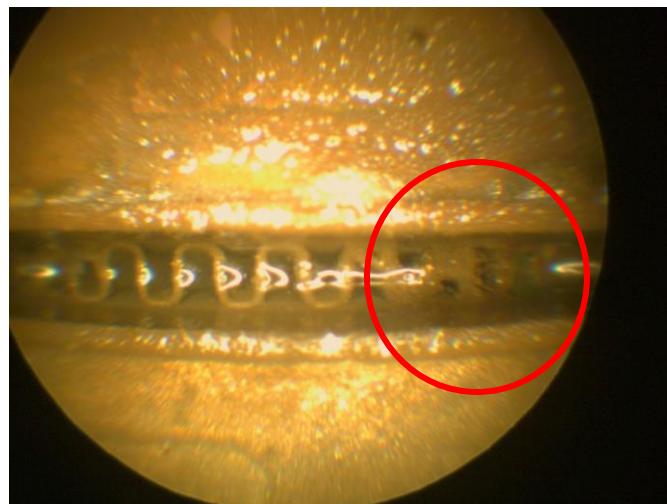
Figure 10. Boroscope View of Inlet Water Port (deposits circled in red)

The heat exchanger used for the PLSS 2.0 testing was received at UTAS WL for evaluation. An initial visual examination showed that the inlet and outlet gas ports showed no major signs of corrosion or deposits. The Inlet Water Port fitting, however, showed significant surface corrosion on the inner diameter of the bore that tended to follow the machining marks that suggest that the Hx may not have been passivated after machining. The fins that were visible in the heat exchanger from the Inlet Water Port opening were clogged approximately 20% with deposits (Figure 10). The Outlet Water Port fitting exhibited less corrosion than the Inlet Water Port and exhibited a uniform matte film on the surface. The fins that were visible in the heat exchanger from the Outlet Water Port did not show significant deposits or clogging.

The spiral pattern in the inlet fitting that follows the machining marks is often attributable to a lack of passivation after machining. Particles of tool steel left on the surface of stainless steel can act as initiation sites that break down the passive chromium oxide layer on the stainless steel.

The higher concentration of particles and deposits on the inlet side of the heat exchanger may indicate that this material was coming from upstream in the cooling water flow, though it is possible that it originated to some extent at that point due to the long term wetted storage orientation of the Hx as previously discussed..

Examination of the Heat Exchanger used in the PLSS 2.0 testing indicated that the Inlet Water Port fitting of the showed significant surface corrosion on the inner diameter of the bore that tended to follow the machining marks. That finding suggested that the Hx may not have been passivated after machining. The fins that were visible in the heat exchanger from the Inlet Water Port opening were clogged approximately 20% with deposits. The Outlet Water Port fitting exhibited less corrosion than the Inlet Water Port and exhibited a uniform matte film on the surface. The fins that were visible in the heat exchanger from the Outlet Water Port did not show significant deposits or clogging. It should be noted that the whole assemble was partially filled with water and oriented so that water remained stagnant in the inlet port side of the Heat Exchanger and not the outlet port for a significant period of time based on the storage configuration. The material that was collected was for the most part, inorganic in nature, with a low-level carbon present. The major metals that were identified in particulates dislodged via a water flush of the Heat Exchanger included silver, iron, nickel and copper. Other major constituents included fluorine and oxygen. This data suggested the presence of precipitated silver, oxides of iron, nickel and copper, and potentially a fluorinated compound which could be fluorinated grease commonly used for space hardware applications. The higher concentration of particles and deposits on the inlet side of the heat exchanger may indicate that this material was coming from upstream in the cooling water flow, though it is possible that it originated to some extent at that point due to the long term wetted storage orientation of the Hx. As with the SWME and the pump, these findings indicate that the pump is prone to fin-stock fouling due to water loop precipitates and/or plating products.

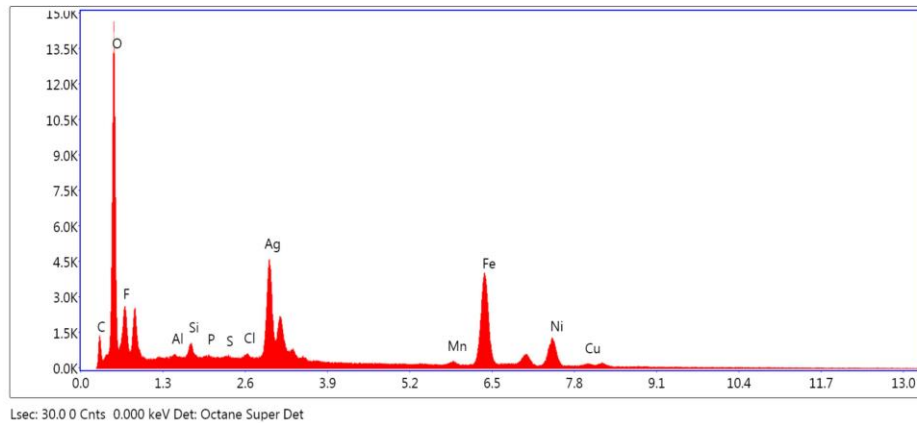
Figure 11. SEM/EDS Results from Select Particulates Collected from the Heat Exchanger Water Circuit

The particles that were collected were for the most part, inorganic in nature, with a low-level carbon present. The major metals that were identified include silver, iron, nickel and copper. These findings are consistent with the water samples taken from the pump, which was also part of this stagnant section of the loop. Other major constituents included fluorine and oxygen. This data suggested the presence of precipitated silver, oxides of iron, nickel and copper, and potentially a fluorinated compound which could be fluorinated grease commonly used for space hardware applications.

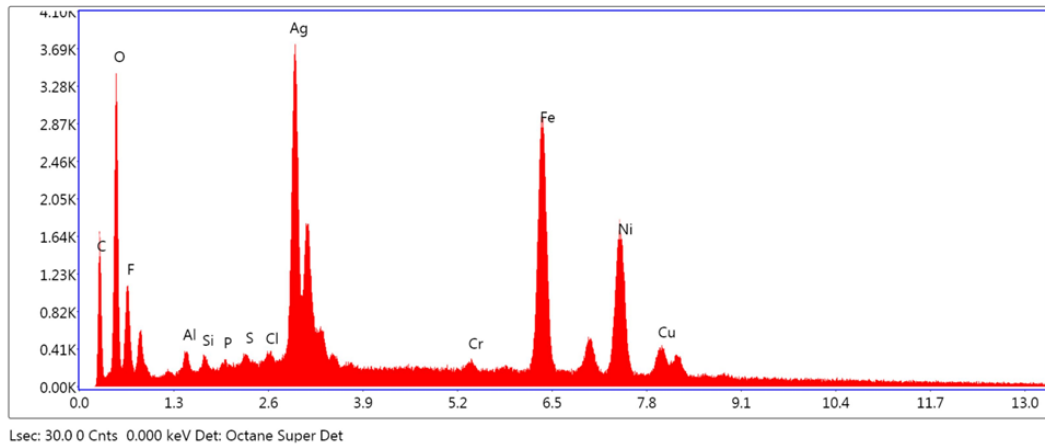
A swab of the residue observed in the inlet and outlet water ports was conducted. The residue was analyzed via SEM/EDS and was found to be high in silver, iron, nickel, chromium and copper and lesser amounts of aluminum. The present of carbon, oxygen and fluorine was also apparent (Figure 12).

Figure 12. SEM/EDS Results From Inlet Water Port Swab Particulates

The data shows the presence of silver which was used as a biocide in the water loop at high concentrations and which rapidly declined in concentration in the water. While silver in contact with stainless steel (base wetted material in the heat exchanger or the BNi2 Braze alloy) are acceptable galvanic couples, that does not preclude the possibility that some corrosion could be initiated. This would explain some of the corrosion products seen on the heat exchanger and the fittings. Furthermore, the presence of BNi2 braze alloy could provide a galvanic couple with silver since it is rich in nickel. It may very well be that the Hx is the primary source of the iron and nickel corrosion products observed in the water loop, given the previously mentioned corrosion observed in the inner diameter of the bore that tended to follow the machining marks and the BNi2 braze alloy in the Hx, but that is speculative.

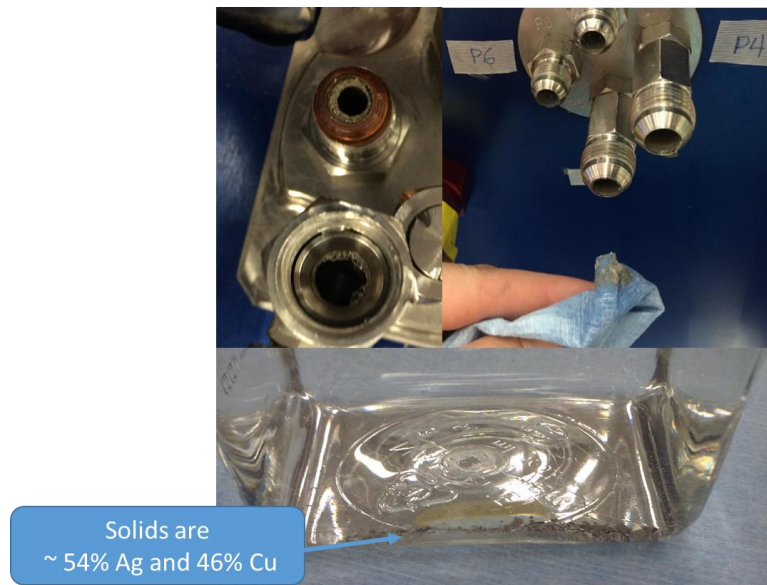
As disassembly of PLSS 2.0 and the PLSS Test System took place, silver colored deposits were found on several components. Examples are shown in 13 and 14. The first one discovered was a quick disconnect (QD) that was located in the Mark III suit assembly. It was discovered at the end of HITL testing. The QD was made of chrome plated brass. During the final disassembly of PLSS 2.0, additional locations were found with a similar silvery substance. These were usually found at the end of flared fitting that had copper flare savers installed. Chemical analysis of these silvery substances confirmed that they were indeed primarily silver. They also had significant amounts of copper and zinc, based on the parent material of the component in question. It is hypothesized that the cause of these precipitates is an oxidation-reduction reaction based on the galvanic potential between the silver biocide and the copper or brass.

Figure 13. Solid Silver Particles from PLSS 2.0 Back plate Fittings

As disassembly of PLSS 2.0 and the PLSS Test System took place, silver colored deposits were found on several components including QDs made of chrome plated brass. During the final disassembly of PLSS 2.0, several additional locations were found with a silver colored deposits. The location was usually at the end of flared fittings that had copper flare savers installed. Chemical analysis of these silver colored deposits confirmed that they were indeed primarily silver. They also had significant amounts of copper and zinc, based on the parent material of the component in question. It is hypothesized that the cause of these precipitates is an oxidation-reduction reaction based on the galvanic potential between the silver biocide and the copper or brass.

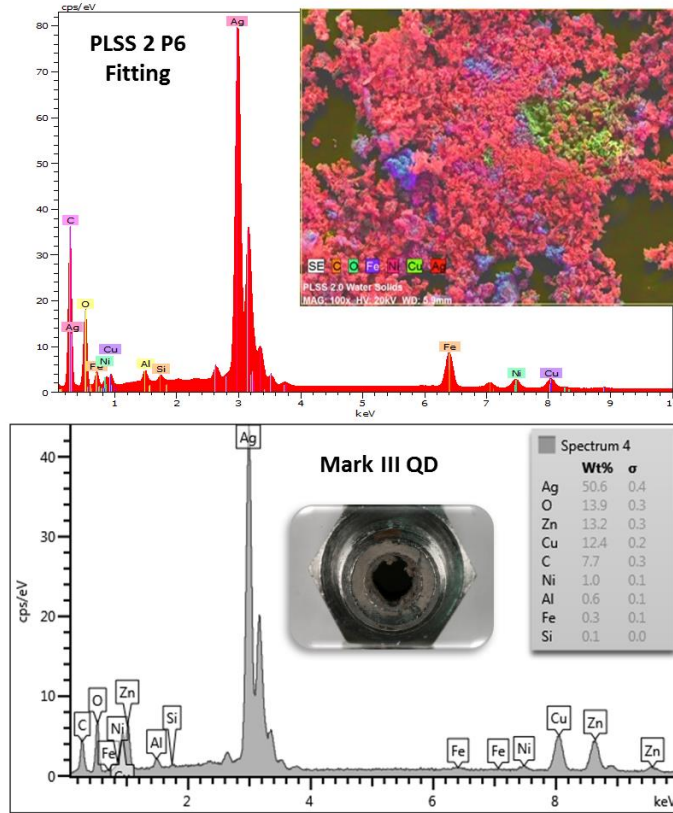
Figure 14. Analysis of Solid Materials Found on Fittings and QDs
