Vehicle Integrated Propulsion Research (VIPR) III Volcanic Ash Environment (VAE) Preliminary Visual and Teardown Observations

Michael Venti, NASA Armstrong Flight Research Center
John Lekki NASA Glenn Research Center
Grizelda Loykraft Air Force Research Laboratory (AFRL)

VIPR III Volcanic Ash Environment

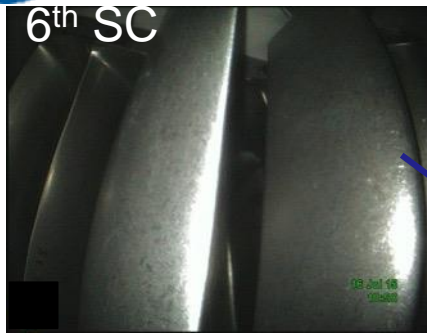
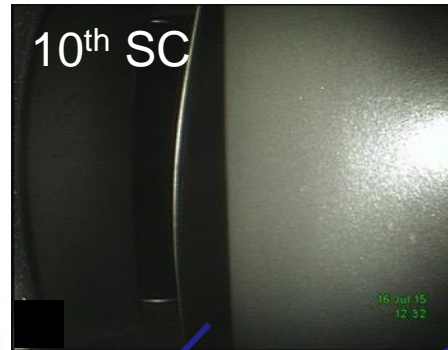
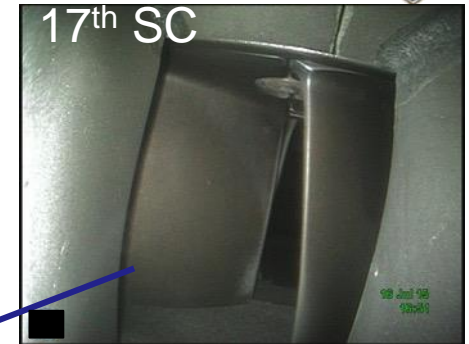
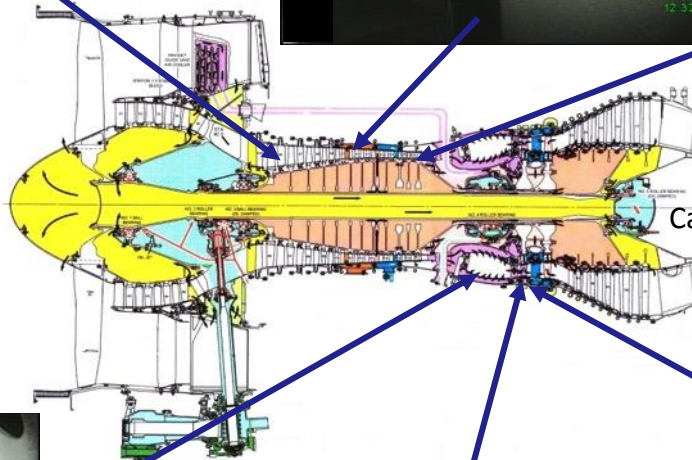
Baseline – Post Water Wash 14 July 2015

Whiteish coating →
Calcium Carbonate Used During Prior Research

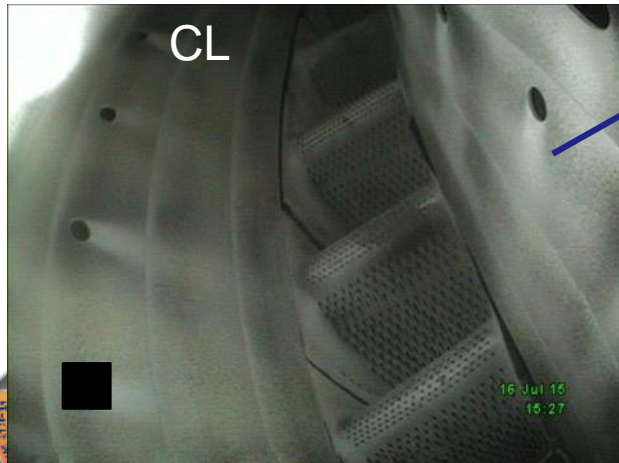
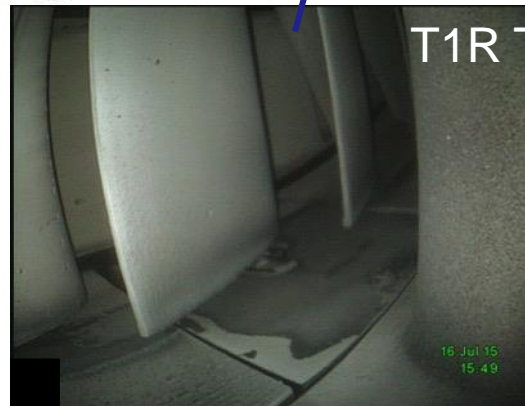
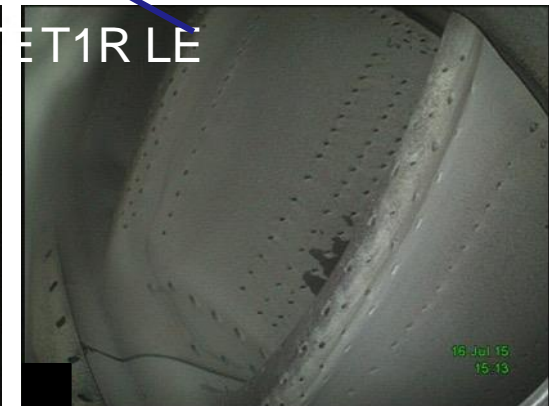
Baseline – Post Water Wash 14 July 2015

- No issues with blades or vanes
- TBC intact
- No blade distress
- Darker areas on blades potentially soot from shutdown
- No appearance of coating or alloy burning

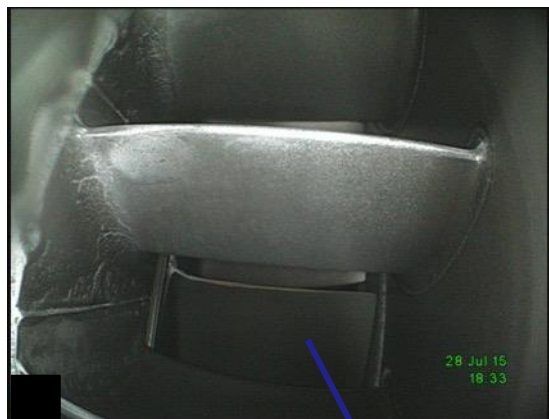
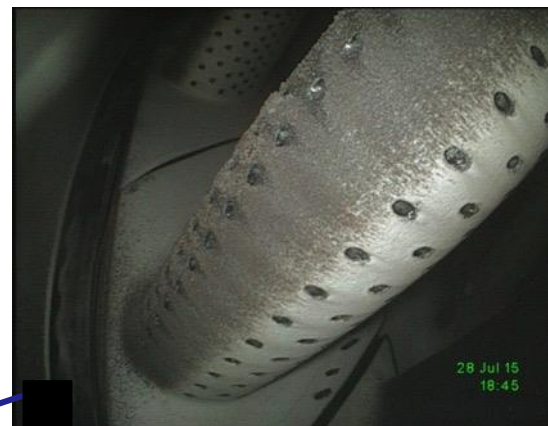
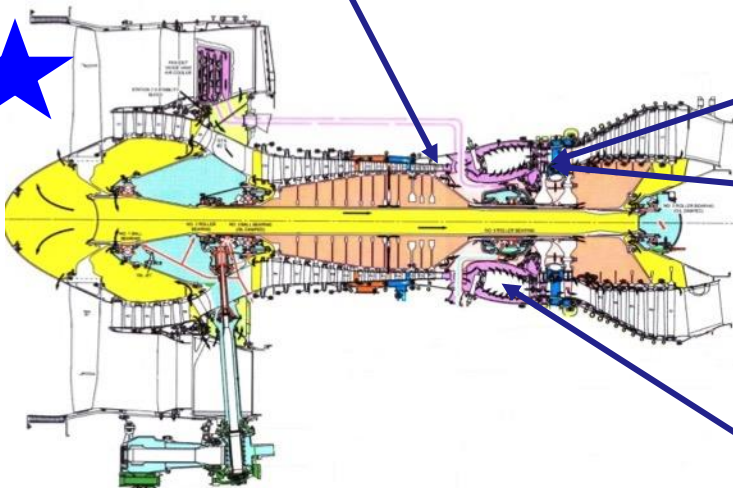
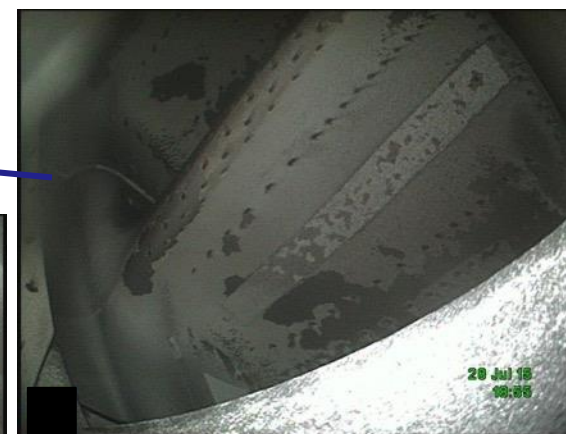
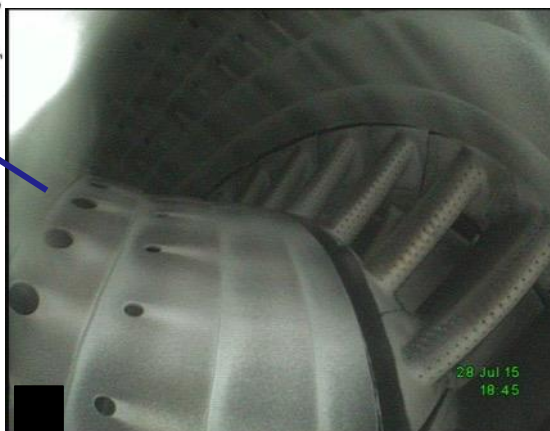
Run 1 Low Ash Rate 28 July 2015

- No evidence of ash accumulation on turbine parts
- Slight plugging of cooling holes in first stage turbine vane
- Cooling air still flowing, not a concern to continue running
- Mild ash accumulation on 10th stage bleed cap
- HPC very clean, no obvious wear or discoloration

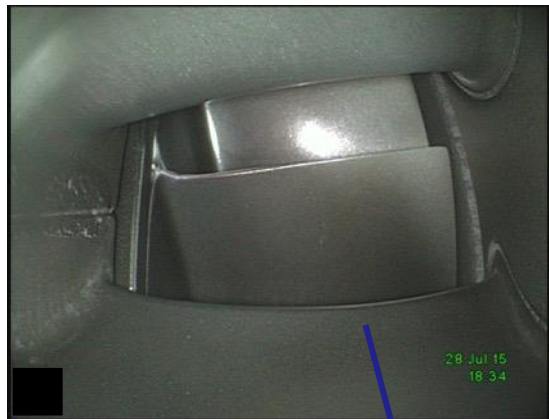
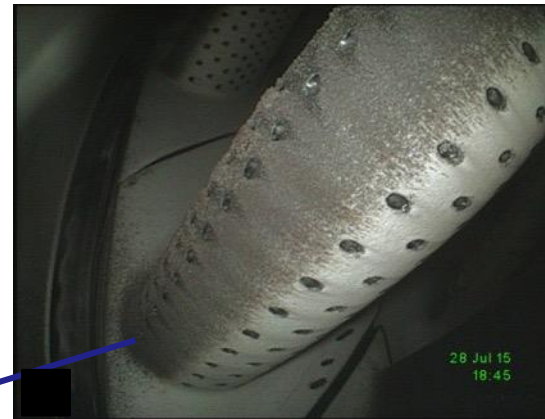
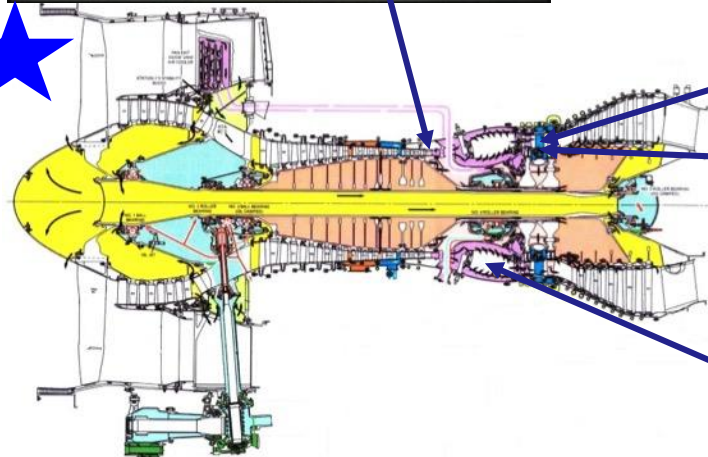
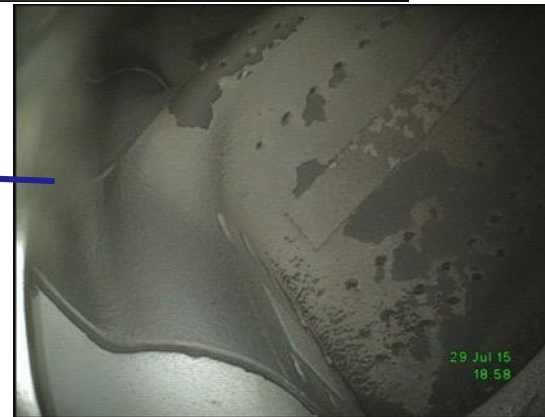
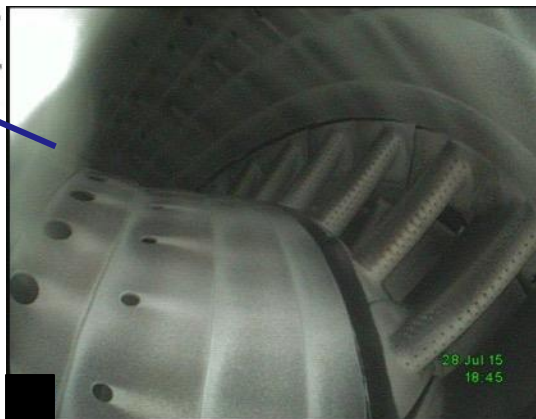
Run 2 Low Ash Rate 29 July 2015

- Slight ash seen on first vane leading edge
- No ash seen on gauge point area of 1st vane
- No ash seen on first blade
- 1st blade outer edge seal leading edge region
 - *May have small ash particles*

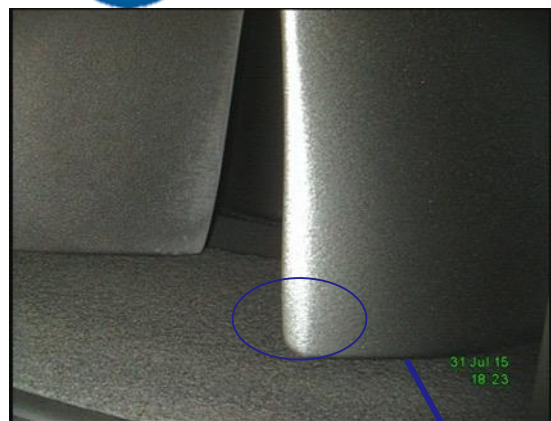
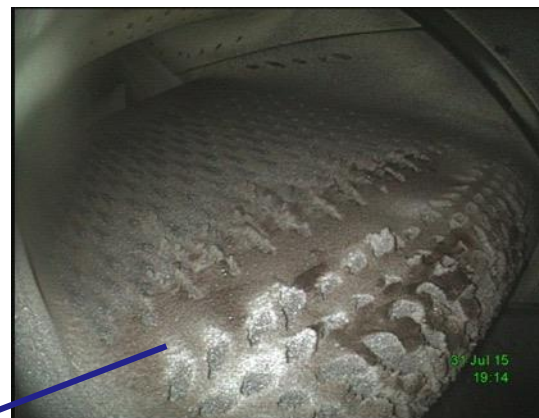
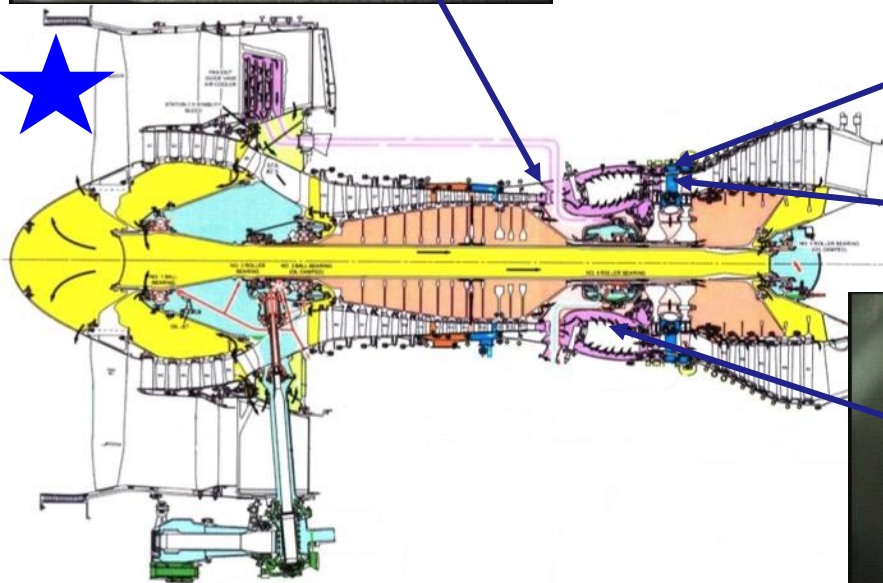
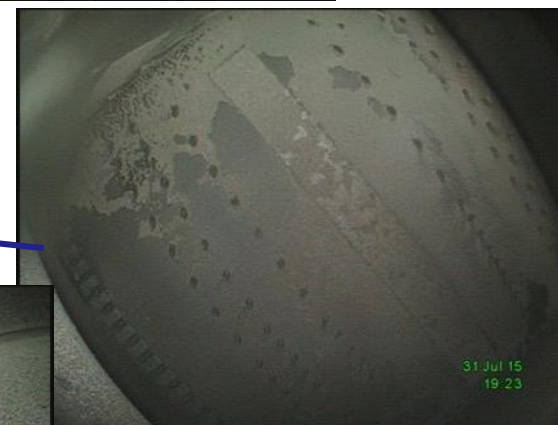
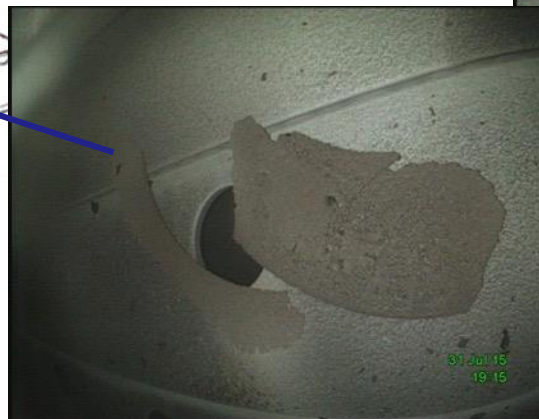
Run 3 Low Ash Rate 31 July 2015

- **More build up**
 - 1st vanes leading edge and forward pressure side
- **Aft pressure side gauge area (A4)**
 - No built up thus -not reducing the gauge area
- ★ • **1st blades**
 - Still show very little effect of the ash
- **Shedding material starting to show up in combustor area**
- **Other areas around the fuel nozzle show some very local ash accumulation**
- **Turbine ash accumulation in is still very low**
 - Not expected to impact the durability or ability to continue to high rate

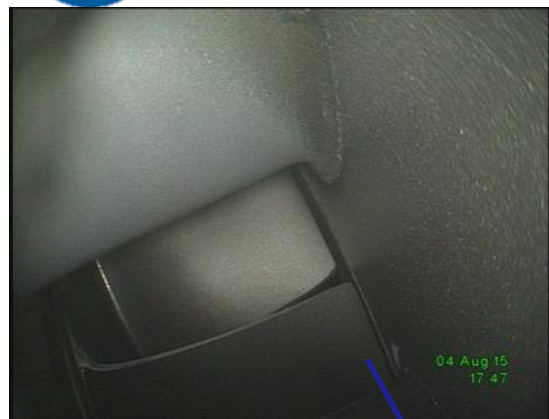
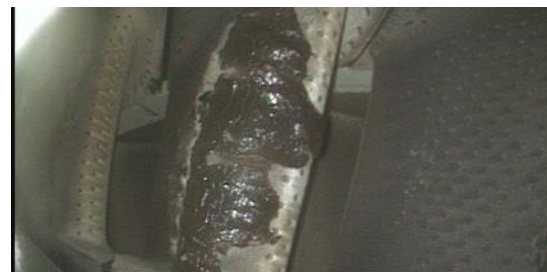
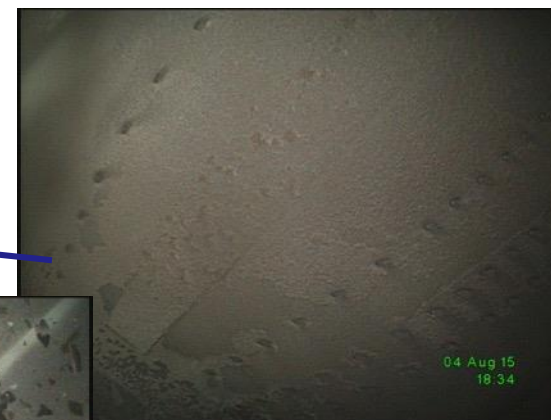
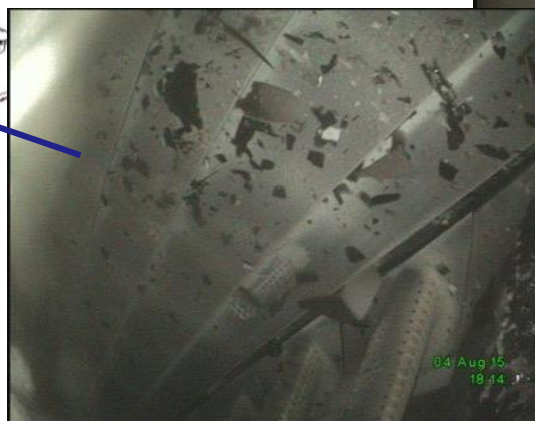
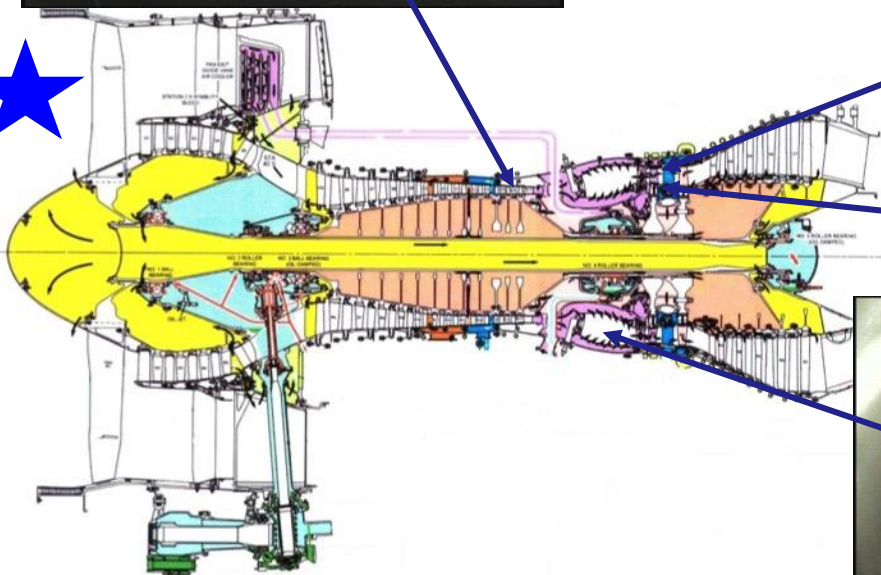
Run 4 High Ash Rate 4 August 2015

- **1st stage turbine vanes**
 - Build up appears to be glassified ash as expected
 - Gauge point region -still not significantly closed down
- **Combustor and turbine**
 - Show large thin flakes of ash shedding
- **1st blades still are relatively clean**
 - No concerns
- **Recommend**
 - Continue running at this point

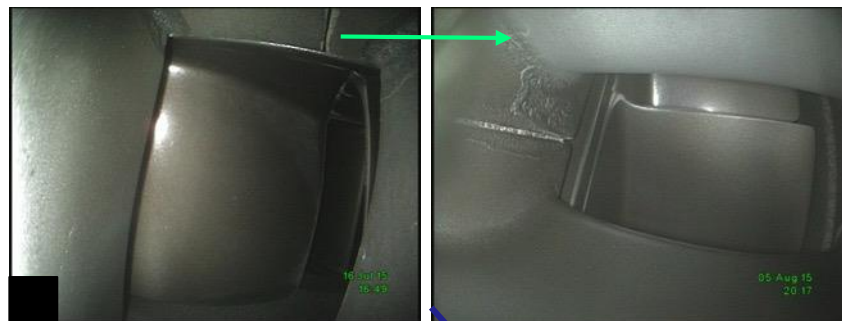
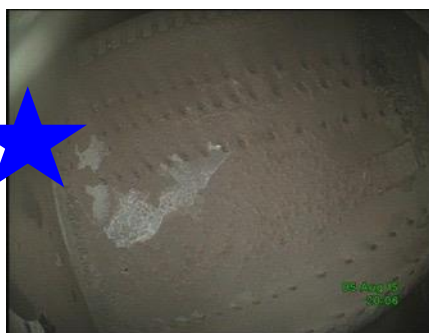
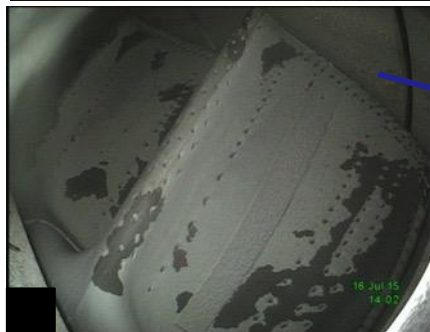
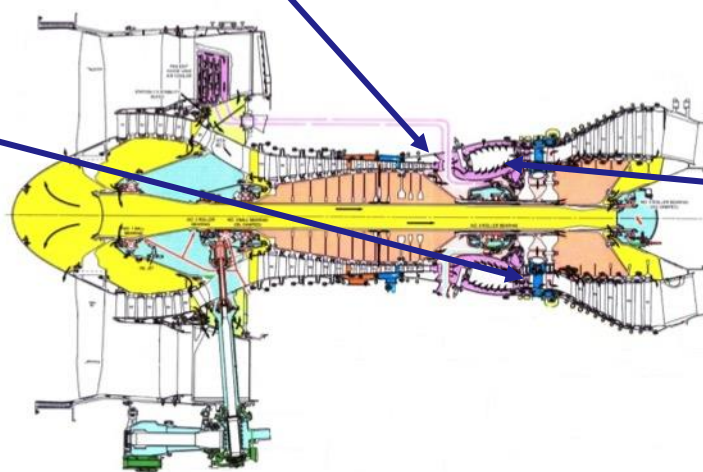
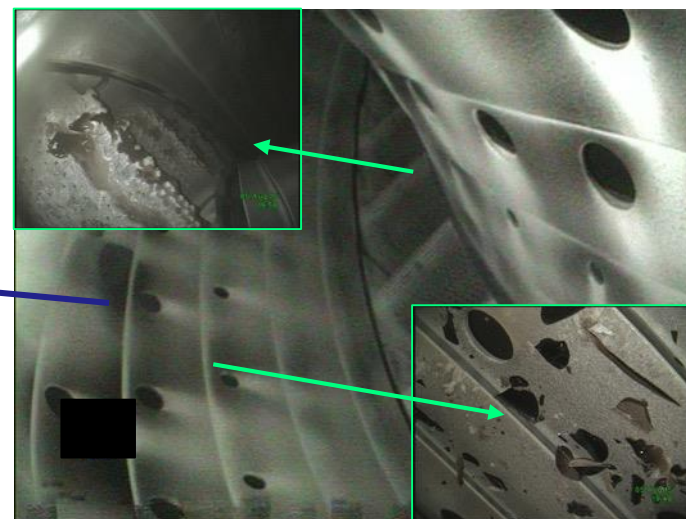
Run 5 High Ash Rate 5 August 15

- **1st vane**
 - Build up and shedding looks similar to the 1st high rate run day
 - Gauge area (A4) still not built up.
- **Combustor looks similar to first high run day**
- **New boroscope finding on last day**
 - Slight build up on some 1st blade leading edges
 - Assume it's ash, but does not look “glassified”
 - Disassembly will be required to tell if it's ash or not
