# Evidence of Processing Non-Idealities in 4H-SiC Integrated Circuits Fabricated With Two Levels of Metal Interconnect

David J. Spry<sup>1,a\*</sup>, Philip G. Neudeck<sup>1,b</sup>, Liangyu Chen<sup>2,c</sup>, Laura J. Evans<sup>1</sup>, Dorothy Lukco<sup>3</sup>, Carl W. Chang<sup>3</sup>, and Glenn M. Beheim<sup>1</sup>

1) NASA Glenn Research Center, 21000 Brookpark Rd., Cleveland, OH 44135, USA

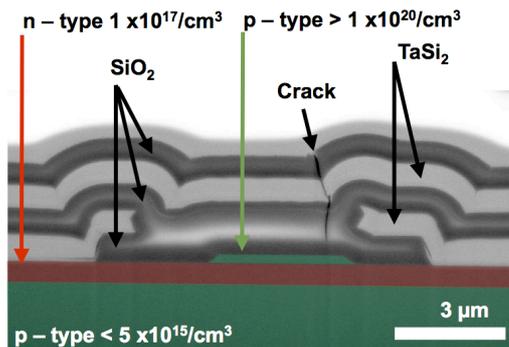
**Crack Formation Induced Fail-Open of Top Metal Interconnect.** The focused ion beam (FIB) cross-section shown in Fig.1, illustrates an example of dielectric and metal cracks that caused topmost metal conductive interconnect traces to electrically fail open. It is important to note that the crack forms only on the right side of Fig. 1 where the patterned edge of a lower TaSi<sub>2</sub> metal trace slightly overlaps (distorting upward) the edge of a SiC mesa feature due to slight misalignment of these two mask features. Devices close to the wafer center (roughly < 1 cm) did not exhibit this problem as the misalignment in this region was insufficient to result in such overlap/distortion. Misalignment and cracking grew more severe with increasing radial distance from the wafer center, consistent with rotational misalignment of the bottom metal mask pattern to the substrate n-mesa pattern during fabrication. Such cracks are not observed on other kinds of topology, such as where the lower TaSi<sub>2</sub> trace edge ends over the flat SiC region on the left side of Fig. 1. Cracking has neither been observed on the large bond pad edge cross-section shown in Fig. 2. If there had been

Fig. 1. Cracking sometimes occurs Where metal 1 and metal 2 overlaps the gate.

cracking at the edge of the bond pad (Fig. 2), previous experiments have shown that the underlying TaSi<sub>2</sub> metal laterally oxidizes causing electrical failure of the bond pad in less than a few hours at 500 °C. The measured resistance vs. time between adjacent connected bond pads plotted in Fig. 2 demonstrates desired minimal change in conduction properties (in part due to absence of crack features) over 4800 hours of 500 °C electrical testing time. Since it is related to misalignment, this cracking problem should be solvable by improved alignment and/or design rules with larger misalignment tolerances so as to prevent overlapping of lower metal edges with mesa features. The SiO<sub>2</sub> where the cracks originated was possibly weakened by water vapor absorption. To inhibit this possible contributing mechanism to the observed cracking, a protective stoichiometric Si<sub>3</sub>N<sub>4</sub> cap is planned for the next wafer run.

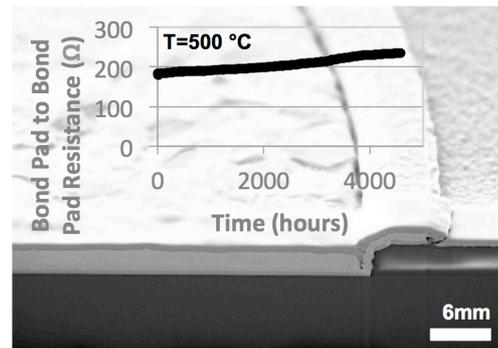
Fig. 2. By design, cracking did not occur around the oxide on bond pads. There was 32% increase in pad to pad resistance over 4800 hours.

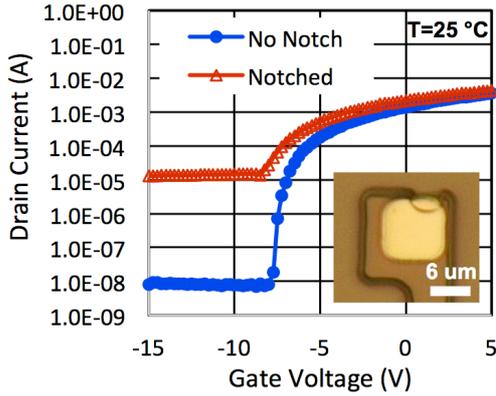
**Gate-to-Channel Leakage/Short From Notching of Gate Etch Mask Metal.** As described in [2], the JFET fabrication process starts by patterning a gate etch mask and dry etching ~2000 Å into the SiC to define the p<sup>+</sup> gate. The gate etch mask remains in place for a subsequent self-aligned implant step followed by liftoff patterning of a second metal etch mask that laterally defines the JFET n-channels when an additional ~5000 Å of SiC is dry etched. While the gate etch mask is supposed to prevent removal of any SiC from p<sup>+</sup> gate regions during the second (n-channel) dry etch, this particular JFET IC wafer displayed random notches in the gate mesa pattern. These notches arose from non-uniform oxidation/peeling along the edges of the gate etch mask during a prolonged unplanned storage of the sample in room air. When the second dry (n-mesa) etch was conducted, the notched regions did not sufficiently protect the p<sup>+</sup> SiC from removal, which then exposed underlying n-mesa regions in areas where contacts to p<sup>+</sup> gates were subsequently deposited. Fig. 3 inset shows where a p<sup>+</sup> gate contact overlaps such a notch. This allows the deposited metal p<sup>+</sup> gate contact to also form a parasitic electrical contact to the underlying exposed n-channel epilayer, including along the vertical etched sidewall of the n-epilayer. While both Fig. 3 JFETs demonstrate sufficient turn-off for successful circuit operation at 25 °C, turn-off characteristics of “notched” JFETs are undesirably orders of magnitude larger than notch-free devices. While not directly measured at high T, the leakage mechanisms of metal-semiconductor contacts/diodes are known to increase with anneal time and exponentially with T [3]. Therefore, this parasitic leakage is surmised to contribute to rapid failure of circuits at 500 °C. The degree of notching (and thus the degree of leakage) varied across the wafer. Very few devices with more than 10 gate fingers were free of notches. Notches have not been observed in any process runs before and after this wafer whose processing time between the gate and mesa etches have been a week or less, and were shipped to vendors in vacuum boxes.

Fig. 3. JFET turn off leakage with and Without a notch in the p-gate mesa.

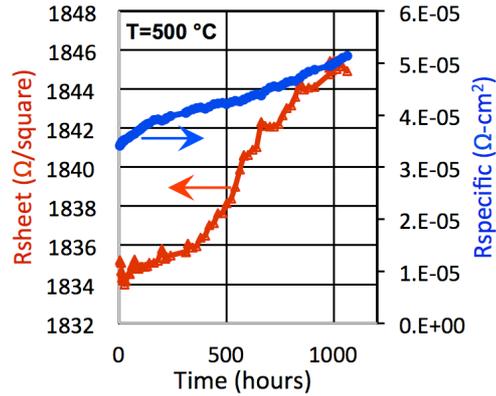
**Device Resistance Degradation.** Fig. 4 plots sheet resistance ( $R_{\text{Sheet}}$ ) and specific contact resistance ( $R_{\text{Specific}}$ ) extracted from prolonged measurement of a packaged 500 °C transmission line method (TLM) test device of the source/drain implant for over 1000 hours.  $R_{\text{Sheet}}$  changed less than 1% while  $R_{\text{Specific}}$  changed 50%. This suggests a degradation in the contact area or metal while the

Fig. 4. < 1% variation in  $R_{sheet}$ , but 50% increase in  $R_{specific}$ .

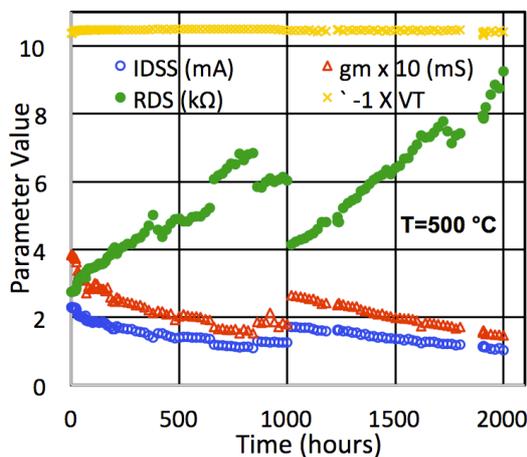
high-dose SiC implanted sheet resistance is stable. The 500 °C testing time evolution of transistor parameters for a JFET in a NOT circuit are shown in Fig. 5. The threshold voltage ( $V_T$ ) changes less than 2% over 2000 hours. Transconductance ( $g_m$ ) and the on-state current ( $I_{DSS}$ ) decrease with time at temperature while on-state resistance  $R_{DS}$  increases, which is qualitatively consistent with the Fig. 4 trend. Data discontinuity shown in Fig. 5 at 1000 hours corresponds to a brief temperature cycle to 25 °C and back. Most of the drift in  $R_{DS}$  recovered during this cycle. It is important to note that the recovery of  $R_{DS}$  seems inconsistent with contact oxidation or metal trace failure mechanisms that would be irrecoverable. Delamination of the contact area has not been seen in focused ion beam (FIB) cut cross-section images of similar devices on the wafer. Therefore, the root physical cause (or causes) of this degradation remains under investigation at this time.

Fig. 5. < 2% variation in  $V_T$ . Note changes from thermal cycle to RT at 1000 hours.

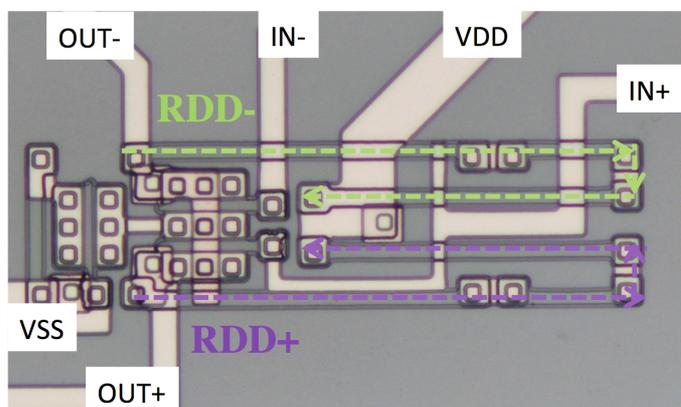
**Parasitic Circuit Imbalance Induced by Mobile Ion Contamination.** Differential amplifier circuits rely on well-balanced circuit legs (i.e., transistors and/or resistors) to operate. Resistive load differential amplifier ICs (including 2-stage op-amps which were also used as sense-amps for test memory ICs) were fabricated and electrically verified as operational at room temperature with expected gains. However, on all ICs custom-packaged for high temperature testing, these differential-based amplifiers all rapidly failed as they were heated past 200 °C. A packaged diff-amp (Fig. 6) underwent bias-temperature stress measurements while directly measuring “balanced” resistors RDD+ and RDD- (highlighted with colored dashed lines) IV characteristics. Fig. 7 shows an example of the resistor IV imbalance measured after +30V 200 °C positive bias stress of the VDD metal trace, while Fig. 8 shows that the imbalance is mostly eliminated following a subsequent -18V 300 °C stress applied to the VDD metal trace. This reversible bias-temperature-time stress behavior is consistent with reversible mobile ion contamination phenomenon well-

Fig. 6. Optical image of the differential amplifier shows the two balanced resistors with one having a VDD trace pass over top.

Subsequent surface analysis detected sodium (Na) on the surface of wafer samples. Some sources of sodium contamination in the NASA processing laboratory have been identified and eliminated. Additional processing steps that largely mimic sodium mitigation strategies of the silicon IC industry as well as layout design changes are being implemented for future processing runs [4,5]. However, the effectiveness of these lower-temperature IC strategies to withstand/enable prolonged 500 °C SiC IC circuit operation remains to be proven.

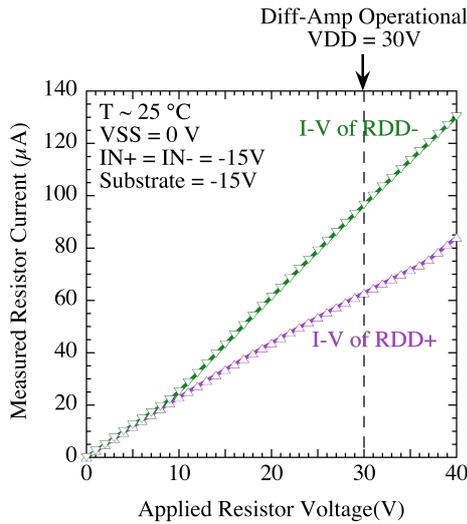
Fig. 7. Diff-amp resistor IV imbalance observed following biased heating (VDD=+30V) to 200 °C and cool down.

known to be detrimental to metal-oxide-semiconductor (MOS) devices [4]. In this particular case, positive ions in the oxide become mobile at elevated temperature and are repelled by positive VDD bias, piling up near the SiC-oxide interface beneath the VDD metal. The resulting positive ion charge buildup near the SiC-insulator interface produces a parasitic surface inversion channel of electrons (supplied by the n-mesa resistor), causing turn-on of a parasitic n-MOSFET under the VDD trace which substantially imbalances current flow of RDD- relative to RDD+. Application of negative VDD terminal bias at temperature drives positive ions back towards the gate, turning off the parasitic MOSFET, restoring post-cool down resistor balance (Fig. 8) and experimental room temperature operation of diff-amp and op-amps.

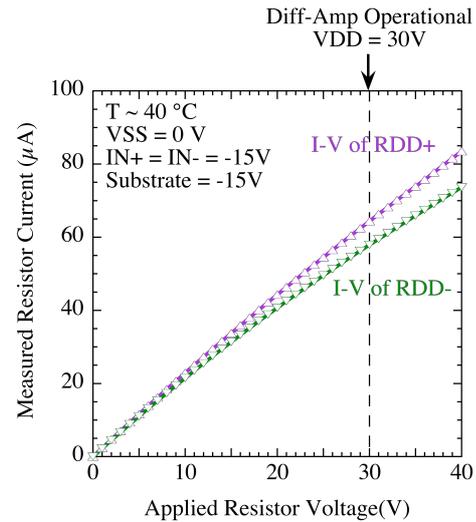
Fig. 8. Observed restoration of diff-amp resistor IV balance following 2 hour 300 °C VDD stress of -18V and cool down.
