NASA Case Study
By Thomas Steva and Jennifer Stevens

MSFC-CS1004-1
Rev. 01/21/16

After Math – Foamology and Flight Rationale

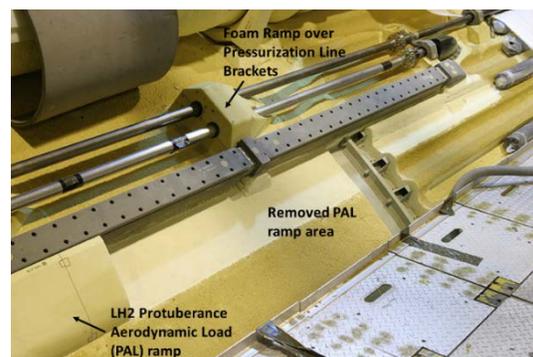
Figure 4 LH2 PAL Ramp with Part Removed (NASA)

In order to properly blend in the removed portion of the LH2 ramp with remaining original structure, it was well agreed that first 10 feet would need be removed and replaced. However, whether or not the entire ramp (both LH2 and LO2 segments) should be removed and re-sprayed as well was a matter of considerable discussion.

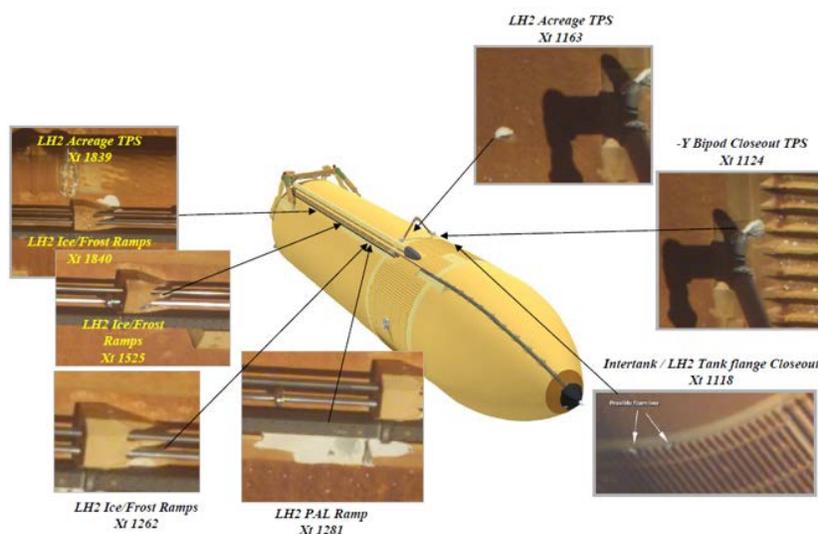
On July 26, 2005, a little over a year after the ET Project decision to use-as-built, STS-114 was launched. At 127 seconds into the flight a 1 pound piece of foam 36"x11"x7" was liberated from the LH2 PAL ramp. The foam was from the older portion of the ramp which had not been replaced. This was within the 135 second mark, the time up until which calculations conducted on hypothetical debris scenarios had indicated that debris from the ET could achieve a great enough velocity, with respect to the vehicle, to do critical damage to the Orbiter tiles. After 135 seconds into flight there is not sufficient atmosphere to cause debris transport to the wings.

Ultimately though, the flight performance of the foam on STS-114 turned out to be significantly different than the prediction. The PAL ramp mass, based on post separation imagery of the divots left in the tank, was almost 80 times greater than the PRA maximum and 25 times greater than the certified limit.

In addition to the PAL ramp there were 15 other instances of significant foam loss. While all were within the certification limit, 13 still exceeded the upper bound of the PRA. Even though the majority of these events occurred after the 135 second mark,

Figure 5 Major areas of foam loss on STS-114 Imagery obtained from orbiter after tank separation.
(NESC/NASA, STS-114 External Tank In-Flight Anomaly Final Report)

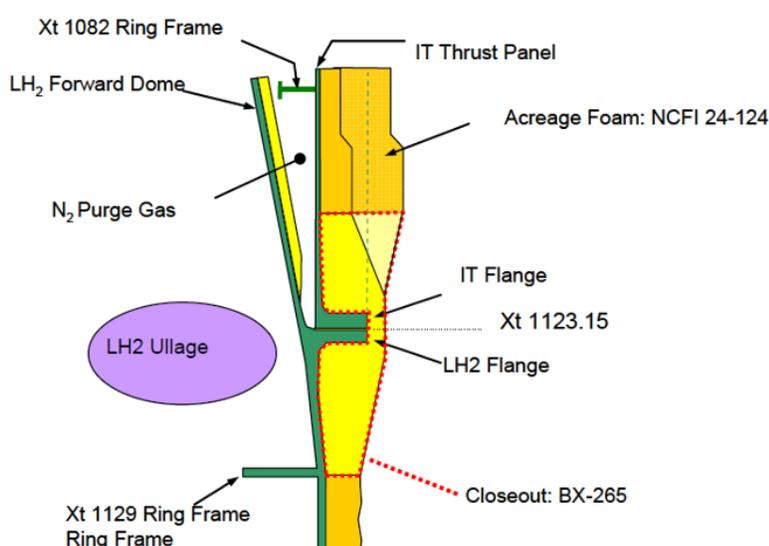
Figure 6 Illustration of the Thrust Panel Y-joint Area (NASA)

One area in particular that had ideal conditions for cryoingestion was the LH2/Intertank flange (Figure 6). After assembling the tank, access was extremely limited to the Y-joint created between the Intertank barrel and the LH2 tank dome and it was not feasible to apply insulation in that location on all surfaces. The resultant areas of exposed metal allowed for the liquefaction and pooling of a significant amount of nitrogen in that region. This condition was the cause of much of the foam liberation seen from the flange closeout on previous flights.

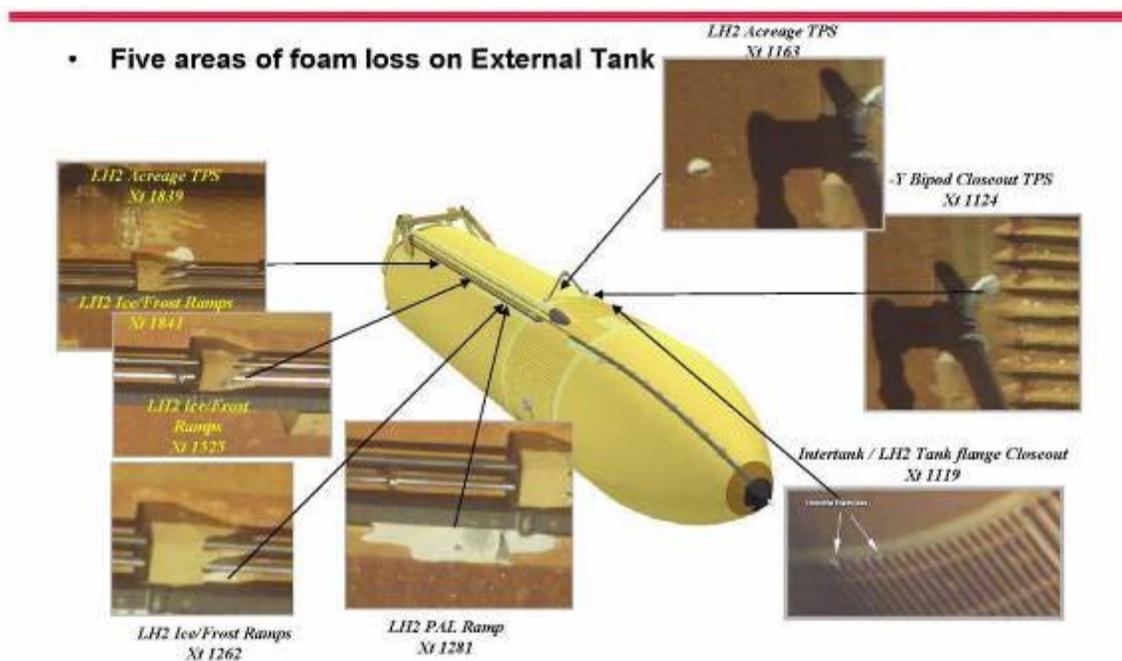
Figure 4.0-1. Five Areas of Foam Loss on STS-114 ET

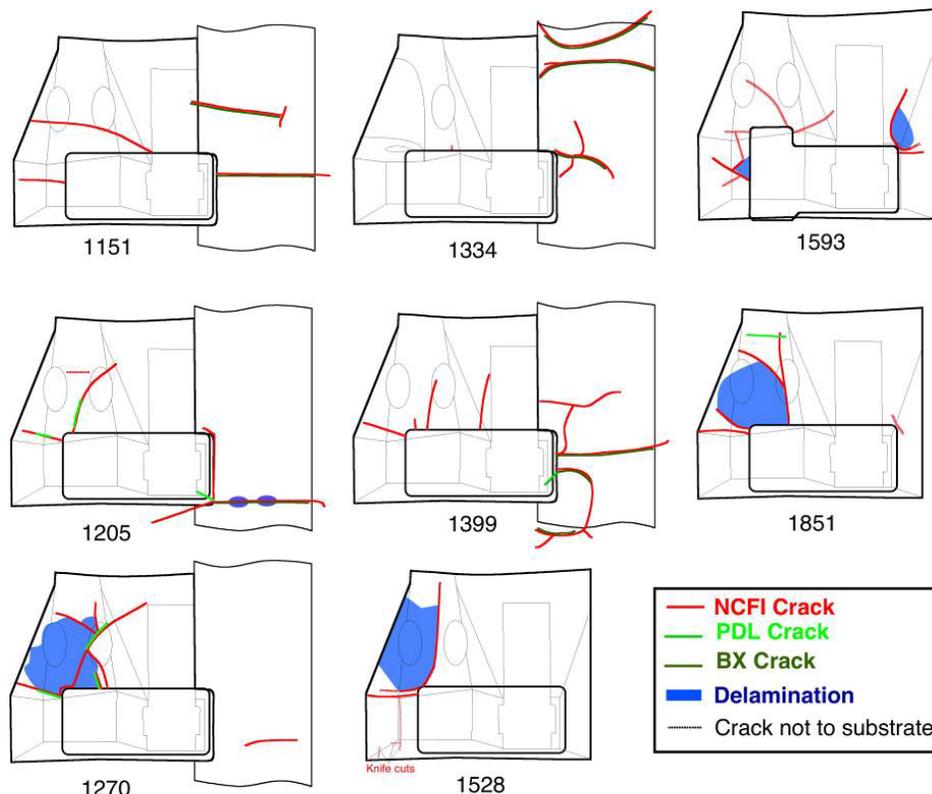
Early in the investigation, the LH₂ PAL Ramp Independent Team postulated a logic path for existence of thermally induced cracks in the acreage NCFI 24-124 beneath the LH₂ PAL Ramp which was subsequently demonstrated to be remarkably accurate. Key factors included the tensile strength of the acreage NCFI 24-124; coefficient of thermal expansion (CTE) mismatch between the acreage foam and the tank aluminum substrate; thermal expansion mismatch between the acreage foam and the LH₂ IFR PDL 1034; stress concentrations at corners of the LH₂ IFR footprint; and the insulation effect of the LH₂ PAL Ramp BX-265. This last aspect could extend high thermal stresses further from tank substrate promoting larger cracks in the NCFI 24-124 under the LH₂ PAL Ramp than in the acreage (subsequently known as the “thick foam over foam” issue). This failure scenario was thoroughly investigated using 3-D stress analyses, fracture mechanics, laboratory testing, and dissection of ET-120, which proved invaluable in understanding foam failure and potential foam liberation mechanisms (the reader is encouraged to review the summary of the ET-120 dissections results, Section 7.3.2, and the comparison between ET-120 cracks and features of the ET-121 debris site, Section 8.3.1.2). The 3-D stress analysis of the LH₂ PAL Ramp predicted the stresses in both the NCFI 24-124 and

BX-265 exceeded the minimum measured tensile strength of these foams in locations consistent with the observed cracks on ET-120 and the features of the debris site of ET-121.

Delaminations provide the void or cavity volume. The cavity is adjacent to the substrate, so the necessary thermal conditions exist to: (a) liquefy or solidify air in the pre-launch environment, and (b) subsequently support phase change when substrate warming occurs after the passage of the LH₂ liquid level in the tank late in flight. Several possibilities for leak paths to atmosphere were postulated by the team including the network of cracks in PDL 1034 around the pressline bracket, (found on ET-120 and LH₂ IFR pathfinder tests), which could provide a connection between the atmosphere and the delamination, or thermal cracks in the acreage NCFI 24-124 extending to the surface. Load generated by the phase change was sufficient to propagate the delaminations from under the LH₂ IFR to the inboard free surface of the acreage NCFI 24-124. When the delamination reached the free surface, the unsupported acreage NCFI 24-124 was liberated in a dynamic event of the pressure release.

Figure 4.5-1. Thermal Cracks and Delaminations in the Acreage NCFI 24-124 (NASA)
