Failure Analysis and Recovery of a 50-mm Highly Elastic Intermetallic NiTi Ball Bearing for an ISS Application

Christopher DellaCorte*, S. Adam Howard* and Lewis E. Moore III†

Abstract

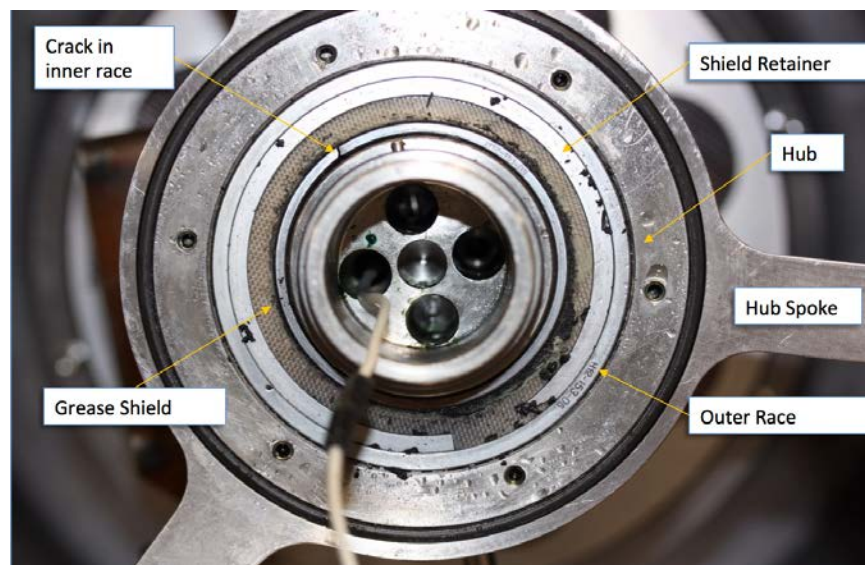
Based upon this image alone, one plausible preliminary failure scenario is that the inner race fractured and caused more generalized damage and wear as the test continued. A close up image of the inner race fracture, shown in Figure 3, offers additional clues to the behavior of the 60NiTi.

Figure 2. Hub-side view of failed ISS Distillation Assembly centrifuge bearing. Note cracked inner race and ejected wear debris

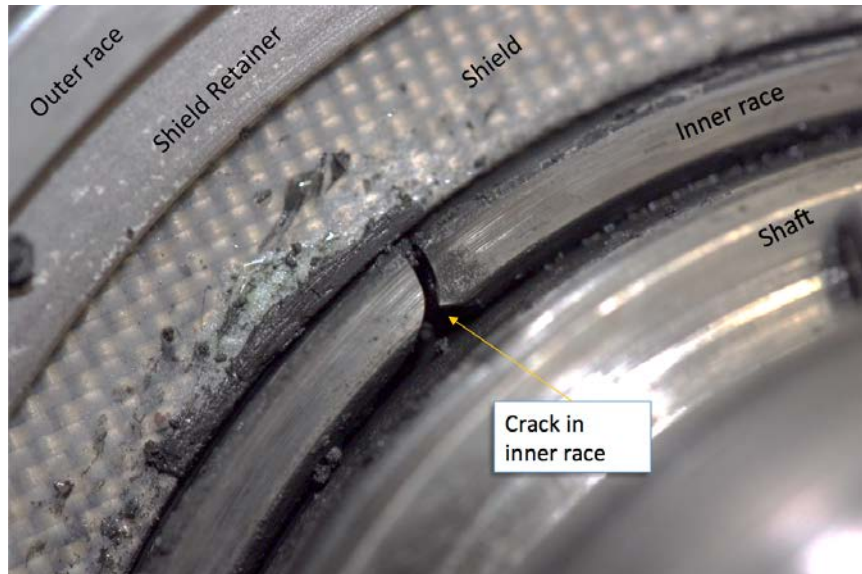
The inner race appears to have sprung radially outward from the DA shaft to the left side of the crack and a significant gap has opened between the faces of the crack. This behavior suggests that the inner ring had been under considerable residual stresses and these may have been a factor in the bearing failure.

Indeed, the bearing manufacturing process for 60NiTi includes a rapid water quench step following heat treatment at 1000 °C [9]. This rapid cooling results in the rise of residual thermal stresses. Unlike steels and other metals in which such residual stresses can be relieved by soaking the parts at elevated temperatures, NiTi has no mechanism for internal atomic level slip. The residual stresses that remain after the quenching step cannot be relieved through additional thermal treatments and these stresses may be a factor in undesirable effects like ring cracks [10, 11].

Figure 3. Close-up view of cracked inner race

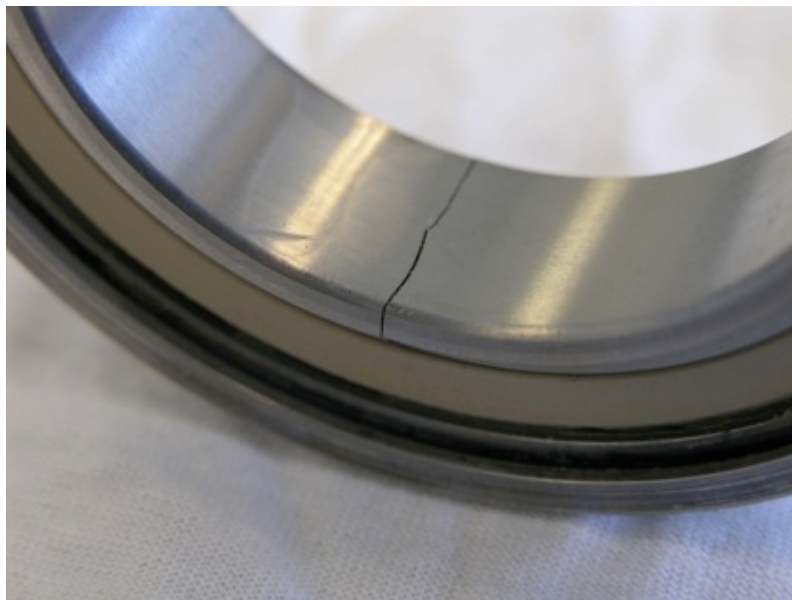
A similar bearing ring crack was observed during prototype bearing development. A bearing had been successfully tested, removed from the test rig and inspected. The bearing was in as-new condition and was placed in storage. Several weeks later, the inner ring developed a crack similar to the one observed in the present case. Figure 4 shows that inner ring crack.

Figure 4. Photo of an early prototype bearing that developed an inner race crack during post-test storage

In this instance, forensic analyses showed that the early prototype 60NiTi material used in this bearing contained significant non-metallic inclusions and other internal flaws that could have triggered the crack. In addition, the bearing was damaged during final machining of the inside surface of the inner ring. Adjacent to the fracture location, a low spot and a deep gouge are observed. This damage was a

manufacturing flaw that resulted from the inner ring becoming loose in the machining fixture. Thus this post-test ring crack was attributed to the known material and machining flaws [11].

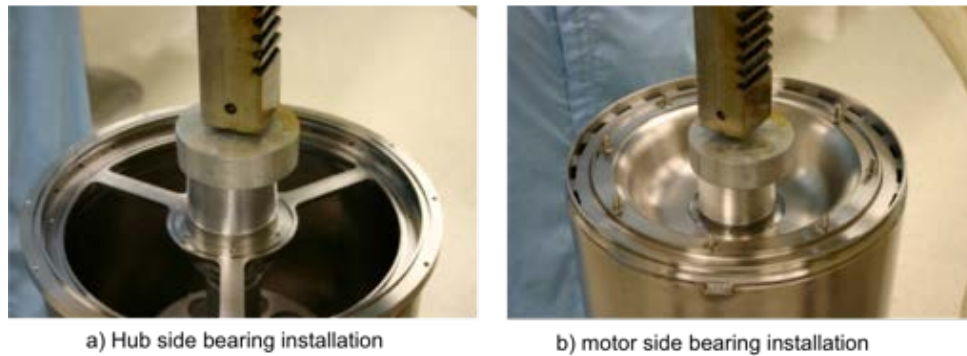
Aside from the differing levels of interference fits, the most obvious difference between the motor and hub-side bearing locations is the structural design of the housings. As shown in Figures 1 and 5, the motor-side bearing housing has an axial symmetric bowl shape while the hub-side bearing housing is comprised of a shallow cylinder supported by a three-spoke flat plate. The spoke design provides ready physical access to the central portion of the drum to enable the installation of piping and other internal elements. Figure 5(c), for example, shows a close-up view of the hub-side of the drum where a fluid pick-up tube is visible. To determine whether the differences between the hub and motor side housing structures were a contributing factor in the bearing failure, a finite element based analysis was undertaken.

Figure 5. End views of DA drum shown during bearing installation. Hub side bearing housing structure (a) differs significantly from motor side (b).

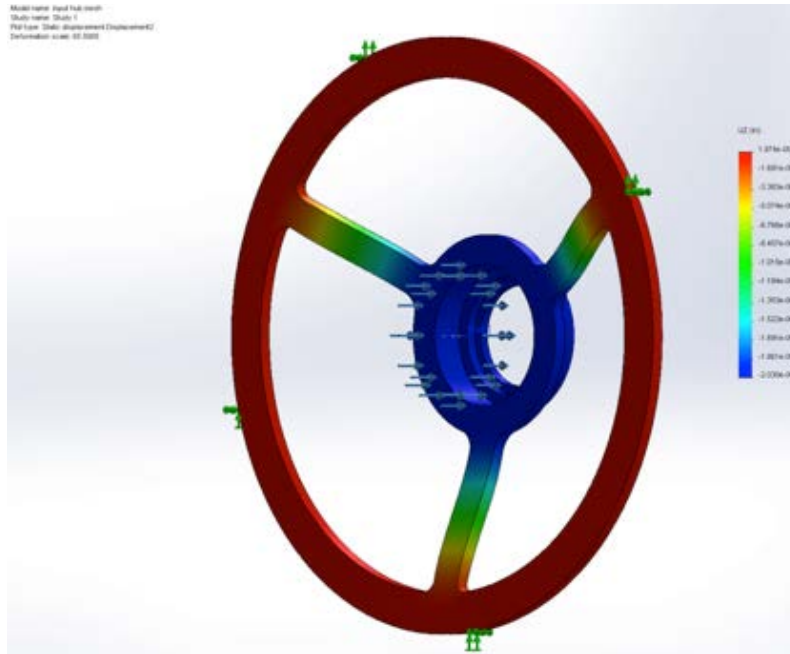
To estimate the magnitude of the deformations of the hub-side bearing outer race, a finite element model was developed. Figure 6 displays the model result for the axial deformation of the hub-side three-spoke structure under a greater than normal 200-lb (890-N) axial load. The normal axial load for the DA is only 40 lb (178 N). The 200-lb (890-N) case was run to determine whether axial deformation arising from the spring preload could possibly distort the hub-housing geometry. The result was clear. Even under exacerbated axial load the housing shape remains round. It was noted, however, that significant axial deformation of the spokes occurs even under the 40-lb (178-N) design load. This deformation effectively reduces the axial preload through reduction of the distance between the outer races of the hub and

motor-side bearings. Thus if the wave spring height reduction is used to set preload, it is likely that the installed preload will be lower than expected by about 10%.

Figure 6. Finite element deformation of the DA hub side structure in response to a large (200-lb (890-N)) axial load. Note that the hub bore remains round

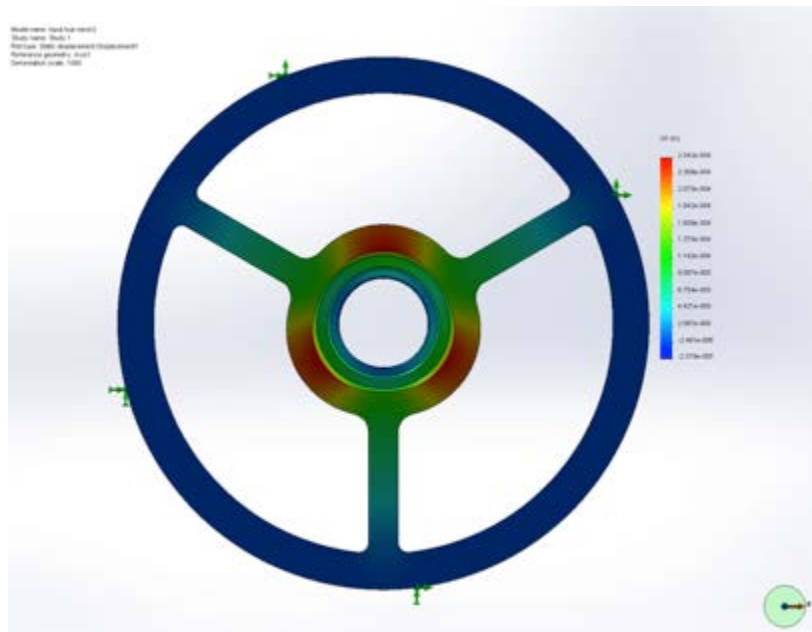
Figure 7. Finite element deformation of the DA hub side structure into which a bearing is installed with a heavy (0.0011 in/28 μ m) press fit. Note that the three spoke locations provide high rigidity leading to an irregular bore shape

The second case examined was for a heavy interference press fit (0.0011 in (28 μm) diameter difference) of a round bearing into the circular hub-side housing bore. Figure 7 shows the result.

At the spoke locations, the bearing outer race diameter is reduced by approximately the same magnitude as the bearing clearance and the less rigid housing sections between the spokes allows the bearing housing to take on a tri-lobe shape with radial variation of approximately 0.0002 in (5 μm). Such roundness variation combined with the loss of internal clearance could be responsible for the rapid bearing failure. To corroborate such a root cause theory, however, requires experimental verification.

Selective fitting of the bearings, especially in the hub-side DA housing, should be done to seek a fit in which the bearing outside diameter and the hub bore diameter are as closely matched as possible. The design calls for a range of 0.0001 in (2.5 μm) clearance to 0.0006 in (15 μm) interference. Another approach is to manufacture bearings with varying diameters to accommodate future DA machines with less or no interference thus avoiding the deleterious effects of outer race distortion and loss of internal clearance. Furthermore, bearings with larger internal clearances can be used so that any outer race press fit will not result in a significant or even complete loss of internal ball-to-race clearance. Conversely, bearing designs less sensitive to internal clearance variations, such as angular contact bearings, could be considered.

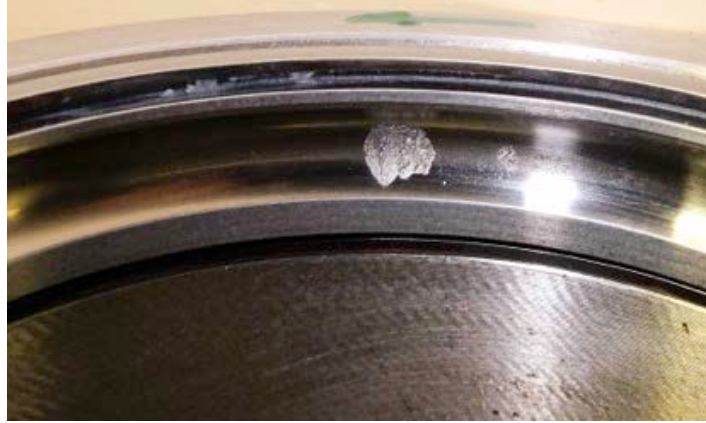
After 150 hr of test time the bearings continued to turn smoothly. At 157 hr an audible noise was noted and the torque sensor indicated a measurable torque ripple. The test was stopped and the bearings were removed, disassembled and inspected. The shimmed bearing had suffered from fatigue damage. The grease was discolored and wear debris was observed. The fatigue damage resulted in deep raceway pits and spall craters. These were located in the regions that overlapped the shims. The other test bearing that was not shimmed showed no signs of damage. Figure 10 is a close up photograph of the raceway surface of the shimmed outer race after test. Significant surface pitting and spall regions are present. The inner race also showed signs of surface distress (small pits) but it was uniformly distributed around the raceway and less severe.

Figure 10. Raceway pit developed during shimmed bearing test after 157 hr of run-time

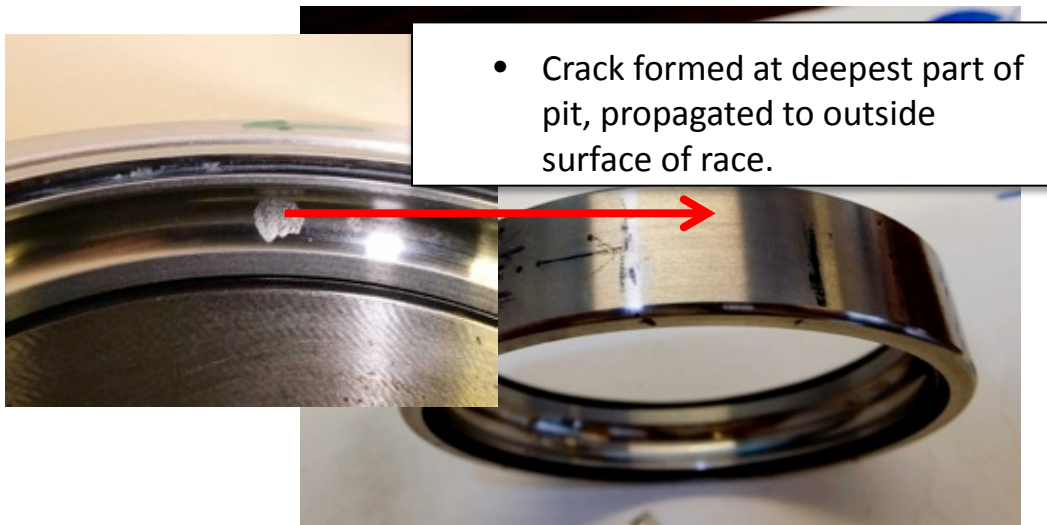
In the largest spall crater, approximately 4 mm in diameter, cross-race cracks had developed. In some places these cracks had propagated to the outer surface of the race as shown in Figure 11.

Figure 11. Crack originating in the fatigue spall on raceway has propagated to the outer surface of the race after 157 hr of run-time

If this test been allowed to run longer it is reasonable to expect the damage to progress possibly until the race cracked through completely. Upon reflection, it is possible that the failure path for the DA bearing was surface fatigue followed by pit growth, crack formation and propagation and finally, race fracture. At the onset of the investigation, one theory was that the raceway residual stresses had led to ring fracture and subsequent bearing wear and debris generation. Based upon the shimmed bearing experiment, it appears that ring fracture may have been the final step, not the initiation step.

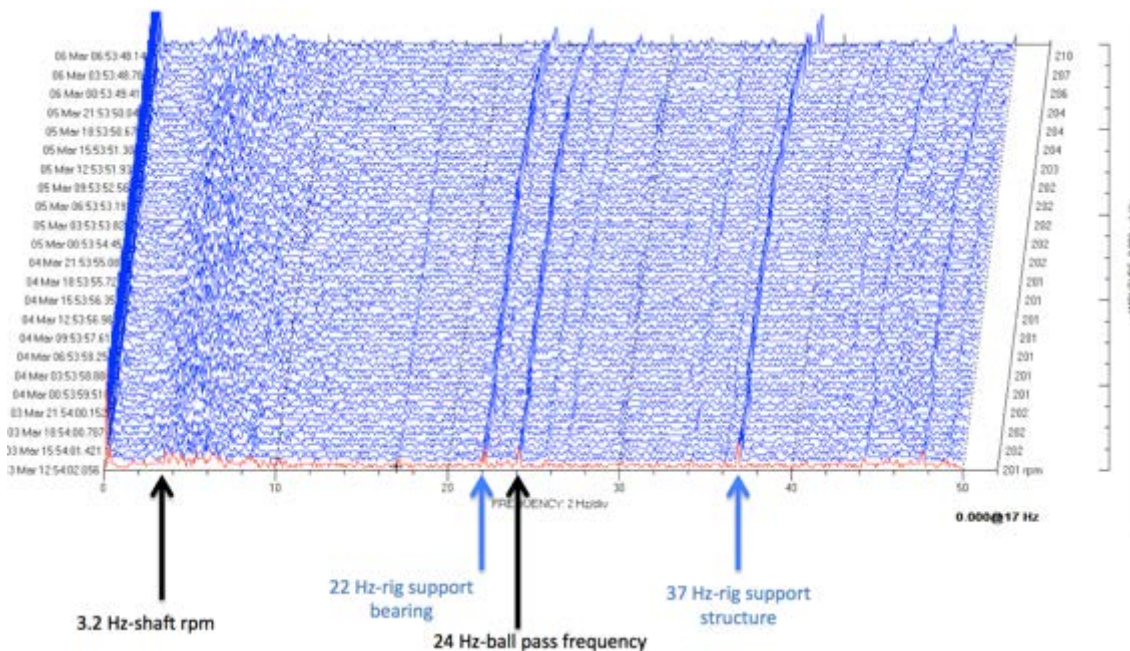
The cascade vibration plot provides a convenient visual method to judge bearing condition. Each peak in the spectra corresponds to different aspects of the test rig and test bearing. For example, vibration at the rig speed (3.2 Hz or 200 rpm) would arise from any anomaly associated with the drive motor, couplings or drive shafts. Vibrations generated by the test rig support bearings arise at 22 Hz owing to the number of rolling elements and internal geometry of these bearings. The test rig structure has some activity at 37 Hz. A key test bearing frequency for health monitoring is 24 Hz. This frequency represents the ball pass frequency on the inner race. Slight roundness and other variations will lead to vibration at this frequency. Any significant increase in the amplitude at 24 Hz could signal raceway surface damage in the ball path. Thus the cascade plot serves as a snapshot of bearing health.

Figure 12. Cascade plot of hourly test rig vibration spectra captured during a three-day test period. Overall vibrations are very low and consistent

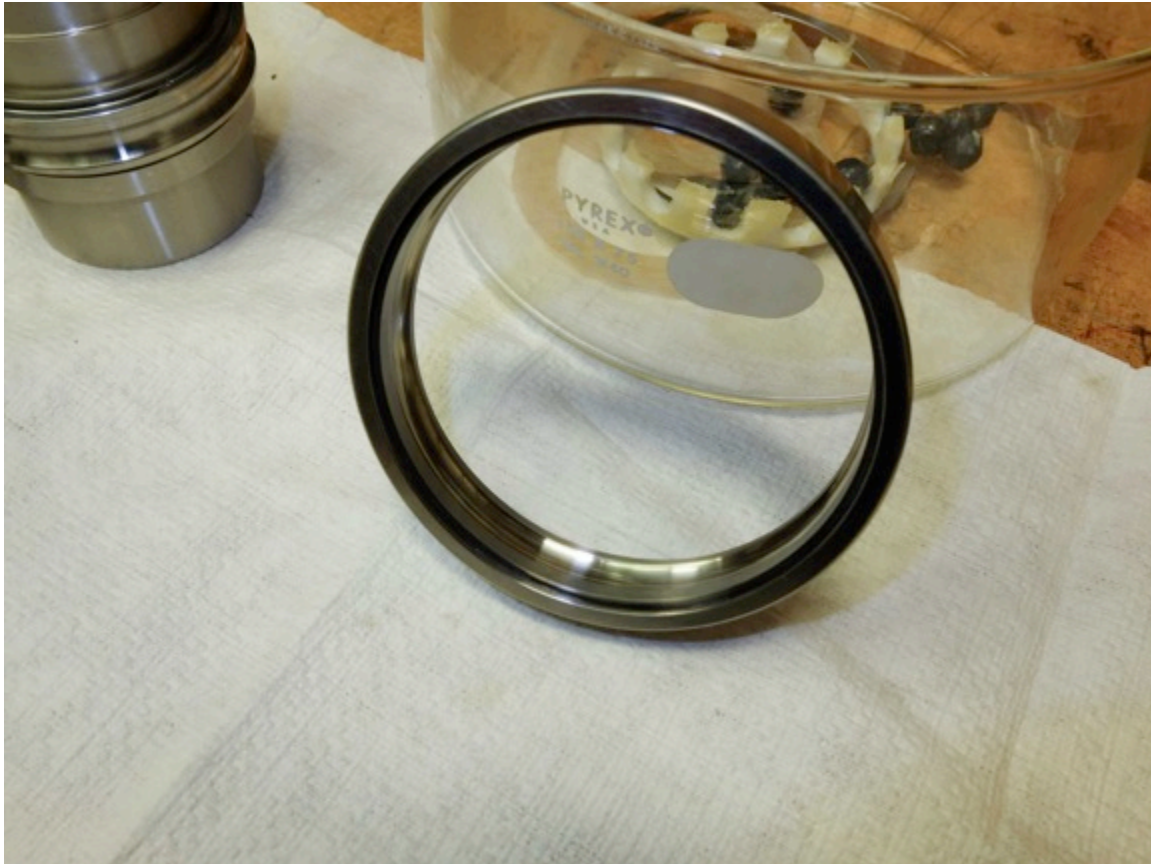
During the inspection the races were examined under 10x optical magnification and appeared to be in excellent condition. They exhibited no surface pits, scratches or wear tracks. Also, the retainer was unworn and the grease color and consistency was the same as the beginning-of-test. Following the inspection, the bearings were solvent cleaned, re-greased and installed back into the test rig. After a few hours of operation the torque ripple subsided leaving a vibration spectra that resembled one from before the inspection.

Figure 13. Photograph of the test bearing during an interim inspection at 1075 hr. Overall condition of the bearing races, balls and retainer was unchanged from beginning of test. The grease consistency and color was also unchanged
