Swift BAT Thermal Recovery After Loop Heat Pipe #0 Secondary Heater Controller Failure in October 2015

Michael K. Choi*

NASA Goddard Space Flight Center, Greenbelt, MD 20771

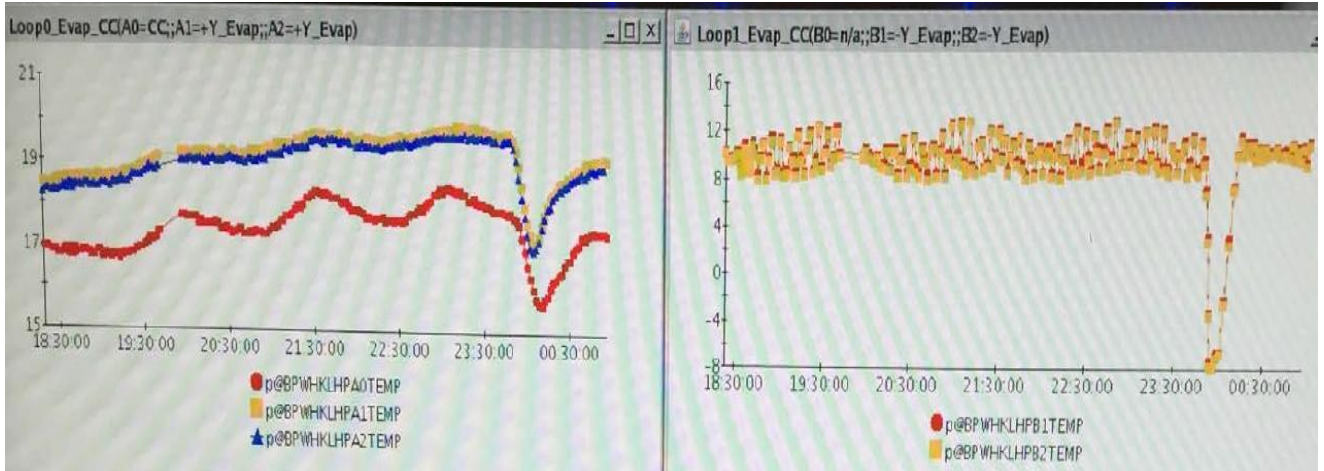
Figure 10. CC and Evaporator Temperatures of LHP #0 and LHP #1 on November 1, 2015.

On October 31, 2015, the secondary heater controller of LHP #0 failed. Fig. 10 shows the LHP #0 CC flight temperature telemetry during the failure. From October 30-31, the LHP #0 CC temperature became unstable and oscillated between 8°C and 22°C for about 24 hours. Note that prior to the failure, the heater controller maintained the LHP #0 CC temperature at the 8.8°C set point. At 14:00 Universal Time (UT) on October 31, the LHP #0 CC temperature had a temperature droop. It decreased to 1°C first and settled at approximately 18°C. Fig. 11 through 13 show the flight temperature telemetry of the LHP #0 evaporator, liquid line/vapor line, and condenser respectively. At 20:00 UT on October 31, the Detector Module (DM) Block temperature increased to 21°C (Fig. 14), which led to an increase in the average DM XA1 temperature to 25.9°C. It also led to noisy detectors and high triggering rates. Therefore the detector high voltage was reduced from 200 V to 100 V.

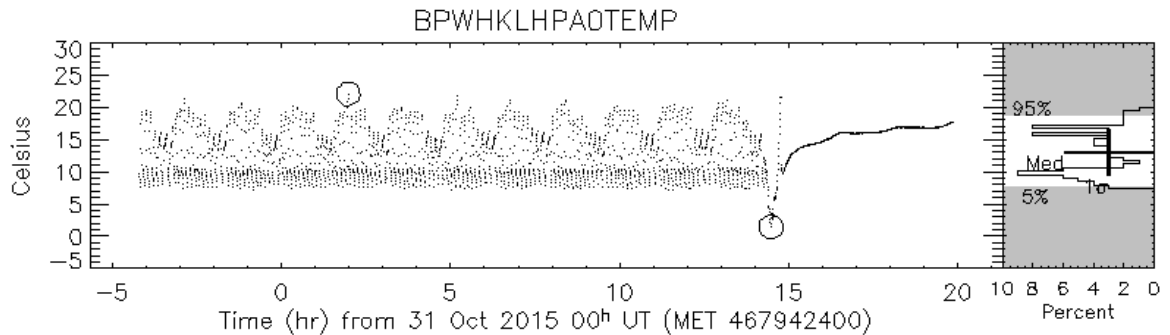
Figure 15. LHP #0 CC Temperature on October 31, 2015.

Fig. 15 through Fig. 21 show the flight temperature telemetry of LHP #0 on October 31, 2015. The LHP #0 CC temperature (about 18.6°C) is much higher than the LHP #0 secondary heater controller set point (8.8°C). After the LHP #0 secondary heater controller failed, it was unable to control the LHP #0 CC temperature. It possibly failed on (i.e., operating at 100% duty cycle). As a result, the LHP #0 evaporator temperature increased to 20°C. To verify this hypothesis, the set point of this heater controller was decreased in 0.5°C decrements by sending commands

during command passes, such as Tracking and Data Relay Satellite System (TDRSS). The temperatures of LHP #0 CC and evaporator did not respond to the commands.

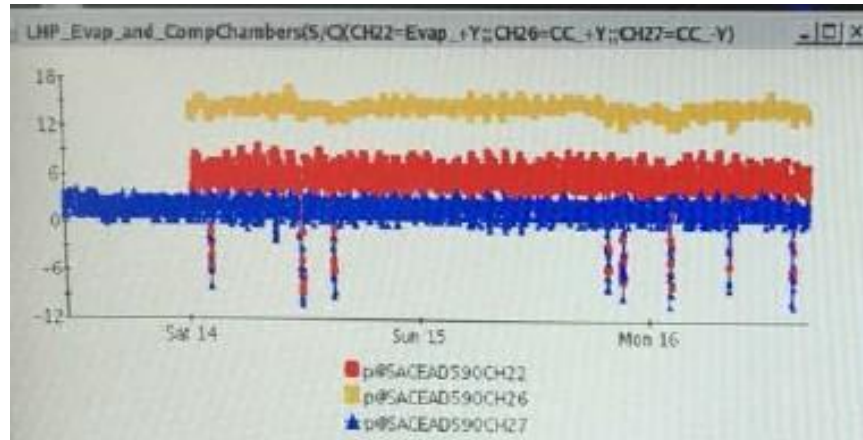
Figure 23. LHP CC and Evaporator Temperatures from 14-16 November, 2015 (S/C Sensors).

Decreasing the LHP #1 heater controller set-point led to small temperature droops. The droops are caused by the VCHP, which is controlled by a channel of the same controller as the CC. Since the droops were not large, there was no risk of shutting down the LHP. Examples of droops are as follows. First, LHP #1 had four droops over 24 hours on November 21. Two were about 13 hours apart, and two were about 3 hours apart. The LHP #1 droops caused droops of 1.5°C maximum on the DM Block temperatures or about 1°C on the DM XA1 temperatures. Second, the temperature telemetry on November 22 showed that LHP #1 had two droops over 24 hours that day. The droops were about 8 hours apart. The number of droops were two less than that of November 21. The LHP #1 droops on November 22 also caused droops of 1.5°C maximum on the DM Block temperatures or about 1°C on the DM XA1 temperatures. The frequency and amplitude of the temperatures droops in the DM XA1 temperatures are acceptable to science.

Fig. 23 shows the LHP CC and evaporator flight temperature telemetry from November 14-16, 2015. The LHP #0 CC temperature was between 12°C and 17°C. The LHP #1 CC temperature was between -1°C and 5°C, except during the droops. It decreased to -11°C minimum during the eight droops over 72 hours. Fig. 24 through Fig. 28 present the LHP flight temperature telemetry on November 26, 2015. Fig. 29 and Fig. 30 present the DM Block and DM XA1 flight temperature telemetry respectively on November 26, 2015. They represent the BAT flight temperatures after its thermal control system recovery. Presently the average DM XA1 temperatures remains at 19.7°C. The BAT is operating nominally.

With the DM XA1 temperatures nearly 5°C warmer than nominal, the detectors became noisy and had high triggering rates. It was necessary to decrease these temperatures to the nominal value. Since the average temperature of the two LHP evaporators determines the DM XA1 temperatures and the LHP #0 failed on, it was necessary to decrease the LHP #1 evaporator temperature significantly. Therefore, the LHP #1 secondary heater controller set-point was decreased gradually by 0.5°C at a time until the LHP temperatures became nearly stabilized. Decreasing the heater controller set point removes thermal energy from the LHP. A large set point change could cause large temperature instabilities and shut down the LHP. Therefore the set point (8.6°C) was decreased gradually during command passes, such as TDRSS, beginning on November 6. On November 16, the average DM XA1 temperatures was restored to the nominal temperature of 19.7°C. The LHP #1 secondary heater controller set-point decrease was completed with a 2.2°C set-point.

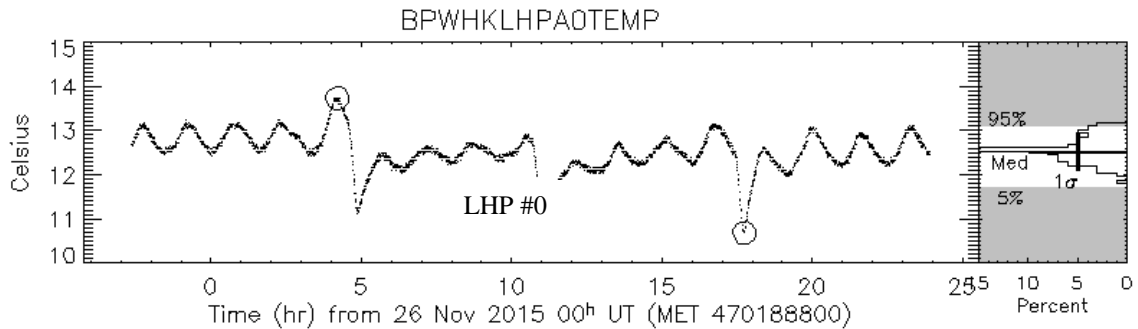
Figure 24. LHP CC Temperature on 26 November, 2015.

BPWHKLHPB0TEMP not shown (temperature sensor had ESD damage during I&T before launch)
