# Large Area Nondestructive Evaluation of a Fatigue Loaded Composite Structure

<sup>1</sup>NASA Langley Research Center, MS231 Hampton, VA 23681

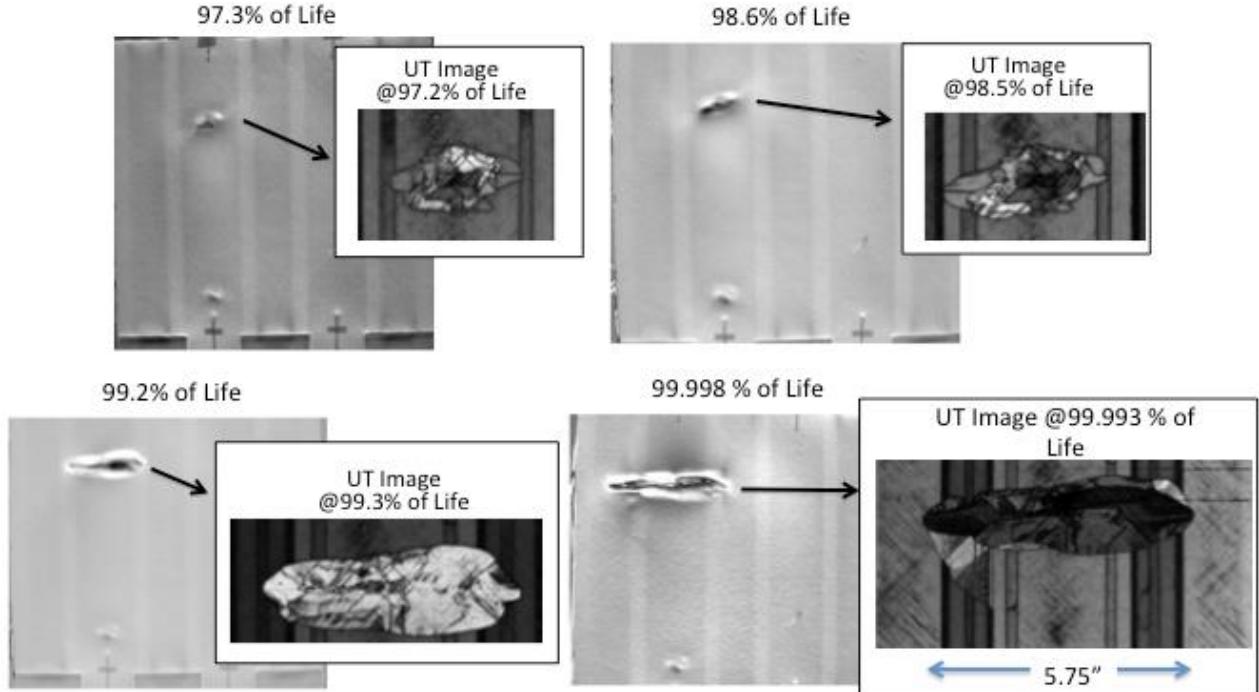
Figure 5: Comparison of processed thermography images to ultrasonic inspection results.

Examples of processed thermal images of the flat side are shown in Figure 5. The processing technique used to improve defect contrast involves a delayed image subtraction [6,13]. A moving buffer is required in the acquisition software in order for this processing technique to be implemented in real time. The delayed subtraction is given as:

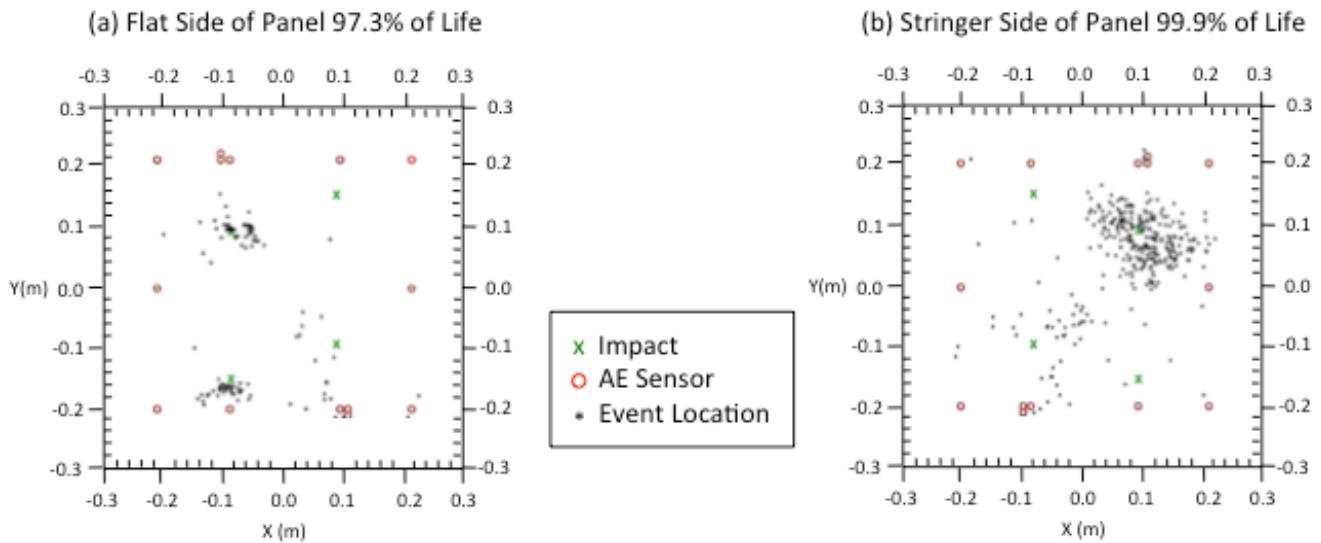
Figure 6: Three-stringer panel acoustic emission event locations.

Figures 6a and 6b where the acoustic emission events are shown for different fatigue tests. The accumulated acoustic events for Fig. 6a were for approximately 50 seconds and for Figure 6b were for 16.5 seconds. As the structure nears failure the accumulated acoustic events increases as a function of time as shown in Figures 6a and 6b.

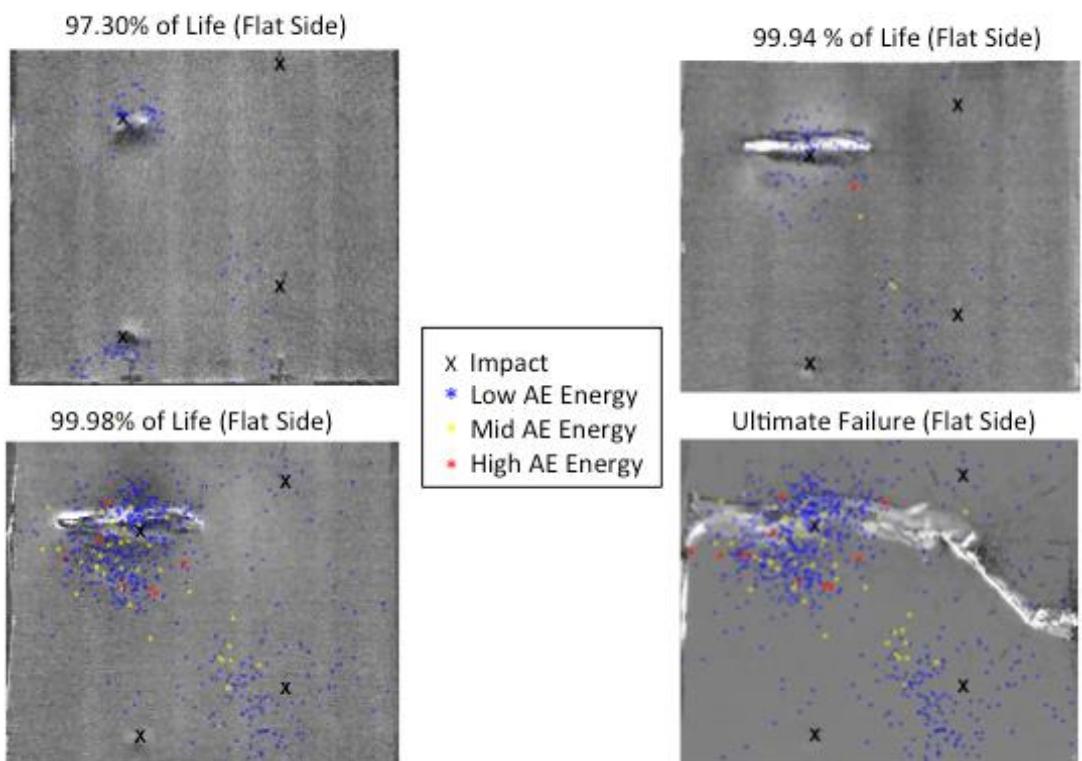
Figure 8. Mapping of acoustic emission data onto processed thermal imagery (Flat Side).

The mapped acoustic emission data as a function of remaining life are shown in Figures 8 and 9 for the flat side and stringer side respectively. The impact locations (X) are also shown. Both the thermal data and the acoustic emission data were synchronized to the load and therefore the timing of the acoustic emission events are matched to the thermal image temporally. For a given location, the mapped indicator (star graphic) size and color are based on the event energy given by:

where the event indicator values of less than 13 (with a minimum size of 10) were given a low energy color of blue (opacity of 0.5), indicator values between 13 and 15 were designated as a mid energy event color yellow (opacity of 0.7), and greater than 15 was a high energy event with color red (opacity of 1.0). As the structure nears failure, the accumulated acoustic events and indicator values increase as shown in Figure 8 and 9. Ultimate failure occurred at the location where the red high energy indicators and mostly yellow indicators are clustered. It is important to note the location of the acoustic emission events are prone to errors due to the progression of damage (fiber breaks, delaminations, matrix cracking) as the structure nears failure. These defects can affect the propagation of the acoustic emission signal in terms velocity and waveform mode conversions resulting in processing errors; however, overall the clustered locations are comparable to the thermal indications of the growing damage areas. In particular for the left image (thermal image from the stringer side) in Figure 9, some of the clustered points tend to accumulate below the delamination on the right side. This clustering was due to a growing disbond between the stringer flange and the skin below the delamination. This disbond between the stringer flange and skin caused ultimate failure.
