James Webb Space Telescope (JWST) Integrated Science Instrument Module (ISIM) Cryo-Vac #3 (CV3) Thermal Vacuum Test

AIAA Working Group on Space Simulation
November, 2016

Ed Packard
NASA Goddard Space Flight Center

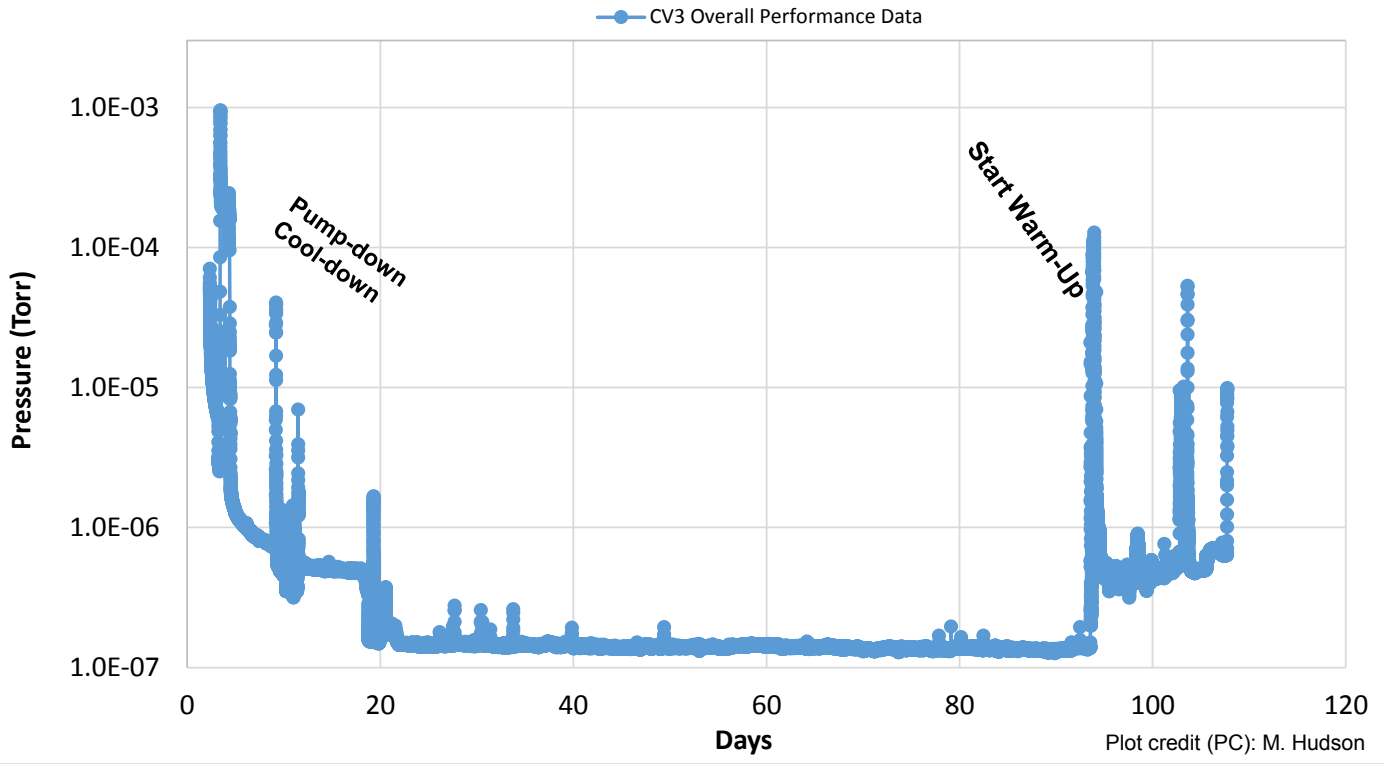
JWST ISIM CV3 Chamber 290 Pressure Data (IG-1)

Pump-down to 5×10^{-7} Torr took about 7.4 days from start of Pumpdown #2, after the initial leak was resolved

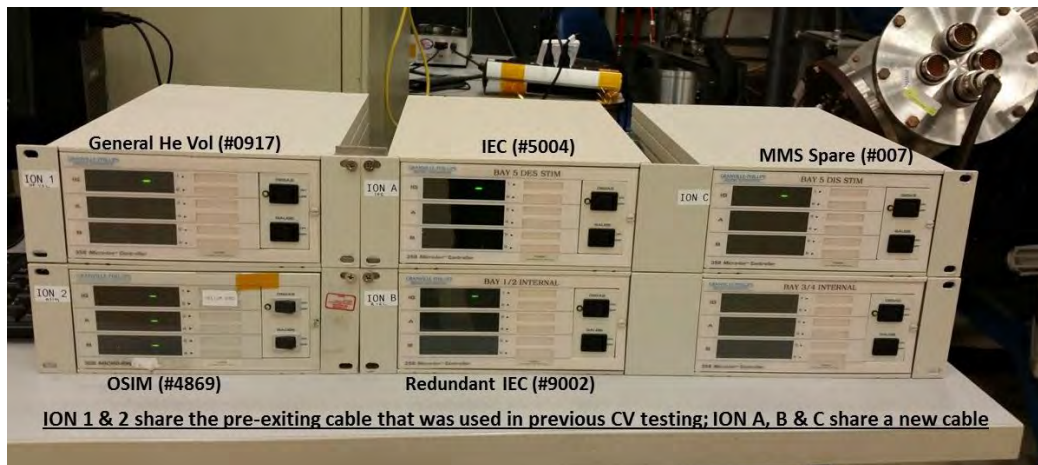
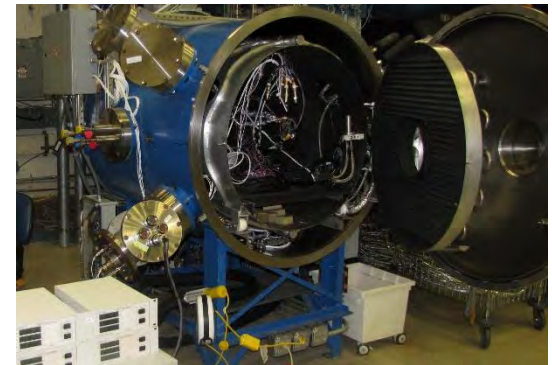
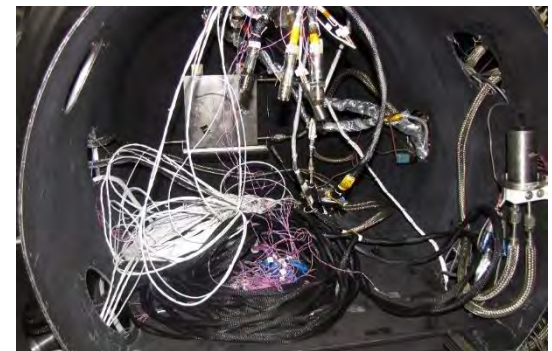
- **Redundant micro ion gauge for IEC**
- During check-out of the CV2 IGs, it was discovered that the extension used for the IEC IG was the root cause for the erratic and unreliable readings (per the spec sheet, maximum cable length allowable is 50')
- Cross-calibration of existing and new harnesses (+1 new redundant IEC micro IG) was performed in Facility 281

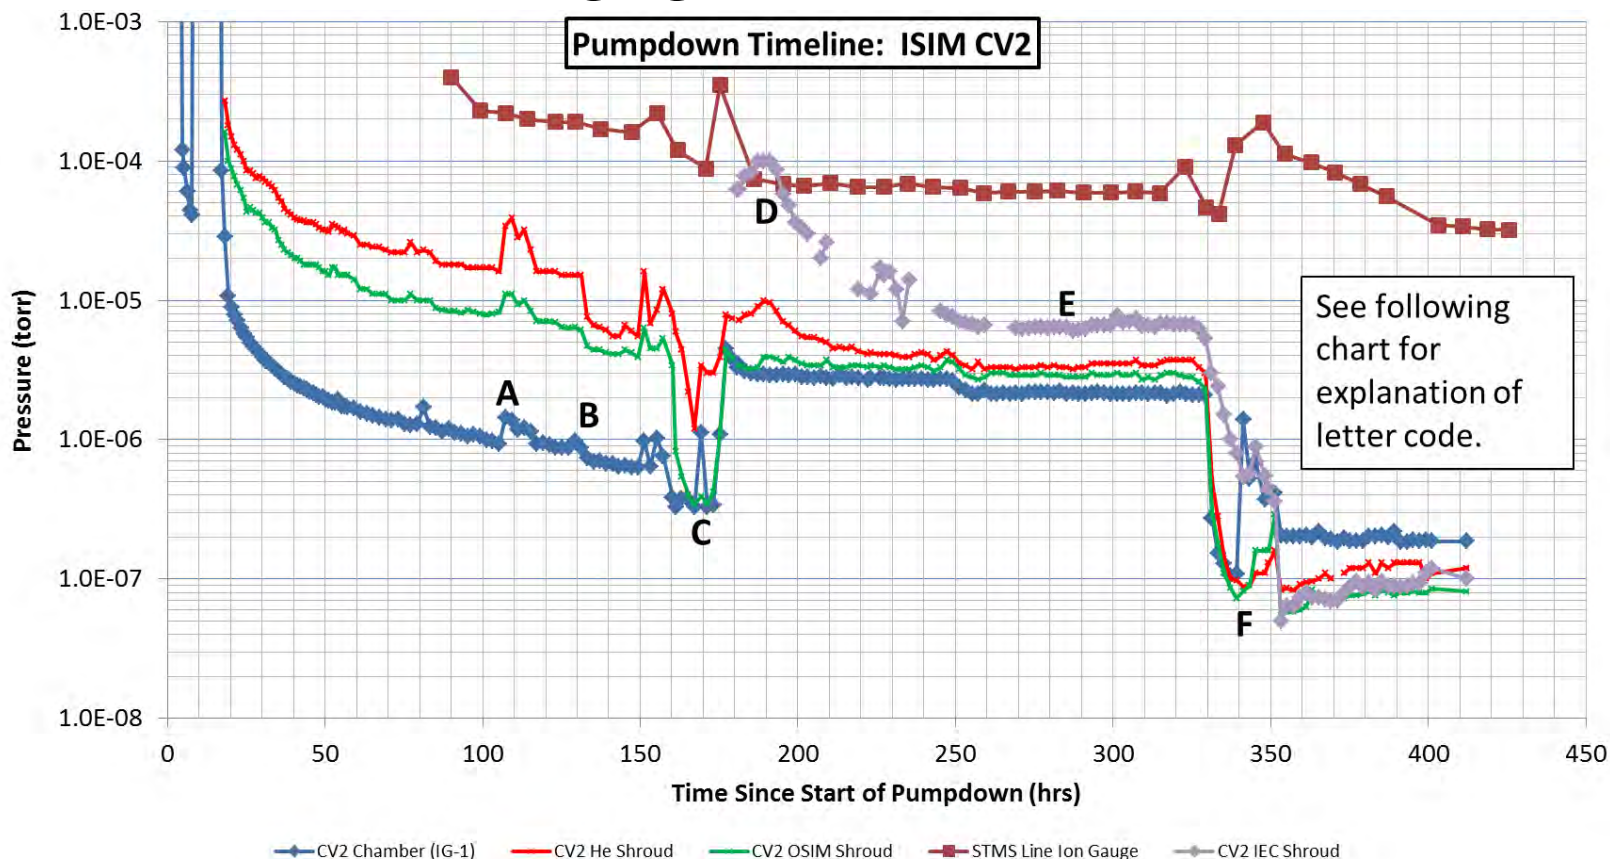
- **A:** Response to raising IEC N₂ panel temp
- **B:** Response to cooling of CQCM lines
- **C:** Adjustments to facility N₂ shroud
- **D:** IEC temperature cycle from 273-308 K and back, after which pressure continues to drop as IEC He panels get cold enough to sink water
- **E:** Pressure in IEC shroud stabilizes, though panels are 130K → 100K, with much lower water vapor pressure than P observed: **suggests an N₂ leak inside IEC shroud; need to check/fix before CV3**
- **F:** He panels reach temperature for sinking N₂/O₂; pressures everywhere plummet

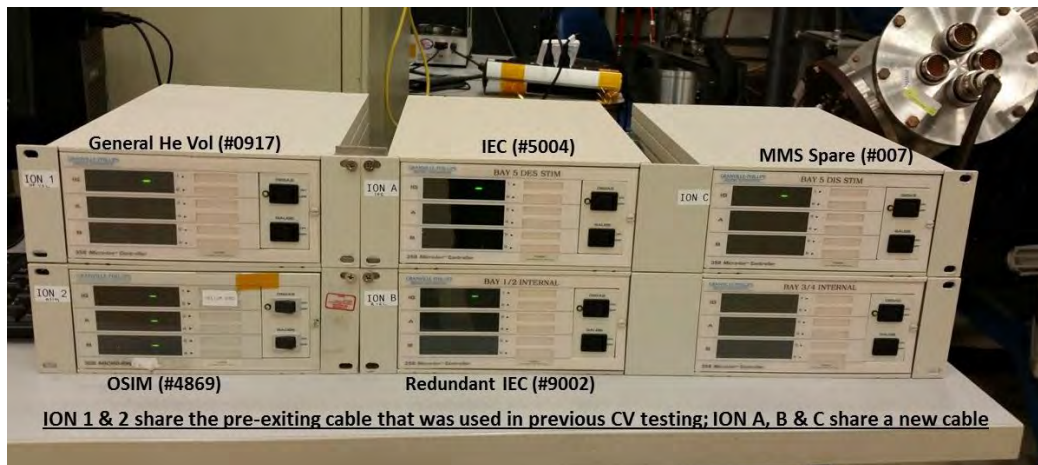
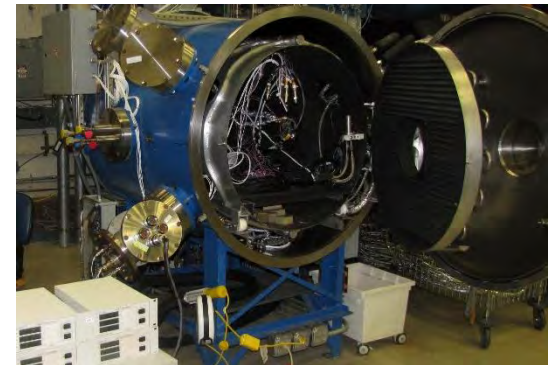
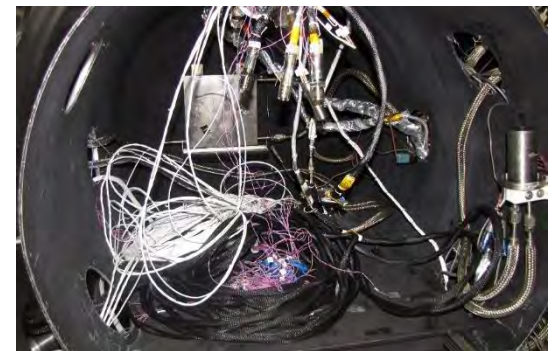
- During check-out of the CV2 IGs, it was discovered that the extension used for the IEC IG was the root cause for the erratic and unreliable readings (per the spec sheet, maximum cable length allowable is 50')
- Cross-calibration of existing and new harnesses (+1 new redundant IEC micro IG) was performed in Facility 281

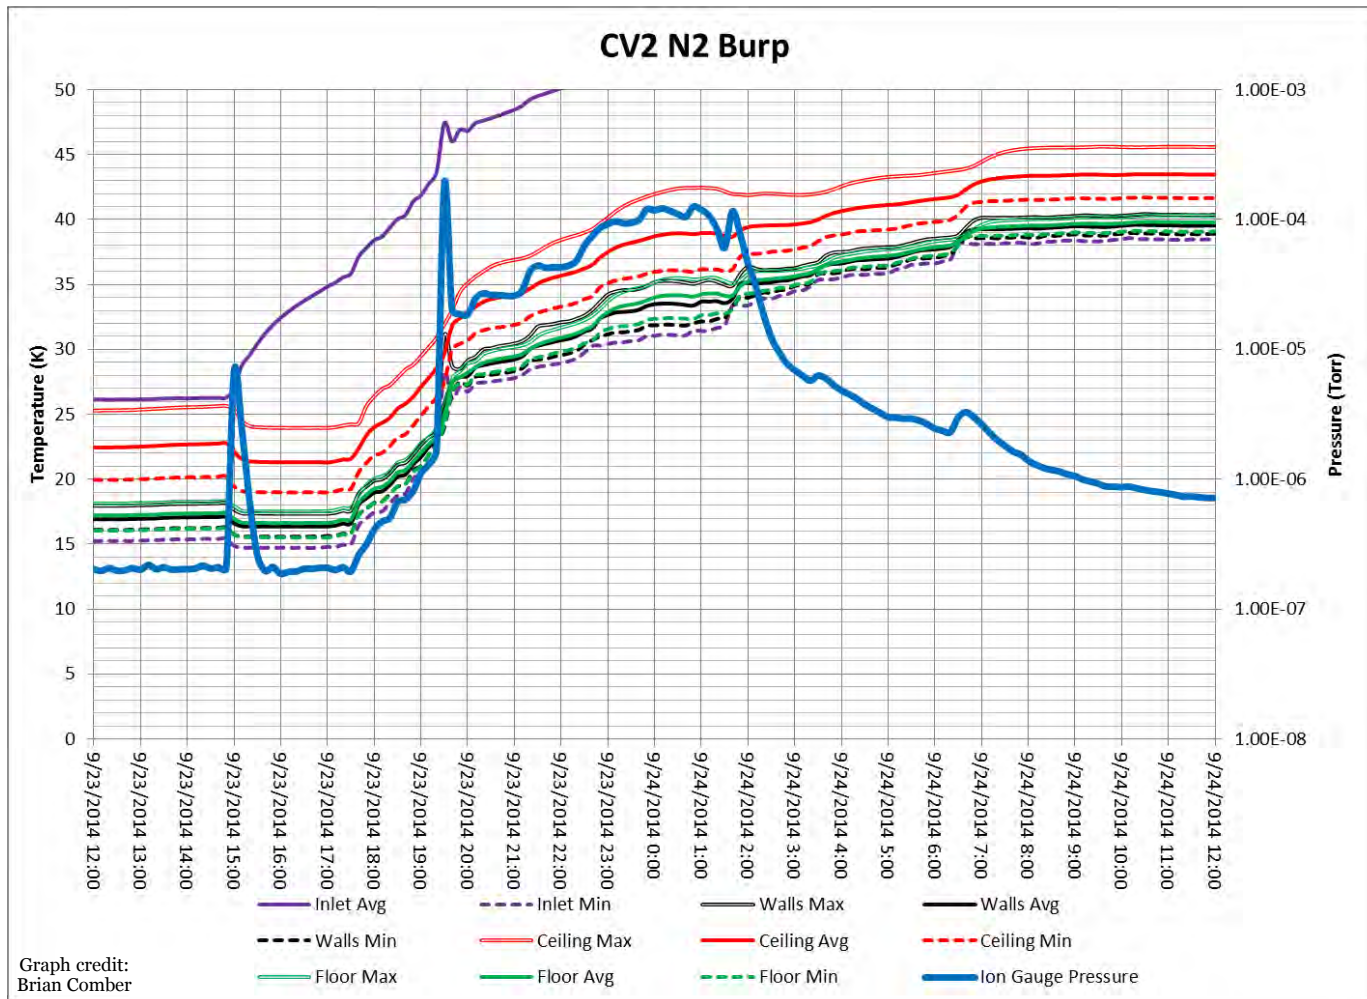
Estimate of gas released: up to 700 g, or 0.65 torr, if released suddenly into the chamber → thermal effects would be significant
