In-Situ Repair of TPS

Mike Fowler

JSC

1/30/17

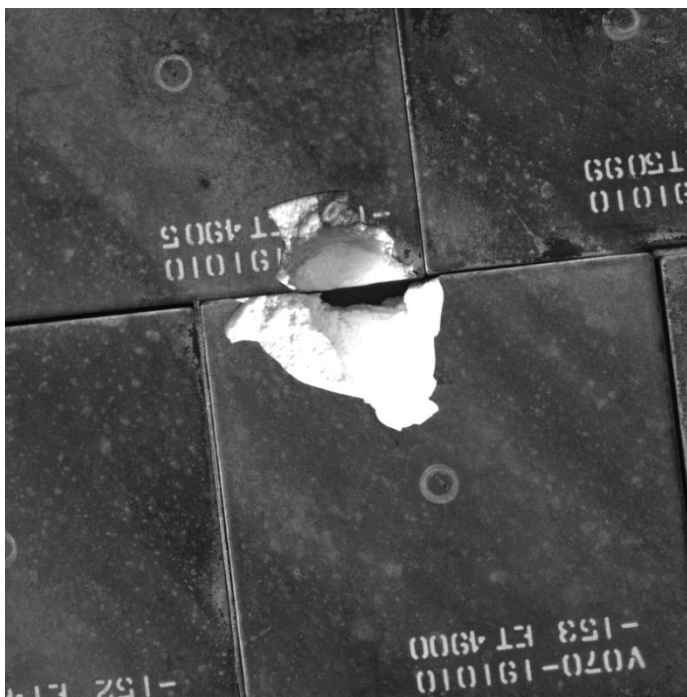
On-orbit

- Damage to NLGD adjacent to seal
- Thermal analysis showed environment low enough to enter without repair
- Led to Arc Jet test

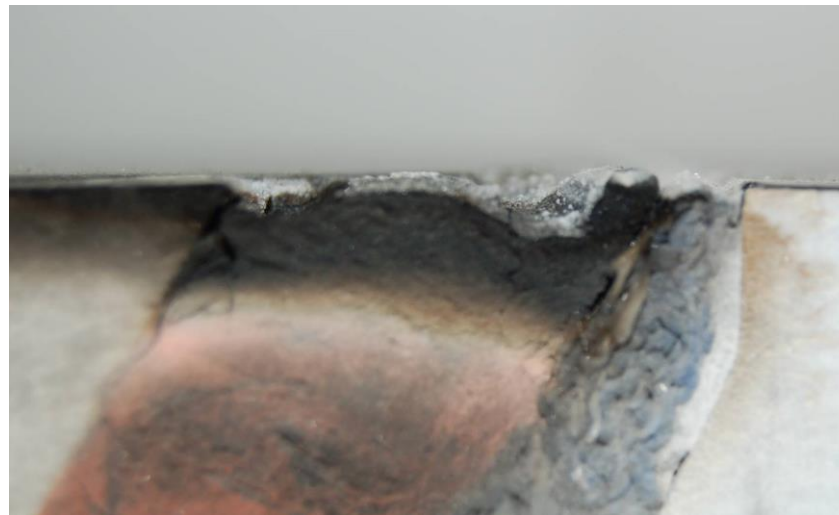
No-swell
above OML

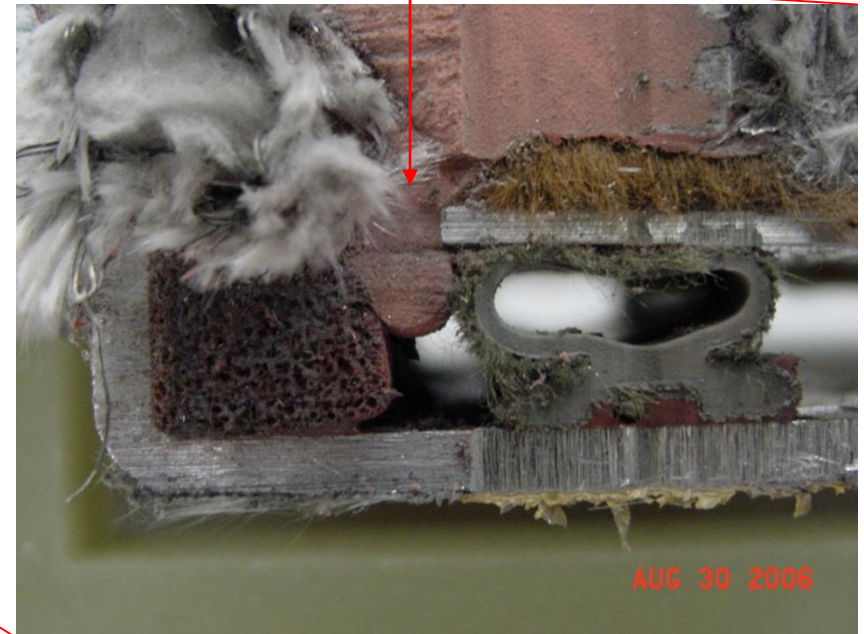
Note: STA-54 extruded into gap
