# Emergency Locator Transmitter Survivability and Reliability Study

*Chad M. Stimson*<sup>cpf</sup> *Justin D. Littell*  
*Langley Research Center, Hampton, Virginia*

*Lisa M. Mazzuca*<sup>cpf</sup> *Anthony W. Foster*  
*Goddard Space Flight Center, Greenbelt, Maryland*

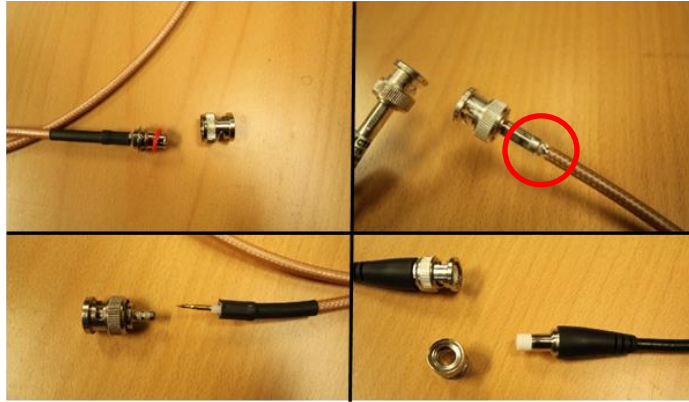
Figure 9. Antenna Cable Connector Failures from Strength Testing

A variety of brand new cable systems supplied by ELT manufacturers and fabricated by a certified aircraft technician at LaRC were included in a total of ten tests. Tests were conducted to failure, which occurred at the BNC connector in each case.

It was observed that vendor supplied cables manufactured in accordance with MIL-DTL-17 exhibited higher static strength characteristics than generic, unmarked cables by a wide margin. For example, the range of static strengths observed with MIL-DTL-17 cable systems was on the order of 80-100 lbf as compared to 20-30 lbf for the generic cables supplied by some ELT vendors. Representative failures are shown in Figure 9.

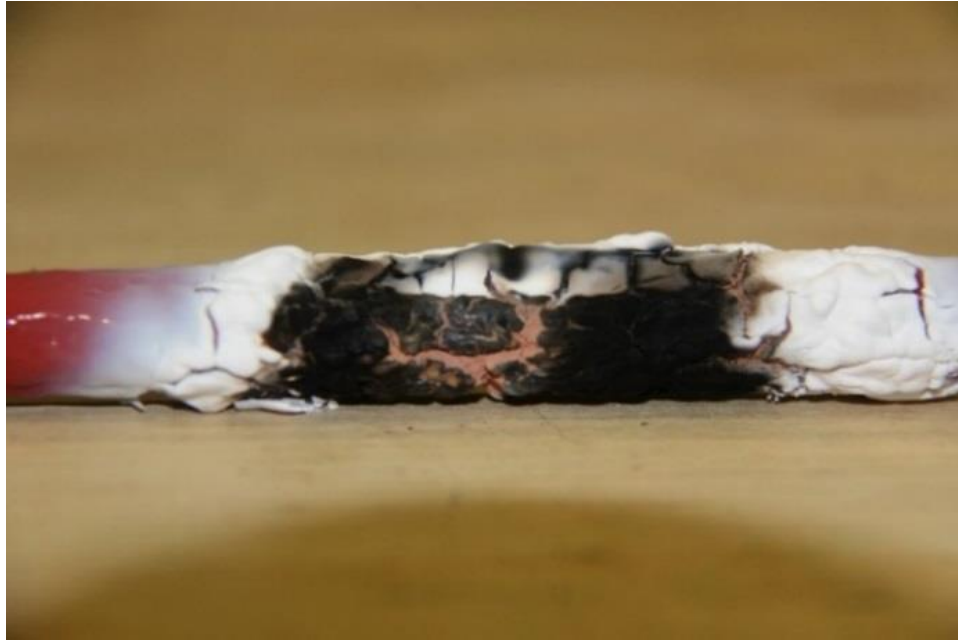
*Figure 12. Firesleeve Post-Test Condition*

All of the fire protection products tested performed reasonably well and extended the time to electrical loss by at least a factor of 2. The top performer was a firesleeve manufactured in accordance with Society of Automotive Engineers (SAE) AS1072. This material extended performance to more than 16 minutes before the test was halted. It was also one of the most economical products at less than \$3 per linear foot and available from numerous online sources. A picture of the post-test condition of the firesleeve is shown in Figure 12.

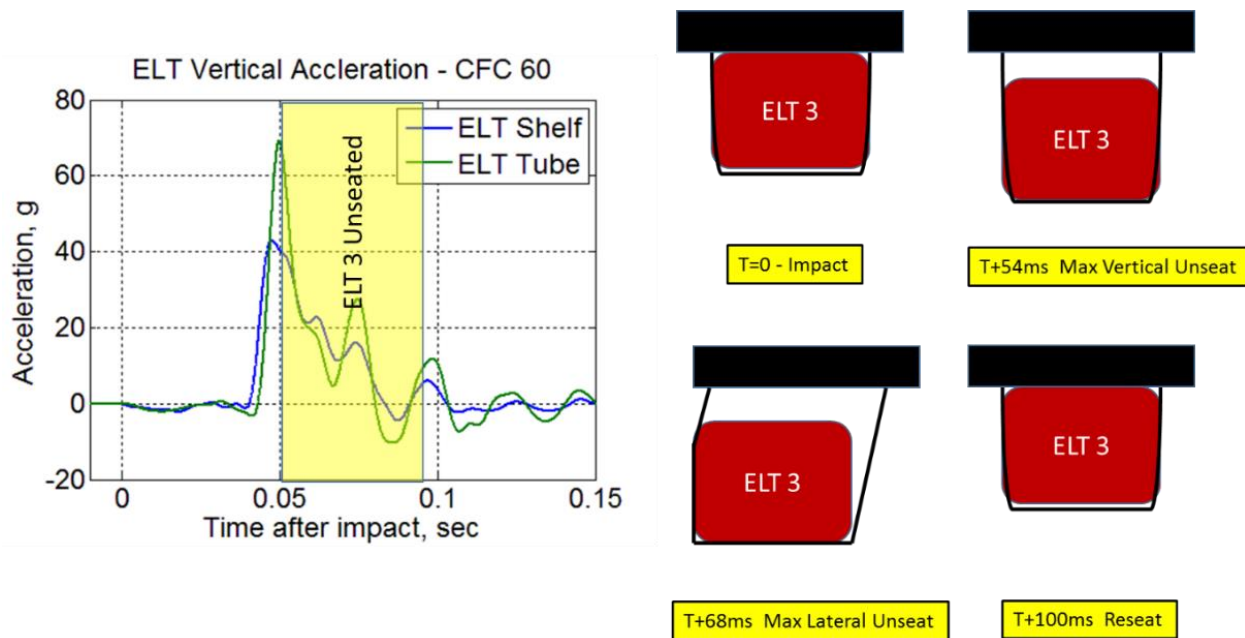
Figure 19. Hook-and-Loop Mounting System Behavior During TRACT 2

There was nominal structural responses from ELTs 1, 2 and 4 during the test, all of which utilized TSO-C126b compliant mounting systems. All units showed no signs of damage when reviewing the video or during post-test inspections. ELT 3, however, exhibited an unseating/reseating behavior as summarized in Figure 19. ELT 3 utilized a hook-and-loop style mounting system, but was brand new.

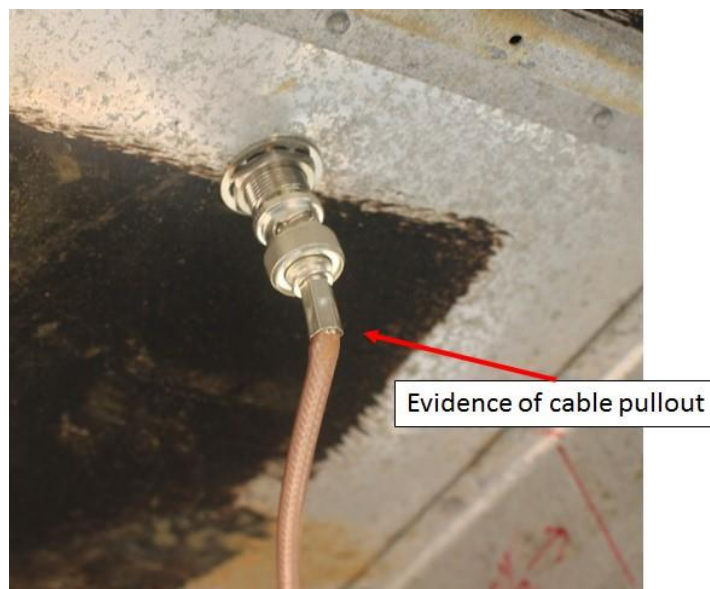
*Figure 27. Antenna Cable Damage Observed After Airplane Crash Test 2*

Closer inspection of ELT 4 showed that the antenna cable had partially pulled out of the end fitting at the antenna connection as shown in Figure 27. Although the installation of this particular system followed all requirements, it intentionally did not follow best practice in that the antenna and beacon were not co-located in the same airframe station, causing the antenna cable to cross the production break between the cabin and tail section of the fuselage. It is believed that the large deformation of this region during the crash test led to the cable connection failure.

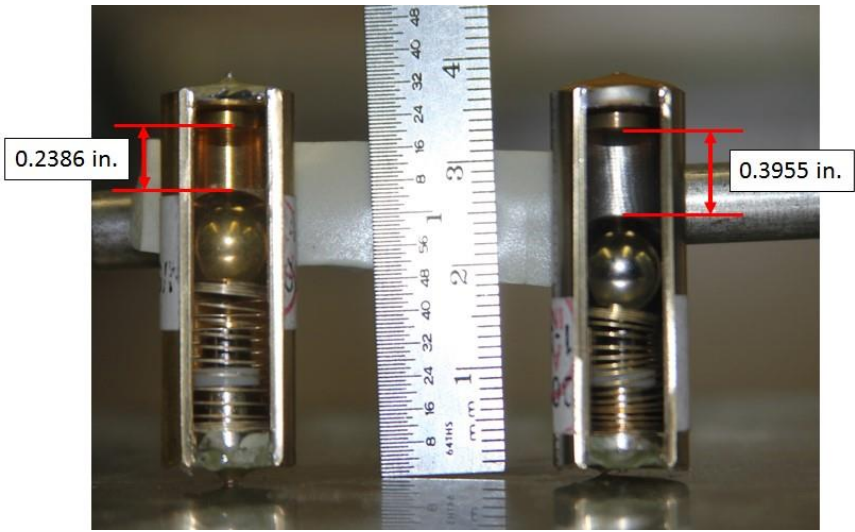
Figure 32. G-switch Variation Between ELT 2 (left) and ELT 4 (right)

As shown in Figure 32, under 1-g vertical loading, the spring inside the g-switch on the right has collapsed to the point that the mass is making contact with the lead, resulting in a “closed” condition. However, the spring inside the g-switch on the left is apparently stiffer and the switch remains in the “open” condition. Given these differences, it should be expected that each switch should perform differently under dynamic loading conditions, which is consistent with crash test performance observations.

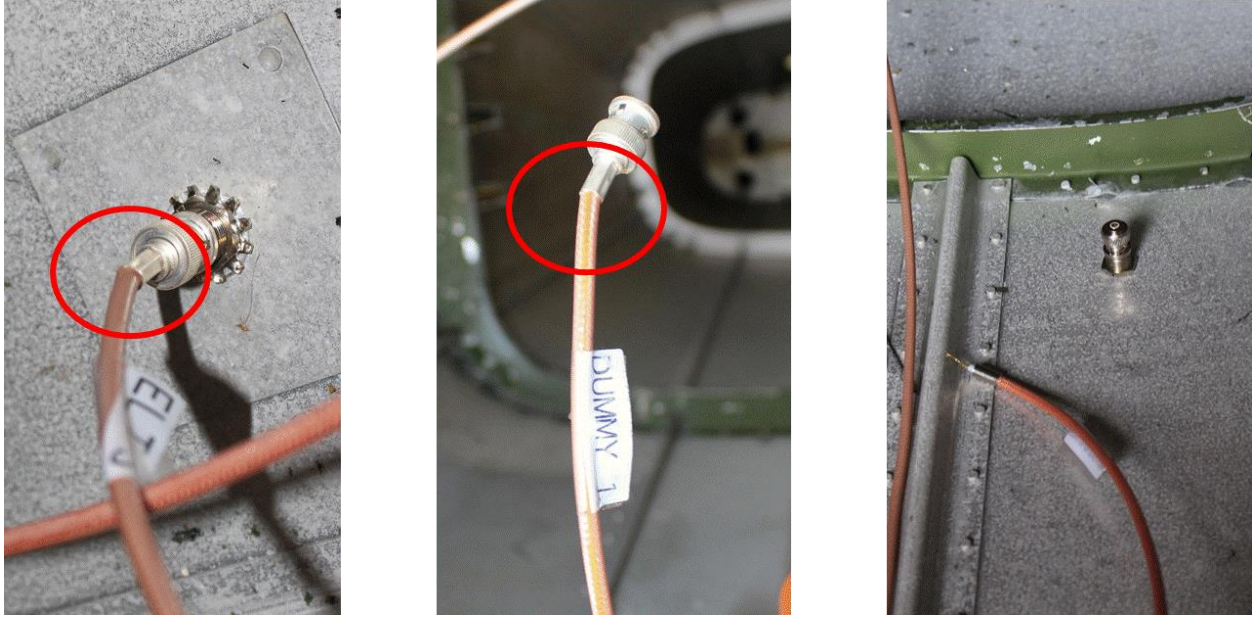
Figure 33. Damaged Antenna Cables - ELT 3 (left), Dummy 1 (center), Dummy 2 (right)

Physical damage was observed in three of the seven antenna cables after the crash test. The damaged cables corresponded to ELT 3 and both “dummy” ELTs. Although the ELT 3 cable showed signs of failure near the antenna connection, the damage did not prohibit successful transmission of the 406 MHz distress signal. More severe damage was exhibited by the “dummy” installations, with cable 1 becoming disconnected, but intact, and cable 2 being severed as the cable pulled out of the end fitting at the antenna connector. The damage experienced by each of these cables is depicted in Figure 33 and was the result of providing little to no slack in the cable runs.

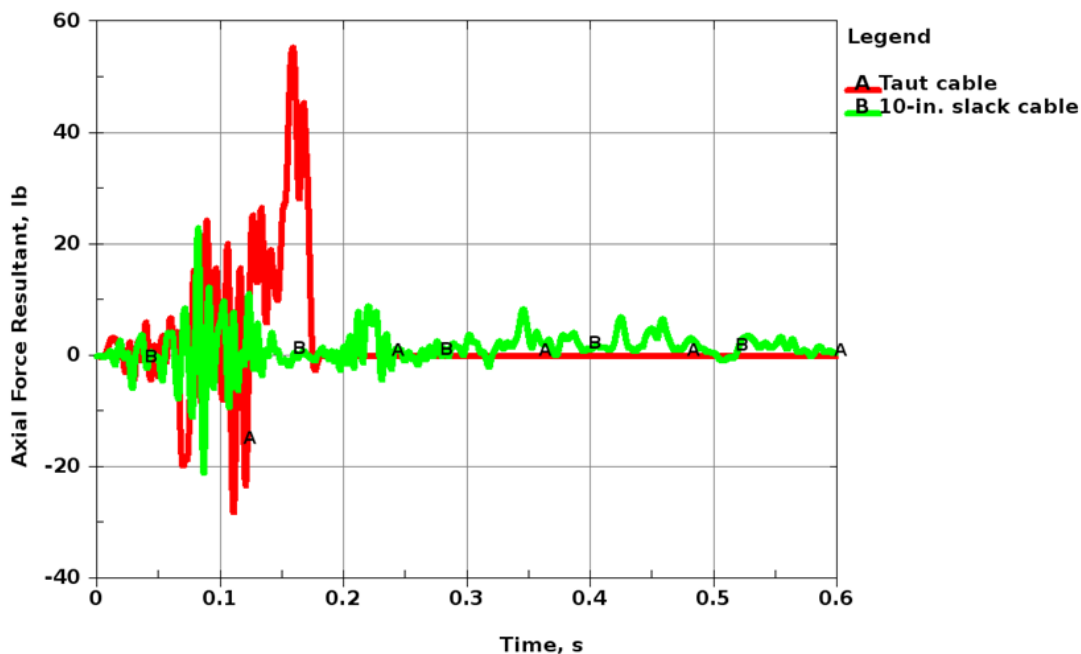
Figure 36. Comparison of Dynamic Cable Connector Forces for Taut and Slack Conditions

It was found that following the best practices described in [31] contributed positively to reducing the forces experienced by the antenna cable connections to acceptable levels. Figure 36 shows the predicted tensile load experienced by the antenna cable connector for two different cable installation schemes undergoing the same crash event. The simulated crash conditions were similar to those tested with the third airplane described previously, but with a rigid (e.g. concrete) impact surface instead of soil.
