Total Ionizing Dose Test Report for the MB85AS4MT ReRAM

Dakai Chen¹, Edward Wilcox², and Kenneth LaBel¹

Test Date: January 23, 2017
Test Report: February 14, 2017

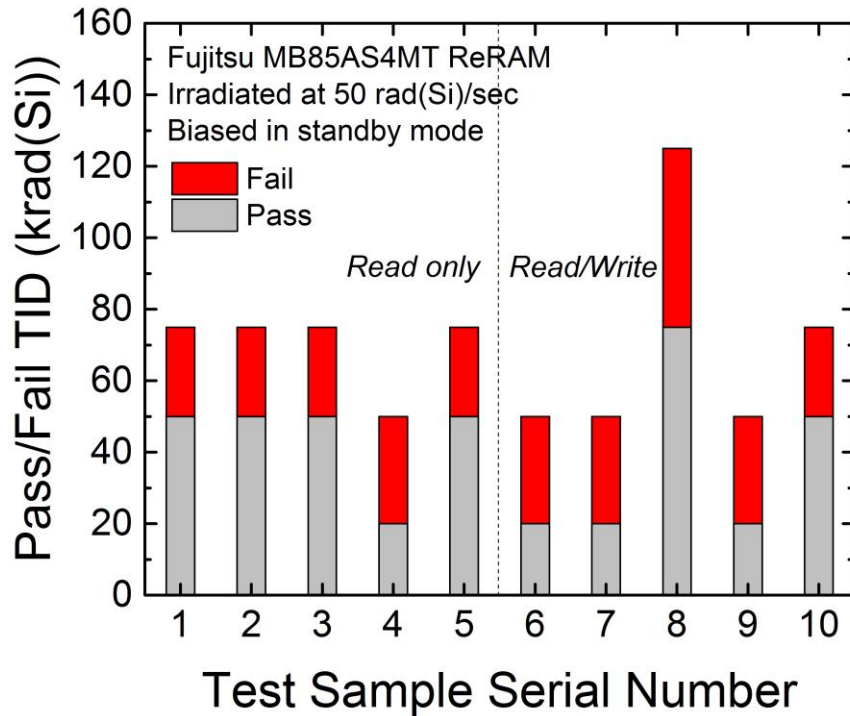
The parts showed functional failure between 20 to 50 krad(Si). The functional failures are characterized by loss of communication. There was no error from the memory array prior to the functional failure. So the ReRAM cells are relatively robust at these TID levels, while the CMOS control circuits are more sensitive.

Figure 4 shows the highest surviving TID and the failing TID levels for the two sets of test samples. In general, the read-only samples showed a higher surviving dose than the samples that were read/write cycled. 4 out of 5 read-only samples remained functional up to 50 krad(Si). The samples that were read/write cycled showed a wider spread in the surviving TID level, with 3 out of 5 samples functional up to 20 krad(Si) and 1 sample functional up to 75 krad(Si).

Figure 4. Pass/fail TID level for all test samples. Each stacked column bar indicate the highest passing TID and the subsequent dose step where the part was characterized and failed.

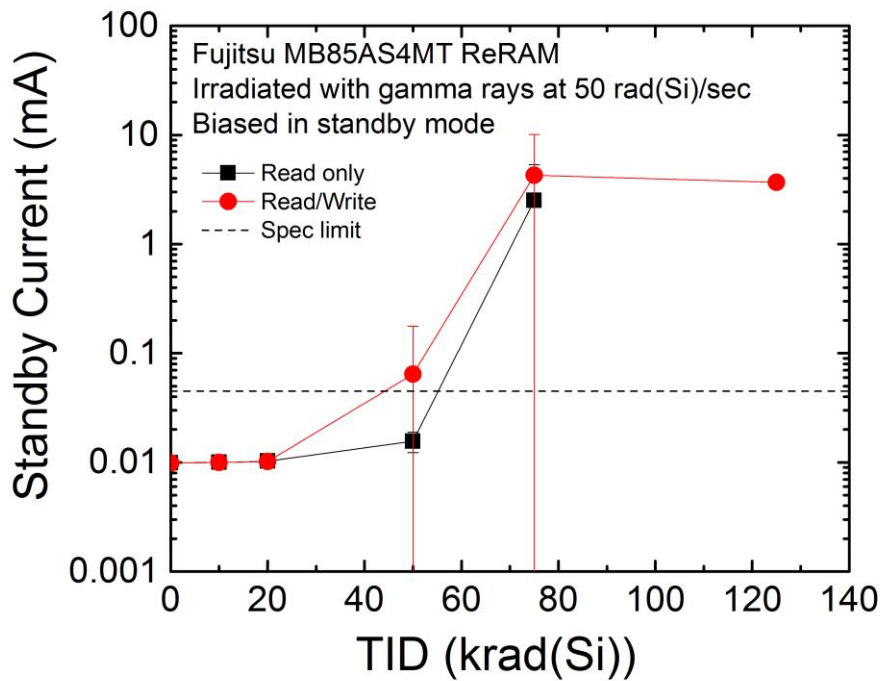
Figure 5 shows the average standby current in milliamps as a function of TID for samples that were read-only and read/write cycled. The error bars indicate part-to-part variability. In general, the test samples that were read/write cycled in between dose steps showed higher standby current than the read-only samples.

Figure 5. Average standby current as a function of TID for the Fujitsu MB85AS4MT ReRAM irradiated with gamma rays at 50 rad(Si)/sec biased under standby mode.

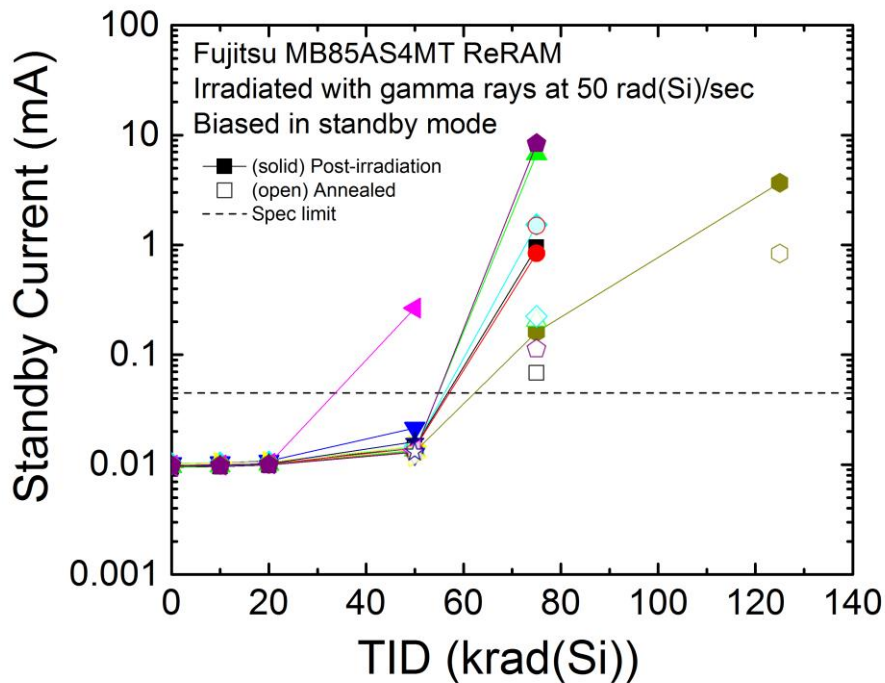
Figure 6 shows the standby current characteristics for all samples, including the annealed data after 168 hour of bias annealing. Note that functional failure can occur even if the standby current is below the specification limit of 45 μ A. However, all failures occurred as the standby current increased beyond the nominal level of ~ 10 μ A. Only 2 parts recovered functionality, even though 4 parts annealed to within the specification range for the standby current. The raw data file can be accessed from the Appendix.

Figure 6. Standby current as a function of TID for the Fujitsu MB85AS4MT ReRAM irradiated with gamma rays at 50 rad(Si)/sec biased under standby mode. Parts were bias annealed for 168 hours following irradiation.
