Post-test Inspection of NASA's Evolutionary Xenon Thruster Long-Duration Test Hardware: Discharge and Neutralizer Cathodes

Rohit Shastry and George C. Soulas

NASA Glenn Research Center, Cleveland, OH 44135, USA

Presented at the 52nd AIAA/SAE/ASEE Joint Propulsion Conference

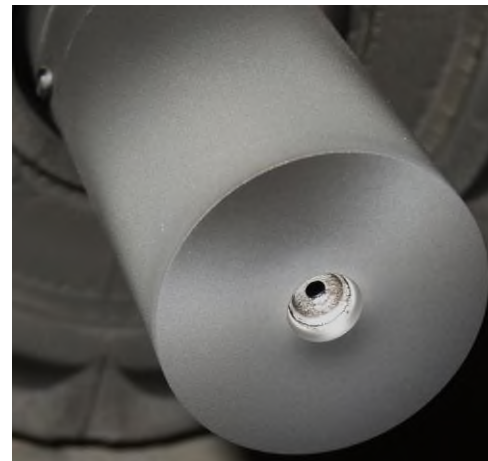
NEXT LDT after 51,184 hours

- Primary purpose of discharge keeper in NEXT is to protect cathode components (cathode tube, heater etc.) from discharge plasma
- Have observed significant erosion of downstream surface as well as orifice in prior life tests
 - NSTAR Life Demonstration Test
 - NSTAR Extended Life Test
 - NEXT 2,000 Wear Test
- Had changed material of NEXT keeper after results from 2 kh wear test to reduce sputter yield and increase keeper lifetime

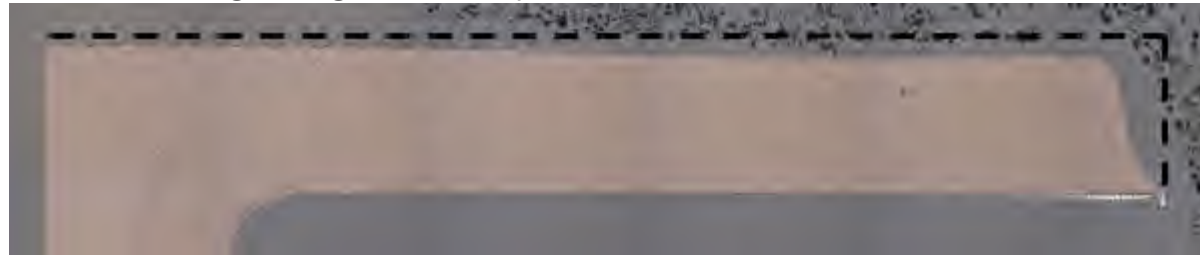
NEXT LDT after 51,184 hours

- Cross section of NEXT LDT keeper indicates maximum erosion was 15.8% of the pretest thickness, at a location of 39% of the total radius
- Results are remarkably close to the NEXT 2 kh wear test – observed maximum erosion of 17% of pretest thickness at location of 40% of total radius
- Minimum orifice diameter did not change significantly
- Deposition observed on upstream surface of orifice plate, similar to previous life tests
- Indicates **substantial** increase in keeper lifetime compared to NSTAR LDT and ELT, as well as NEXT 2 kh WT

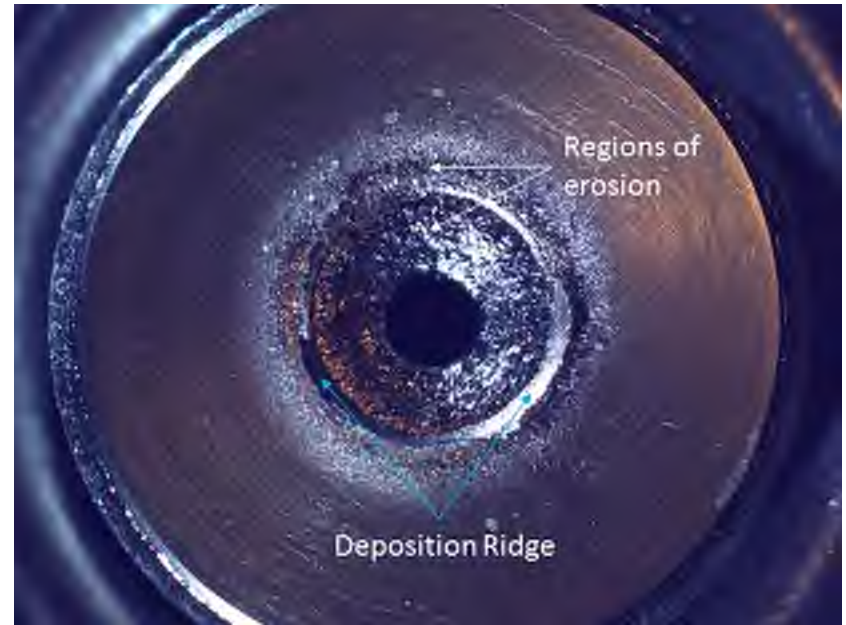
- No wear observed on downstream surface of cathode orifice plate outside of area exposed by keeper orifice
- Presence of a deposition “ridge” in the general location of the keeper orifice circumference
 - Regions of net erosion on both sides of this ridge

- Significant improvement over wear observed in NSTAR ELT
 - Discharge keeper erosion exposed cathode orifice plate, leading to only a 20-50 μm wide fused area attaching the plate to the cathode tube
 - Reduced keeper erosion in NEXT led to successful protection of cathode orifice plate for over 51 kh with ample keeper lifetime remaining

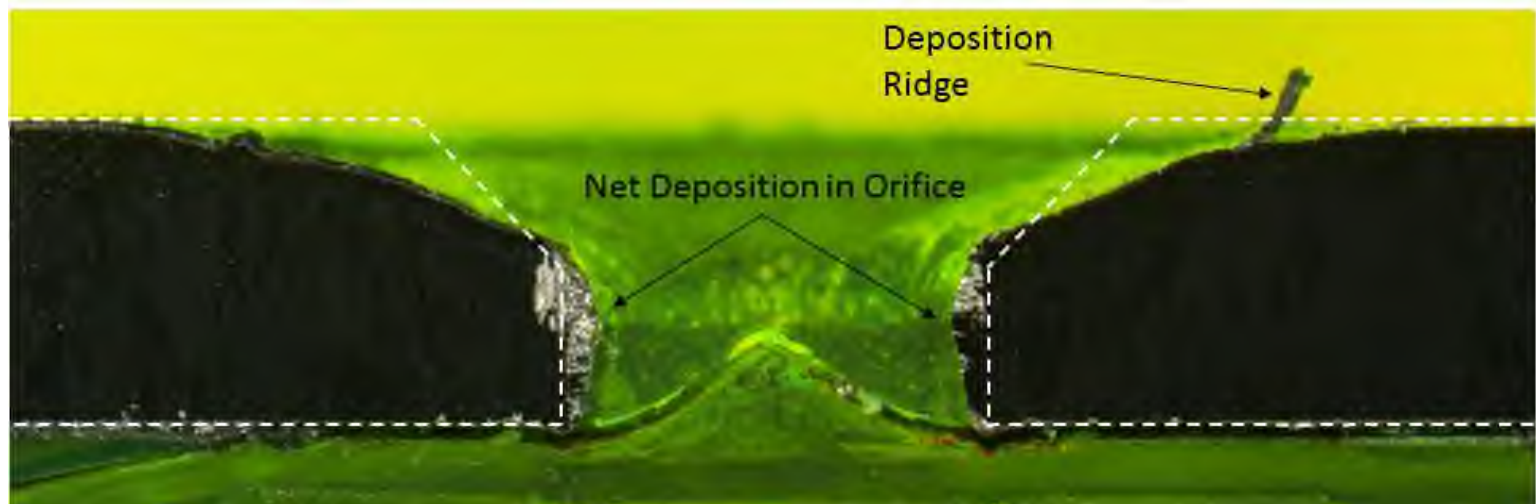
- Cross-sectioned orifice plate reveals net erosion of chamfer area as well as downstream area exposed by keeper orifice
- Deposition observed within cylindrical portion of orifice, reducing diameter by 13% compared to measured pretest diameter
 - Found to be material either from orifice plate or emitter
 - Reduced diameter also observed on NEXT 2 kh WT and NSTAR LDT
- Deposition ridge in middle of eroded area found to be cause of keeper-cathode short

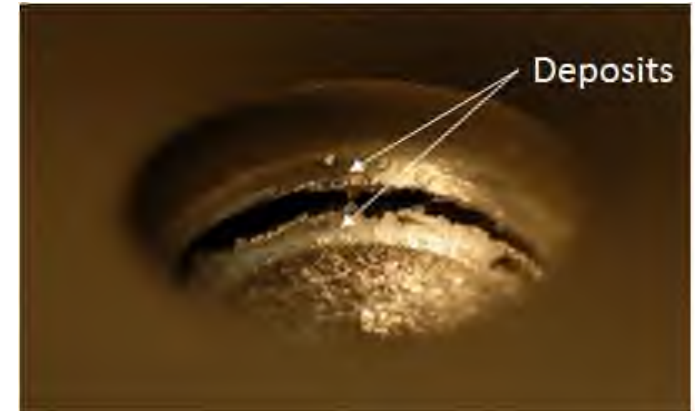
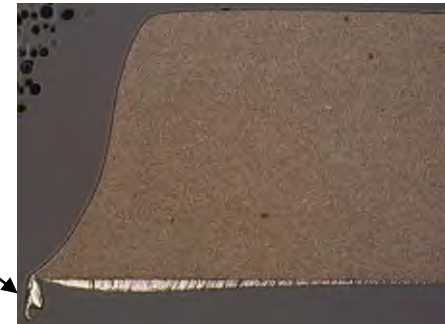
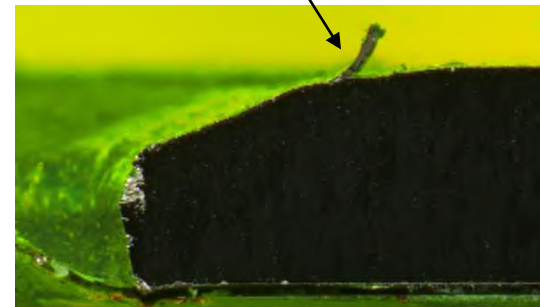
Deposits

- A thermally-induced electrical short between the keeper and cathode was observed during the LDT
 - Began manifesting during ignitions around 13 kh, and was found to potentially increase discharge cathode ignition times
 - Became a more consistent short around 48 kh
- Short was found to be caused by deposits with keeper cathode gap
 - Material analysis indicates it had come from cathode orifice plate, so will occur in flight
- Likely began growing on upstream side of keeper orifice plate, eventually bonding to cathode orifice plate and subsequently breaking in the middle

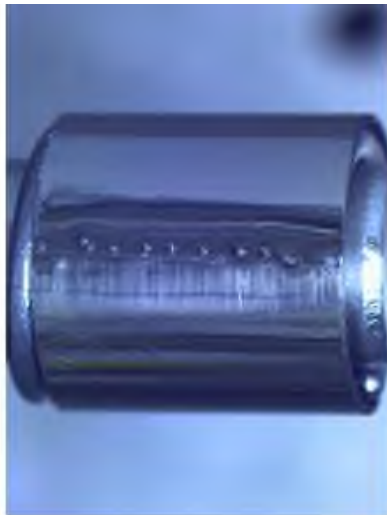
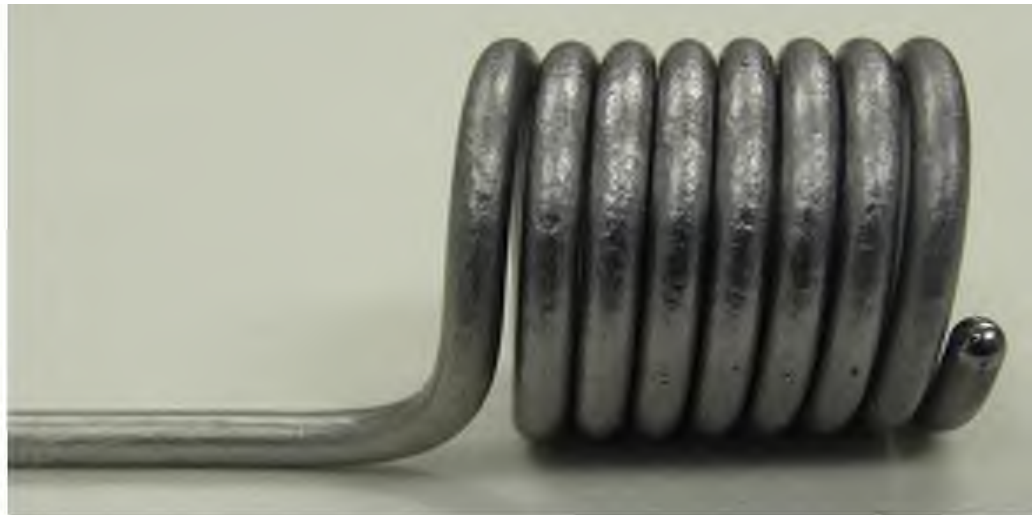
- No visible wear found on discharge heater or radiation shield
 - Significant improvement over NSTAR ELT due to reduced keeper erosion
 - Lack of wear eliminates additional failure modes found in NSTAR such as grid-to-grid shorting due to radiation shield flaking and excessive heater coil erosion
- Heater coil resistance measured during post-test inspection found to be $0.452\ \Omega$, which is in agreement with pretest measurements within the measurement variation

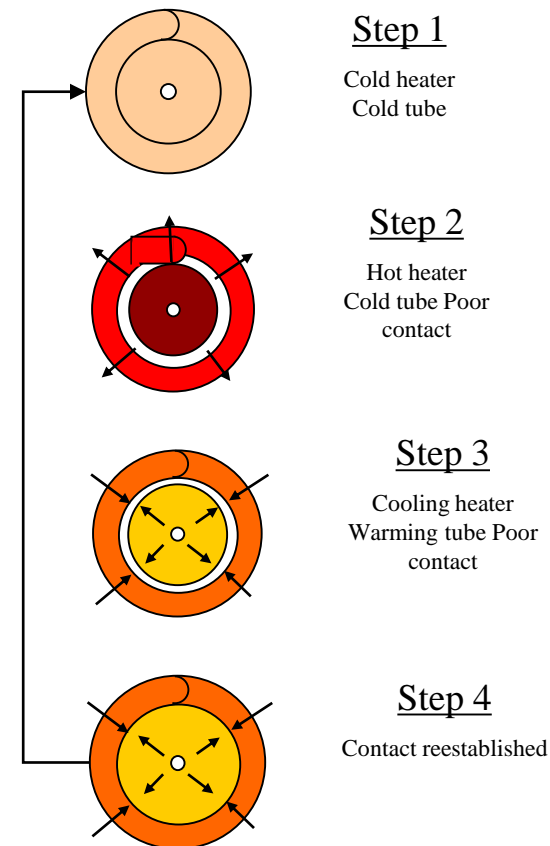
- An intermittent, thermally-induced heater open circuit was observed during the NEXT LDT from ~ 13 – 29 kh
- Speculated cause was poor contact between heater sheath and cathode tube, as a “friction fit” between the components was the only return path for the heater current
- Resistance measurements between cathode components taken during post-test inspection indicate highly variable resistance between heater sheath and cathode tube, sometimes exceeding 20 Ω at room temperature
- Heater easily slipped off when cut and removed from tube, indicating poor contact between components
- Not expected to be an issue for flight cathode due to implementation of more reliable, secure connection between heater sheath and cathode tube

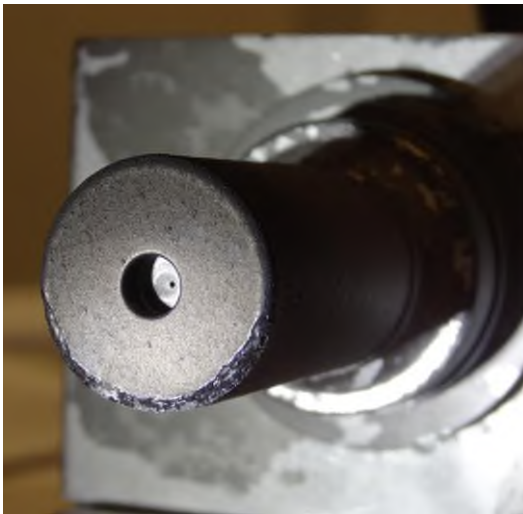
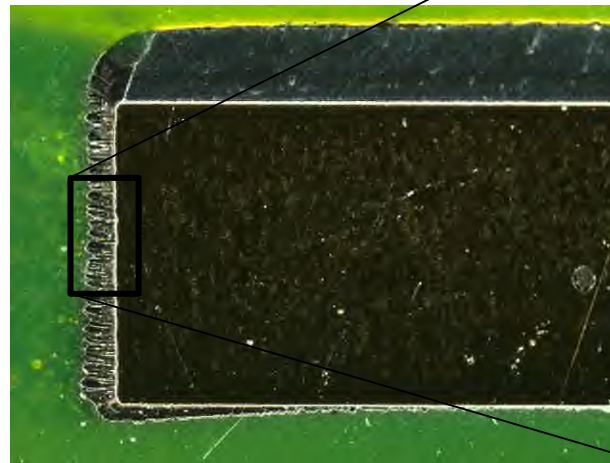
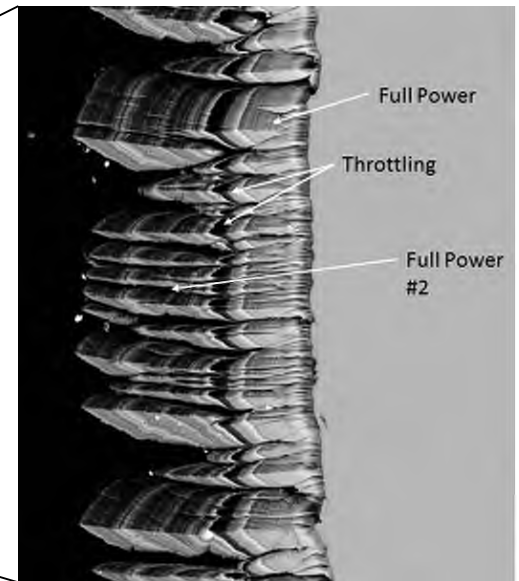
- Deposition found on nearly all surfaces of neutralizer keeper, except for beam side near the downstream end which is susceptible to ion impingement
- Significant deposition layer found on downstream side of orifice plate (27% of pretest thickness) – primarily backspattered carbon from facility
 - Much thicker than what was predicted by QCM measurements
- Deposition within orifice decreased diameter by 6% - combination of carbon from facility and cathode orifice plate material
 - Layered appearance caused by throttling of engine during test
- Effects of deposition on neutralizer flow margin will need to be assessed

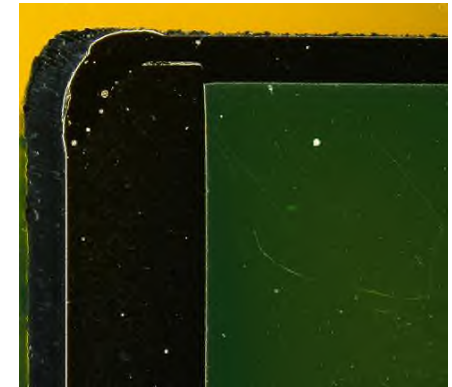
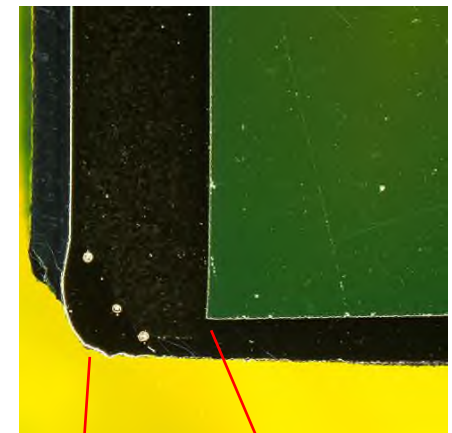
- Net erosion observed on beam side of neutralizer, extending ~ 2.5 orifice plate thicknesses upstream of downstream surface
- At furthest downstream location, orifice plate had eroded by 24% of the tube wall thickness (at location of weld)
- Upstream of orifice plate, tube wall had eroded by maximum of 17% of pretest thickness
- Compare to NEXT 2 kh wear test, which observed a maximum of 7.5% erosion with a total extent of 6.7 plate thicknesses upstream of downstream surface
- Significant reduction in extent of erosion between two tests likely a result of decreased beam extraction diameter from 40 cm to 36 cm
 - Reduced ion flux to the keeper surface
- Flight design increased thickness of keeper tube by 50%, which was not implemented in LDT hardware

24%
eroded

17%
eroded

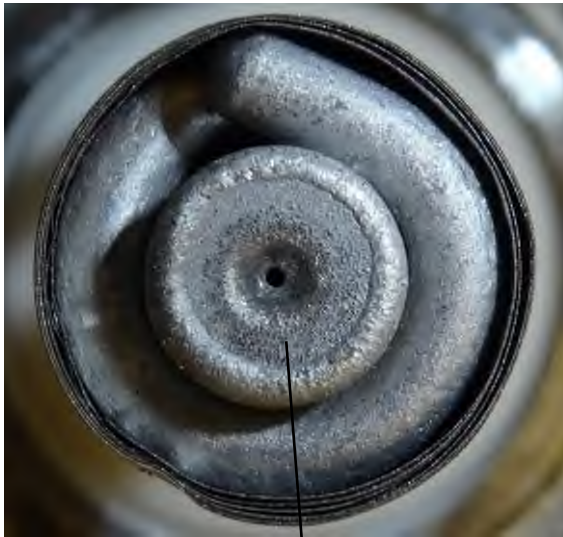
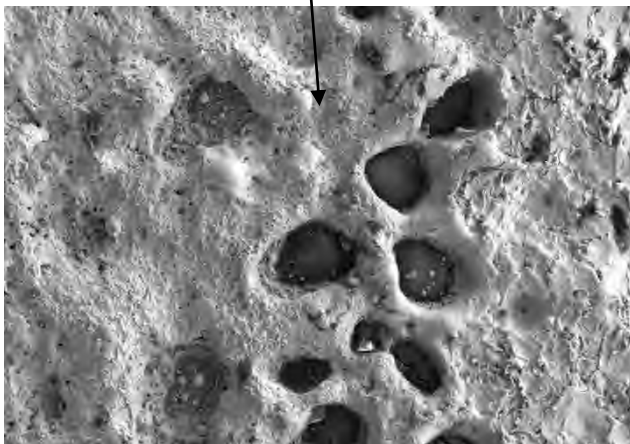
- Texturing of the orifice plate was found, particularly on side closer to ion beam
- Micrographs show that this texturing is actually numerous tiny pits
 - Signs of surface melting also indicate electrical arcing occurred in this area
- Inspection of previously tested neutralizers with NEXT indicate this phenomenon is not limited to the LDT
- Speculated to occur during thruster arcs (“recycles”) when the accelerator grid can reach potentials up to the beam voltage and large currents were found to travel through the neutralizer common line
- Pitting is superficial and did not thin orifice plate
 - Not expected to be an issue
- Orifice plate and weld are fully intact

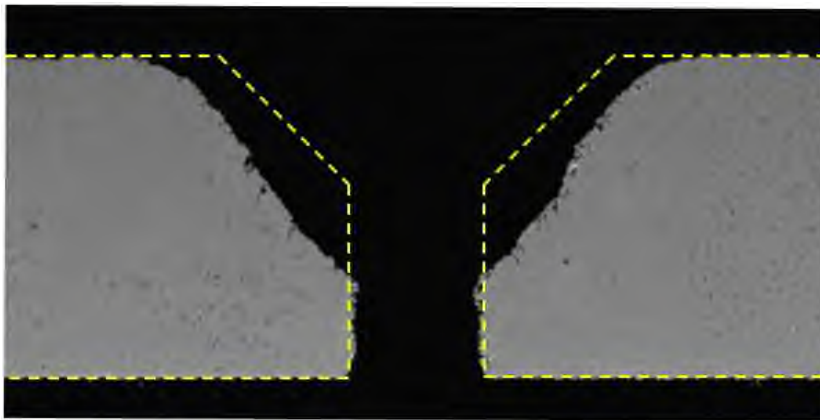
NEXT LDT after 51,184 hours

- Significant erosion of orifice chamfer occurred, with surface appearing somewhat porous
 - Indicates either net deposition or pitting similar to downstream surface
- Net deposition found in upstream cylindrical portion, decreasing minimum diameter by 8%
 - Material determined to be either from orifice plate itself or emitter
- Shape differs from what was found in NSTAR ELT, where downstream portion of chamfer remained intact and cylindrical portion exhibited “fluting”
 - Orifice dimensions and operating currents differ between two cathodes

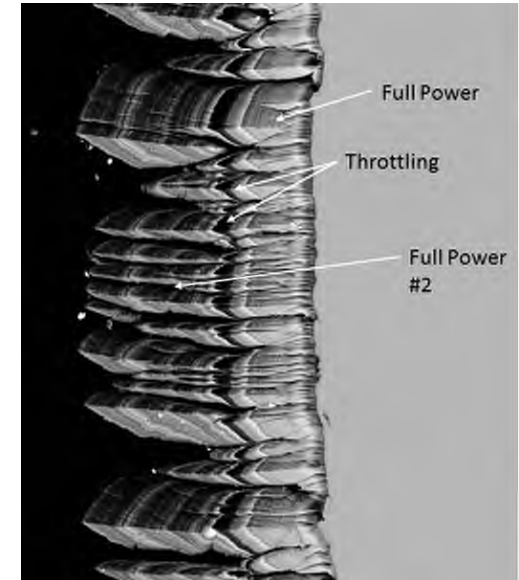
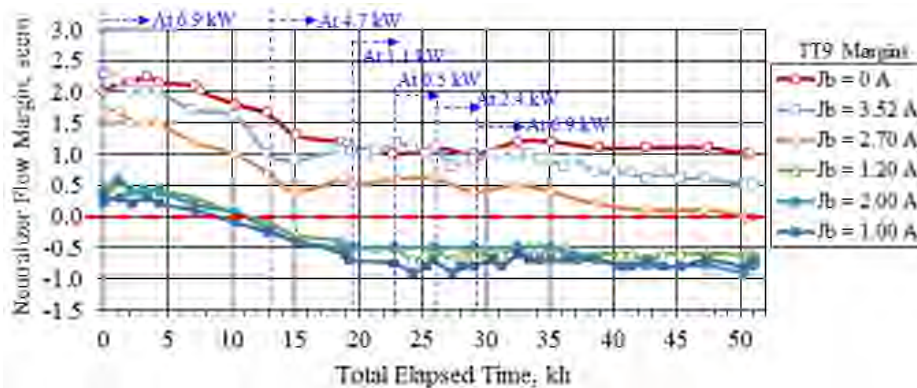
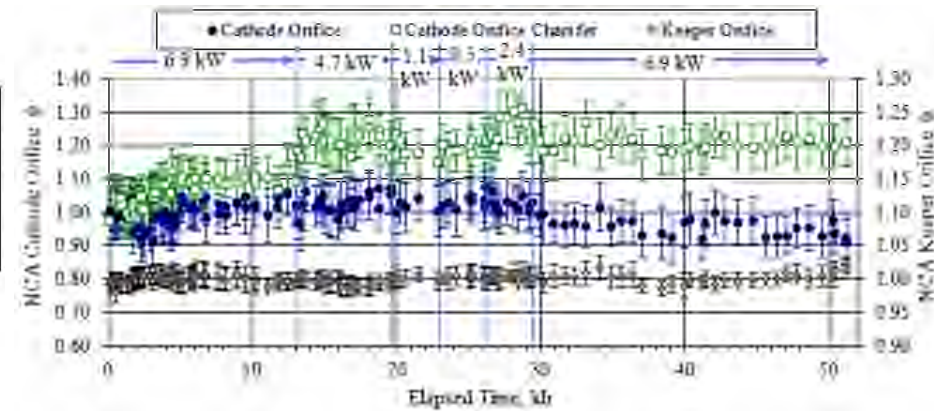
- Loss of flow margin from plume mode observed during NEXT LDT
- Speculated that this loss was tied to changes in cathode orifice geometry
- Cathode simulations performed at JPL show an enlargement of the orifice causes a decrease in neutralizer keeper voltage, which was correlated to flow margin loss during test
- Evidence that erosion of cathode orifice was greatest at higher beam currents, when largest losses to flow margin occurred
- Cathode-keeper gap for flight design was changed and neutralizer flows are adjusted in latest throttle tables to ensure adequate flow margin is maintained throughout lifetime

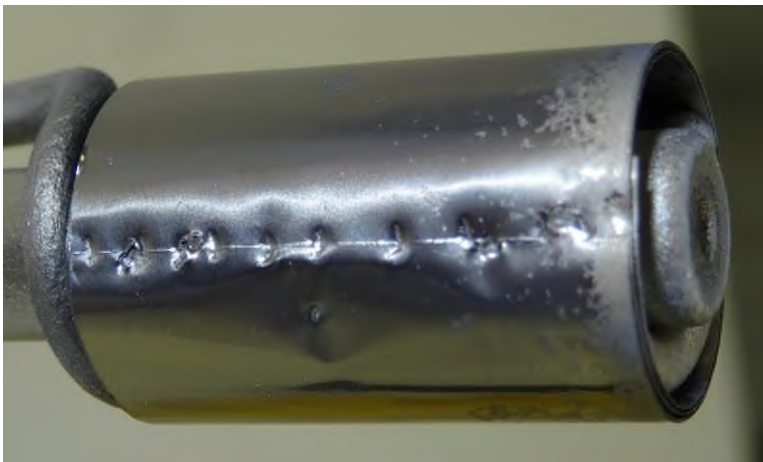
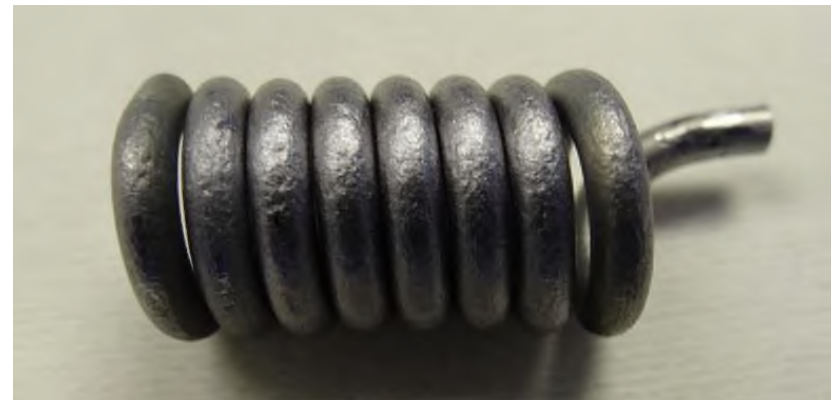
- Neutralizer radiation shield found to be in excellent condition with no sign of wear except for near downstream edge
- Arc tracks found on outermost surface of radiation shield, likely correlated with pitting on cathode orifice plate
 - Also found on NEXT 2 kh WT radiation shield, to a much lesser extent
 - Did not appear to have impact on ignition times or mechanical integrity of shield
- Heater was also found to be excellent condition except for texturing on downstream surface of coil, also likely correlated with pitting phenomenon
 - Resistance of heater found to increase slightly from 0.240 Ω (pretest) to 0.260 Ω (post-test)

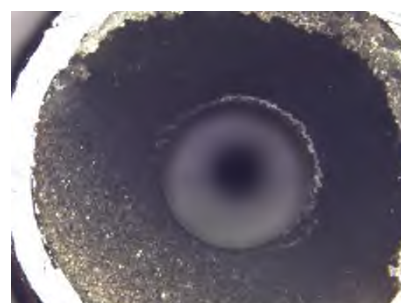
NEXT LDT LVPI

- Observed low impedance between neutralizer common and facility ground during test, sometimes as low as $\sim 10 \text{ k}\Omega$
- Found to be caused by deposition within low voltage propellant isolator
 - Deposition found to have come from metallic ends, likely caused by arcing within isolator
- Plasma shield with relatively high open-area fraction downstream of LVPI may allow plasma to seed breakdowns within LVPI
- Evidence of arcing also found in NEXT 2 kh WT LVPI, but not in PM1R
 - PM1R LVPI (and present design) has plasma shield with much lower OAF, potentially mitigating issue
