Topic: Orbiter Water Dump Nozzles Redesign Lessons Learned

Orbiter Water Dump Nozzles Redesign Lessons Learned

Hank Rotter

April 14, 2017

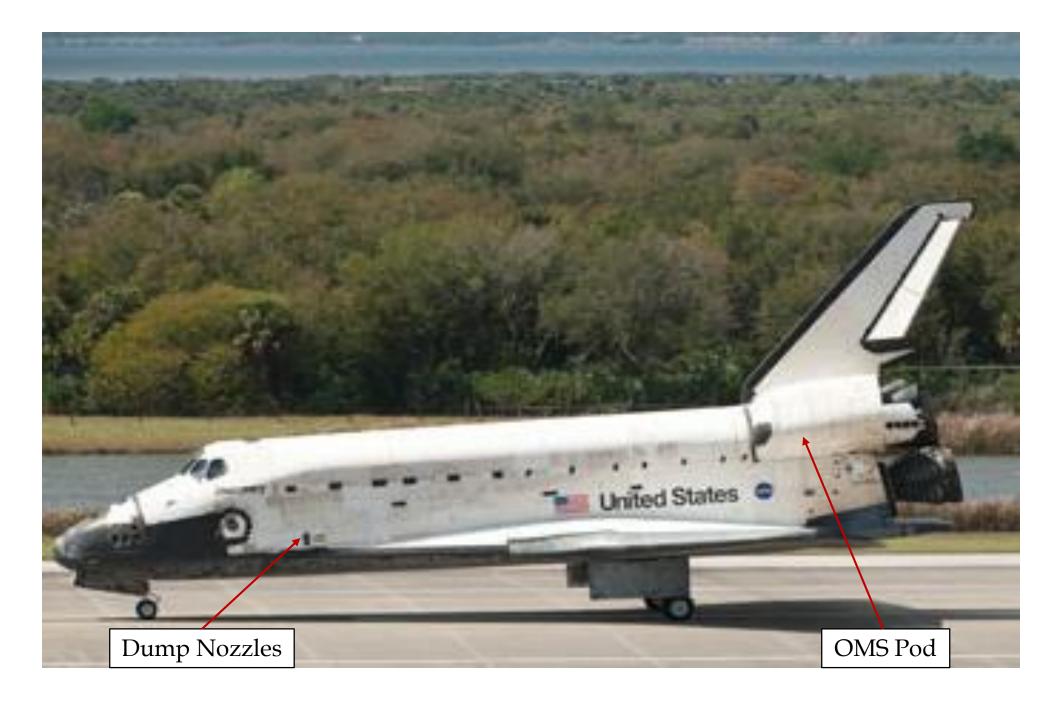
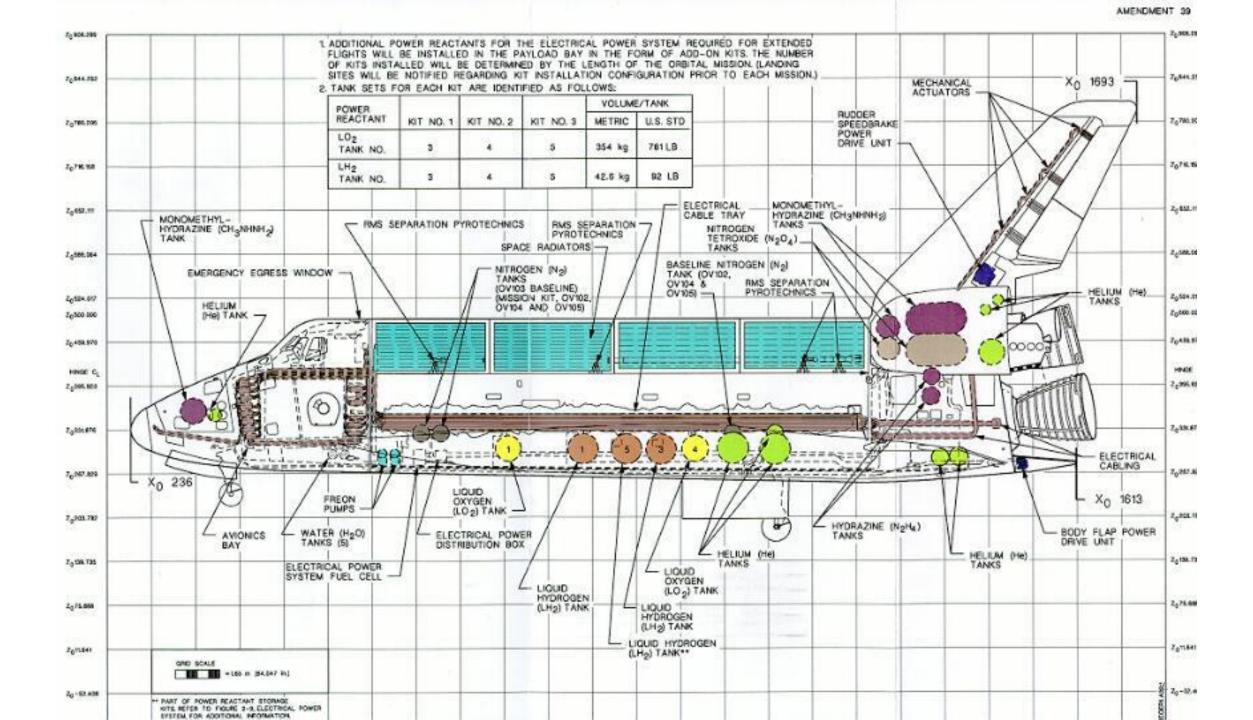
- During STS-41B and STS-41D Space Shuttle missions, an icicle formed over the supply and wastewater dump nozzles. This could have caused hazardous impacts on the side and aft end of the Orbiter during entry.
- The two occurrences of this problem had two different causes:

\odot STS-41B – problem caused by a water pressure drop to the nozzles that widened the spray patterns.

STS-41D – problem caused by the new thermal protection blankets installation around the nozzles.

- The concern was that during the entry, the air flow path was aligned from the Orbiter side nozzles' location to the Orbital Maneuvering System (OMS) pod location, and any ice on the nozzles could strike the OMS pod when released.
- My task was to redesign the nozzle configuration to prevent icicle formation.

- The STS-41B icicle that formed in a vacuum at about 80% density of solid ice was about 200 lbs of fuel cell water and wastewater (humidity water and urine ice pellets):
 - The base of the icicle was about 2+ ft diameter over both nozzles, and estimated to be about 5+ ft long:
 - This was based on the entry burn stain from the urine solids on the Orbiter Thermal Protection System (TPS) tile.
 - The length was based on vacuum chamber testing.
- Post-landing inspection found several tiles damaged in line to the OMS pod, and several hits on top of the left wing.
- The big concern the OMS fuel tank's pod structural cover, which had about 2 sq ft damage on pod tile with the non-metallic structure, crumbled behind the tile, with only the wire mesh holding the tile together.
- Note that no tile was missing during the decent.

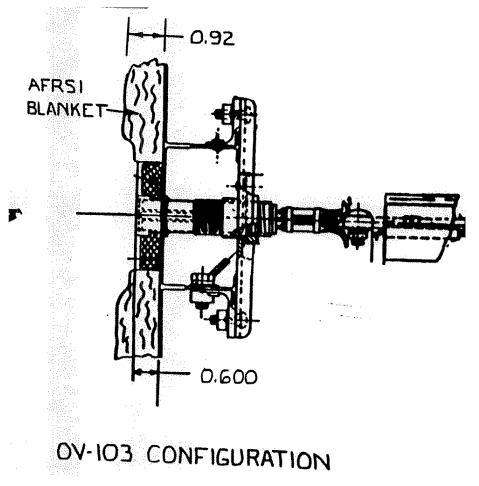
- STS-41D was the first flight with TPS blankets on the side of the Orbiter that formed an ideal trap for ice collection around the nozzles:
 - The nozzle was recessed in a blanket circular valley.
 - This time, the flight directors listened and the
 Orbiter arm was moved to view the icicle.
 - A procedure was developed to bump the icicle off with the arm after testing the strength of the ice attachment to the side blankets in a vacuum chamber.
 - \odot The icicle removal was successful.

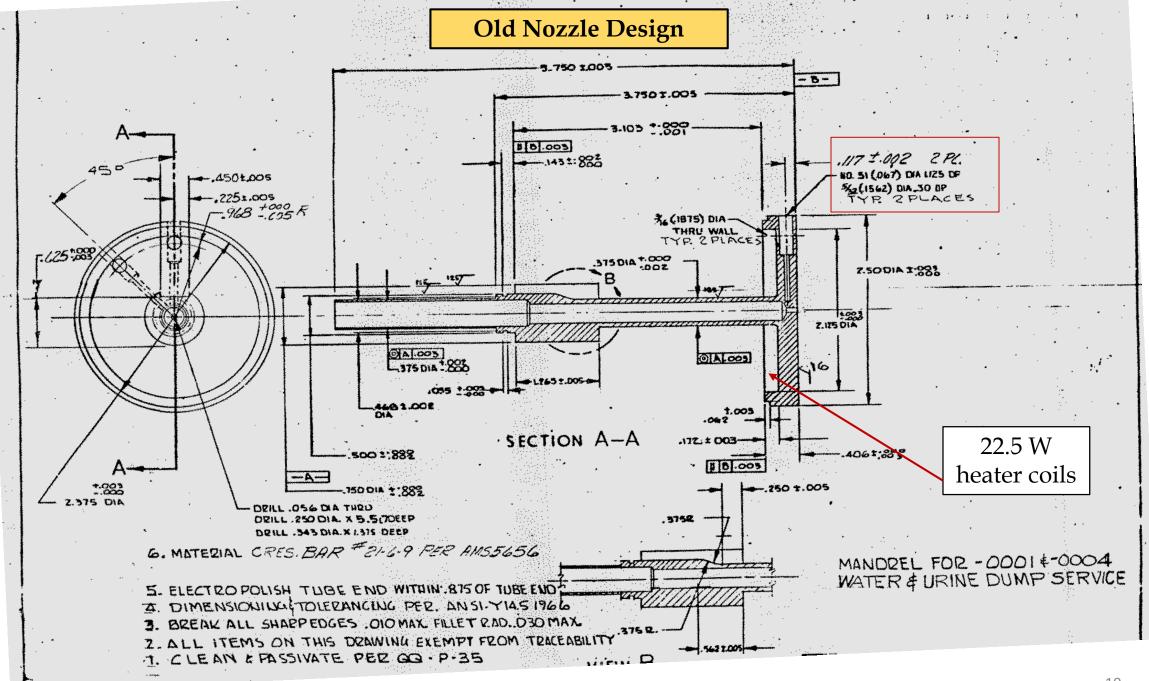
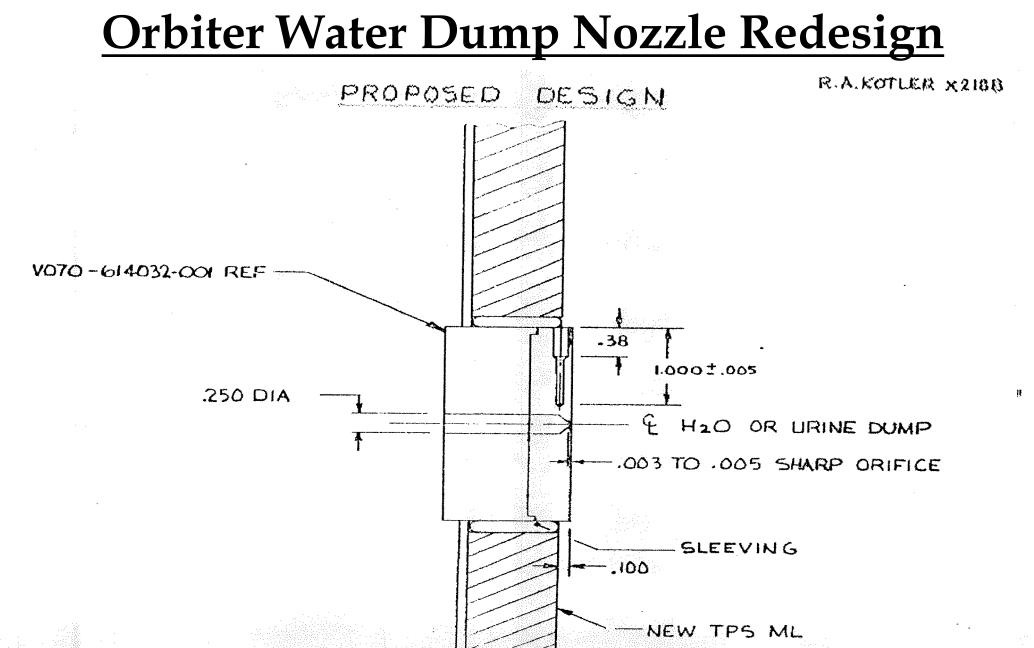
• After testing several nozzle designs, a sharp edge orifice was selected that had a near zero spray pattern:

At 20 ft, it had less than 2 ft diameter spray pattern vs. the old nozzle of about
 6+ ft diameter at normal water pressure.

• At 50% pressure, the sharp edge nozzle spray pattern had almost no change.

- I directed Rockwell and the nozzle vendor to drill out the current straight-edge nozzle to a sharp-edge nozzle and assumed that Rockwell and the vendor would do the drawing dimensional tolerance analysis. This led to the following problems:
 - Because this was a simple drill out of the flow path with ¼ bit, no one did the analysis.
 - Because of this, we drilled out two spare dump nozzles, and installed them for the next flight.
- Directed Rockwell to install black tile around the two nozzles with the nozzle 0.1 inch above the tile on vehicles with the TPS blankets.

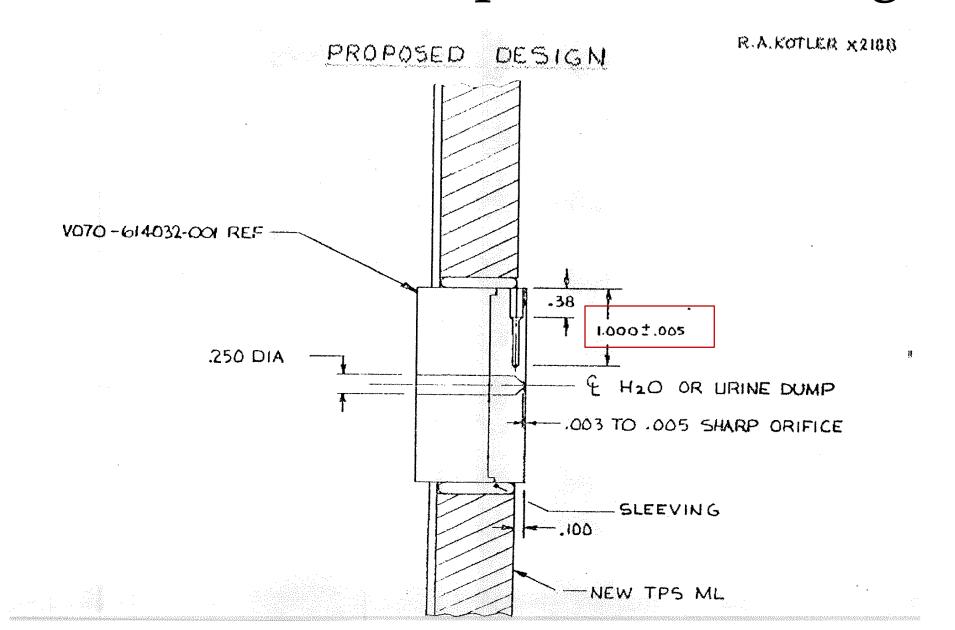
- One of the four sensor wells had a small water leak path through it and unusual temperature drops during the supply water dumps the first error.
- Rockwell or their vendor suggested putting a braze plug in the bottom of the sensor well about 0.1 to 0.2 inch thick.
- I assumed that they had a solder expert to review this, but no one did it.
- The next flight had two new nozzles installed with a braze plug, and we had the same problem with a water leak into a sensor well.
- Brazen requires two surfaces with no more than a 0.0005-inch thick layer of braze compound.
- Then we brazed a metal plug into the bottom of old nozzle sensor wells and changed the drawing to include a new nozzle that did not require the plug.
