Surveys of Returned ISS Hardware for MMMOD Impacts

1 PMA-2 COVER

5 AIRLOCK SHIELD PANELS

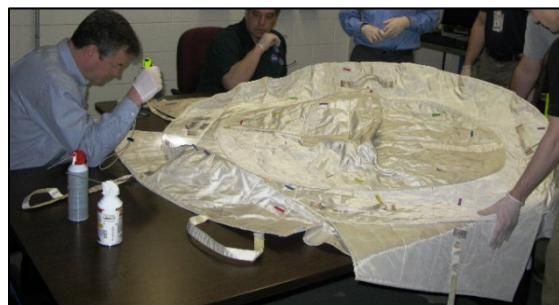
Figure 2. PMA-2 cover inspection

Fig. 2 shows the inspection of the PMA-2 cover at JSC. The circular blanket was approximately 2 meters in diameter with a 0.20 mm thick beta cloth (silica fiber) outer cover. Also inspected were nine beta cloth straps that were used to hold the cover in place on the PMA. The inspection was performed in three steps. An initial screening was performed on all space exposed surfaces with 15X handheld magnifiers, with 34 areas of interest marked for further study. In the second step each area of interest was examined with a handheld 25X-200X microscope enabling a more detailed characterization. 26 sites were observed with distinct hypervelocity impact features and 8 sites were judged to be non-MMOD. Fig. 3 shows feature #1 from Tab.1 as typical MMOD impact damage observed during the inspection. The final inspection step involved a boom mounted digital microscope that allowed precise measurements of the entry hole.

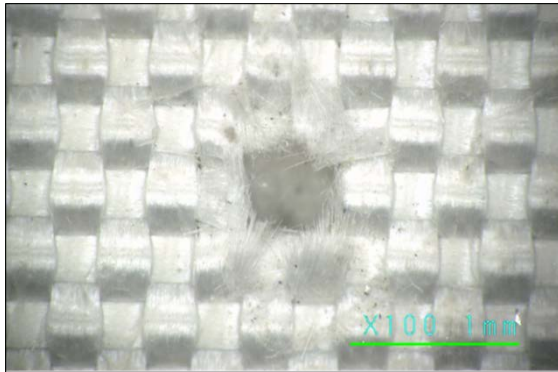
Damage sizes on the beta cloth outer surface of the cover and the hold-down straps ranged from just over 1mm to 0.13mm in diameter.

Figure 3. Typical impact damage on PMA-2 cover

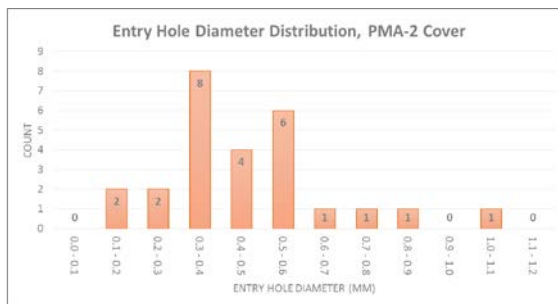
Figure 4. Distribution of PMA-2 entry hole sizes

Eq. 1 results in a circular area with the same area as the measured hole assuming elliptical geometry for the hole. Calculated entry hole diameters are provided in Tab. 1. It can be seen in the distribution of entry hole diameters (Fig. 4) that feature sizes in the 0.3 to 0.6 mm range were the most common. The mean value of the 26 observations was 0.45 mm.

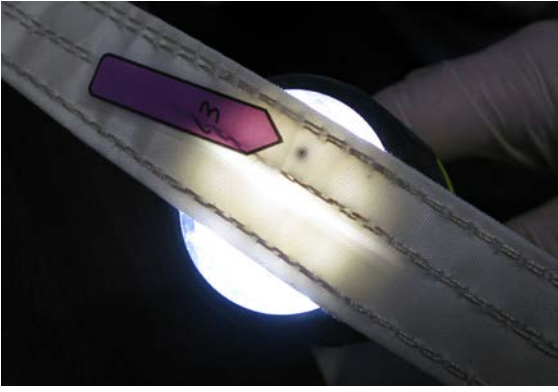
An example of the scanning electron microscopy used to determine the nature of the impactors on the PMA-2 cover is provided for impact #13, observed on one of the tie down straps. The impact area is backlit in Fig. 5, highlighting the extent of the subsurface damage. The impact event melted both the projectile and the beta cloth target (Figs. 6-7). Analysis by scanning electron microscope indicated this damage was due to a micrometeoroid impactor rich in iron, nickel and sulfur.

Figure 5. Impact in PMA-2 cover tie down strap

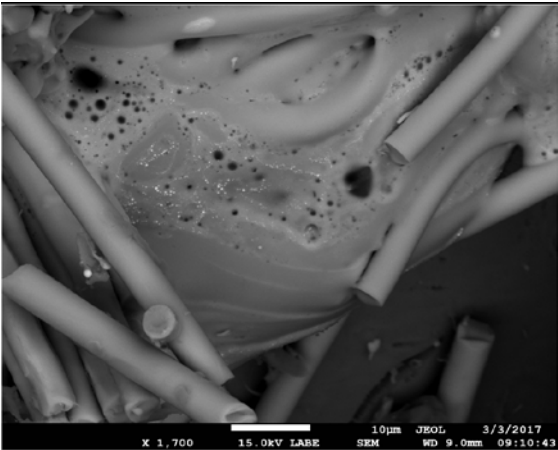
Figure 6. Impactor melt flow around beta cloth fibers

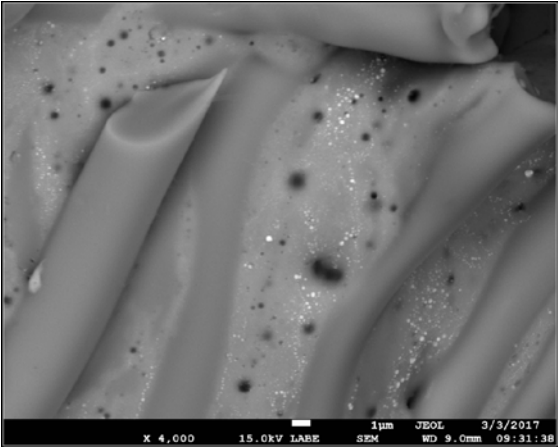
Figure 7. Close-up image of impactor melt droplets

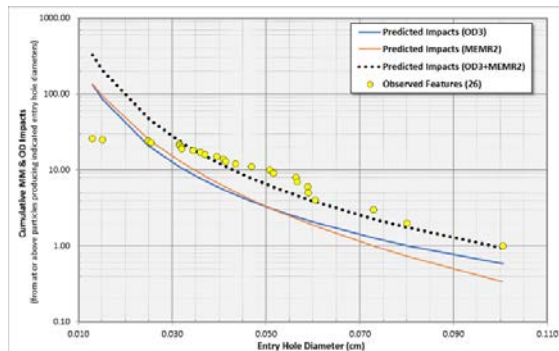
Fig. 9 compares the observed entry hole diameters on the PMA-2 cover with Bumper 3 predictions for the expected number of impacts from ORDEM 3.0 and MEMR2. Observations below 0.03 cm show typical roll-off at the small end of MMOD inspection data sets, due to the difficulty in finding small impact features (i.e., sensor/observation limitations).

Figure 9. Comparison of 26 estimated particle sizes causing observed damage on the PMA-2 cover and Bumper 3 predictions

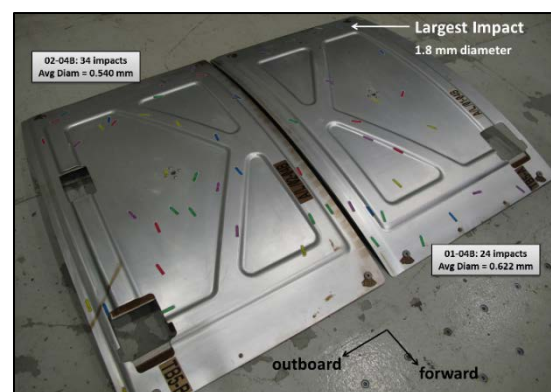
The airlock shield panels are made of aluminum 6061-T6 and are each 1.3 m long, 0.84 m wide and 0.2 cm thick. The survey of these panels was limited to a visual inspection with additional characterization by handheld digital microscope. Craters less than 0.25 mm diameter were not recorded. The inspection measured the “inside diameter” of the crater, recorded at the original height of the panel surface. A total of 58 craters were observed, 34 on the outboard panel and 24 on the inboard. The inspected shield panels can be seen in Fig. 11 with the 58 regions of interest flagged (colored arrows). 56 of the 58 observed craters were nearly circular, with only two elliptical craters recorded. The largest circular impact crater (Fig. 12) measured 1.8 mm in diameter.

Figure 11. Inspection results on airlock shields

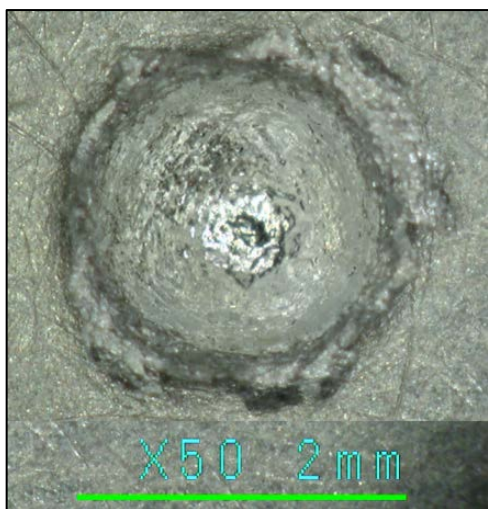
Figure 12. 1.8 mm impact crater on airlock panel

This impact produced a 2 mm diameter bulge on the backside of the 2.03 mm shield panel. An elliptical crater measuring 2.4 x 0.9 mm (Fig. 13) was observed on the same panel.

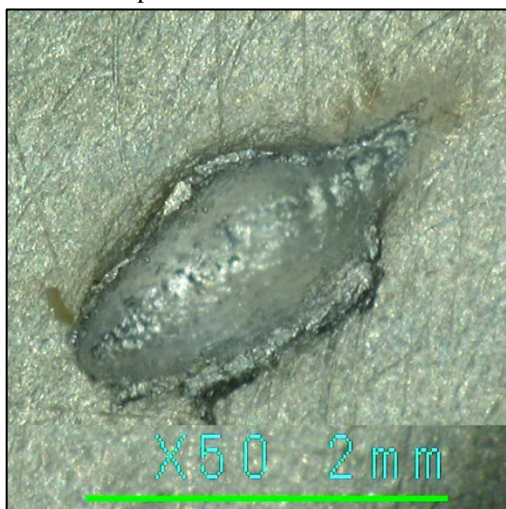
Figure 13. 2.4 x 0.9 mm impact crater on airlock panel

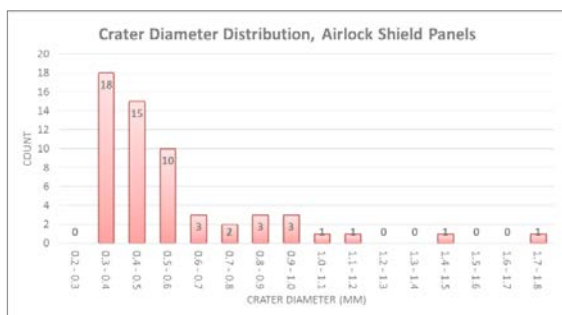
An equivalent circular crater size was calculated from measured dimensions using Eq. 1 and the crater diameter distribution is given in Fig. 14.

Figure 14. Distribution of airlock crater diameters

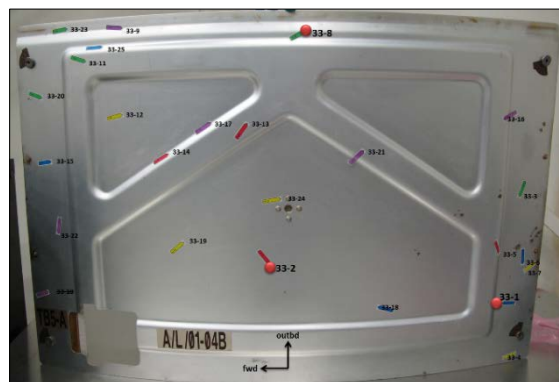
Figure 15. 24 craters on airlock shield 01-04B, sampled craters highlighted with red circles

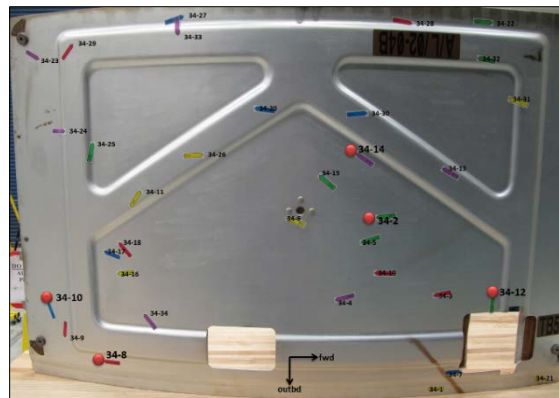
Figure 16. 34 craters on airlock shield 02-04B, sampled craters highlighted with red circles

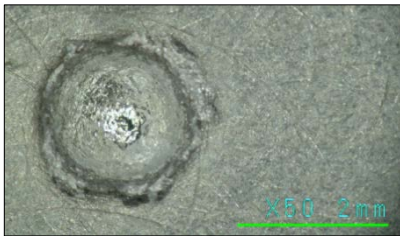
Crater 33-1 is shown in Fig. 17. An extracted sample from the crater with the associated SEM image and spectra are given in Fig. 18. This sample along with many others appeared to have silica melted into the aluminium.

Figure 17. 1.8mm diameter crater in airlock (33-1)

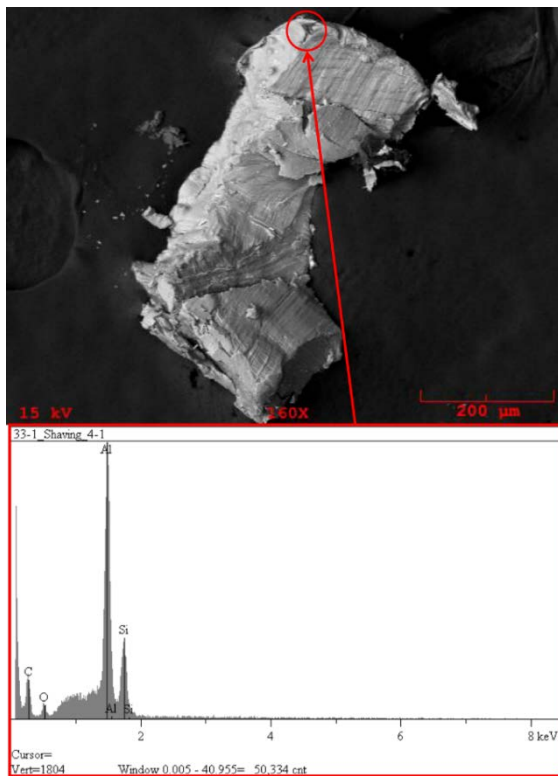
Figure 18. SEM results of sample from crater 33-1 indicate trace silica melt in the aluminum

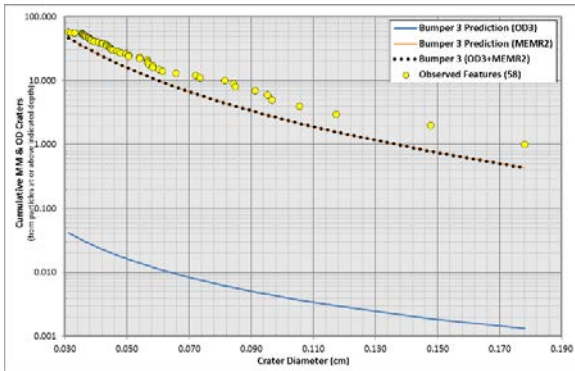
All 58 observed craters are compared with ORDEM 3 and MEMR2 in Fig. 20. Bumper 3 predicts nearly all ($\geq 99.7\%$) of the craters are from micrometeoroids. The predicted number of MMOD impacts was higher than observed. The explanation for this is that there were more orbital debris impacts observed and very little orbital debris was predicted to hit these panels because their location on ISS should have prevented orbital debris from impacting them. We believe the likely explanation for this discrepancy is that the orbital debris found on the airlock panels was due to secondary debris (ejecta or penetration products) produced by MMOD impacts on the ISS radiators and solar arrays. The composition of the OD particles determined by SEM analysis supports this hypothesis, with many of the craters containing silica (potentially from solar arrays) and paint (possibly from radiators).

Figure 20. Observed craters from ORDEM 3 and MEMR2 compared to Bumper 3 predictions

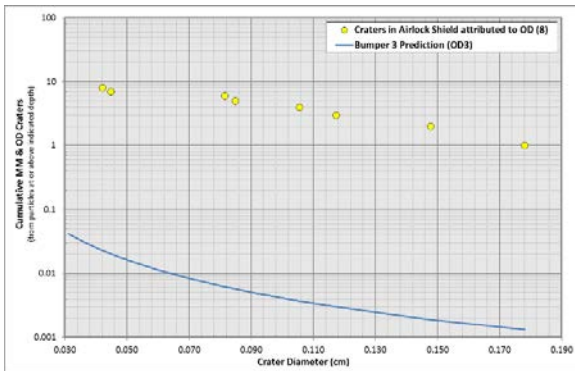
8 of the 9 samples that were analyzed produced indications of orbital debris. The 8 observed craters attributed to orbital debris are compared to ORDEM 3 predictions in Fig. 21. The predicted number of craters from orbital debris is very small compared to micrometeoroids due to the orientation of the shield panels on the zenith/aft facing region of the airlock.

Figure 21. Observed craters from ORDEM 3 compared to Bumper 3 predictions
