Lessons from the James Webb Space Telescope Vibration Test Prep

T. Schwartz
NASA GSFC

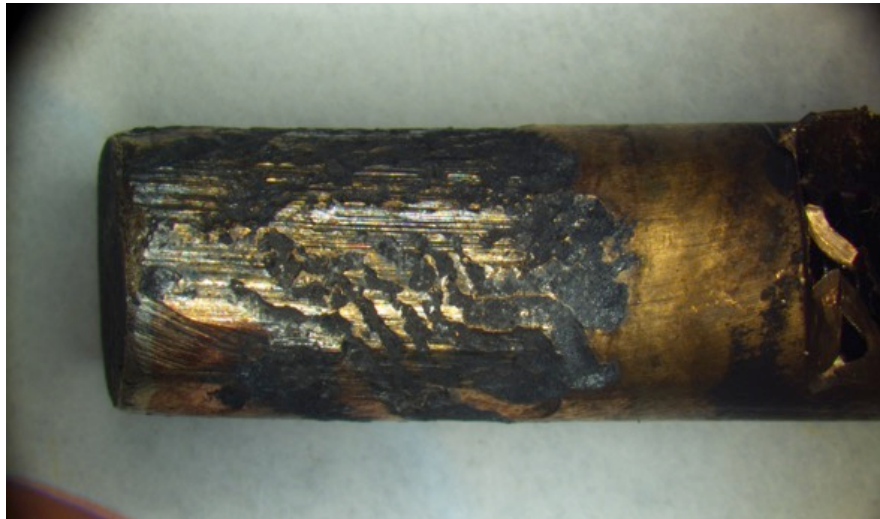
- Poor Coherence on Shaker#2:
 - Determined to be caused by poor connection between copper current lead and aluminum lead block on shaker
 - The likely root cause of the poor connection is a combination of dimensional discrepancy and galvanic corrosion

Arcing caused by the poor electrical connection.

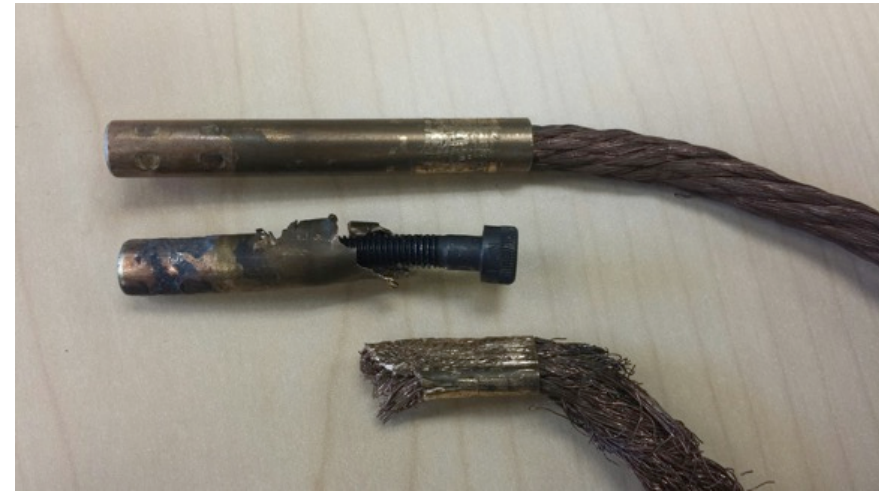
A good electrode on the top

The bad electrode on the bottom

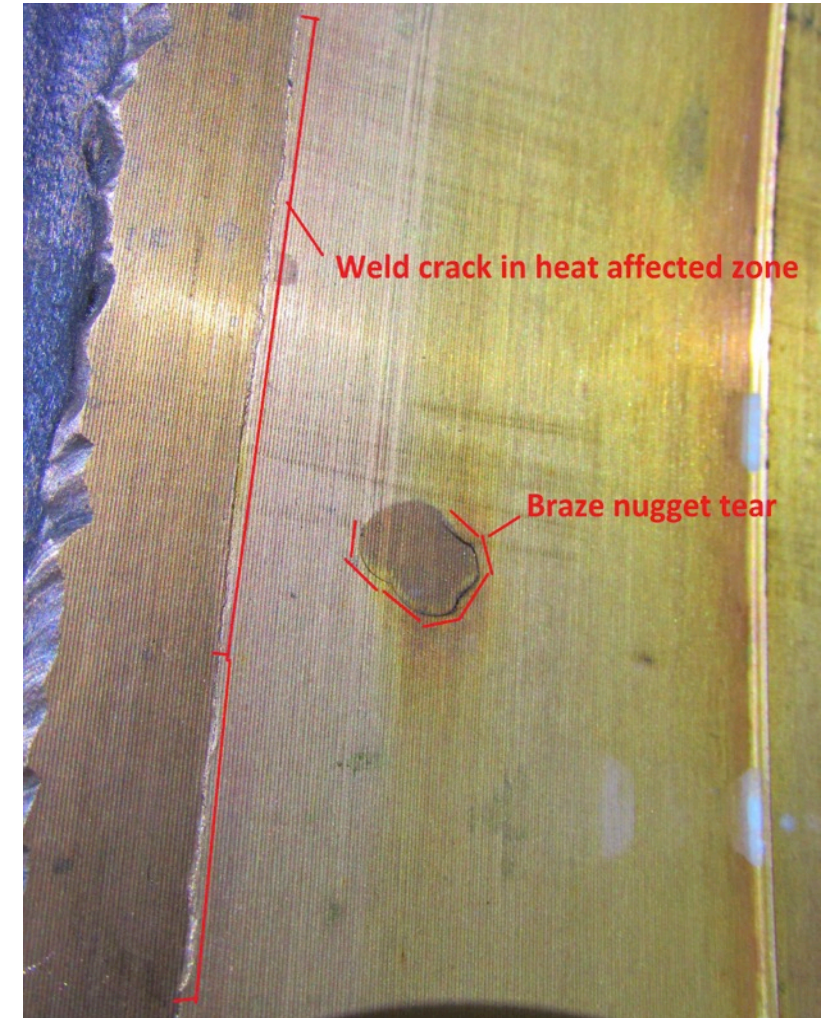
- Opening the shaker up to investigate the coherence problem uncovered cracks in the copper compensating bands
 - Cracks formed in weld areas joining copper plates
 - Cracks formed in the plug welds joining the copper plate to the steel body
- Further investigation showed these cracks in all 3 DP shakers
- DP return the 2 vertical shakers to Corona for repair
- Horizontal shaker remained installed at GSFC

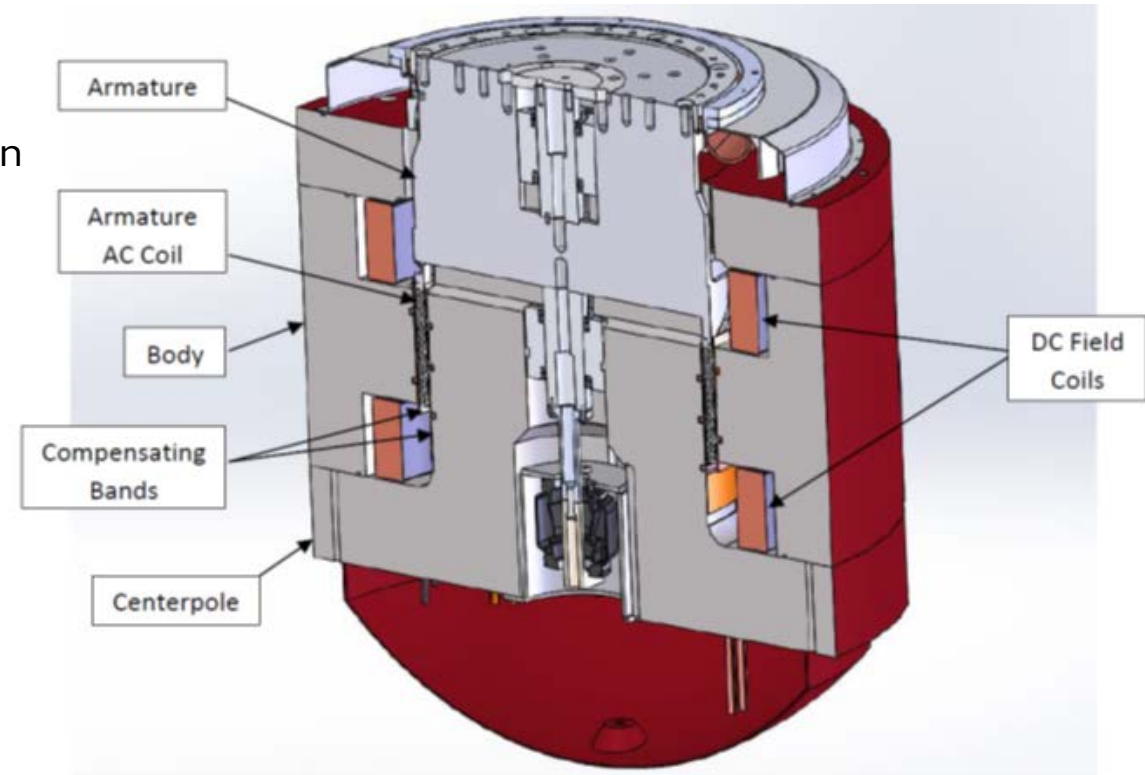
Figure 1: cross section 5022-3 shaker

- The shaker tear down also revealed some possible wear on the upper armature bearing
 - Initially thought the coherence problem could be stiction in bearing or armature rubbing
 - Raised concerns that shaker armature is over constrained
- Possible solutions
 - Redesign shaker driver adapter, adding compliance
 - Increase armature gap in shaker body
 - Compute lateral armature deflections from test data
- DP offers that the copper bands can be removed
 - Acts as a transformer but only at high frequencies (>500Hz)
 - Eliminates troublesome cracked components
 - Increases gap around armature

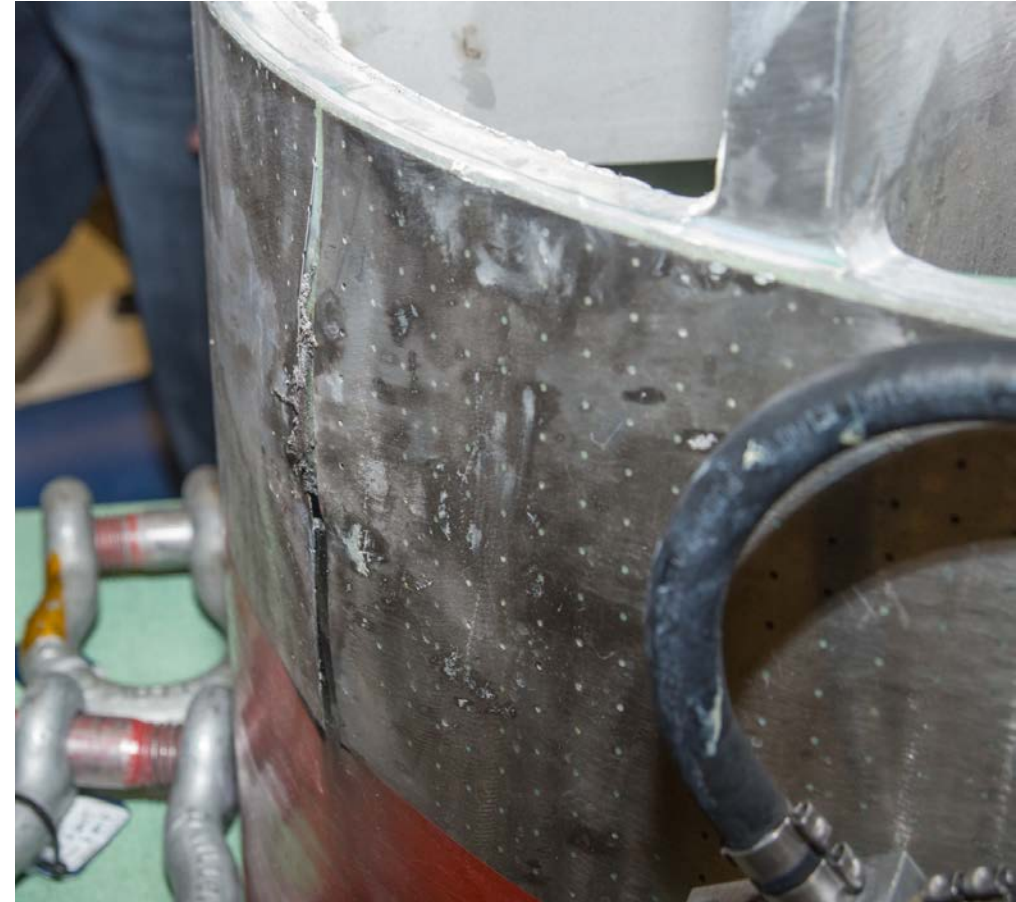
- Shaker #1 completes factory acceptance test and is shipped to GSFC
- During on site acceptance testing, at 27 min into a 30 min random test at 80% force, the amplifier aborted on a peak current fault
- The armature had ruptured and gallons of armature cooling water erupted into the shaker body.

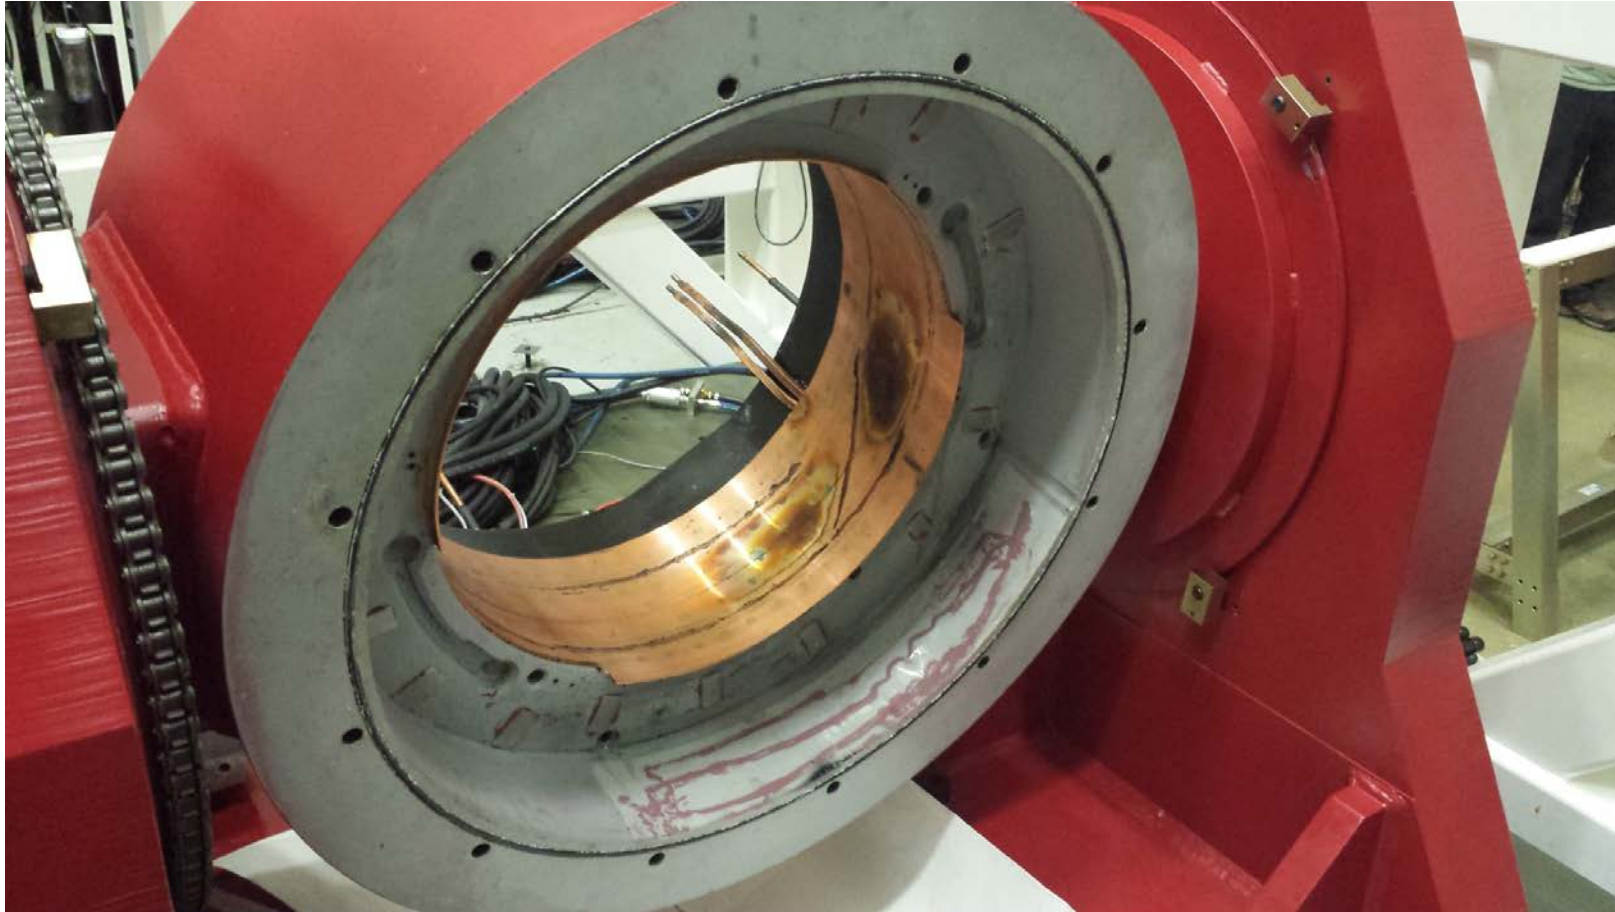
Shaker #1 Compensating Band

- Poor process control resulted in a poor installation of the compensating band
 - Copper was not in sufficiently in contact with the steel
 - Welding process not well controlled, resulted in poor heat conduction
 - The final machining of the band (following welding) resulted in very thin sections of the band
- The armature in shaker #1 was the armature exposed to “no copper” testing
 - Overheating of the fiberglass insulation resulted in compromised mechanical and dielectric properties resulting in catastrophic arcing

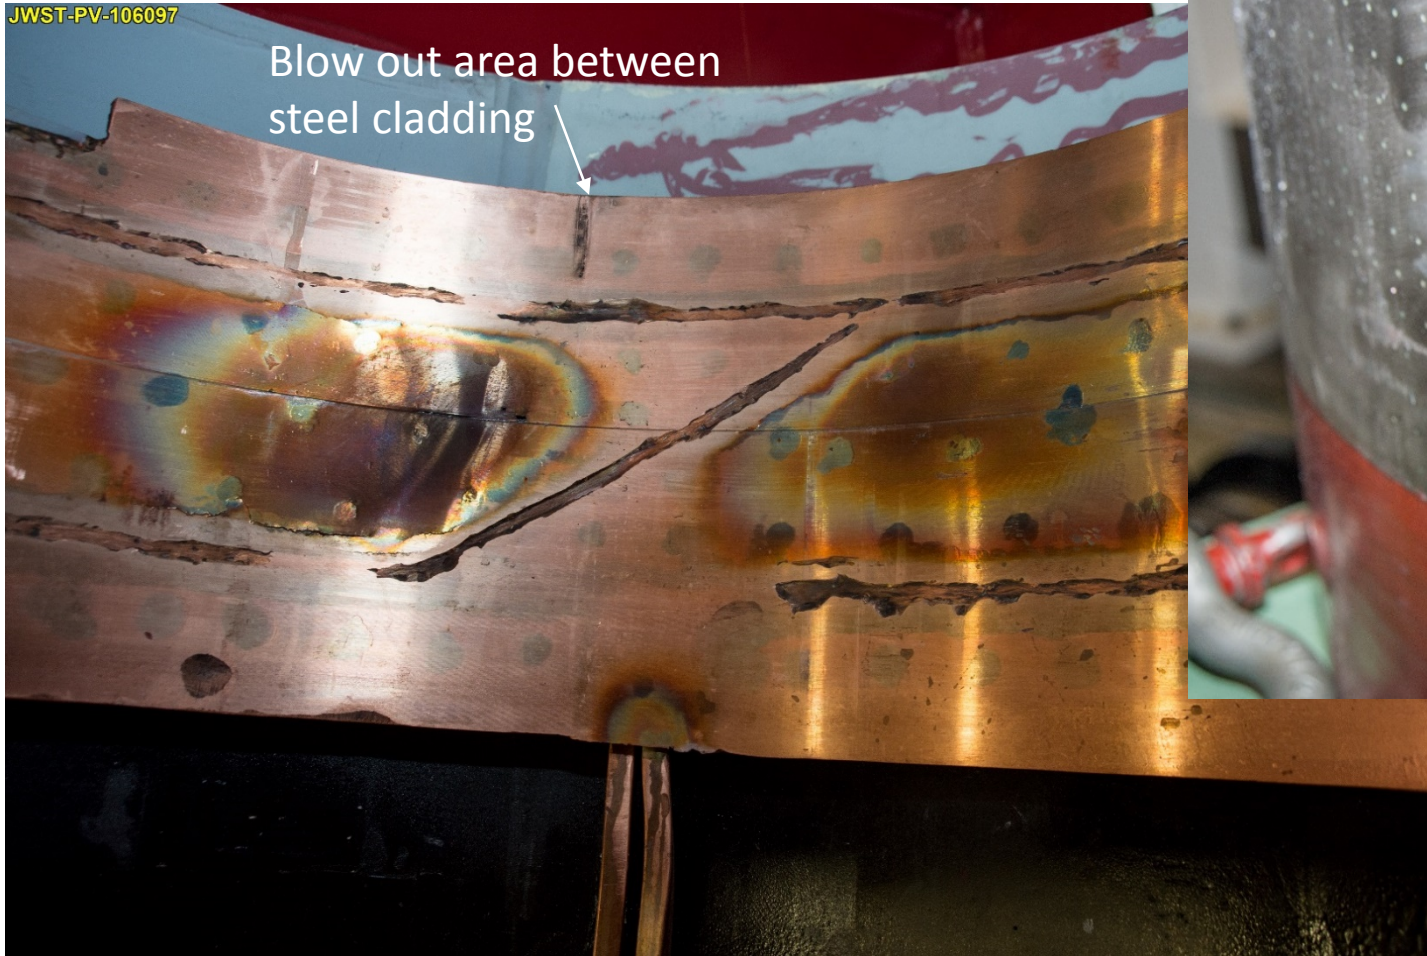
JWST-PV-106097

Shaker #1 Hot Spots and Rupture

Blow out area between
steel cladding
