Thermal Inspection of a Composite Fuselage Section using a Fixed Eigenvector Principal Component Analysis Method

Joseph N. Zalameda^{*a}, Sean Bolduc^b, and Rebecca Harman^b,

^aNASA Langley Research Center Hampton, VA 23681-2199;

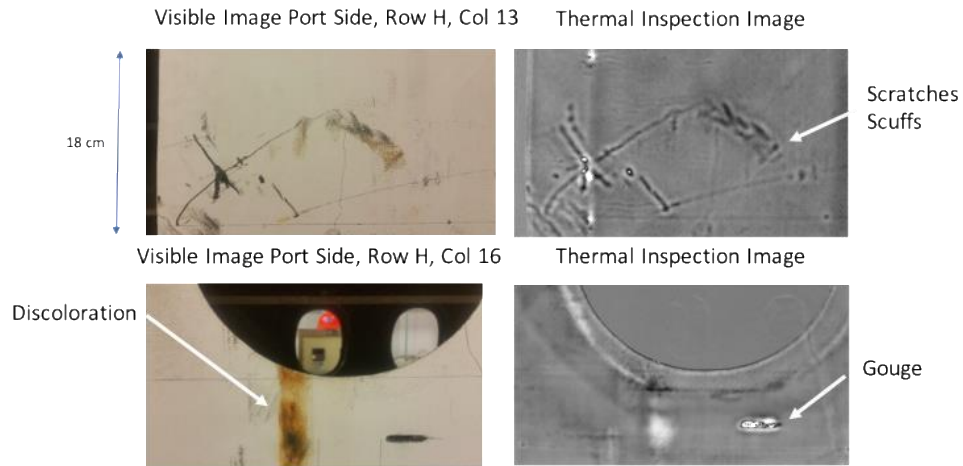
The fuselage section has surface visible damage in the form of deep scratches, gouges, and discolored areas. In addition, it was found through handling that water intrusion (water droplets leaking out when rotating fuselage) and crushed core damage was also evident. For some of these defects thermography was effective in determining the extent of the damage. Example inspection images of surface scratches/scuff marks, discoloration, and a gouge is shown in figure 7. The thermal inspection images reveal that the damage shape is very similar to the visible imagery. This indicates the damage is localized to the visible shape. This is also true for the gouge defect shown in the bottom right image of figure 7. The discolored area shown in the bottom left image of figure 7 is a rust spot. This rust spot appears to be rusted metal (from a metal support) that has adhered to the outer surface. Without the visible image the corresponding thermal inspection image would appear to show a defect at the rust spot location. From figure 7, one can conclude that the visible imagery is important to interpret the thermal inspection images. Additionally, the areas of the fuselage underside were not painted and this was enough to change the thermal response as shown in figure 8. This shows the sensitivity of the thermal inspection to “see through the paint” and it appears the paint did not limit the inspection of the fuselage.

Figure 7. Example inspected areas of surface scratches, gouges, and discoloration.

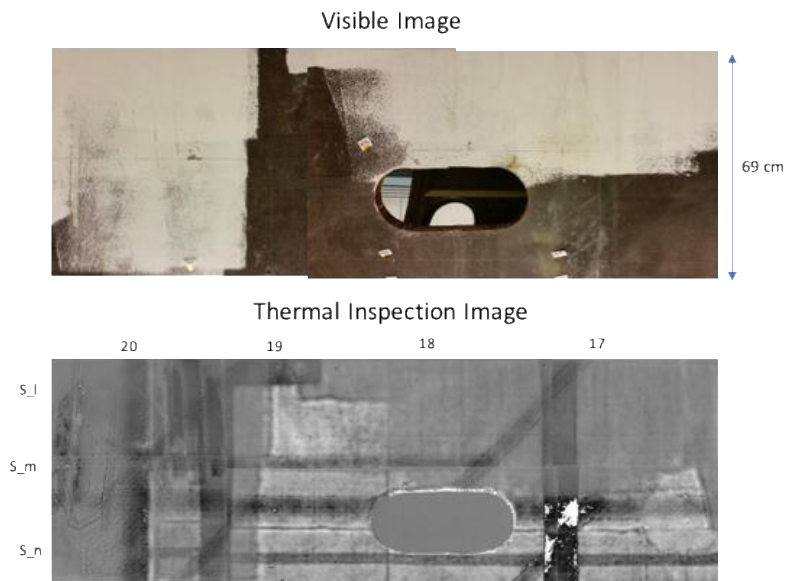
Figure 8. Variation in the thermal inspection imagery due to paint.

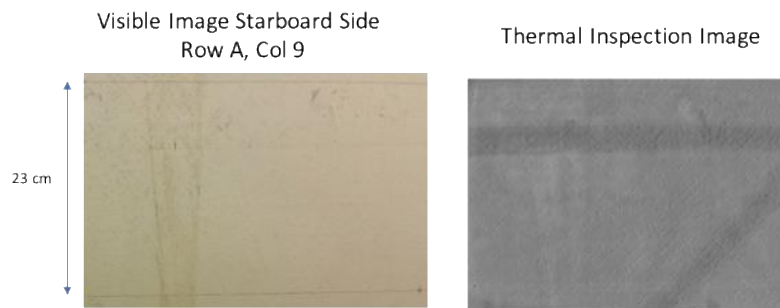
A crown section adjacent to the cockpit window contained a region of core crushed (larger than the inspection footprint). The face sheets in these regions could be compressed to over 1.27 cm by merely pressing on them. The flash thermal inspection was not able to detect the core crushed region as shown in figure 9. The damaged core does not affect thermal response because the Nomex® core thermal properties are very close to those of air. Lastly, suspected water damaged areas were detected just below the starboard side windows. It appears water may have migrated from the window edge into the fuselage. Water damage is suspected because the fuselage section was exposed to the weather, some water was noted dripping (very small amount) from the fuselage during rotation, and also the irregular shape of the suspected water damage from the thermal inspection images as shown in figure 10. Sectioning the fuselage would help to determine if this is actual water damage. Also of interest is what underlying change in the thermal properties of the substructure would cause the irregular shape detected in figure 10. Similar suspected water damage areas were also detected adjacent to the door bottom. No passive cool spots were detected that would indicate water evaporation during thermal data collection.

Figure 9. Thermal inspection of core crushed area showing no obvious thermal indication.

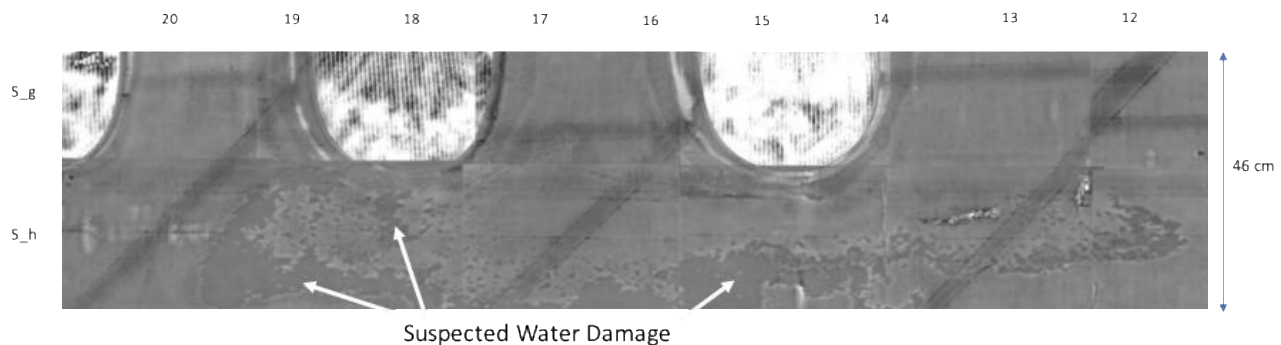
Figure 10. Thermal inspection of suspected water damaged areas.
