Cyclic Fatigue Durability of uncoated and EBC coated 3D SiC/SiC Composites under thermal gradient conditions at 2700F in air

Craig Smith, Bryan Harder, Dongming Zhu
NASA Glenn Research Center, Cleveland, OH

Ramakrishna Bhatt, Sreeramesh Kalluri
Ohio Aerospace Institute, Cleveland, OH

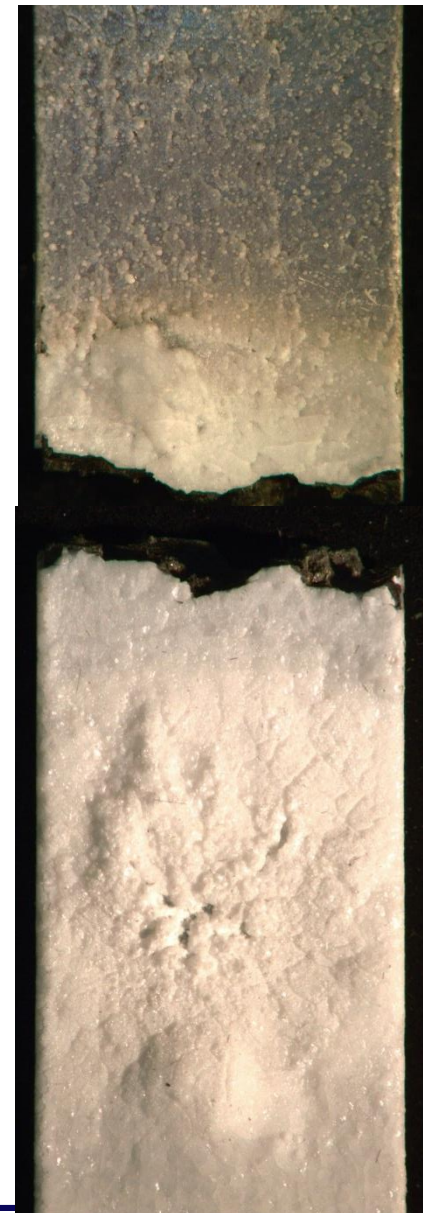
Examination of Sample that Broke During 487 Hour Thermal Gradient SPLCF

- The sample broke outside the hottest region
- The fracture surface was close to the edge of the hot zone (~2200°F)
- The EBC showed pitting/ cracking in the hot zone, below the fracture surface

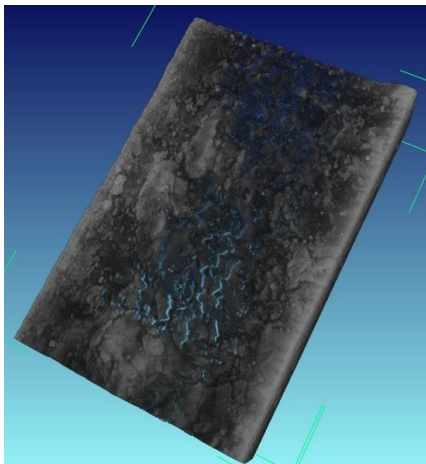
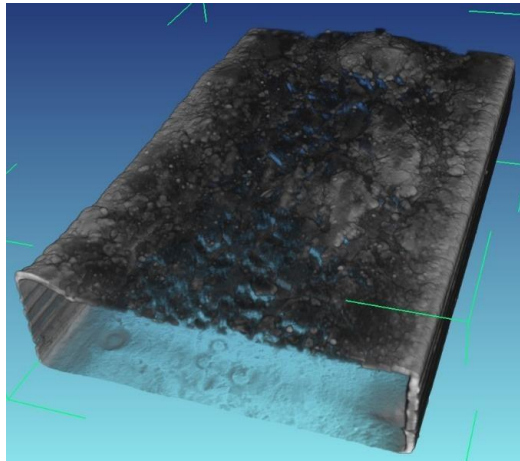
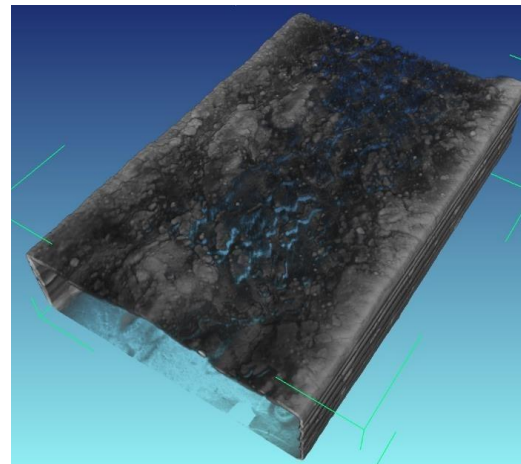
Before Testing- Only EBC Shown

- Thermal gradient tests are relevant for cooled CMCs
- Interpretation of the data is complicated
- CT images of as-produced sample showed regions of thin coatings
- After the 487 hour SPLCF, some areas of the coating were missing
- The sample may have been overheated beyond 3000F (EBC temperature)
- This sample lasted 487 hours under thermal gradient SPLCF
- More tests are underway to evaluate the material
 - Steam exposure, more thermal gradient tests

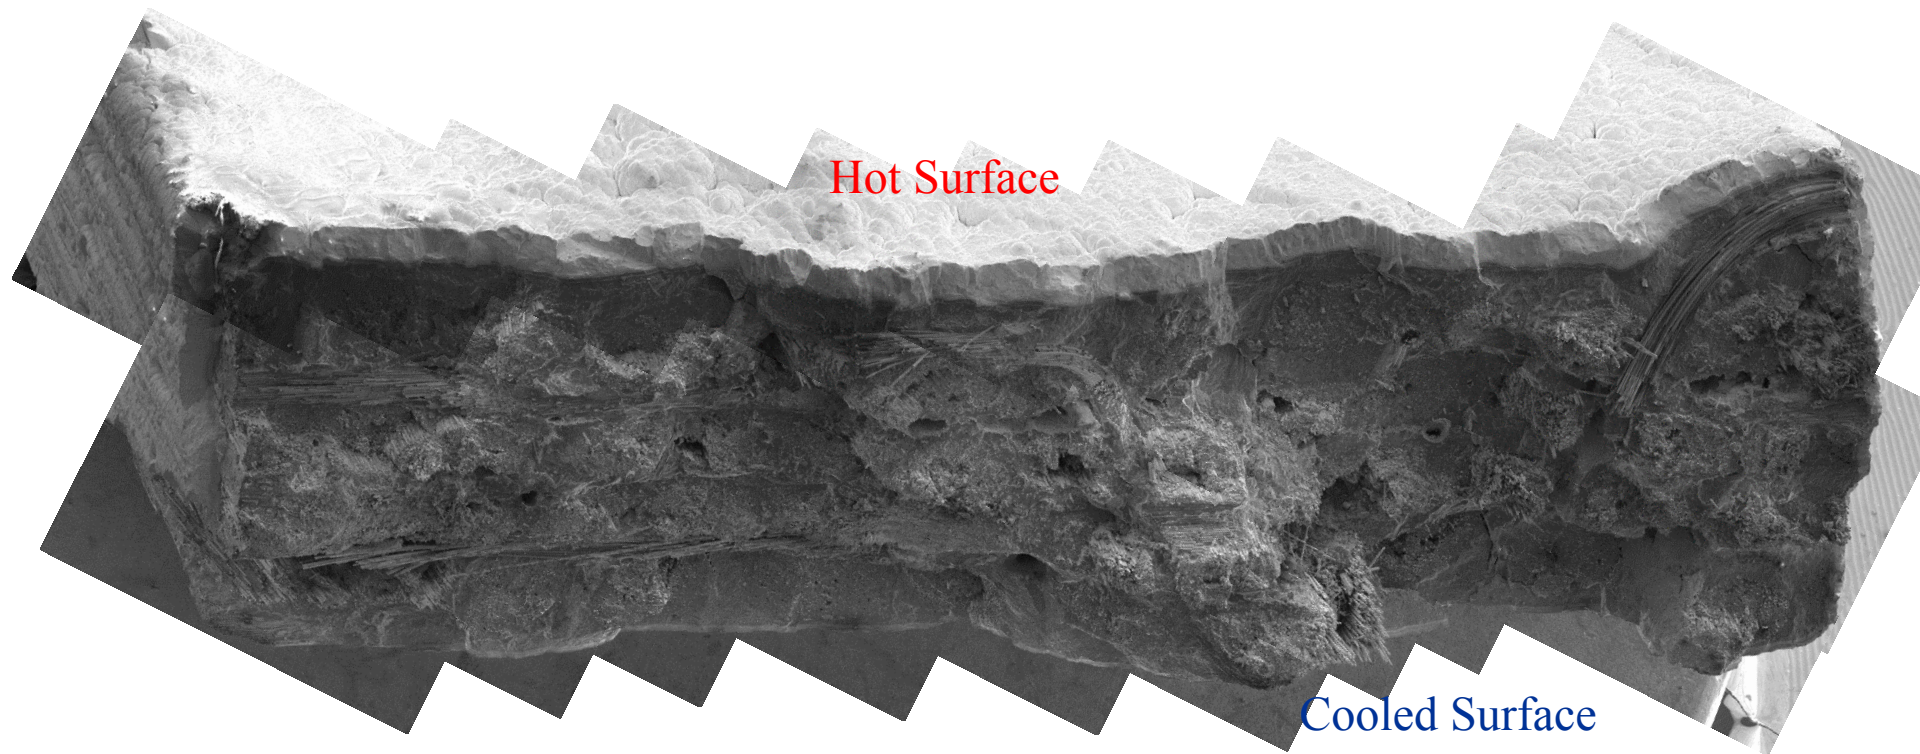
SEM of Fracture Surface after 487 hour Laser SPLCF

- Very flat fracture surface, little fiber pull-out

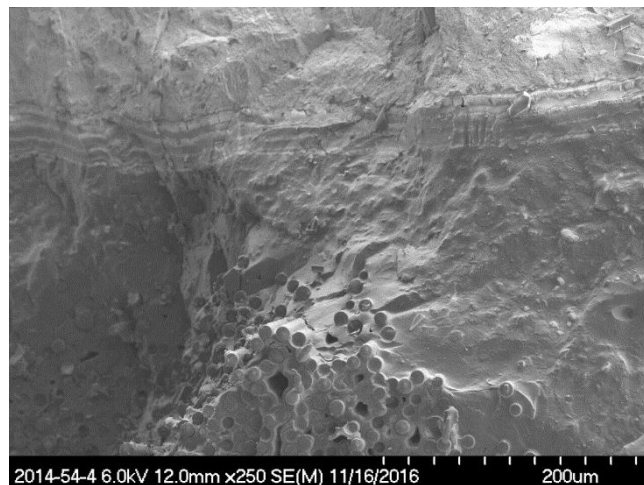
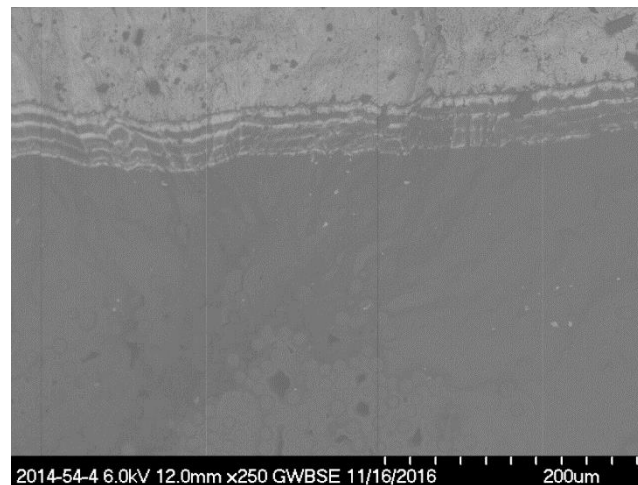
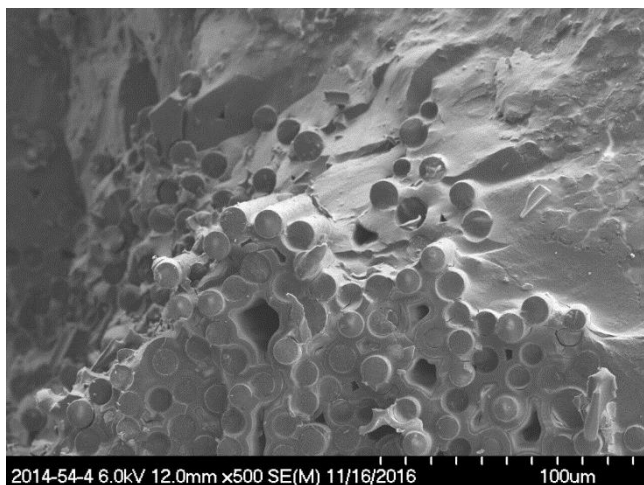
SEM of Fracture Surface after 487 hour Laser SPLCF

- Most of the fiber tows exhibited brittle failure
- Oxygen mapping of the cross-section was planned, but not yet completed
 - We want to know if the bond coat is oxidizing in air, before moving on to steam
 - Regardless, the sample lasted 487 hours
