Cyclic Fatigue Durability of Un-coated and EBC Coated 3D SiC/SiC Composites under Thermal Gradient Conditions at 2700°F in Air

Craig Smith, Bryan Harder, Dongming Zhu
NASA Glenn Research Center, Cleveland, OH

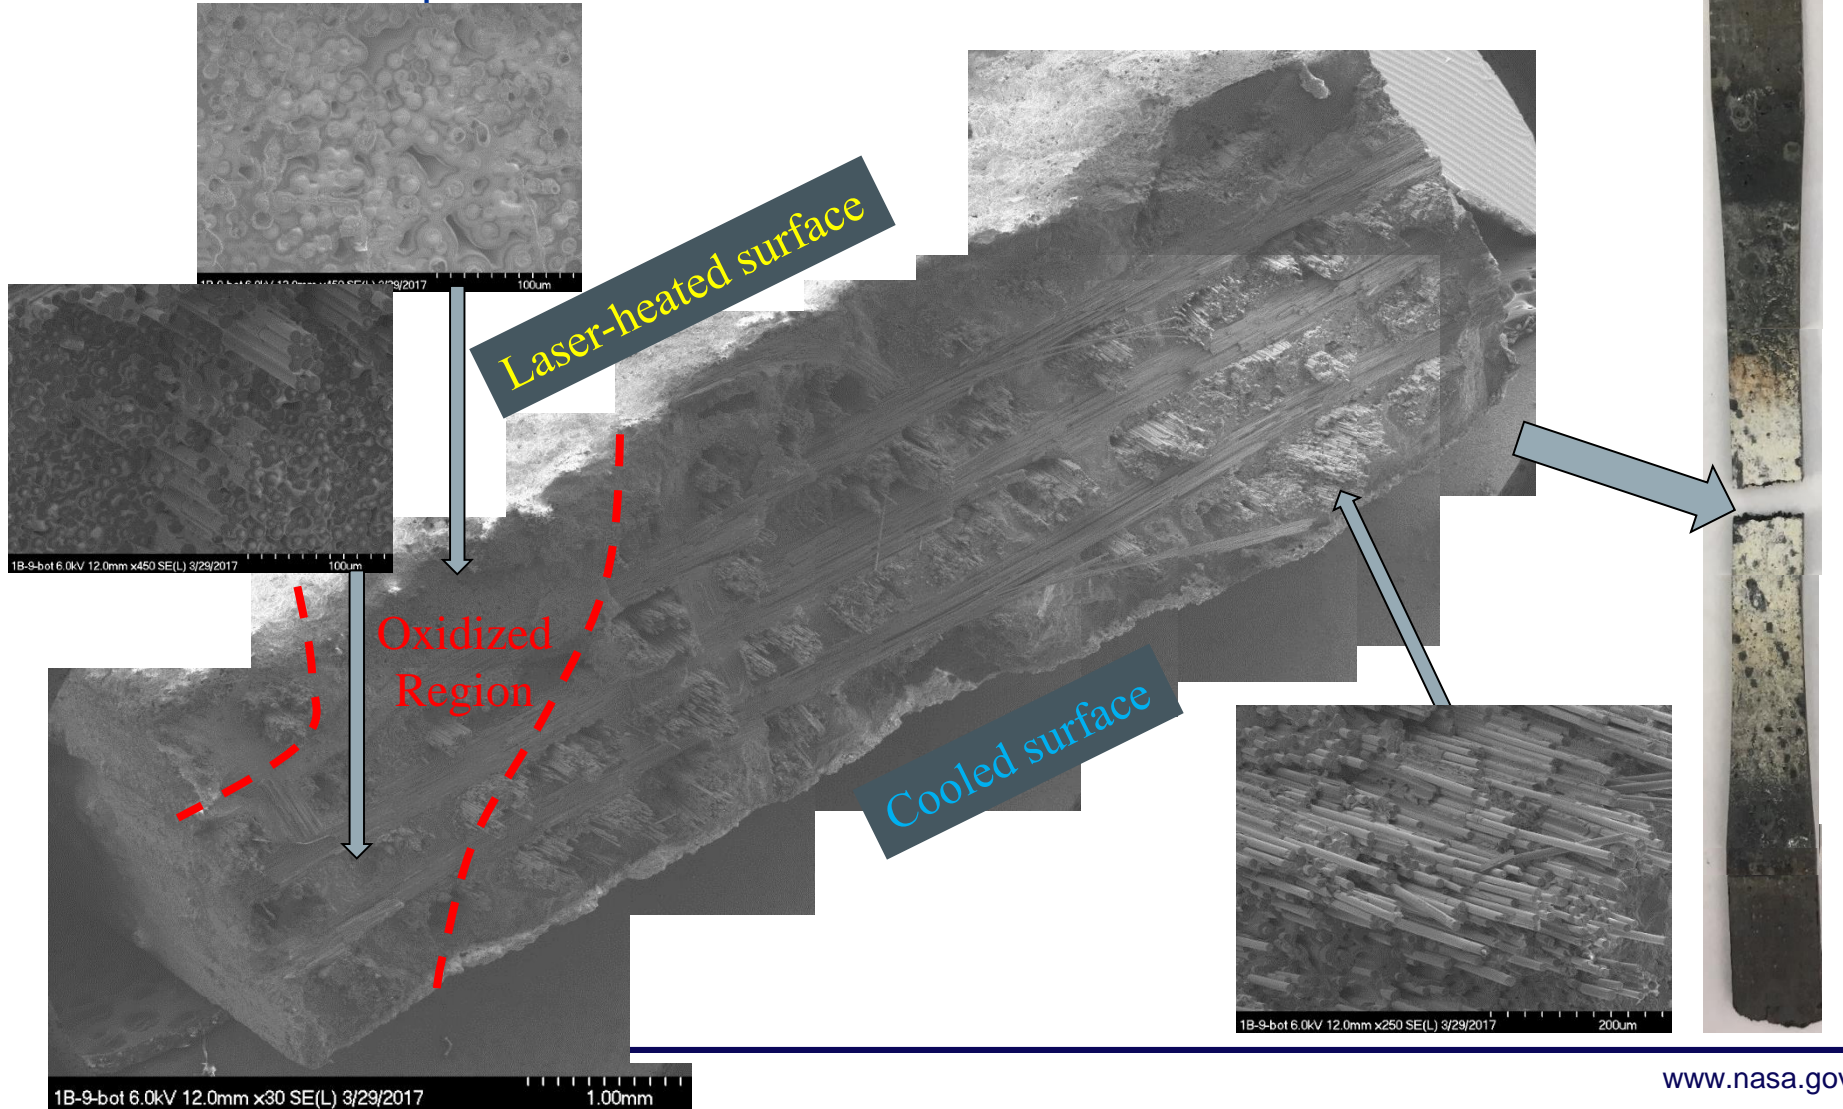
- Broke after >300 hours total SPLCF (103 MPa peak)
- The sample broke in the center of the hot zone

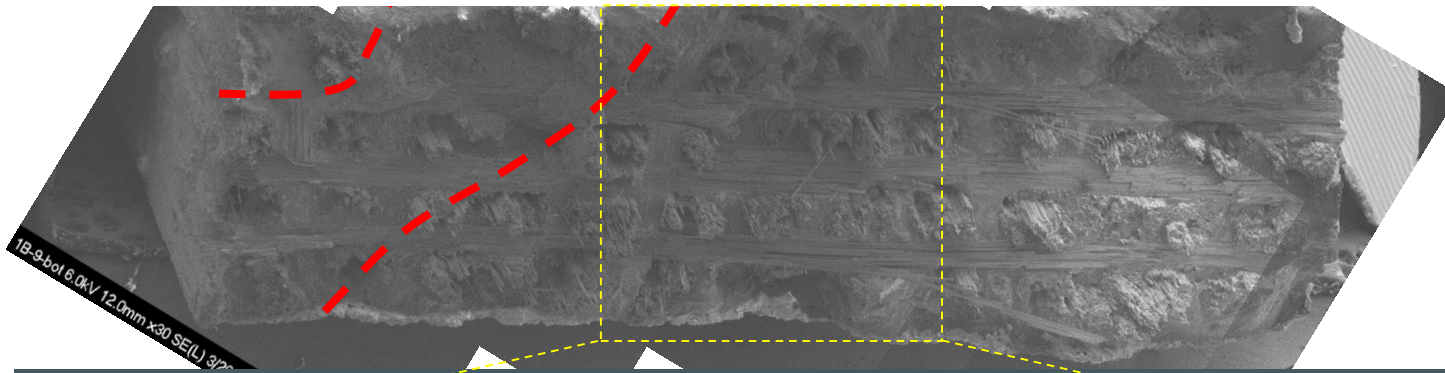
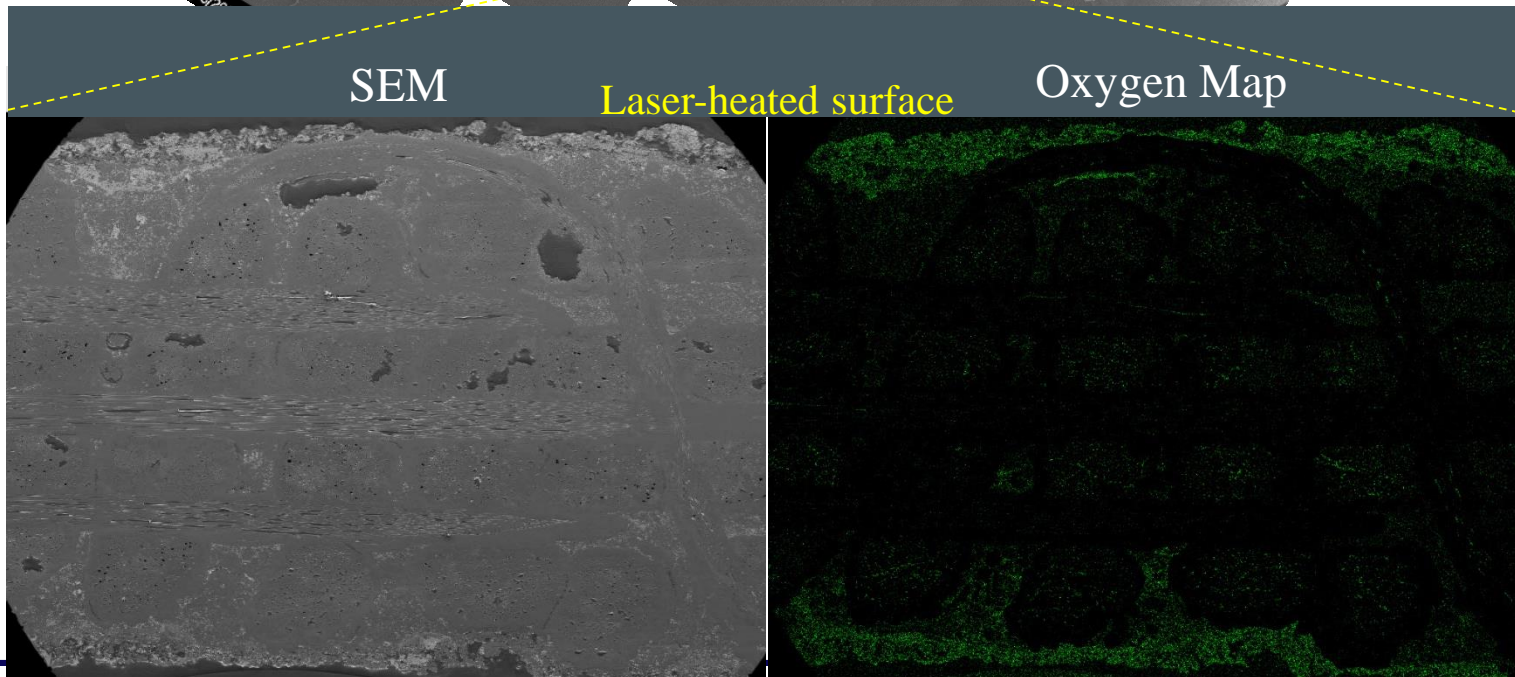
- The fracture surface was mounted in epoxy and polished
- Oxygen mapping with EDS revealed little internal oxygen

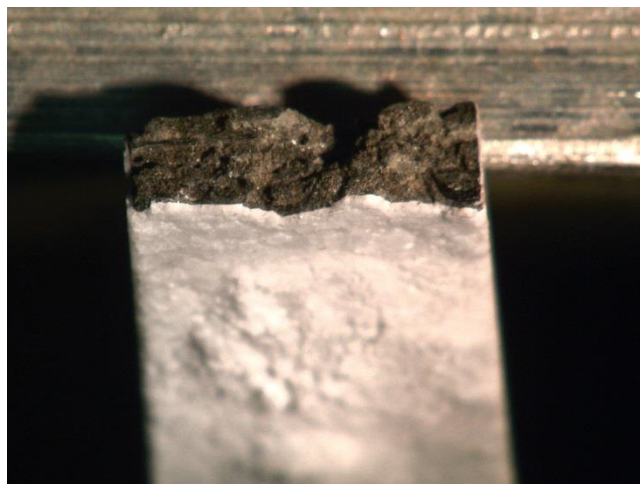
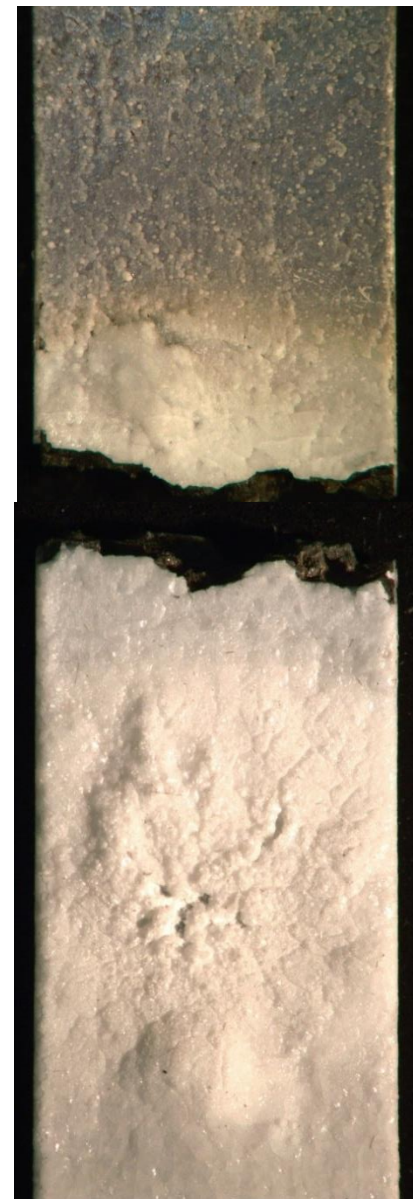
- Broke after 487 hours SPLCF at 69 MPa
- The sample broke outside the hottest region
- The fracture surface was close to the edge of the hot zone ($\sim 2200^{\circ}\text{F}$)
- The EBC showed pitting/ cracking in the hot zone, below the fracture surface

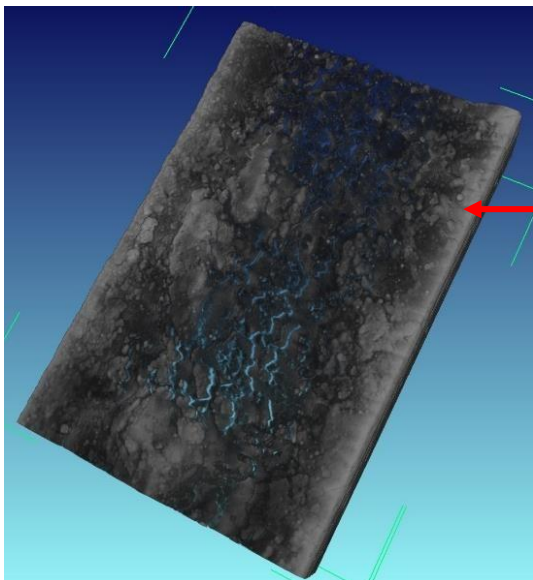
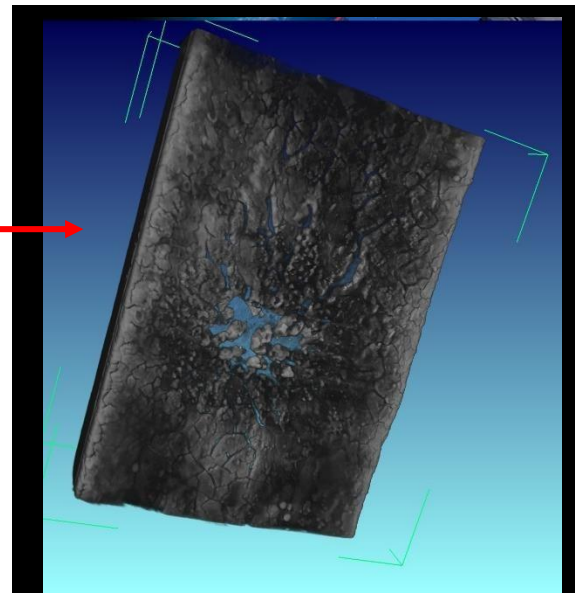
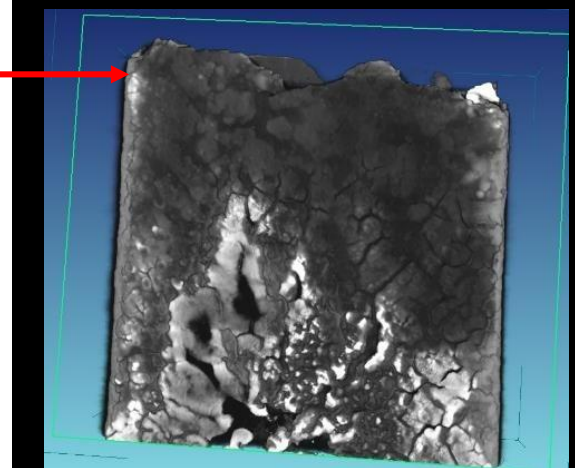
- Prior to testing, the EBC appeared to have thin areas
- After testing, there appeared to be an increase in the size of the thin areas

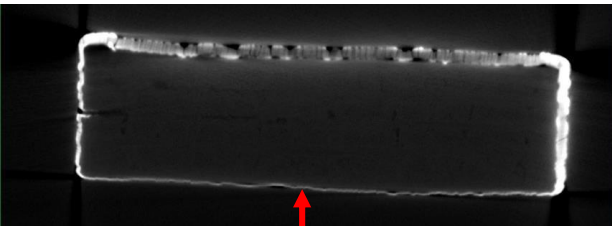
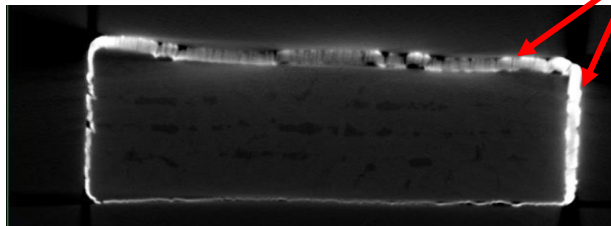
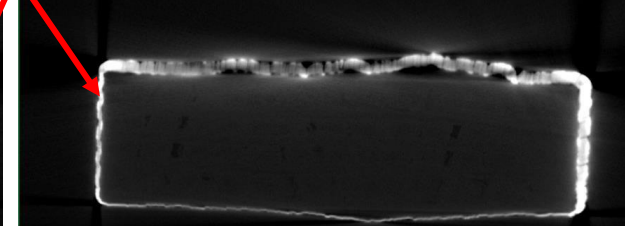
Before Testing

EBC covers three sides

Bond coat covers all sides

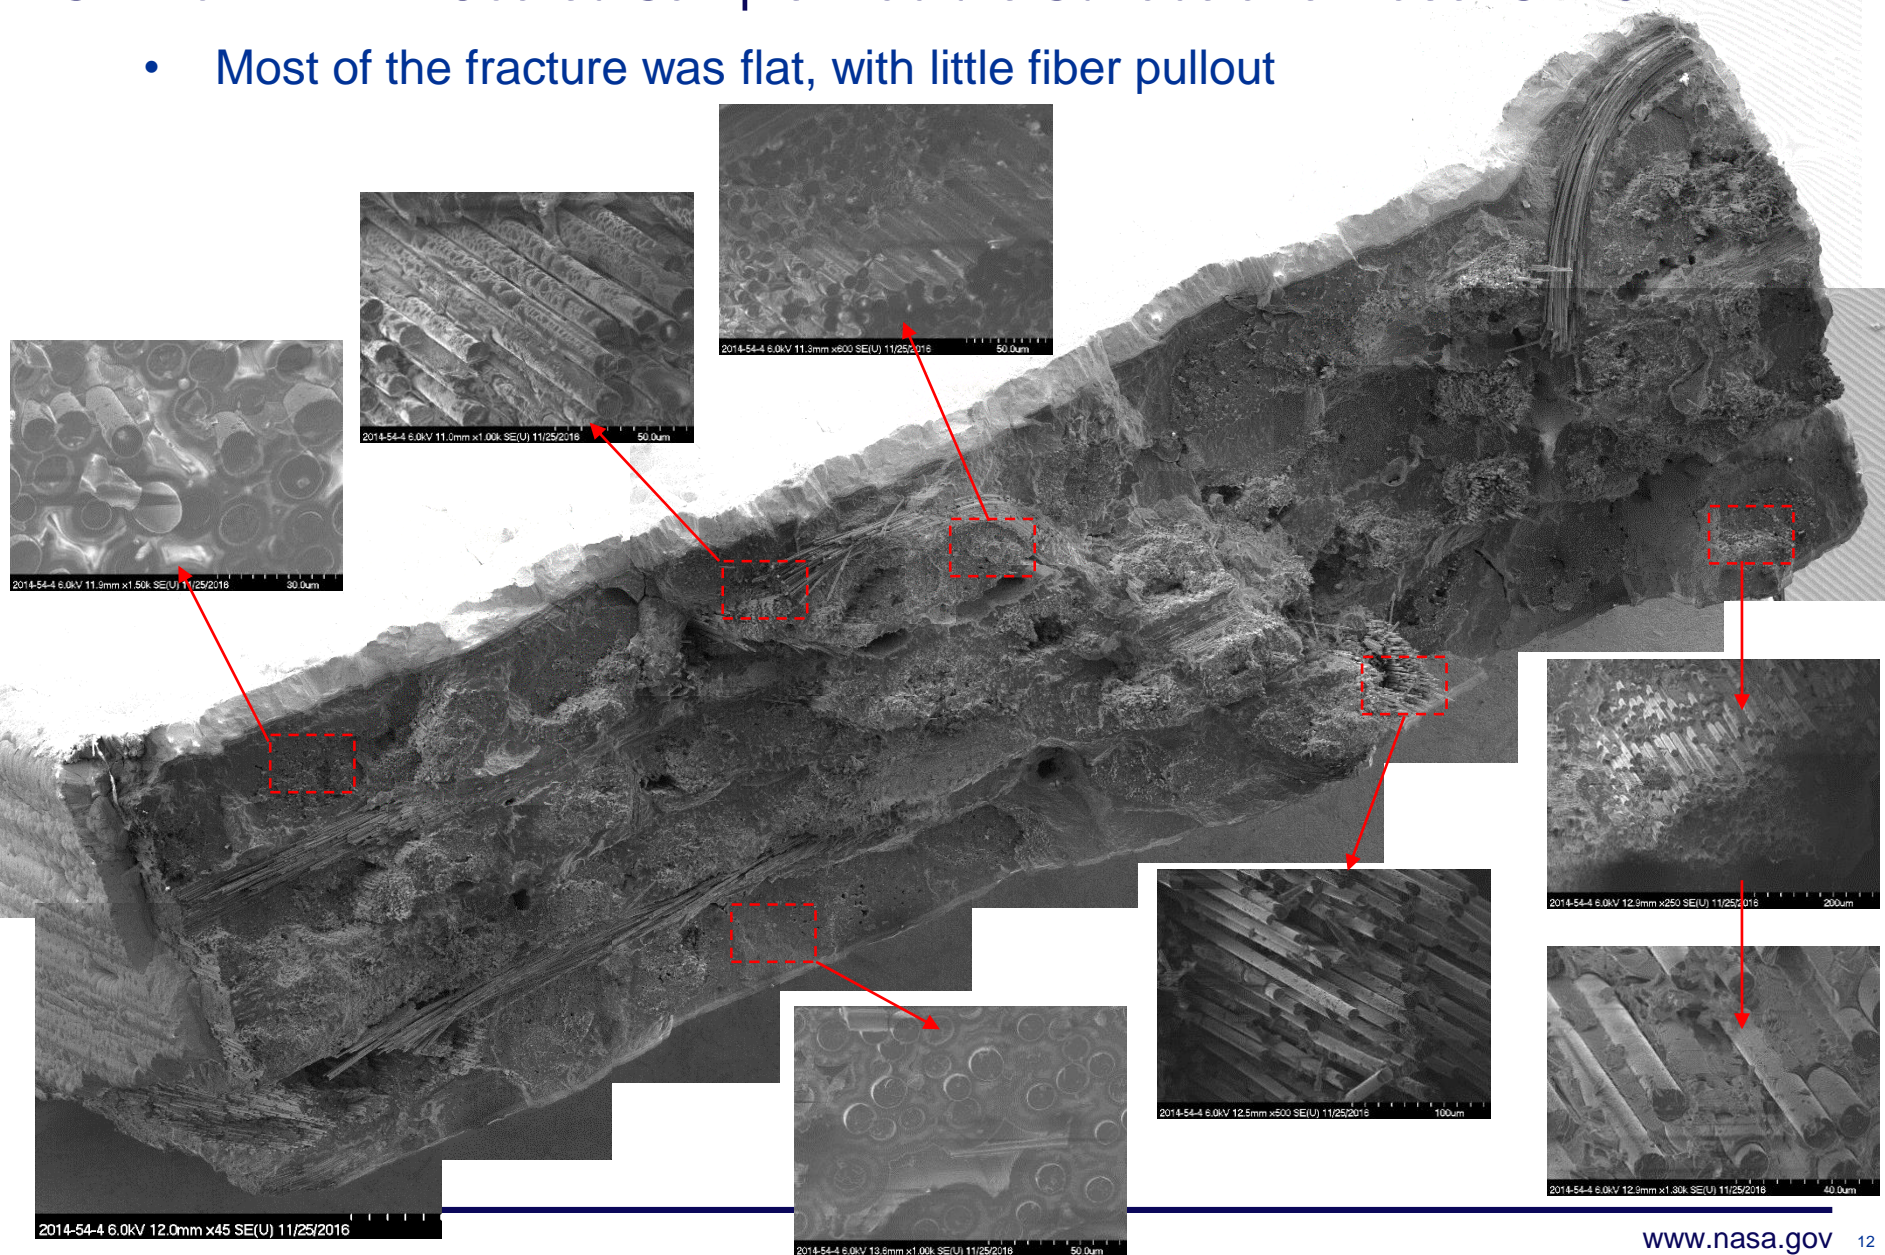
- Most of the fracture was flat, with little fiber pullout

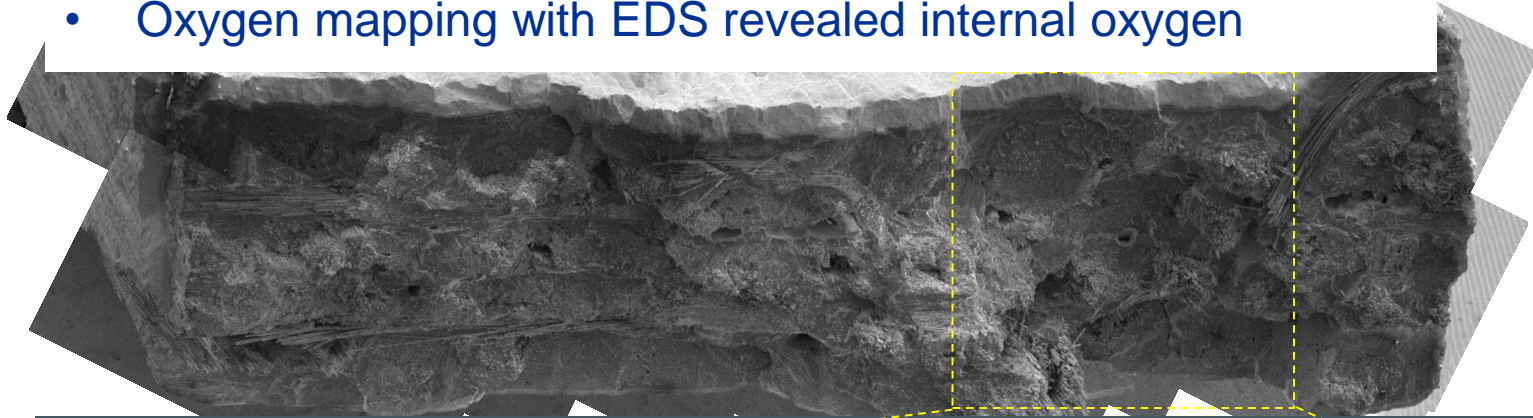
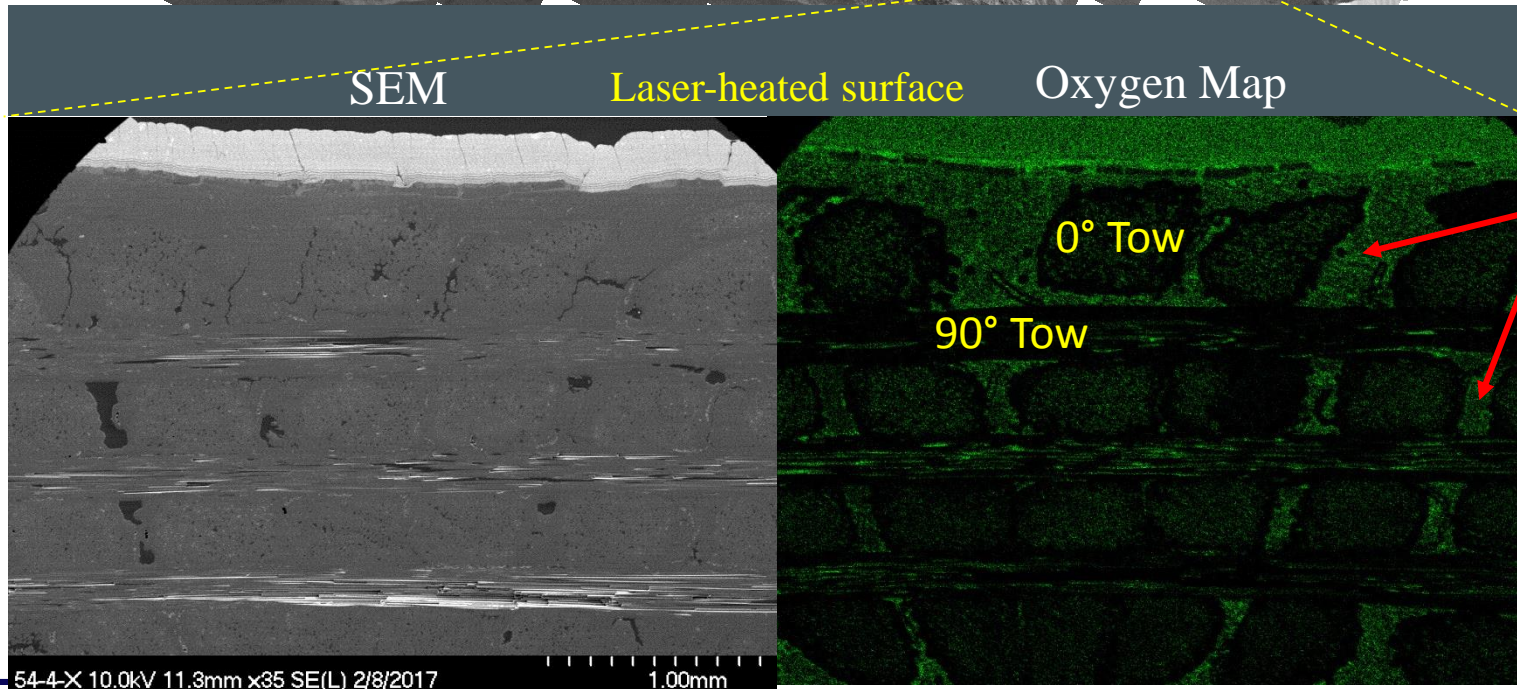
- The fracture surface was mounted in epoxy and polished
- Oxygen mapping with EDS revealed internal oxygen

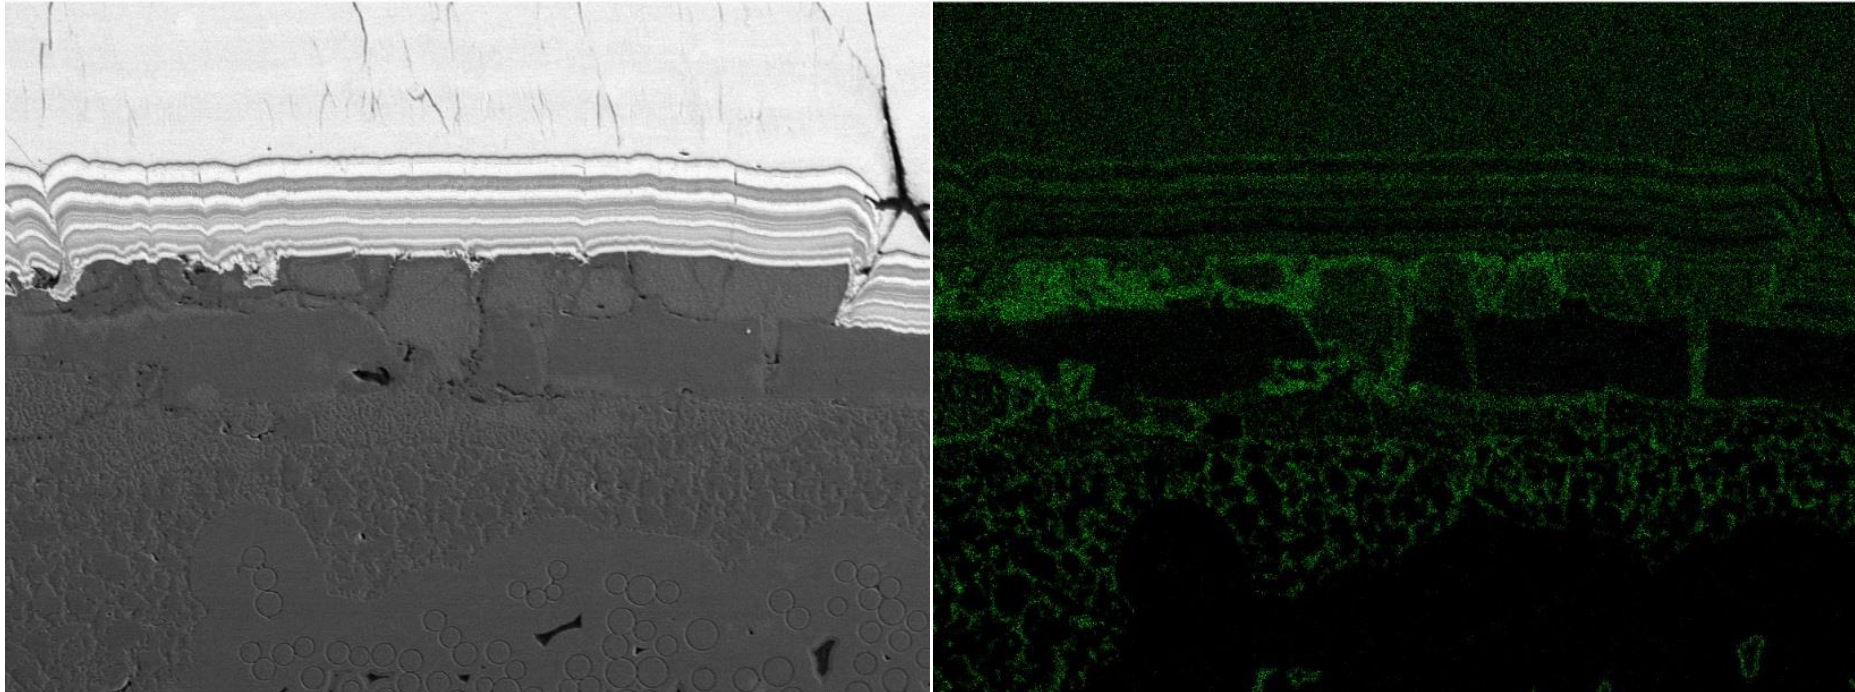
- There does not appear to be a thermally grown oxide layer beneath the coating
