Nuclear Cryogenic Propulsion Stage (NCPS) Fuel Element Testing in the Nuclear Thermal Rocket Element Environmental Simulator (NTREES)

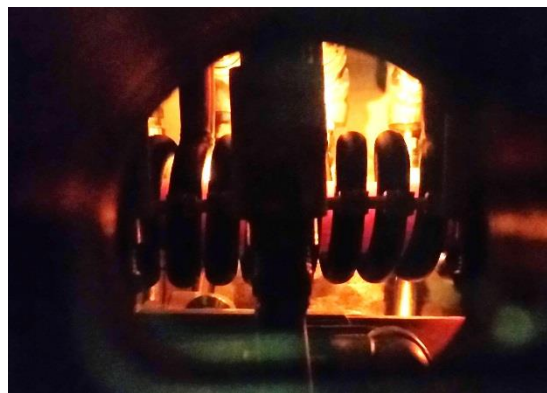
Figure 3 Fuel Element at Nominal Power
