New Understanding of Hubble Space Telescope Gyro Current Increase Led to a Method to Save a Failing Gyro

**17th European Space Mechanisms and Tribology Symposium (ESMATs)
20th - 22nd September 2017**

Kenneth A. Blumenstock

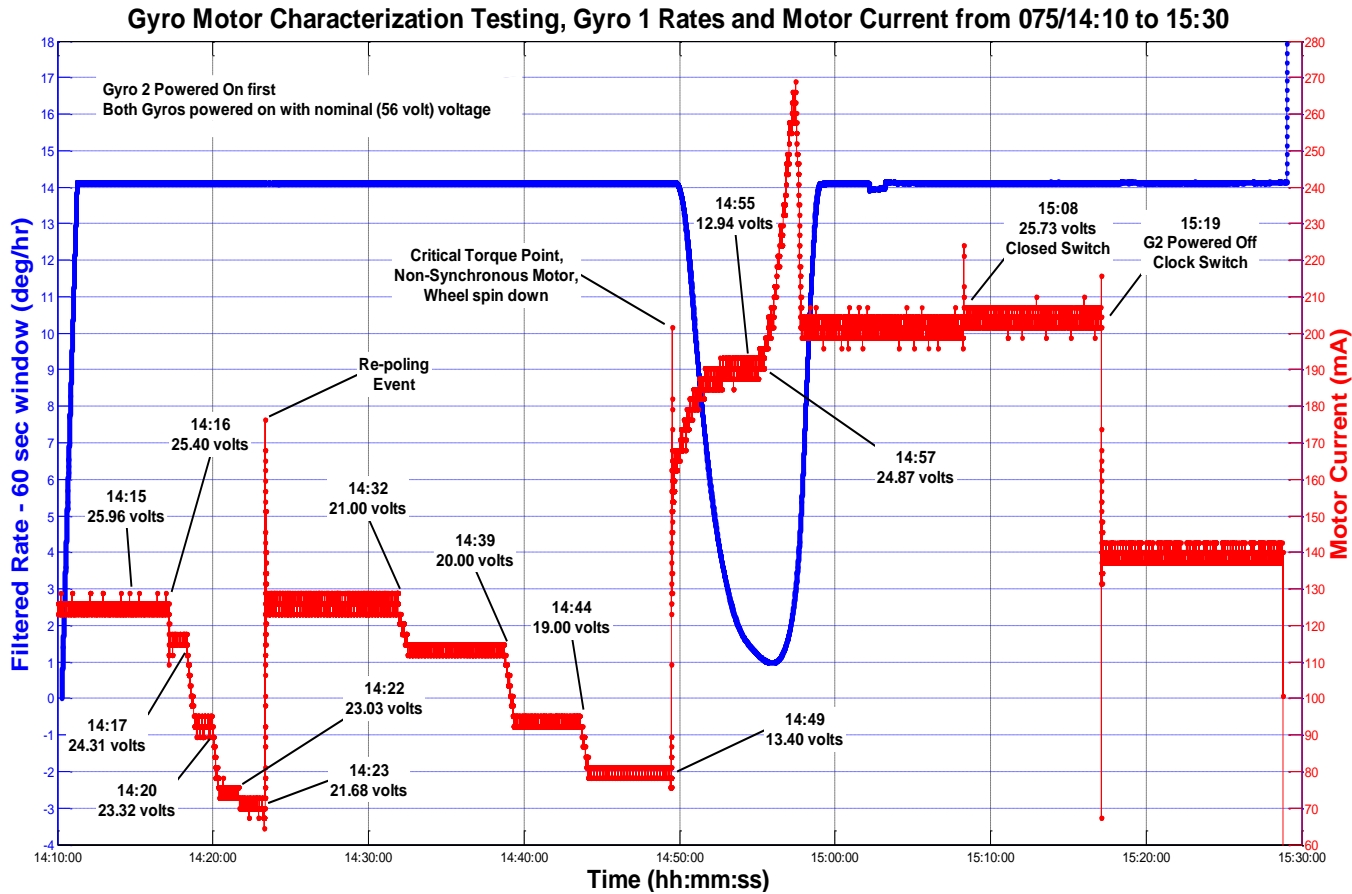
VEST Data

- We utilized the HST Vehicle Electrical Systems Test (VEST) facility
- I received permission to modify the hardware to reduce voltage to the gyro
- As voltage was lowered, the motor became more efficient as phase angle increased, so voltage and current dropped
- Once the “optimal” phase angle was reached, re-poling occurred, weakening magnetization, causing the current to jump higher

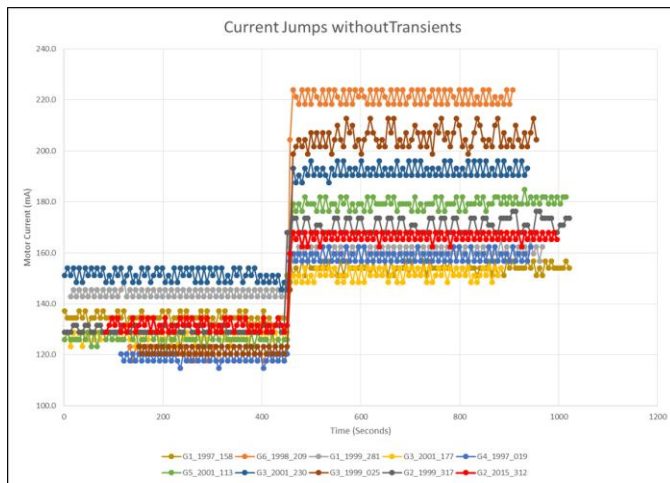
Current Jumps Without Transients

- Past data shows that current jumps are not always discrete, with increased current with transients dropping somewhat after an increase, never taking more than two minutes stabilize
- It is believed that the post-current jump transients are the result of residual particles being ground up in the gas bearings after the remagnetization event.
