NASA/TM-2017-219497

Mission Success of U.S. Launch Vehicle Flights from a Propulsion Stage-based Perspective: 1980-2015

April 2017

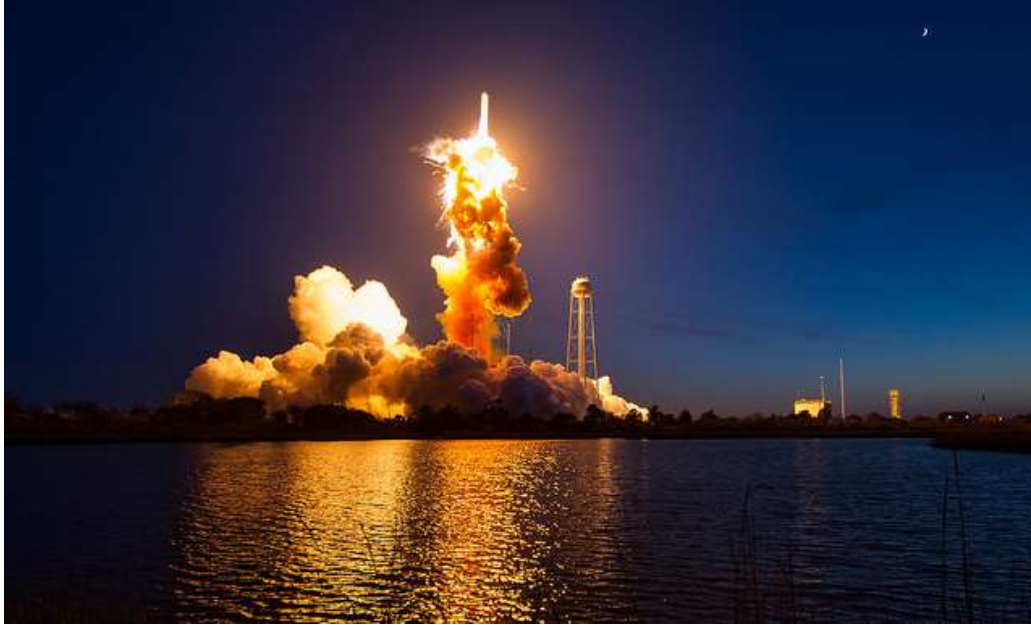
Figure C-1. Explosion in the Antares MES. Credit: NASA

Aerojet Rocketdyne, Orbital Sciences and NASA conducted separate investigations after the accident with differing conclusions [26]. Orbital’s investigation report identified the likely source of the failure as a machining defect in the turbine assembly of the turbopump during manufacturing while Aerojet’s suggested the failure source was foreign object debris. The NASA Independent Review Team (IRT) identified three possible technical root causes of the failure: inadequate design of the AJ-26 liquid oxygen (LO2) hydraulic balance assembly (HBA) and turbine-end bearing, foreign object debris introduced into the LO2 turbopump, and a machining defect in the liquid oxygen turbopump. The IRT eventually concluded that the most likely cause of the MES-1 explosion was due to loss of radial positioning in the LO2 turbopump 1, which caused friction due to rubbing between rotating and stationary components in the turbopump Hydraulic Balance Assembly (HBA) seal package, leading to ignition and fire [27].

In December 2014, Orbital Sciences announced that the RD-181—a modified version of the RD-191—would replace the AJ26 on the Antares 200-series.

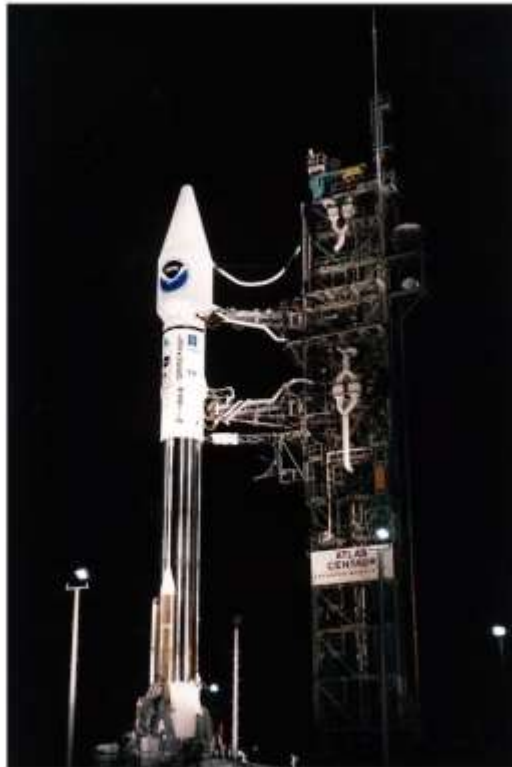
Figure C-3. An Atlas I rocket awaits lift-off. Credit: NASA

<i>Vehicle/Flight: Atlas-I (AC-74)</i>					
<i>Date</i>	<i>Vehicle Type</i>	<i>Failed Stage #</i>	<i>Failed Stage Type</i>	<i>Initial Manifestation Type</i>	<i>Launch Vehicle Demise</i>
3/25/1993	Liquid	1	Liquid	Low performance	None

At T+24s the Atlas' two auxiliary engines began to lose thrust, eventually leveling off at 65% power. Although the Centaur upper stage computer tried to compensate for the thrust loss by extending the first burn by 24 seconds, the stage exhausted its propellant prior to completing the burn. The launch vehicle inserted the Hughes UHF 1 follow-on spacecraft into a lower orbit than anticipated. The satellite maintained functionality, but was considered a loss due to the unacceptable orbit. An improperly torqued set screw in the first stage sustainer engine precision regulator caused reduced power and an early shut down [38].

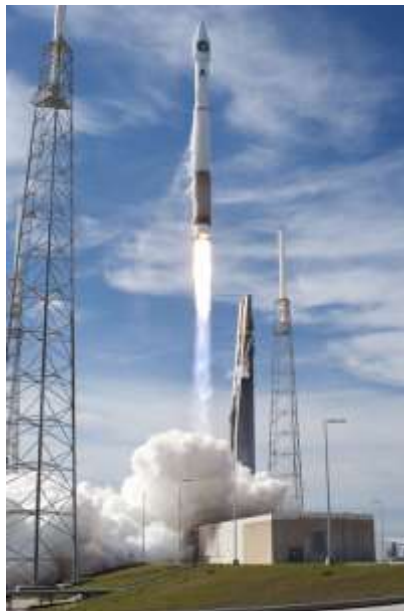
Figure C-4. An Atlas V rocket lifts off from Launch Complex 41. Credit: NASA

<i>Vehicle/Flight: Atlas V</i>					
<i>Date</i>	<i>Vehicle Type</i>	<i>Failed Stage #</i>	<i>Failed Stage Type</i>	<i>Initial Manifestation Type</i>	<i>Launch Vehicle Demise</i>
6/15/2007	Liquid	2	Liquid	Propellant leak/loss - Low performance	None

The Centaur upper stage shut down four seconds earlier than planned due to a fuel leak in the engine system cryogenic liquid hydrogen valve. The leak continued during the nearly one hour coast phase between the two Centaur main engine burns. Some real-time indications of an anomaly occurred during the mission. Several parameters suggested that the temperature was off-nominal, but the effects of the difference on the performance of the engine were unknown until the premature shutdown due to fuel depletion. Although the payload was placed in a lower orbit than planned, a proper orbit was eventually achieved using the spacecraft's on-board propulsion system.

The failed LH2 fuel valve in the RL10 was a new design used in only a half-dozen previous flights (the manufacturer was phasing the old valve out of their product line). Future Atlas 5 and Delta 4 rocket launches -- both rocket families use versions of RL10 engines to power their upper stages -- planned to revert the previous fuel inlet valve design that officials fully trusted. Subsequent testing during the investigation showed that the heritage valve design had larger closing force margins. This mission also experienced a longer than average first burn, which increased valve exposure to cryogenic hydrogen and elevated valve friction. As a result, the valve did not close completely and leaked fuel during the coast phase [40].

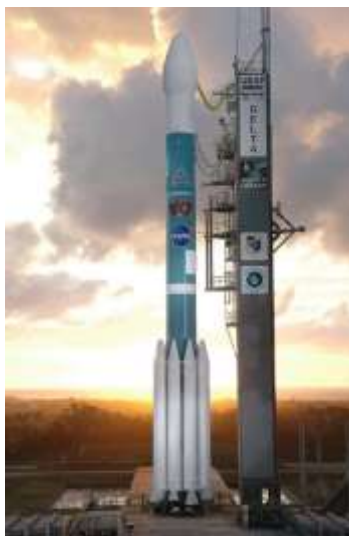
Figure C-5. Delta 7925 at Launch Pad 17-B. Credit: NASA

<i>Vehicle/Flight: Delta-7925</i>					
<i>Date</i>	<i>Vehicle Type</i>	<i>Failed Stage #</i>	<i>Failed Stage Type</i>	<i>Initial Manifestation Type</i>	<i>Launch Vehicle Demise</i>
8/5/1995	Combined	0	Staging	Staging - low performance	None

At T+66s the three strap-on Graphite-Epoxy Motors (GEMs) ignited while the other six motors used to augment launch jettisoned normally. At T+130s, two of the air-started motors jettisoned normally, but one failed to jettison and remained attached to the vehicle. The explosive lines used to separate the motor were damaged due to exposure to excessively high temperatures caused by a failure of the insulation to protect the rocket's booster separation circuits [42]. The added weight of the motor resulted in a significant loss of velocity after the first stage shut down. The second stage computer attempted to correct this error by extending the initial burn an extra 35 seconds, but the tanks ran dry after just 10 seconds during the follow-on burn. The payload eventually achieved geostationary orbit at the expense of over half of its orbital life expectancy [4].

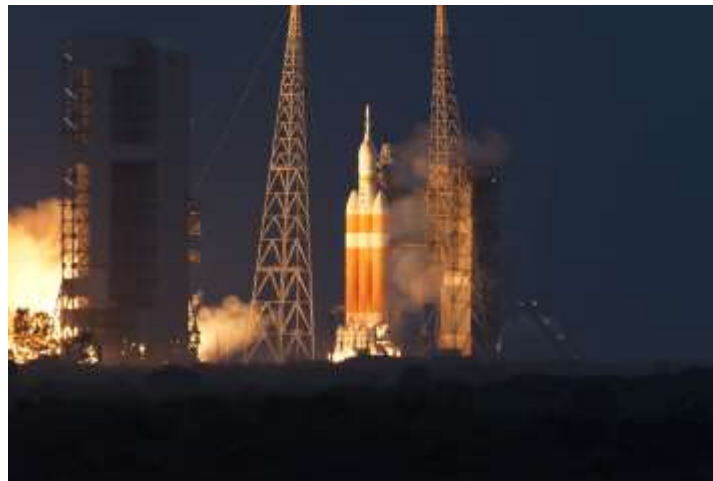
Figure C-6. A Delta-IV Heavy rocket lifts off from Launch Complex 37. Credit: NASA

As a result of the early shutdown, the upper stage was left with a 1500 foot-per-second speed deficit and attempted to compensate. The upper stage had three planned burns over the 6-hour mission to geosynchronous orbit. The first burn of the upper stage was designed with propellant margin in case of any Common Core Booster shortfalls, and burned much longer than the planned 7-minute first burn, but still could not reach a stable orbit, releasing its payload too low. The second stage made its second burn and coasted for 5 hours before its final burn. The final (third) circularization burn was to last 3 minutes, but the stage shut down two-thirds of the way in, having spent all of its fuel.

This same configuration worked without a problem in previous Delta IV incarnations. However, the acceleration profile, combined with the liquid levels and flow rate of the new mission, resulted in the cavitation phenomena. Cavitation margin adjustments were taken into consideration for subsequent flights, with throttling schedules and ullage pressurization management strategies [46].

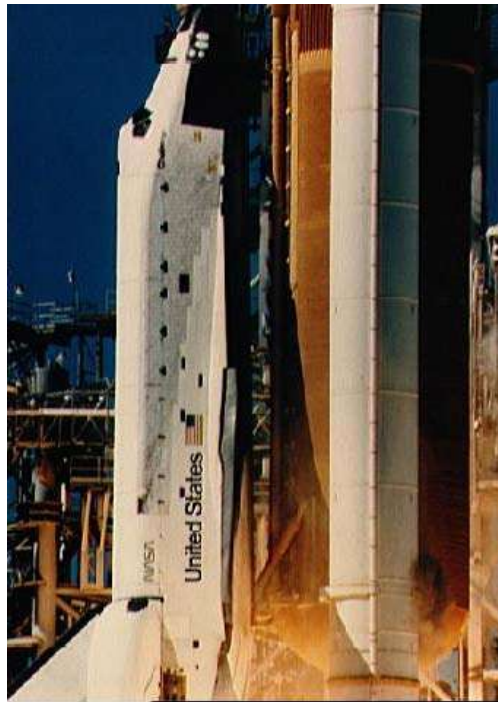
Figure C-9. A puff of black smoke is seen coming from the lower portion of the right SRB.
Credit: NASA

<i>Vehicle/Flight: Space Shuttle (51-L Challenger)</i>					
<i>Date</i>	<i>Vehicle Type</i>	<i>Failed Stage #</i>	<i>Failed Stage Type</i>	<i>Initial Manifestation Type</i>	<i>Launch Vehicle Demise</i>
1/28/1986	Combined	0	Solid	Case Breach	Environment

Ultimately, the propagation of the failure was enabled by the proximity of critical structural, load bearing, and propellant containment components to the initial case breach, a failure that might have had relatively benign consequences within a different architecture.

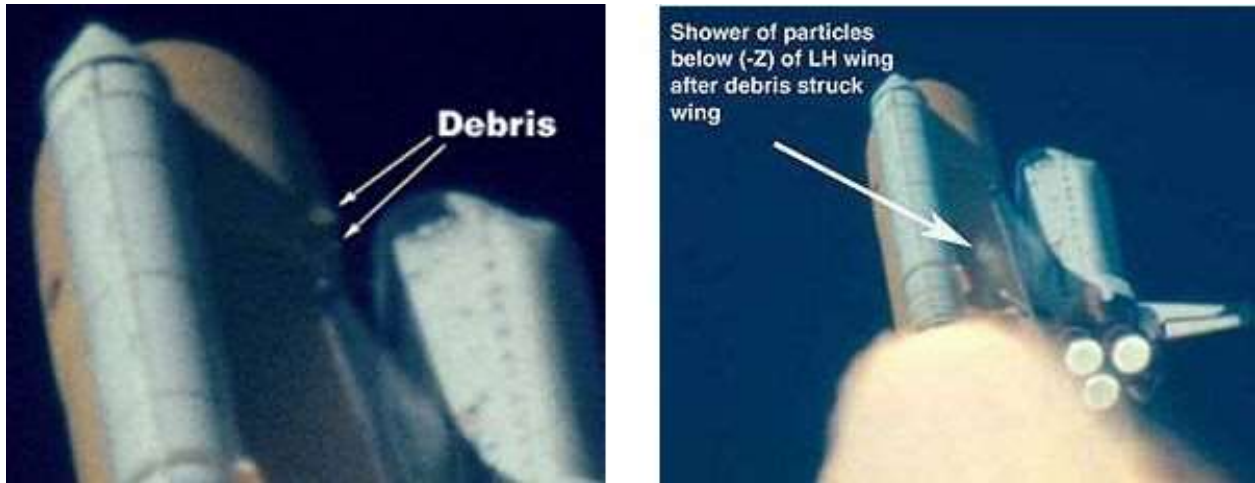
Figure C-10. Columbia debris particles and wing strike. Credit: NASA

<i>Vehicle/Flight: Space Shuttle (STS-107 Columbia)</i>					
<i>Date</i>	<i>Vehicle Type</i>	<i>Failed Stage #</i>	<i>Failed Stage Type</i>	<i>Initial Manifestation Type</i>	<i>Launch Vehicle Demise</i>
1/16/2003	Combined	1	Liquid	Damage to Payload	None (Orbiter reached intended orbit and destroyed during reentry)

At T+81.7s one large piece and at least two smaller pieces of insulation foam separated from the External Tank (ET) left bipod ramp. At T+81.9s the larger piece struck the underside of the left wing, striking between Reinforced Carbon Carbon (RCC) panels 5 through 9. The larger piece of foam was determined to be 21 to 27 inches long and 12 to 18 inches wide. It was moving at a relative velocity to the Shuttle of 625 to 840 feet per second at the time of impact. The impact was of sufficient force to crack the RCC that provided the thermal protective barrier to the internal wing structure. On entry, the extreme temperatures generated in the vehicle flow-field were thus able to penetrate to the internal wing structure, causing structural failure, loss of control, and complete vehicle breakup [57].
