Advanced Stirling Radioisotope Generator EU2 Anomaly Investigation

The Advanced Stirling Radioisotope Generator (ASRG) Engineering Unit 2 (EU2) is the highest fidelity electrically-heated Stirling radioisotope generator built to date. NASA Glenn Research Center (GRC) completed the assembly of the ASRG EU2 in September, 2014 using hardware from the now cancelled ASRG flight development project. The ASRG EU2 integrated the first pair of Sunpower's ASC-E3 Stirling convertors (ASC-E3 #1 and #2) in an aluminum generator housing with Lockheed Martin's Engineering Development Unit (EDU) 4 controller. After just 179 hours of EU2 generator operation, the first power fluctuation occurred on ASC-E3 #1. The first power fluctuation occurred 175 hours later on ASC-E3 #2. Over time, the power fluctuations became more frequent on both convertors and larger in magnitude. Eventually the EU2 was shut down in January, 2015. An anomaly investigation was chartered to determine root cause of the power fluctuations and other anomalous observations. A team with members from GRC, Sunpower, and Lockheed Martin conducted a thorough investigation of the EU2 anomalies. Findings from the EU2 disassembly identif

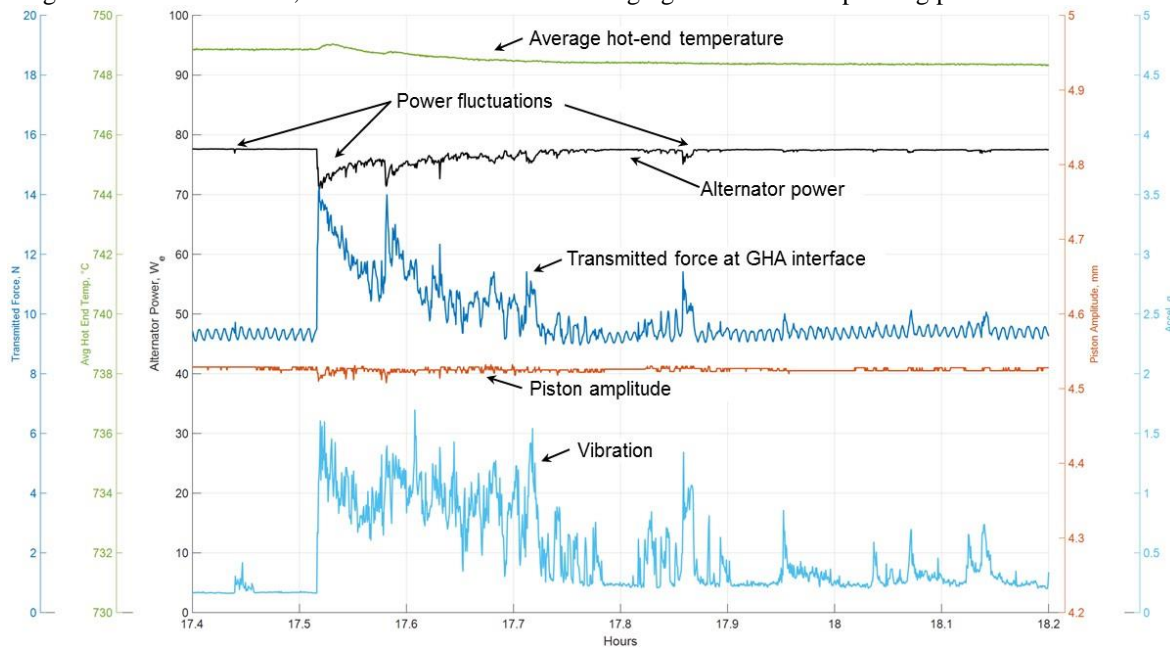
Figure 5. Example of power fluctuations that occurred on ASC-E3 #1 on 14 December 2014.

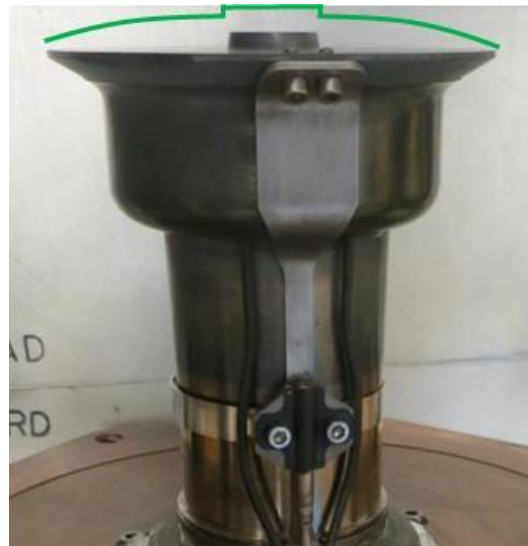
Heat collector crowning did not appear to play a role in the EU2 anomalous observations. Thermal simulations showed that when operating in an argon atmosphere, as was the case with EU2, the gap created by the crowning would not have significantly affected the heat transfer due to the presence of argon in the gap. Further, the change in heat transfer would not have caused the anomalous observations seen in the EU2. However, because 0.06 mm crowning could adversely affect heat transfer between the heat source and the heat collector in vacuum, the team did investigate further to better understand the cause of the crowning.

Figure 10. Exaggerated illustration of crowning of ASC-E3 #1 and #2 across the heat collector

One plausible explanation for heat collector crowning is that it may be caused by creep due to thermal stresses from thermal gradients within the heat collector. Creep occurs at stresses which are less than the high-temperature yield strength of the material. An FEA creep analysis of the ASC-E3 heater head at temperature and pressure did suggest that crowning could occur due to creep.
