Columbia Crew Survival Investigation Report

What happened to the
STS-107 *Columbia* crew

and what can be learned from it.

Nigel J. Packham
JSC S&MA

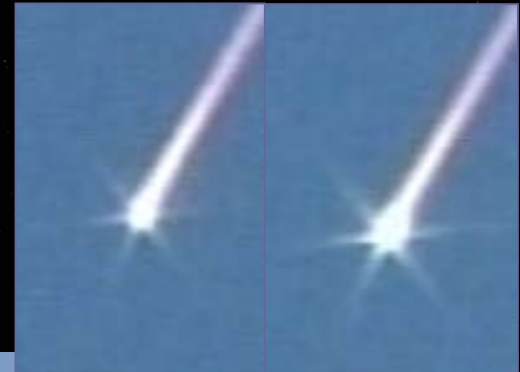
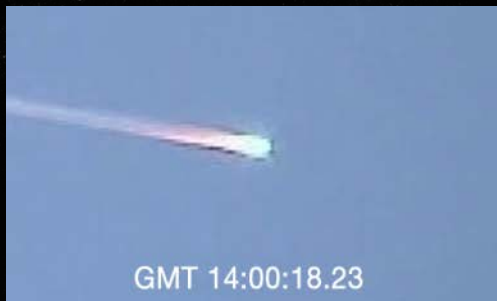
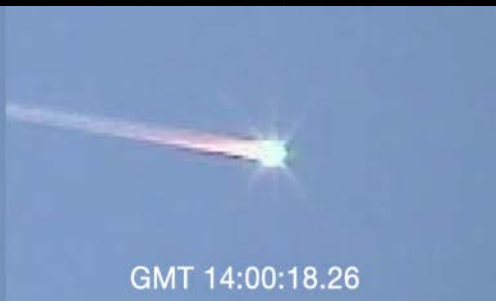
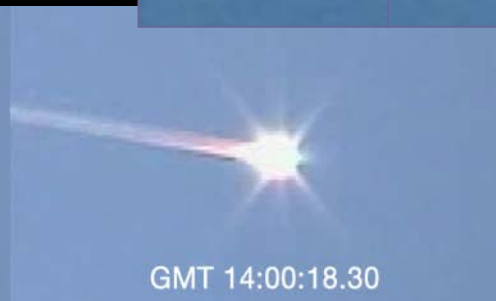
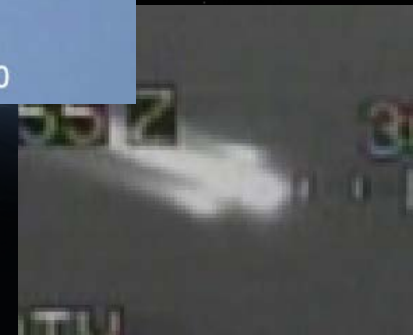
- Video anchored key events
 - Loss of Control
 - Vehicle breakup
 - Forebody breakup

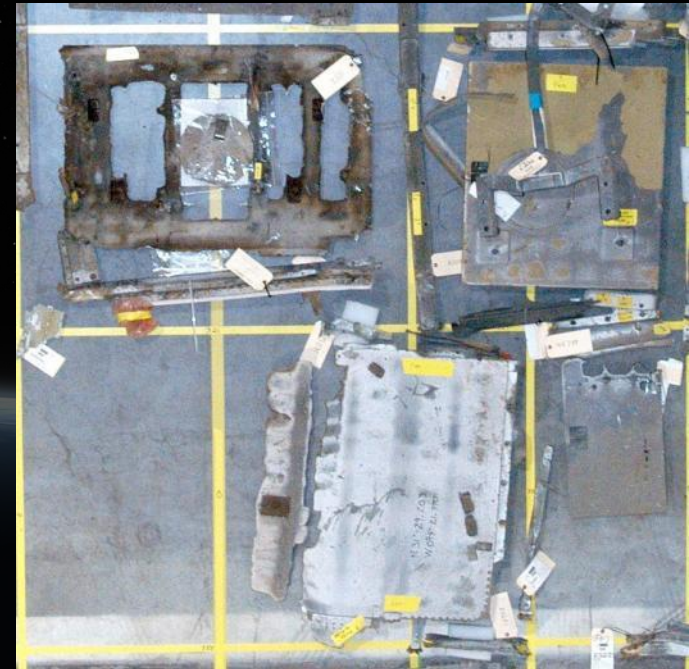
- Debris analysis proved to be immensely complicated
 - Easy to develop a false scenario from one or two pieces of debris
 - Best for broad assessments
 - fire?
 - directional loading?
 - thermal events?

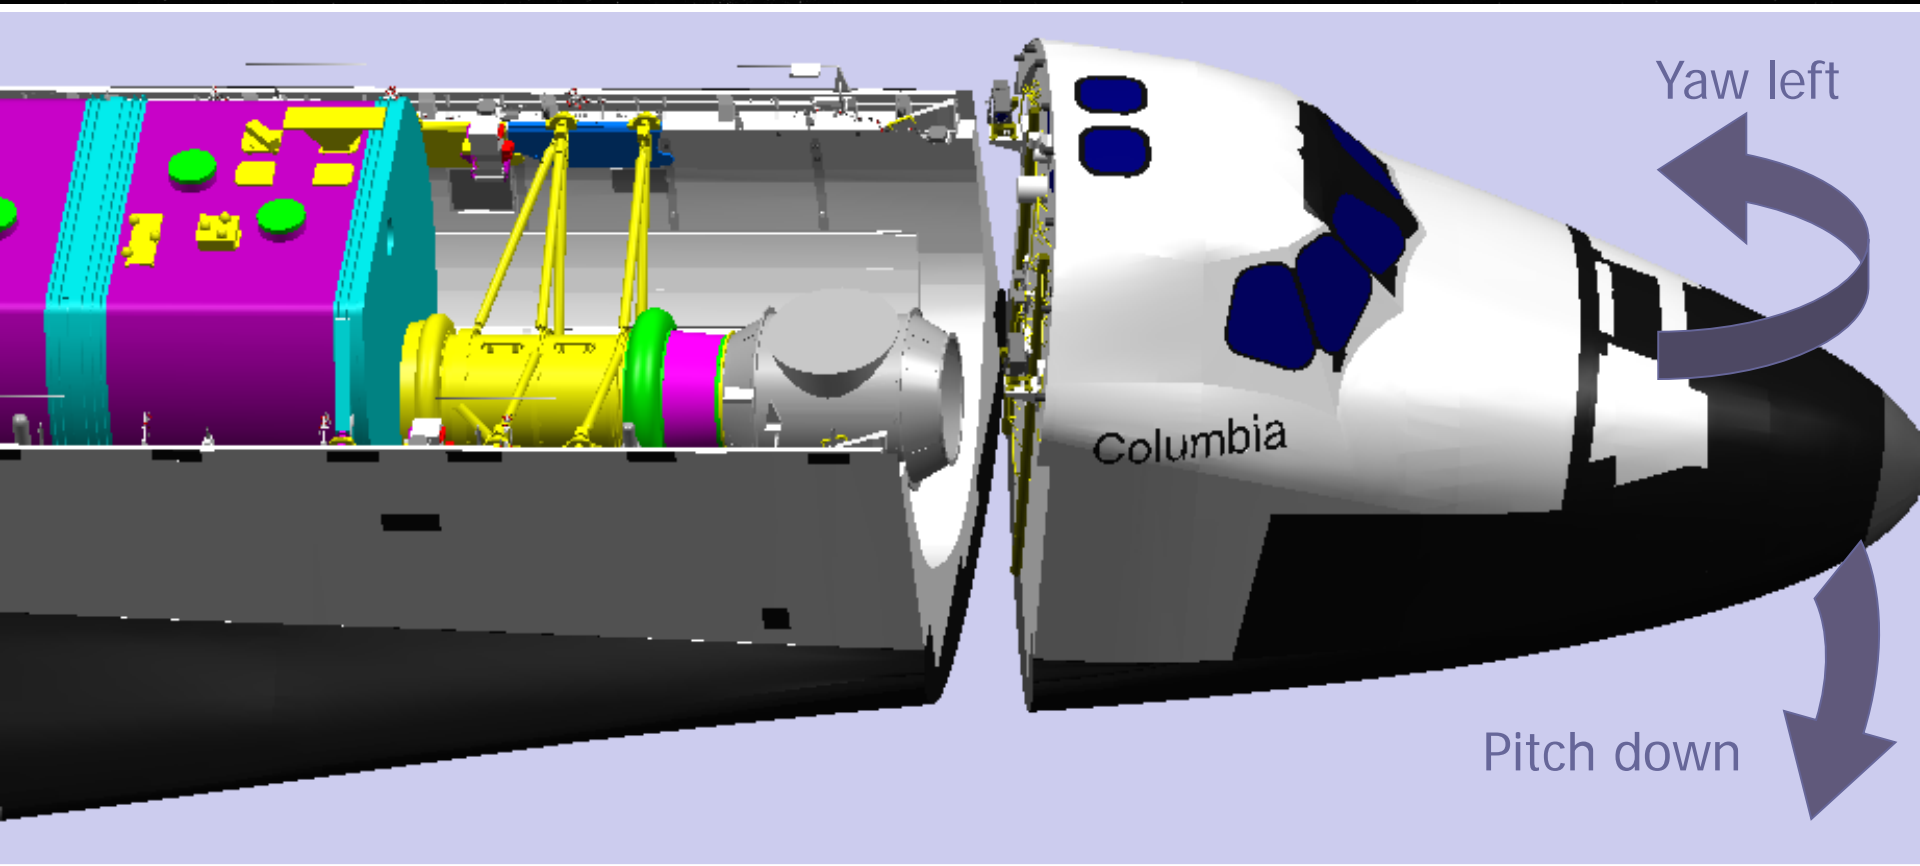
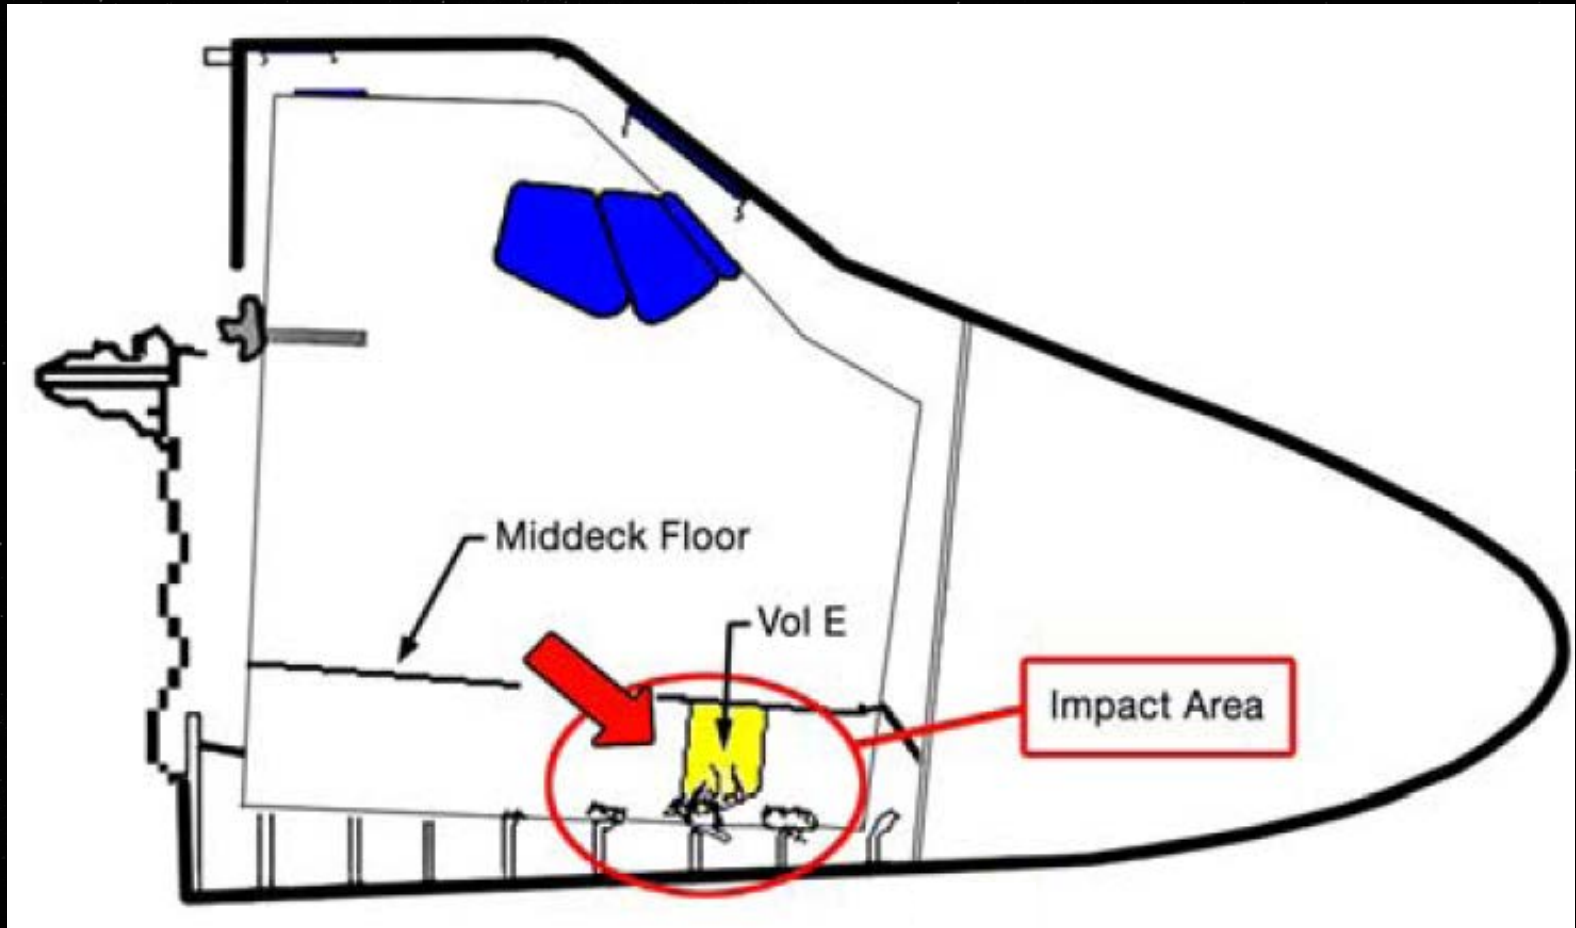
CE Video

- 14:00:03 - 14:00:05 –RGPC2 data indicate cabin parameters were normal, auxiliary power units (APUs) were running but hydraulic pressures and quantities were zero
 - Panel R2 APU switches
- 14:00:18 – Main vehicle break-up, or “Catastrophic Event” (CE), based on video & Operational/ Experimental (OEX) recorder power loss
 - Forebody separation was due to starboard payload bay sill failure (thermal), and the starboard X-link pulled through the 582 ring frame. The forebody yawed left and pitched down, and the port X-link failed at the 582. The crew module shifted inside the forward fuselage, causing impacts & probable breaches (Vol. E damaged from below)

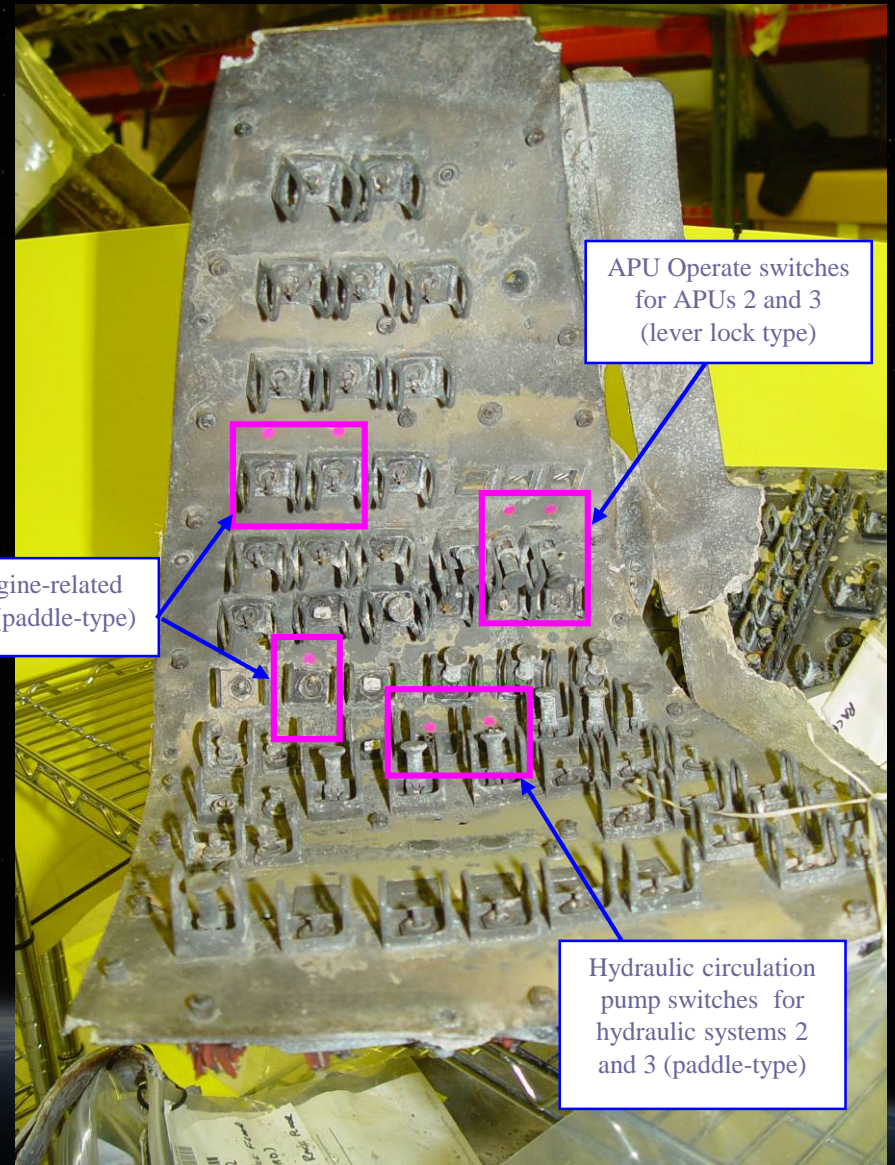
APU Operate switches for APUs 2 and 3 (lever lock type)

Hydraulic circulation pump switches for hydraulic systems 2 and 3 (paddle-type)
