Ceramic Capacitor Delamination Problem

Safety and Mission Assurance
Jack Shue, Senior Applications
Assurance Engineer

December, 2017

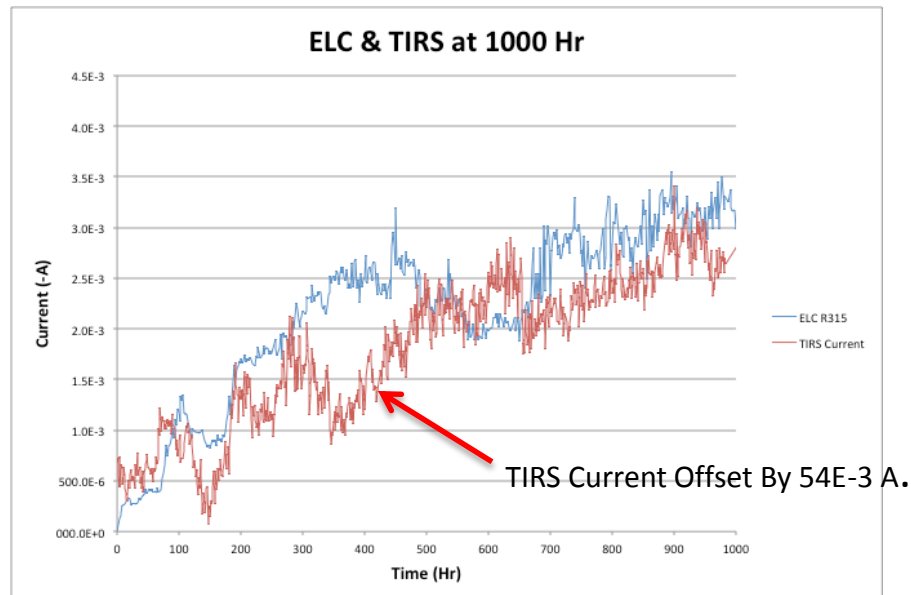
- In preparation for TIRS-2, Code 300 was reviewing anomaly history of TIRS, noting the behavior and open items on the fishbone
- Code 300 was concurrently performing reverse bias capacitor testing to support projects using the Express Logistics Carrier (ELC) on ISS.
- Behavior of the on-orbit leakage currents on TIRS bore a striking resemblance to the reverse bias capacitor performance in our ground testing

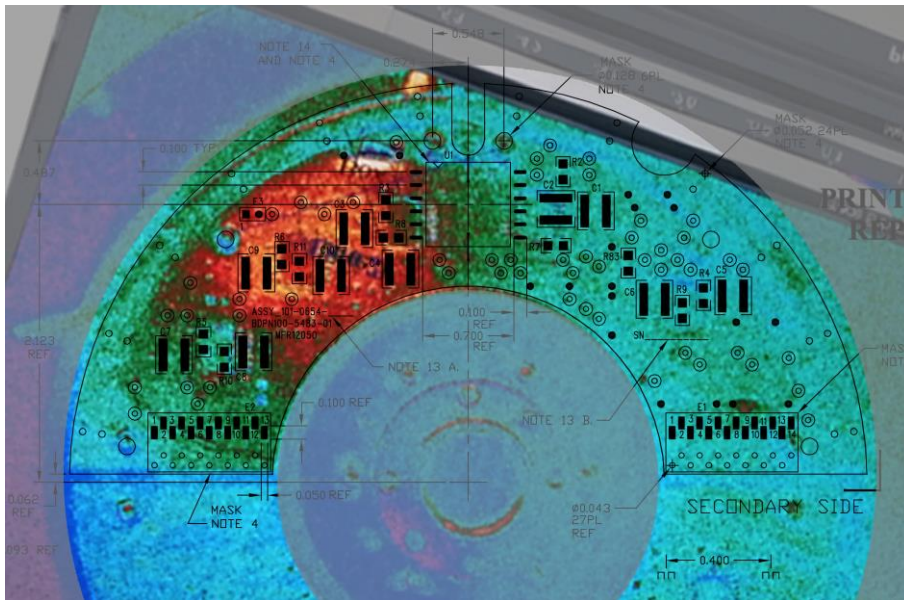
- After weeks of operation, noticeable locations of excessive temperature rise were seen on the board. These were located in the vicinity of some RC filters feeding into amplifiers on the board

Differential Temperatures
from Front of PWA

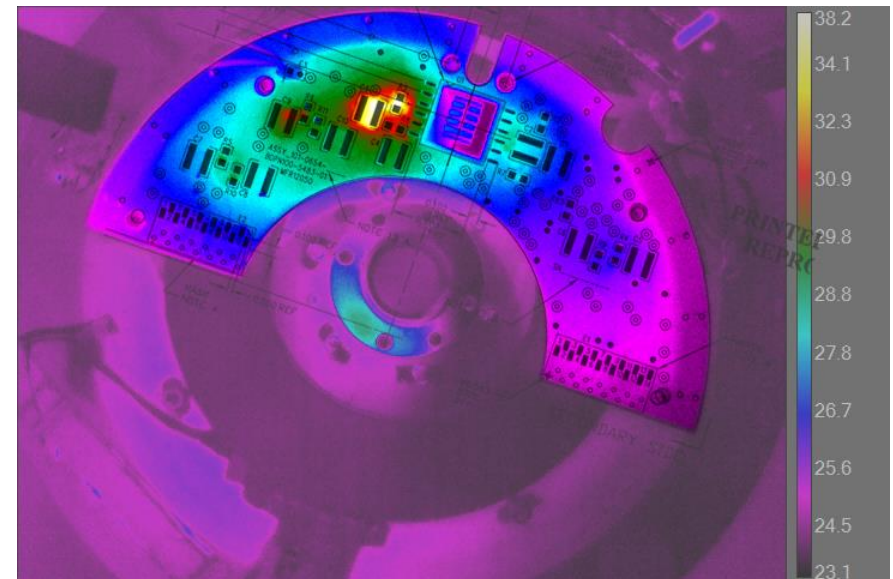
Actual Temperatures
Once the PWA was Inverted

- Localized heating gave a strong indication that the caps were cracked.
- The manufactures do not recommend hand-soldering of ceramic capacitors, and the "failing parts" were hand soldered.
- This is the first instance we have seen of cracked capacitors making it through I&T undetected and becoming anomalous on-orbit.
- In all cases the cracks on TIRS did not propagate to the surface of the part.

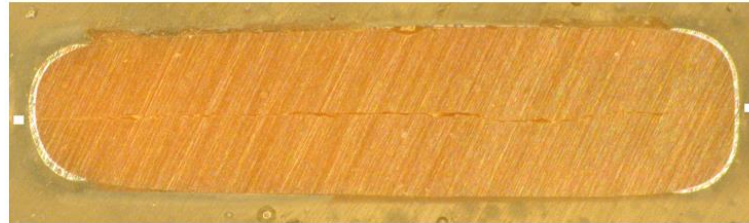
- Sectioning at the 5-percent cross section level found a delamination spanning between capacitor terminations.
- Cross sectioning continued to approximately the 10-percent level, at which the delamination was fully revealed and seen to extend from termination to termination of the capacitor.

Figure 1. A delamination spanning between terminations was found at the 10-percent level. Square dots in the image above mark the ends of the crack. Note that the cross section plane is near the end of the part and does not reveal the electrodes.

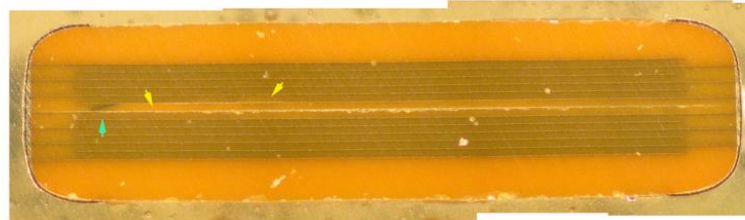
Figure 2. The 21-percent level with polish first reveals the electrode structure and simultaneously revealed a diagonal crack, marked by a green arrow, bridging between the center, and an adjacent electrode. This location is considered a likely candidate for the failure site. Yellow arrows mark a difference in layer color later shown to be caused by internal light reflection from a discontinuity in the dielectric. EDS found no material difference between the layers.

- Ultimately, the part was replaced and the rest of the lot remained in place
