NASA Electronic Parts and Packaging (NEPP) Program

NEPP Task: “Screening Techniques for Ceramic Capacitors with
Microcracks”

Susceptibility to Cracking of Different Lots of CDR35 Capacitors

Alexander Teverovsky

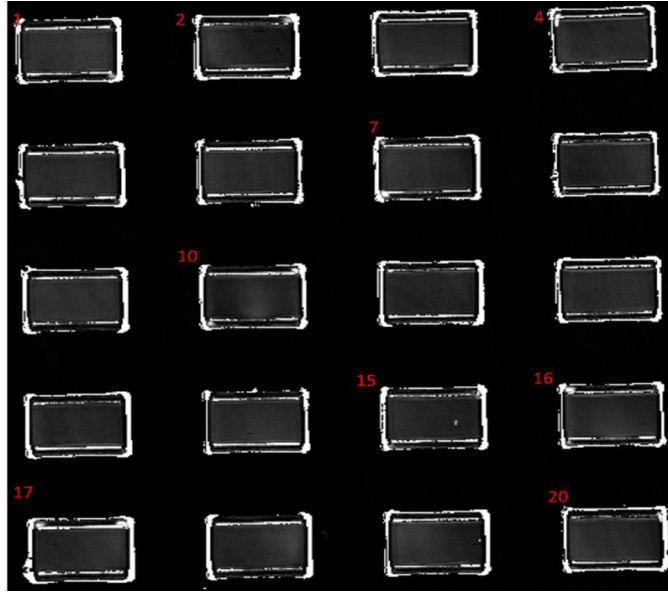
No anomalies in both lots of capacitors were observed during visual examinations using an optical microscope with magnification up to ten times. All capacitors from Mfr.C passed ultrasonic inspections, but some capacitors from Mfr.A had delaminations (see Fig.5.). Delaminations or possibly some internal cracks at the corners near terminations were detected in nine out of 20 tested capacitors (see details in report J17062 CSAM).

Figure 5. Results of bulk C-SAM scanning for 20 capacitors from Mfr.A (courtesy of Chris Greenwell, ASRC). Numbers correspond to the parts where delaminations were detected.

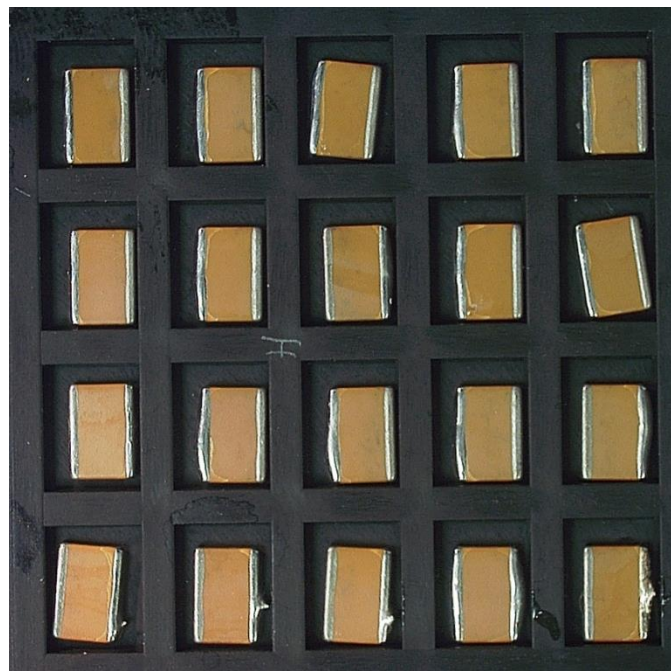
External visual examination of capacitors after terminal solder dip testing at 350 °C showed that capacitors from Mfr.C had only one sample with a tiny corner crack; however, all 20 tested capacitors from Mfr.A had significant corner cracking and in many cases the cracks were stretching along the whole terminal (see Fig.10). C-SAM inspections confirmed the presence of corner cracks and delaminations in capacitors from Mfr.A and did not reveal any anomalies in capacitors from Mfr.C (see Fig. 11).

Figure 10. Capacitors from Mfr.A after terminal solder dip testing.

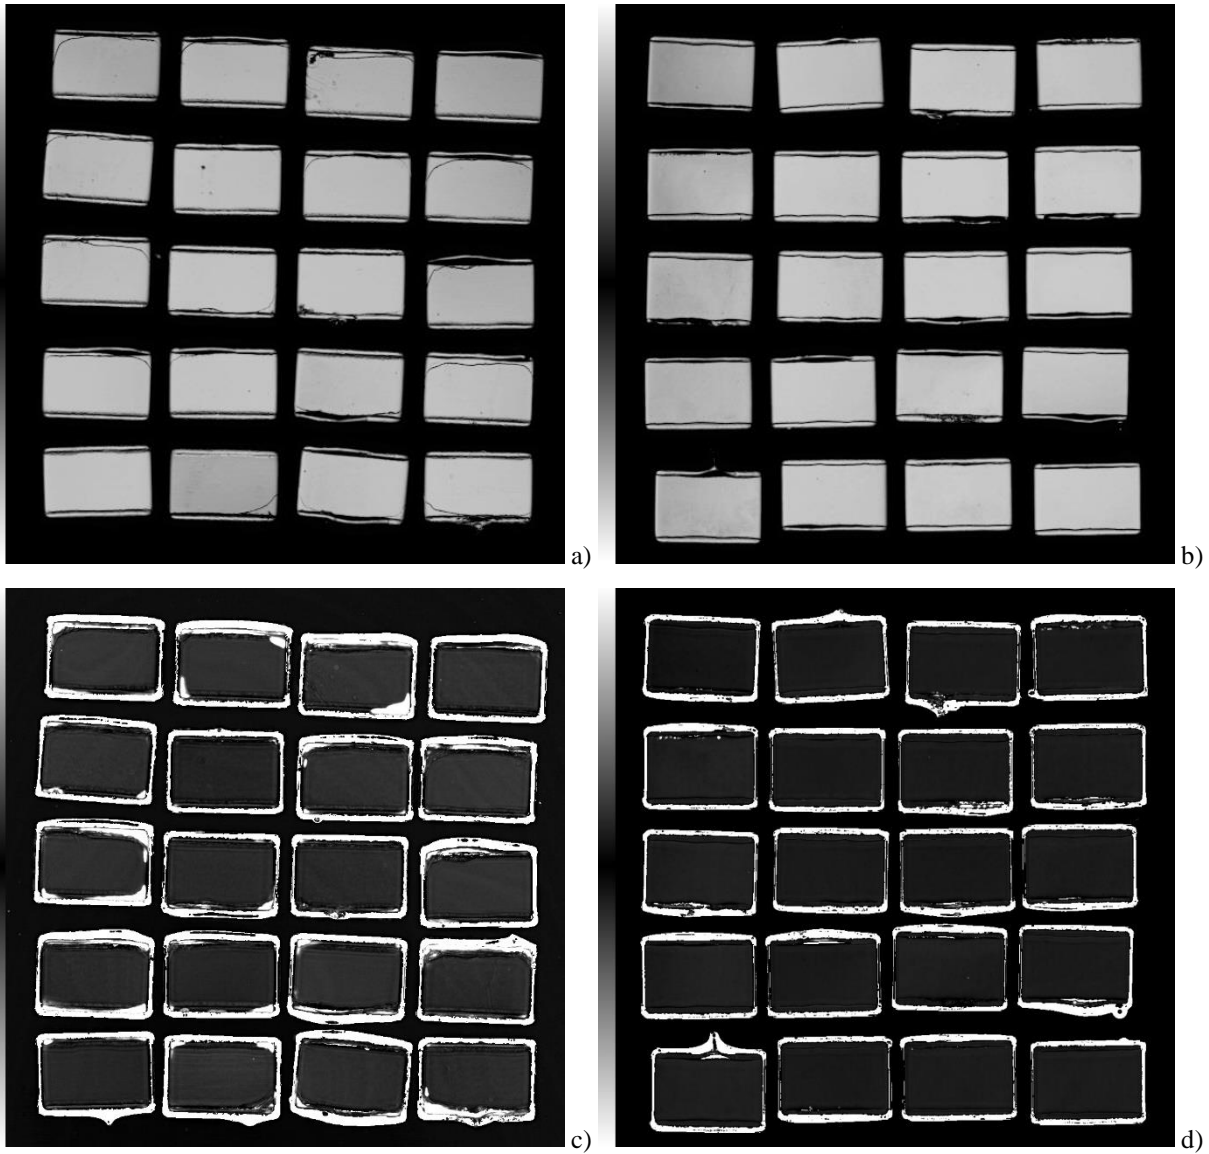
Figure 11. Surface (a, b) and bulk (c, d) scan acoustic images of capacitors from Mfr.A (a, c) and Mfr.C (b, d) after TSD350.

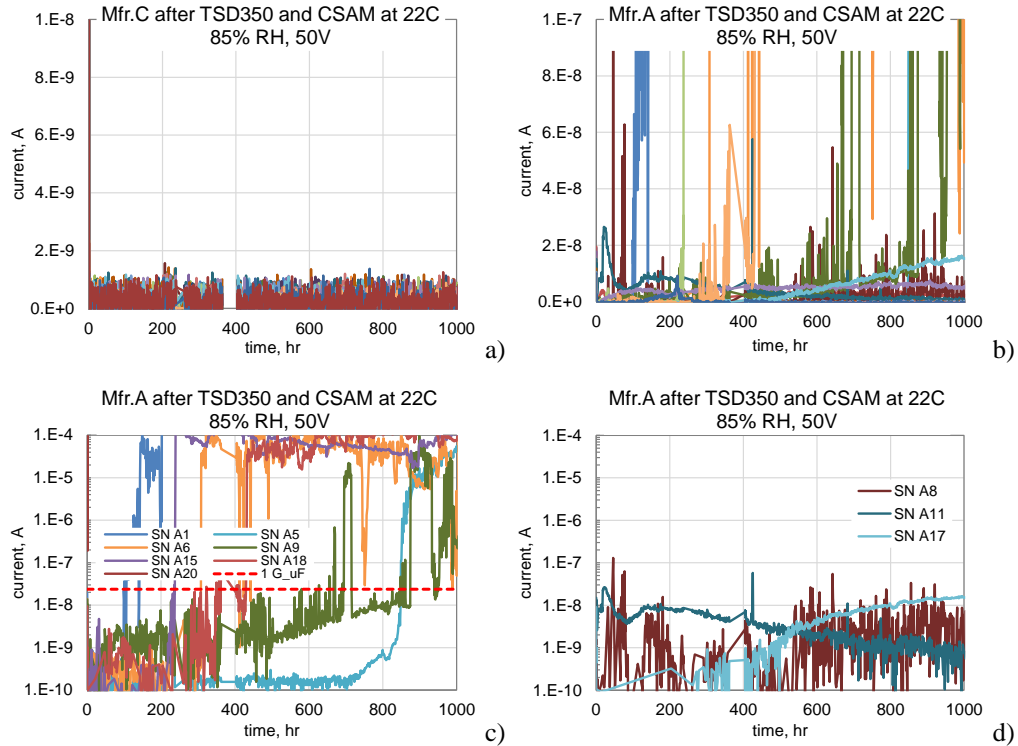
Finally, the test voltage was increased to the rated level, and leakage currents at 22 °C and 85% RH were monitored for 1000 hours more. Results of this testing are shown in Fig.14. All samples from Mfr.C remained below 1 nA, whereas 6 out of 20 samples from Mfr.A had leakage currents exceeding the formal criteria based on the requirements for $IR \geq 1 \text{ Gohm}_\mu\text{F}$ that corresponds to 23.8 nA at 50 V. The failures were observed after different periods of testing ranging from 100 to 860 hours (Fig. 14c); however, the failures were intermittent and the parts exhibited unstable currents even before the failures occurred. Three parts that did not formally fail the testing behaved also erratically (Fig.14d). A similar behavior of different lots of 0.47 μF 50 V capacitors was observed in our previous work [6], and is common for ceramic capacitors with cracks.

Figure 14. Leakage currents in CDR35 0.47 μF 50 V capacitors from Mfr.C (a) and Mfr.A (b, c, d) during 1000 hour testing at 22 $^{\circ}\text{C}$, 85% RH, and 50 V. Leakage currents in figures c) and d) have logarithmic scale to reveal details of the behavior of capacitors that failed (c) and had some spiking of currents that remained below the failure criteria (d).

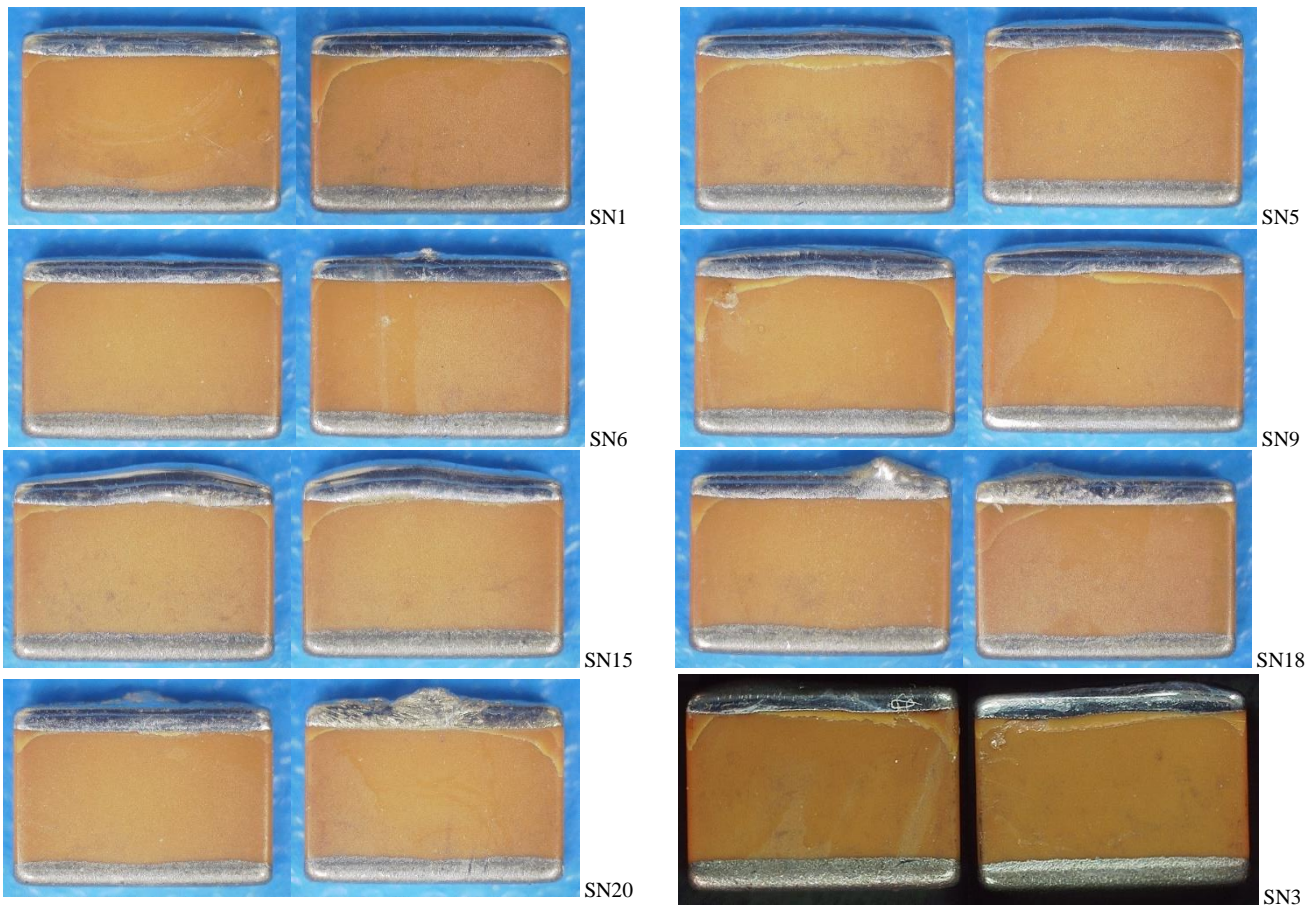
Optical images showing cracks at the solder dipped terminal in all failed samples are shown in Fig. 16. Note, that other samples, e.g. SN3, had similar cracks, but did not fail electrically. This means that the presence of corner cracks and delaminations does not necessarily result in electrical failures.

Figure 16. Two-side external views of the failed samples (blue background) and a sample with normal electrical characteristics, SN3.

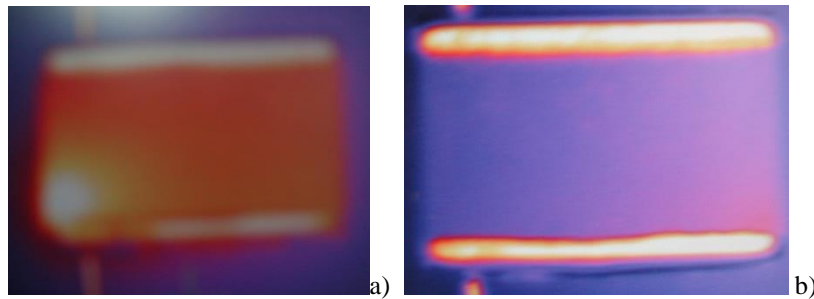
Due to low leakage currents, attempts to reveal hot spots in the parts using an infrared camera were not successful for any samples except for SN1 and SN5. The hot spots were clearly observed in SN1 and could be detected in SN5 (see Fig.18). In both cases, the shorting areas were at the corners of capacitors where the cracking was most significant.

Figure 18. Infrared images of SN1 (a) and SN5 (b) indicating hot spots at the corners of capacitors.

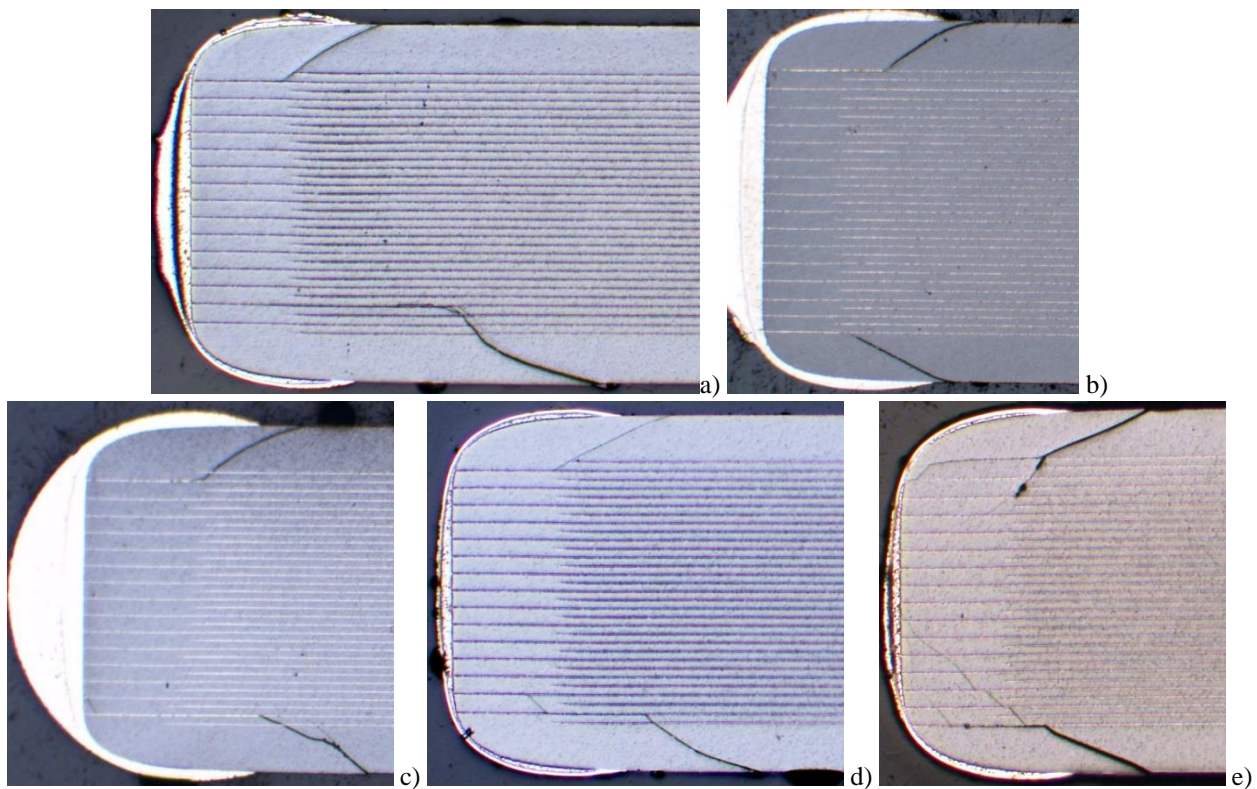
Overall views of cracks that were revealed near corners of the capacitors during cross-sectioning are shown in Fig.19. Typical close-up and SEM views of the cracks are shown in Fig.20 to 24. In all cases the cracks that apparently initiated at the surface of capacitors near terminals were directed through the cover plates towards the central area of terminals at an angle $\sim 45^\circ$. The cracks stopped at electrodes and propagated further along the electrode/ceramic interfaces. A similar appearance of the crack and delamination was observed during failure analysis of the part failed on the engineering BEI Encoder unit (report J16090FA). However, in that case, the crack was internal and originated likely from the delamination.

No conductive materials were revealed by SEM and EDS examinations. Still, most likely they were present somewhere inside the cracks as a result of electrochemical migration (ECM) that was accelerated by the presence of moisture and resulted in formations of a conductive path between the electrodes.

Figure 19. Overall views of crack revealed during cross-sectioning. a) SN1 $R \sim 18k$, b) SN5 $R \sim 100k$, c) SN15 $R \sim 10G$, d) SN18 $R \sim 20M$, e) SN20 $R \sim 1M$. The values of R were measured after each cross-sectioning step with a hand meter at ~ 0.7 V.

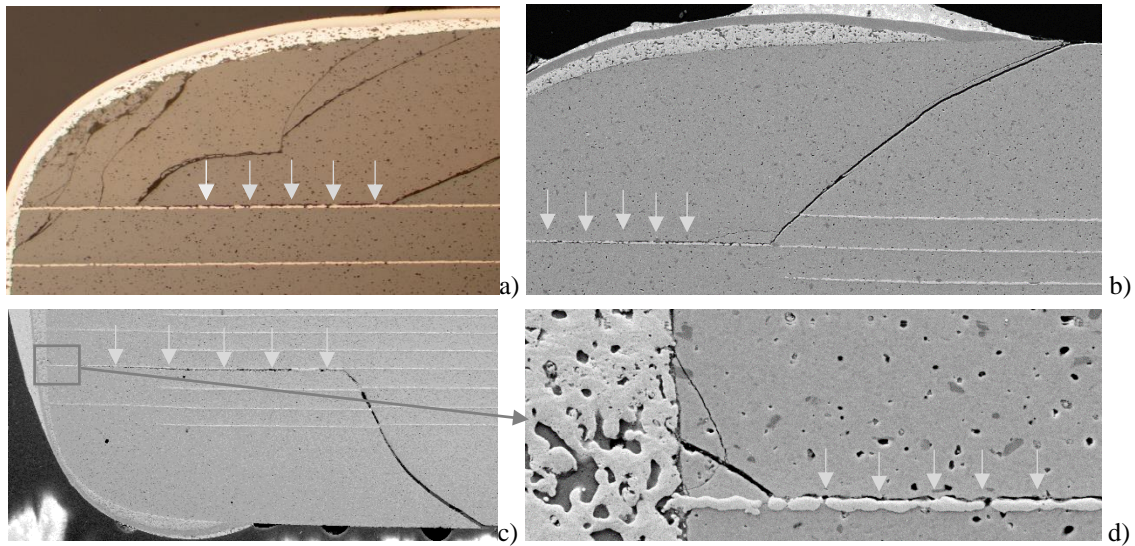
Figure 20. Close-up views of SN1 showing cracks and delaminations along electrodes. b) Top area of Fig 19a, step 2, R=17.7k. b) Top area of Fig 19a, step 4, R=41k. c, d) bottom area of Fig 19a, step 4 of cross-sectioning. Here and below arrows indicate delamination.

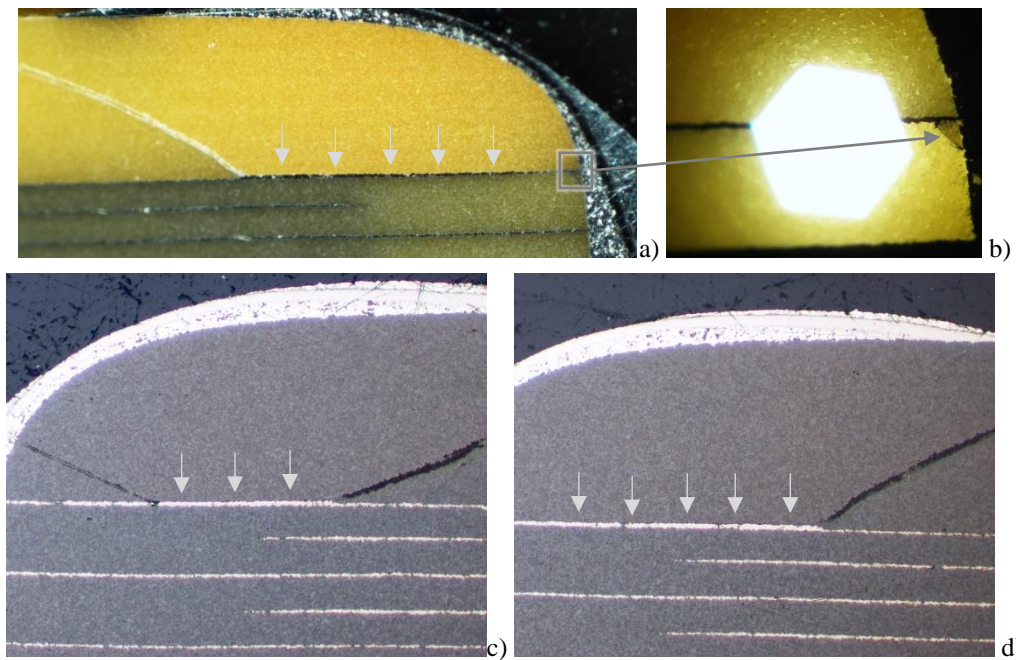
Figure 21 Close-up of the top (a, b) and bottom (c, d) areas of SN5 (Fig. 19b). A tiny crack between delamination and terminal (b) was revealed using the vicinal illumination technique. Apparently increased thickness of metallization after the crack crossing metal electrode (c, d) is likely due to delamination and smearing of the metal electrode.

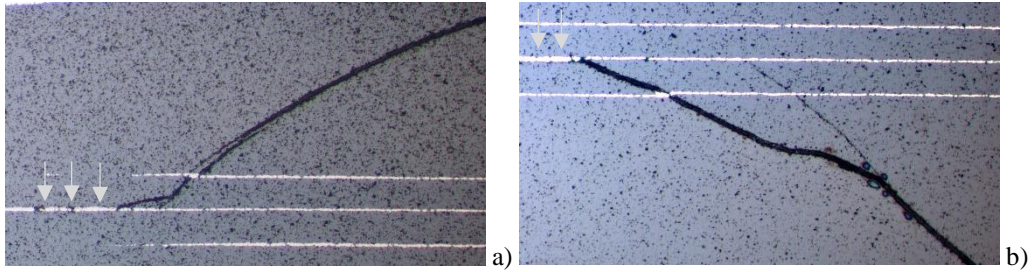
Figure 22. Cracks at the top (a) and bottom (b) corners in SN15 (Fig. 19c).

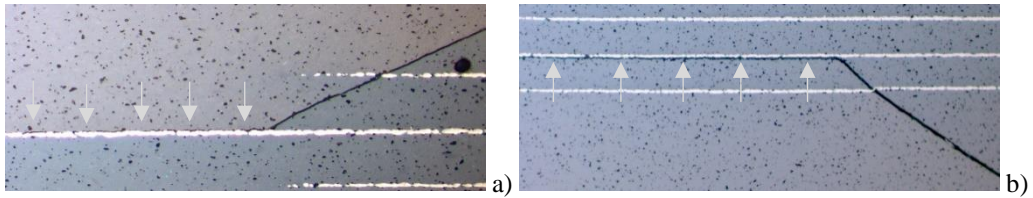
Figure 23. Cracks at the top (a) and bottom (b) corners and delaminations in SN18 (Fig. 19d).

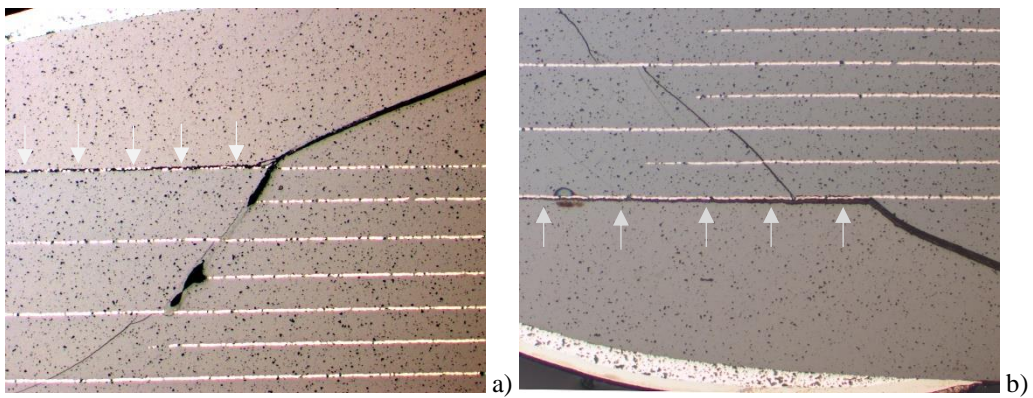
Figure 24. Cracks at the top (a) and bottom (b) corners and delaminations in SN20 (Fig. 19e).

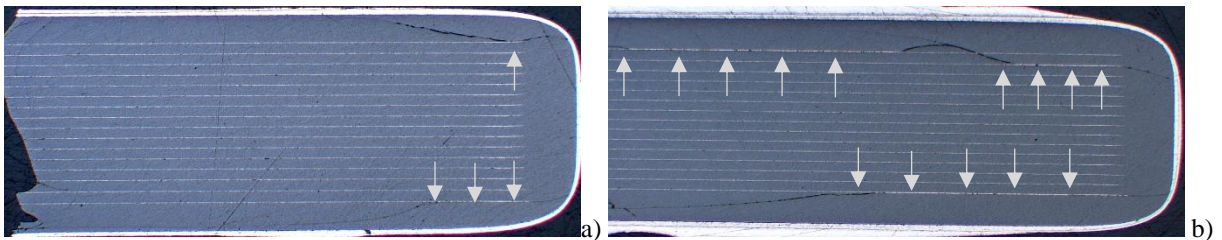
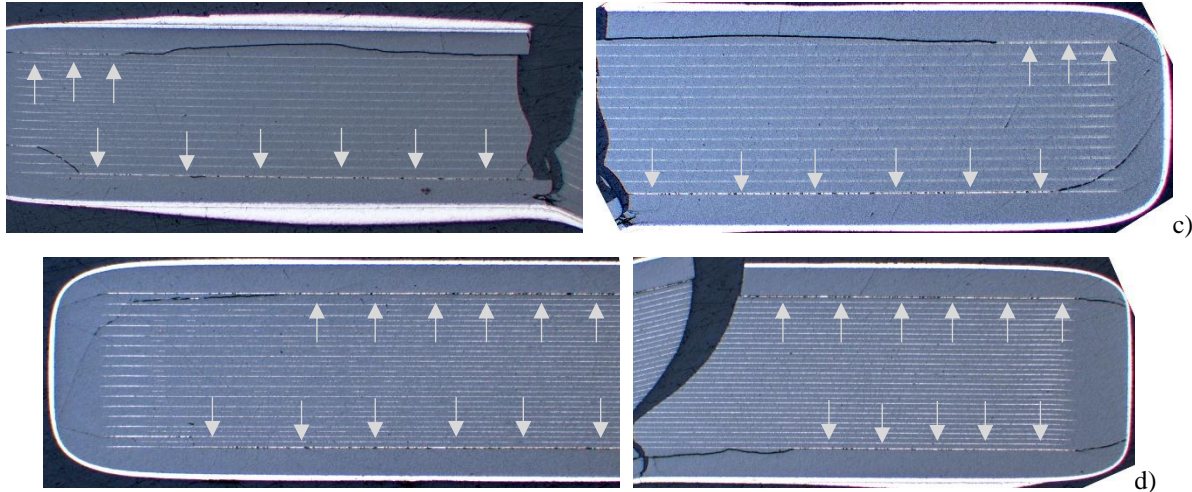
No delaminations were observed on virgin samples from Mfr.A and on both, virgin and post-TSD350 groups of samples from Mfr.C. Results of cross-sectioning for the post-TSD350 Mfr.A capacitors (see Fig.25) revealed delaminations along the electrodes similar to what was observed in failed samples. It appears that cracks initiated by fracturing propagated through the part along the electrode/ceramic delaminated interfaces close to the surface of capacitors.

Figure 25. Cross-sections along the terminals that were stressed by TSD350 for SN1c (a), SN2c (b), right and left portions of SN4c (c) and SN5c (d). The parts did not fail electrically during humidity testing, but were fractured in the middle before cross-sectioning.
