Advanced Stirling Radioisotope Generator Engineering Unit 2 Anomaly Investigation

*Edward J. Lewandowski
Glenn Research Center, Cleveland, Ohio*

This paper chronicles the EU2 anomaly investigation process that took place in 2015. Findings from the disassembly and inspection of the GHA and ASC–E3 convertors are discussed, along with the proximate cause of the power fluctuations. Extensive analysis, modeling, and follow-on testing was conducted, leading to possible failure theories and an assessment of likely root cause and conclusions. Recommendations are provided for future Stirling generator development.

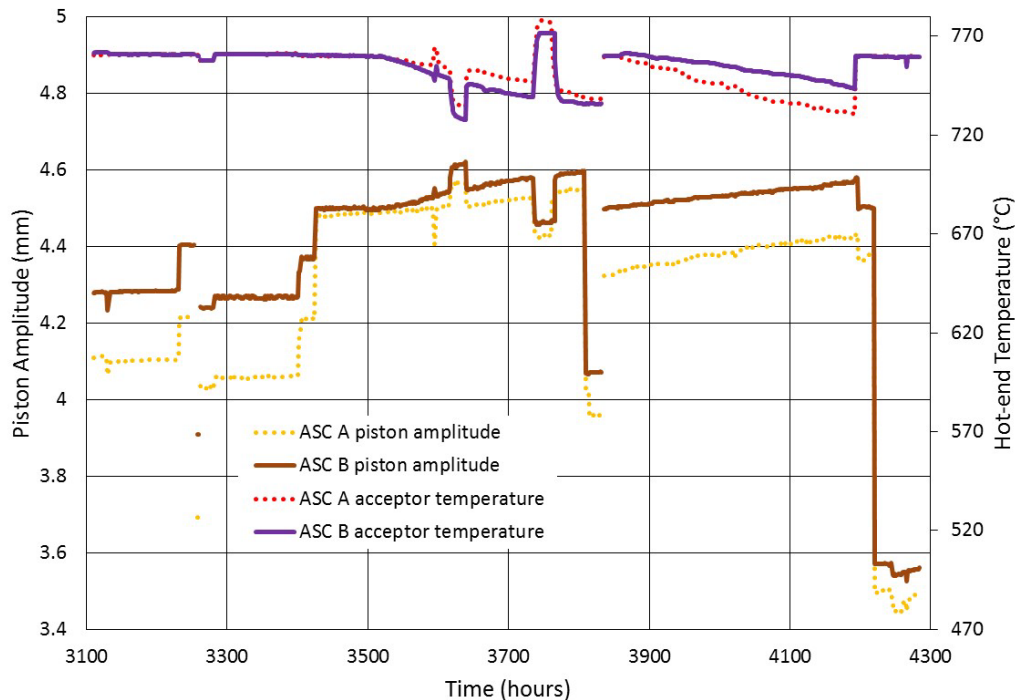
The fourth observation was a slow downward drift in hot-end temperature and upward piston amplitude over many hours. The drift began about when the EU2 began operation under fixed heat input at 3,495 hr of ASC operation. Previously, the hot-end temperature was fixed, and the test system adjusted heat input to maintain temperature. In Figure 6, the downward drift in hot-end temperature and upward drift in piston amplitude is clearly seen, superimposed on step changes in hot-end temperature and amplitude when the operating point was adjusted. This drift occurred under both ACU control and AC bus control, which began at 3,833 hr. The ASRG was designed to maintain hot-end temperature and piston amplitude open loop by controlling the ASC voltage setpoint, and this amount of drift was abnormal. This drift can also be seen in figures published previously. The downward drift in hot-end temperature is apparent in Figures 7 and 8 in Reference 2 and the upward drift in piston amplitude is seen in Figure 8 in Reference 2.

Figure 6.—Slow drift in hot-end temperature and piston amplitude during Engineering Unit 2 operation.

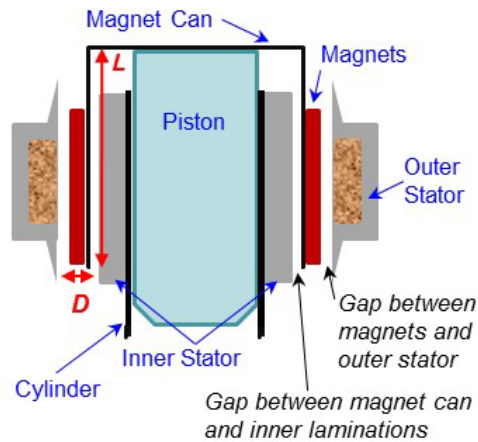
Figure 9.—Cross section of ASC alternator showing location of airgaps.

The magnet can clearance theory postulates that insufficient running clearance, possibly in combination with imperfect alignment of the magnet can within the airgap between the inner stator and the outer stator (Figure 9), could not accommodate all thermal and dynamic effects encountered during operation. This would result in rubbing contact between the magnets and outer stator and/or between the magnet can and the inner stator, initiating damage and eventual failure.
