**Corrosion Failure in Electronic Devices for Aerospace  
Application**

Michelle Pierre

NASA Kennedy Space Center

Michelle S. Pierre<sup>a</sup> and Eliza L. Montgomery<sup>b</sup>  
*NASA Kennedy Space Center, FL, 32899*

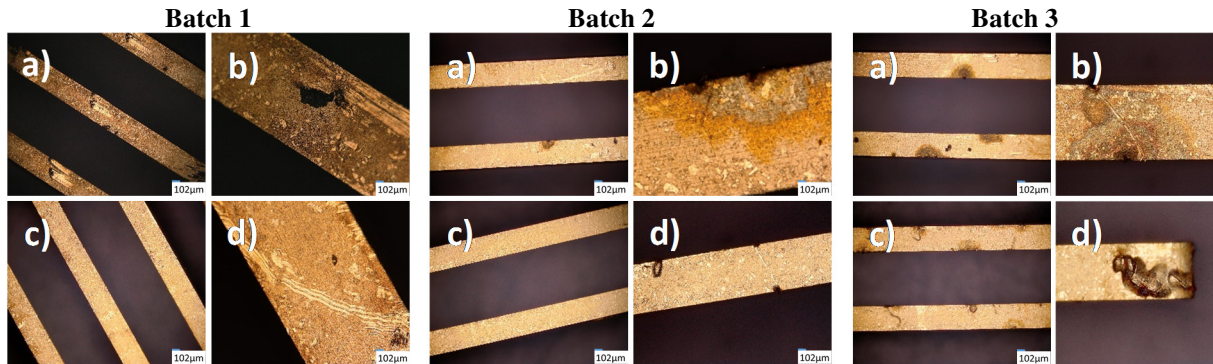
Optical microscopy was used to help identify and plot fundamental areas of failure on the pins of the optocoupler batches. A significant amount of damage were observed on each of the pins of the samples received as seen in Figure 4. Corrosion was not localized to just one area of the pins but rather randomly along the sides, surfaces, and tips of the pins. The gold top coating was prevalent with cracks, pitting, discoloration, and blistering. Additionally, symmetrical scratching marks from some type of mechanical device handling (Figure 4, Batch 1, a) were observed in all the batches. Additionally, various forms of blisters were observed in all the batches. For example, blisters erupted with corrosion product were the most common form that were found, but there were areas with intact blisters with no visual evidence of cracking or eruption, and blisters surrounded by cracks and/or pits. Figure 5 depicts 1000x magnification of the typical blistering found on the pins and is a clear example of blisters that erupted from the gold coating with corrosion product.

**Figure 4. Optical Microscope images of pins from Batches 1-3 showing various failures such as cracking, pitting, corrosion discoloration and unknown scratching marks.**

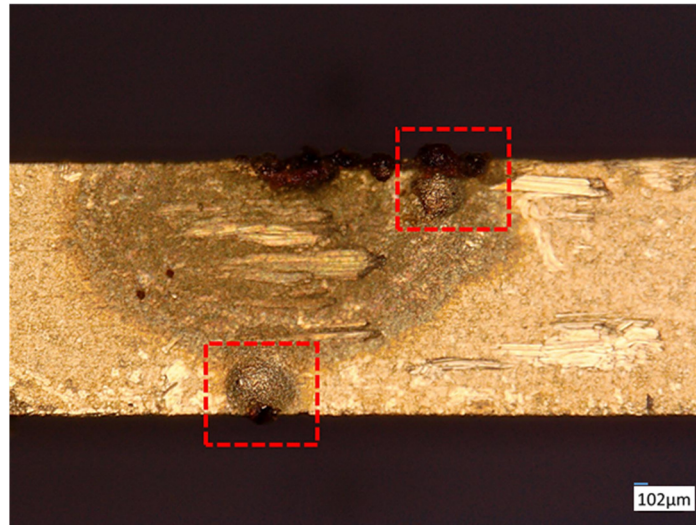
**Figure 5. Optical Microscope image of a pin from Batch 3 showing blisters impregnated with corrosion products outlined in red.**

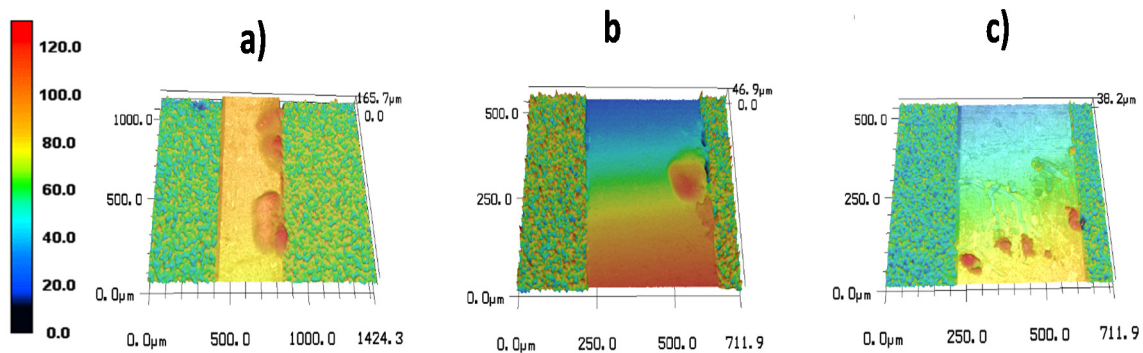
Laser microscopy of the three-dimensional surface of a typical blister found on the optocouplers are depicted in Figure 6. Profiles of various forms of: (a) blisters along the edge of the pin, (b) blisters with scratches and discoloration, and (c) blisters on the surface of the pin. The volume of the blisters varies presumably with time and continued exposure to the contaminant. The blisters tend to have a depth between 80-120 µm.

**Figure 6. Three-dimensional images of various blisters: (a) blisters along the edge of the pin, (b) blister with scratches and discoloration, and (c) blisters on the surface of the pin.**

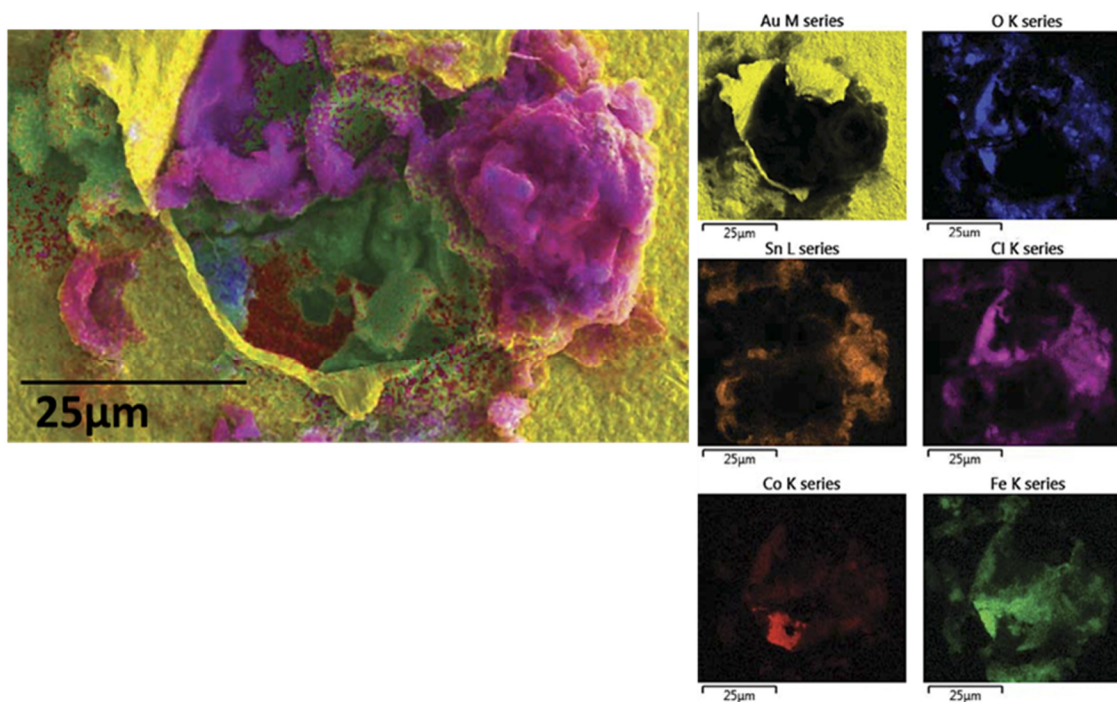
The overall EDS mapping seen in Figure identifies clearly the area of top coated gold and the interior layers under the top coat with contamination-related elements O, Sn, and Cl (Figure 7) <sup>5</sup>. The base metal is made from an alloy of Fe and Ni, and the strike plate is Ni. The soldering contains Co and Cu in small quantities. These elements can be accounted for although they should not be exposed above the Au plating when in service. Figure 8 shows the different surface morphologies found on the samples: (a) area of pin with no surface defect or discoloration thus corrosion product should not be present, (b) area directly on top of the pin with an erupted blister surrounded by corrosion product, and (c) an erupted blister on edge of the pin. Figures 9 – 13 show the SEM data and EDS analysis for optocoupler batches received and the major systematic corrosion failures are identified along with the chemical components found in the corrosion products. Figure 9 depicts pins from sample Batch 1. Spectrums (1) is a sample

Figure 7. Combined EDS Mapping of an erupted blister.<sup>5</sup>

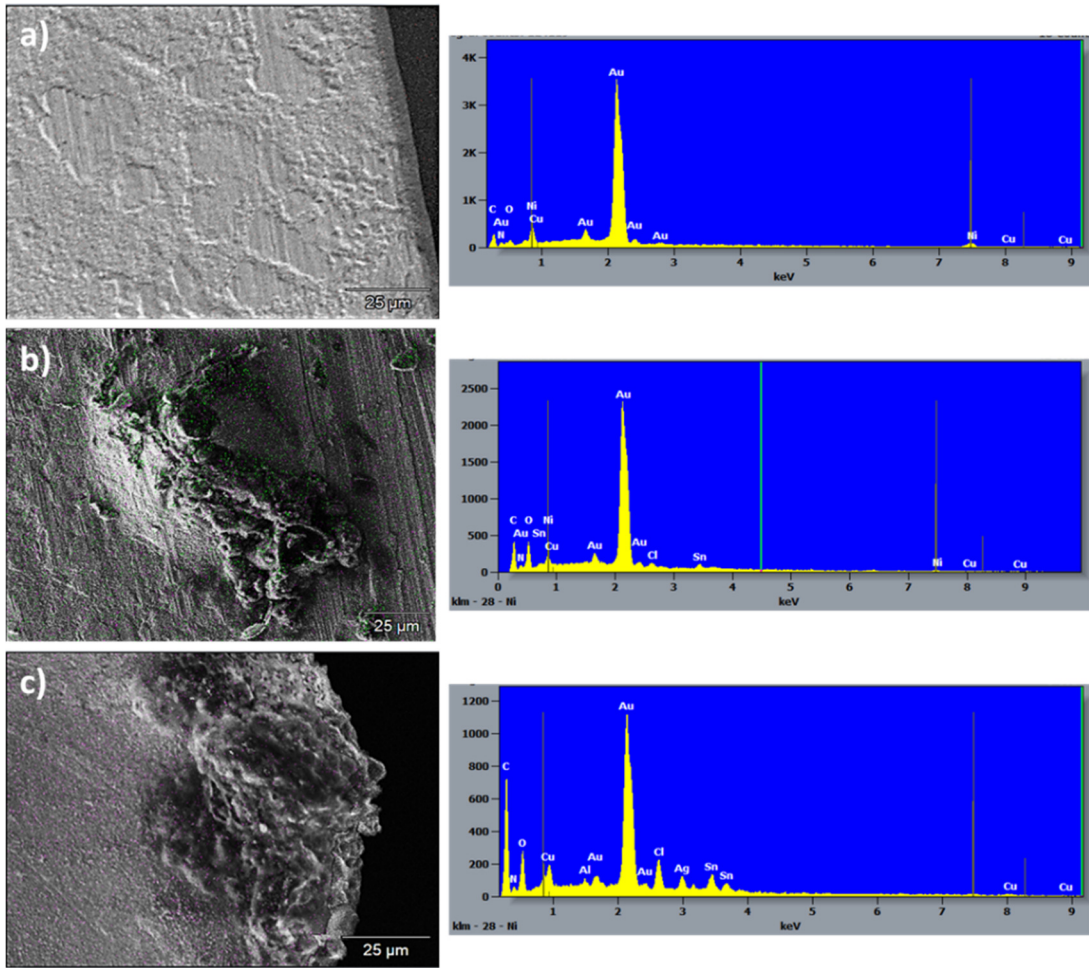
Figure 8. SEM images (left) and EDS analysis (right): (a) defect free surface area, (b) blistering with corrosion eruption on the surface of the pin and (c) blistering on edge of the pin.

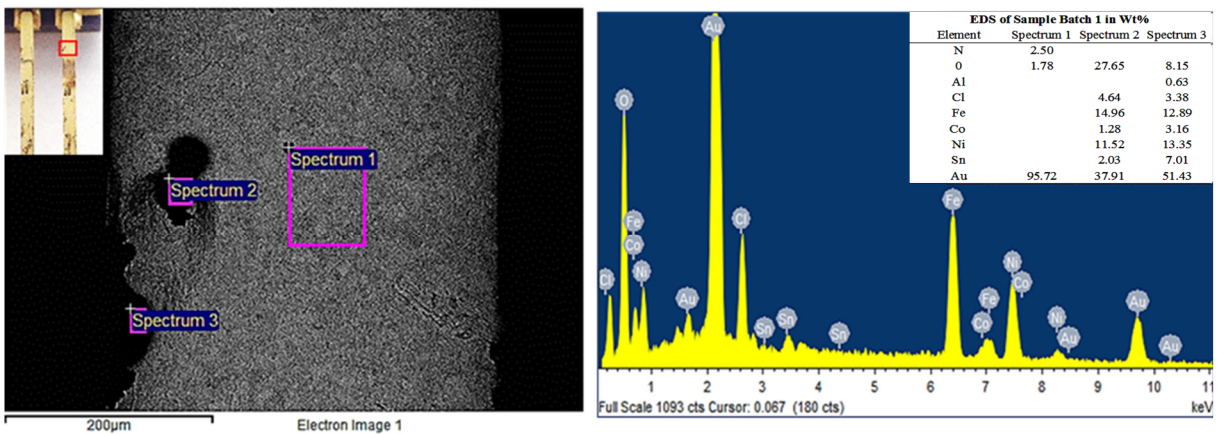
Figure 9. SEM and EDS analysis of optocoupler batch Batch 1.

area on the pin that shows no mechanical or corrosion defects and is considered a control area, (2) is a typical pitting hole, and (3) larger pitting area on the side of the pin. The EDS chemical analysis indicates that Spectrum 1 has no elemental detection of corrosion products while spectrums 2 and 3 have several contaminants identified as Cl, Fe and Sn. The amount of Au in the pitting areas is significantly less than seen in spectrum 1. Spectrum 1, the control area, is composed of primarily of Au and minor contributions of N, and O.

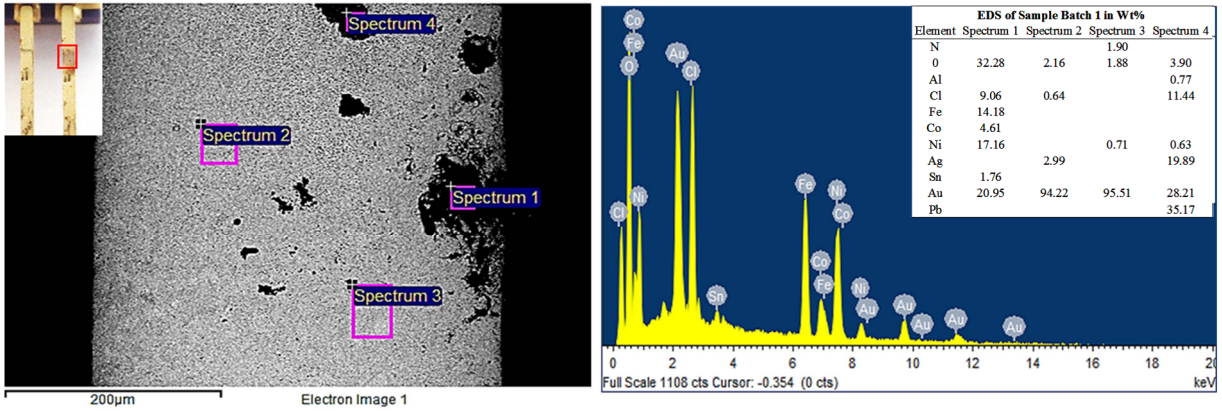
Figure 10 is from Batch 1 from areas with severe discoloration and pitting. Spectrums (1) is taken from an area of the pin with a large pit, (2) has minor defects (3) shows no visual indication of having any defects, and (4) pitting area. EDS analysis of Spectrums 2 and 3 shows no elemental detection of typical corrosion products while spectrums 1 and 4 have several contaminants such as Cl, Fe, and Sn. The amount of Au in the pitting areas is significantly less than the other spectrums. Spectrum 2 had both Ag and Cl elemental contaminants probably due to corrosion diffusion however the source of the Ag is unknown. Figure 11 depicts pins from sample Batch 2 that showed visual signs of discoloration. Spectrums 1, and, 3 have various pitting while spectra 2 and 4 are taken in an area with little defect. EDS analysis of Spectrum 2 shows no elemental detection of typical corrosion products while spectrums 1, and 3 have contaminants such as Cl, Fe, Ni, and Co. The amount of Au in the pitting areas is significantly less than the other spectrums. Figure 12 is the analysis of Batch 3. The sample area used is taken from an area on the edge of the pin that was severely damaged and showed signs of cracking. Spectrums from areas 1, 2 and 3 were all taken in cracked areas that shows detection of Al, Cl, Cu, and Ag elemental contaminants. Figure 13 is from Batch 3 and the area of interest is erupted blister with severe discoloration. Spectrums from area (1) has no visual defect but is on top portion of the blister that didn't erupt, (2) is an area on top of the blister with a minor crack, and (3) is the area where the blister has erupted. EDS analysis of Spectrums 1, 2 and 3 shows detection of several contaminants. However, Cl was only identified in spectrum 3 which has the lowest amount of Au detection.

Figure 10. SEM and EDS analysis of optocoupler Batch 1 taken in an area that is visually discolored and without discoloration.

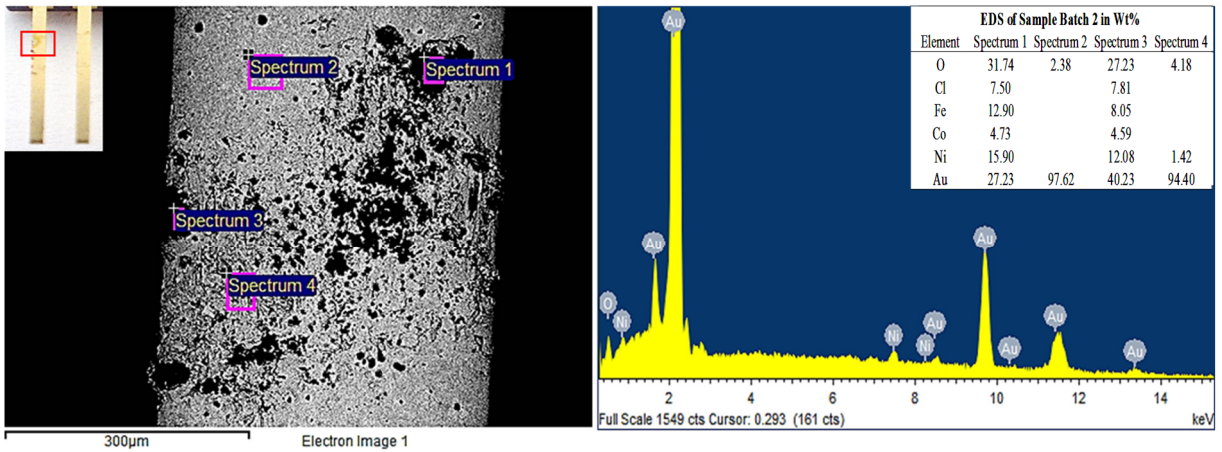
Figure 11. SEM and EDS analysis of optocoupler Batch 2 taken in an area that is visually discolored.

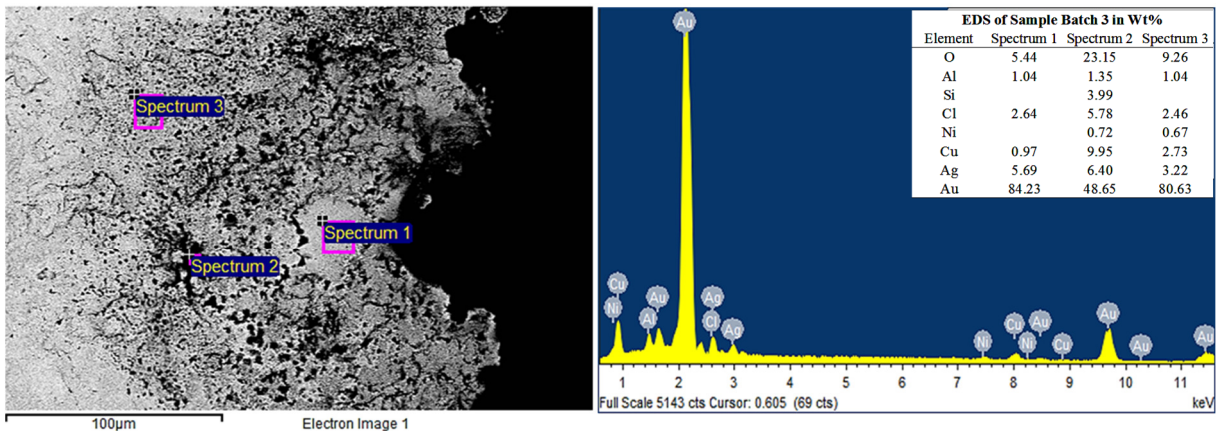
Figure 12. SEM and EDS analysis of optocoupler Batch 3 taken in an area that is severely damaged with cracking and flaking.

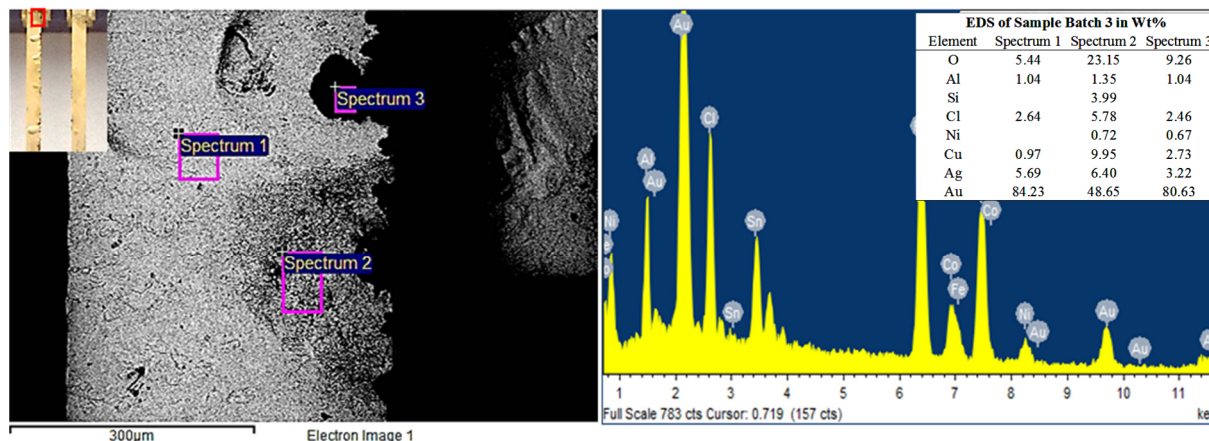
Figure 13. SEM and EDS analysis of optocoupler Batch 3 taken in an area that is visually discolored and blistered.

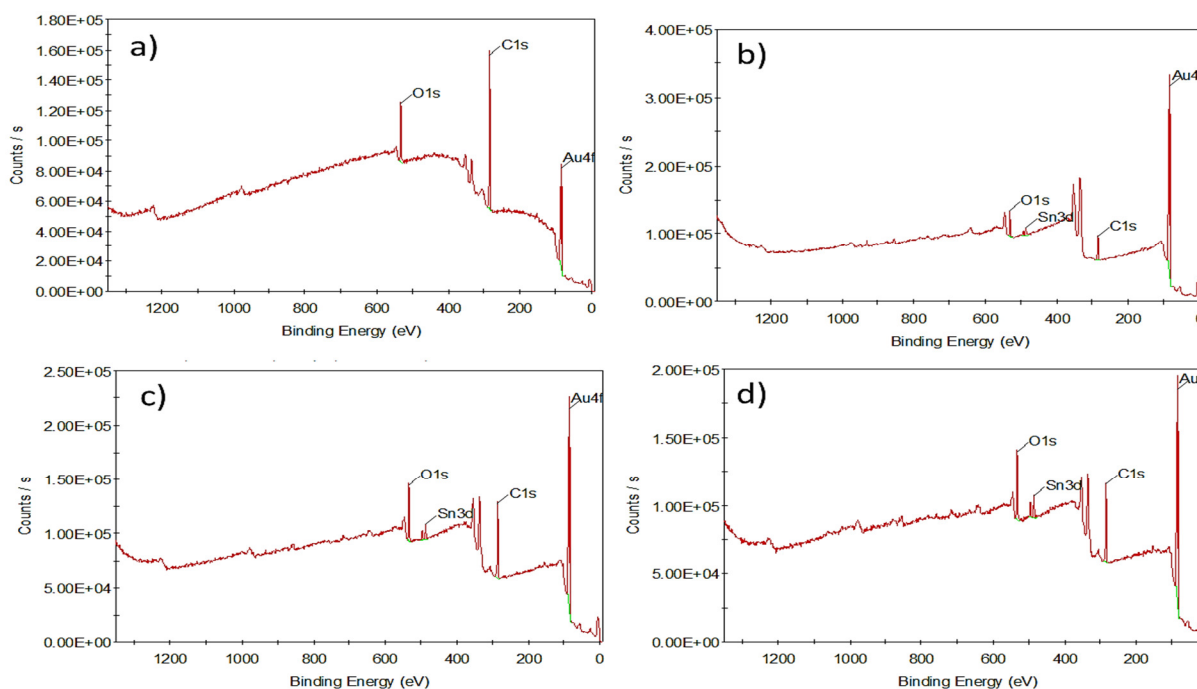
Figure 14 shows the XPS spectra for Batch 1, Batch 2, and two places on Batch 3. The typical spectrums show components of Au, C, O and minor Sn was found in Batches 2 and 3. There is no clear indication of corrosion contaminants on the surface. This analysis was limited by the size of the pins on the optocoupler and the size of the blisters were around 10-30  $\mu\text{m}$  thus making it challenging to focus the x-ray beam directly on the corrosion products identified in the optical microscopy and SEM.

Figure 14. XPS Analysis of Optocouplers from (a) Batch 1 , (b) Batch 2, and two locations in Batch 3 (c) and (d).
