Capture Latch Assembly for the NASA Docking System

Abstract

This paper will present a summary of the Design, Development, and Qualification of the Capture Latch Assembly (CLA) for the NASA Docking System (NDS) Block 1 (NDSB1). The CLA is an integral part of the Soft Capture System (SCS) of the NDSB1, serving the purpose of connecting the mating SCS Rings of two docking vehicles. The paper will present an overview of the function of the CLA and its basic concept of operations, including a summary of the major components of the CLA. The development, qualification, and production of the CLA will then be described. Particular focus will be provided on two major issues that occurred during production and qualification of the CLA. The first issue was failures of the CLA Motor (CLM) during acceptance testing (AT). The failures of the CLM were ultimately determined to be due to design defects and manufacturing errors in the motor commutation sensor assembly. The second issue was failure of the secondary release mechanism, or Contingency Capture Latch Release (CCLR) mechanism during development and qualification testing. The CCLR failures were found to be a result of excess free play in t

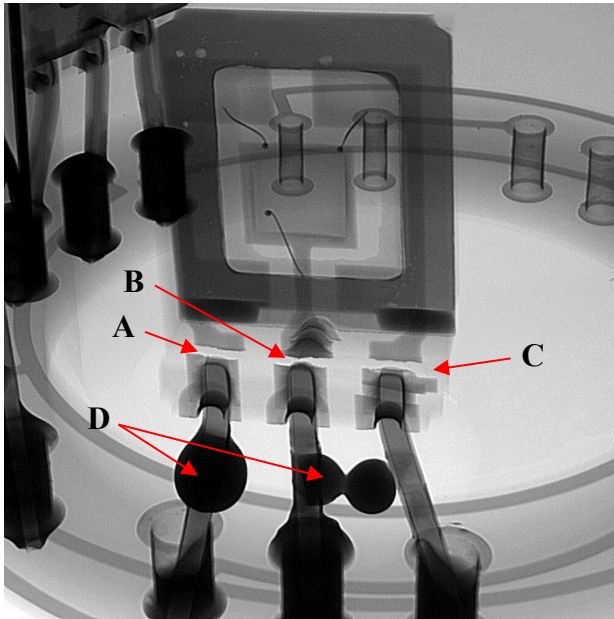
Figure 5. HED X-Ray Showing Cracked Lead

to avoid heat related damage that occurred during the disassembly of the motor in Failure 1. High resolution imaging and X-Ray imaging was performed on the HEDs, which ultimately revealed the cause of the failure, cracks in the HED and HED lead wires, as shown in Figure 5 (items A, B, and C) and Figure 6 (item A). The imaging also revealed the presence of large voids in the potting compound used to fix the HEDs in place, as shown in Figure 5 (item D) and Figure 6 (item B).

Once the fault had been isolated to the HED leads, a root cause analysis was performed to determine why the cracks in the leads had occurred with two contributing factors identified. First, it was noted that the HED leads were splayed apart during assembly to align with holes in the printed circuit board, as shown in Figure 5. The reason the leads were splayed apart during assembly was that an existing circuit board, designed for HED's with different lead spacing, was used for the Capture Latch motor to

minimize development costs. While NASA processes do allow for forming of leads in situations like this, a minimum distance must be maintained between bends in the leads and any joints. In this application, the minimum distance was not maintained for the solder joint at the body of the HED, resulting in stress concentrations at the solder joint and ultimately crack formation over time.

The second contributing factor and root cause was thermal induced stresses in the HED and its lead wires caused by voids in the potting material. These voids allowed for large thermal gradients between the exposed and unexposed portions of the HED, leading to large component stresses and crack formation. The voids were a byproduct of the process for applying and curing the potting material which did not sufficiently eliminate entrained air bubbles prior to curing. The voids were caused by weaknesses in the degas process, and by difficulties containing the potting material prior to curing in the small surrounding volume. Additionally, it was found that differences in the Coefficient of Thermal Expansion (CTE) of the potting material and adjacent materials contributed to the high stresses in the HED.

There were a number of corrective actions performed to resolve this issue. First, the primary root cause was addressed by changing the potting material to a new type that was easier to remove entrained air bubbles and with a CTE that was more compatible with the encapsulated materials. The degas process was improved to ensure bubbles were removed from the potting material and the HED was also encased in RTV silicone to cushion it during thermal expansion. Additional measures were also taken to ensure that if a motor with large voids was produced in spite of the improved processes, it would be flagged and removed from use. To that end, inspections of the potting material were implemented so motors with large voids are rejected. Additionally, the motor testing process was revised (both at the supplier and at Boeing) to include oscilloscope based current monitoring to confirm all HED operate nominally. Furthermore, a

secondary corrective action changed the circuit board design to allow for installation of the HEDs without lead forming.

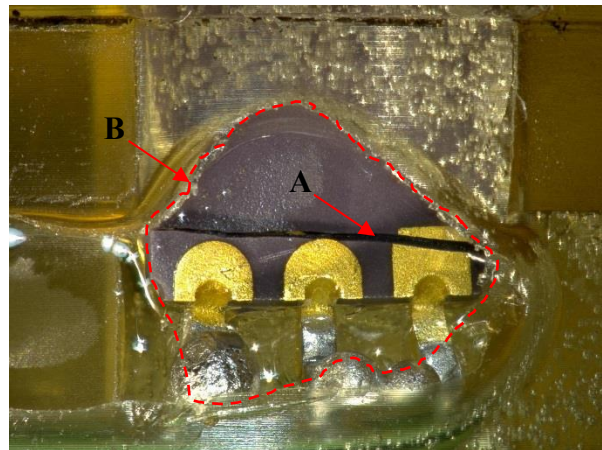
Figure 6. HED Image Showing Body Crack

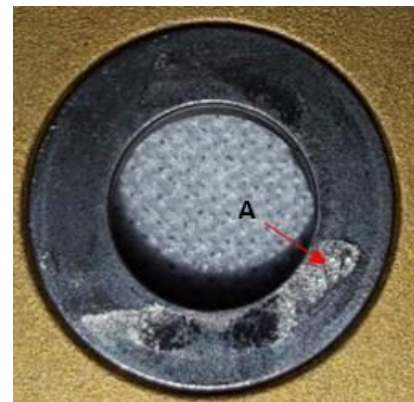
Figure 8. NEA Load Washer

reviewing all data and developing the fault tree, the team determined that the first investigation step should be the teardown and inspection of the secondary release mechanism. The most significant finding of the teardown was the identification of wear marks potentially consistent with galling found on the load washer inside the NEA. The load washer is part of the NEA Cover and has the surface that reacts the load from tension applied to the NEA shaft. Figure 8 shows the load washer and Figure 11 item B shows the approximate position of the load washer in the mechanism. The apparent galling is evident in the silver area on the otherwise black surface of the load washer, as noted as item A in Figure 8.

Based on these results it was determined that the mechanism should be redesigned to remove free play. The design improvement was implemented by installing flat washers and Belleville washers on the pins to remove all gaps, with a slight preload, as shown in Figure 11. Additionally, the NEA was given a small preload. The development capture latch was rebuilt with the redesigned configuration and subject to the same set of tests. The redesigned configuration showed no signs of the galling/excess wear. The Qualification Capture Latch was then rebuilt per the new configuration and subjected to random vibration testing and a secondary release test. The unit passed and was shown to have no excessive wear during a post-test inspection.

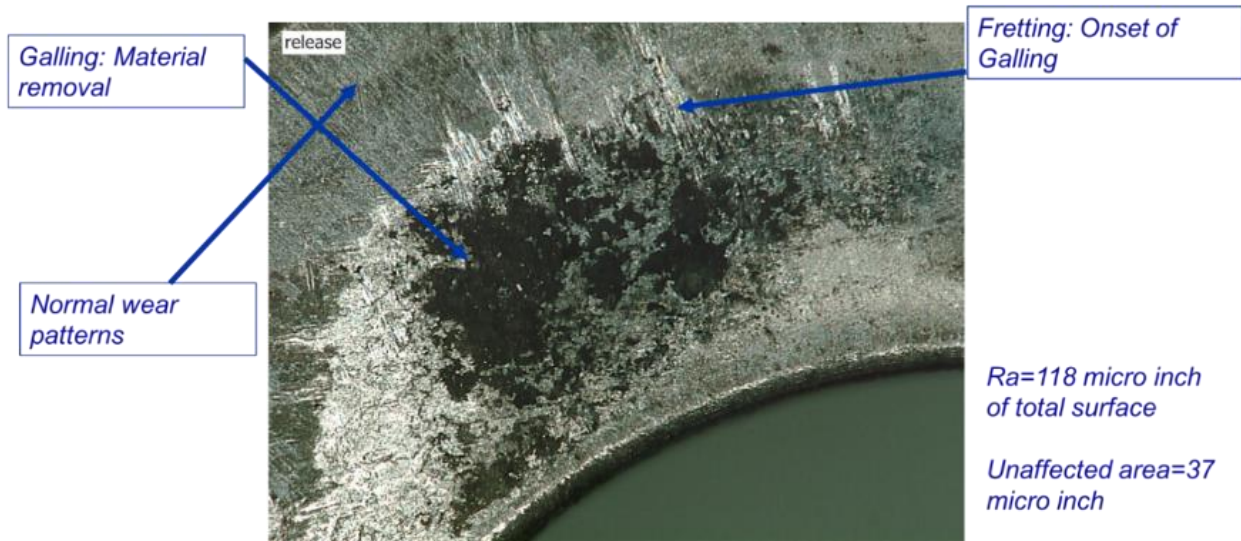
Corresponding wear marks were also observed on the spool half that was located against this surface. Both parts were examined using a laser profilometer, light microscopy, and a scanning electron microscope to determine whether galling of the wear surfaces had occurred. As shown in Figure 9, the profilometry analysis showed that material on the load washer was displaced and removed. The light microscopy measurement confirmed the presence of fretting and galling, as shown in Figure 10. From these results, the investigation team concluded that the most likely cause of the failure to release was galling of the load washer to the spool inside the NEA. The team’s next task was to determine the cause of the galling.

Figure 10. Load Washer Light Microscopy

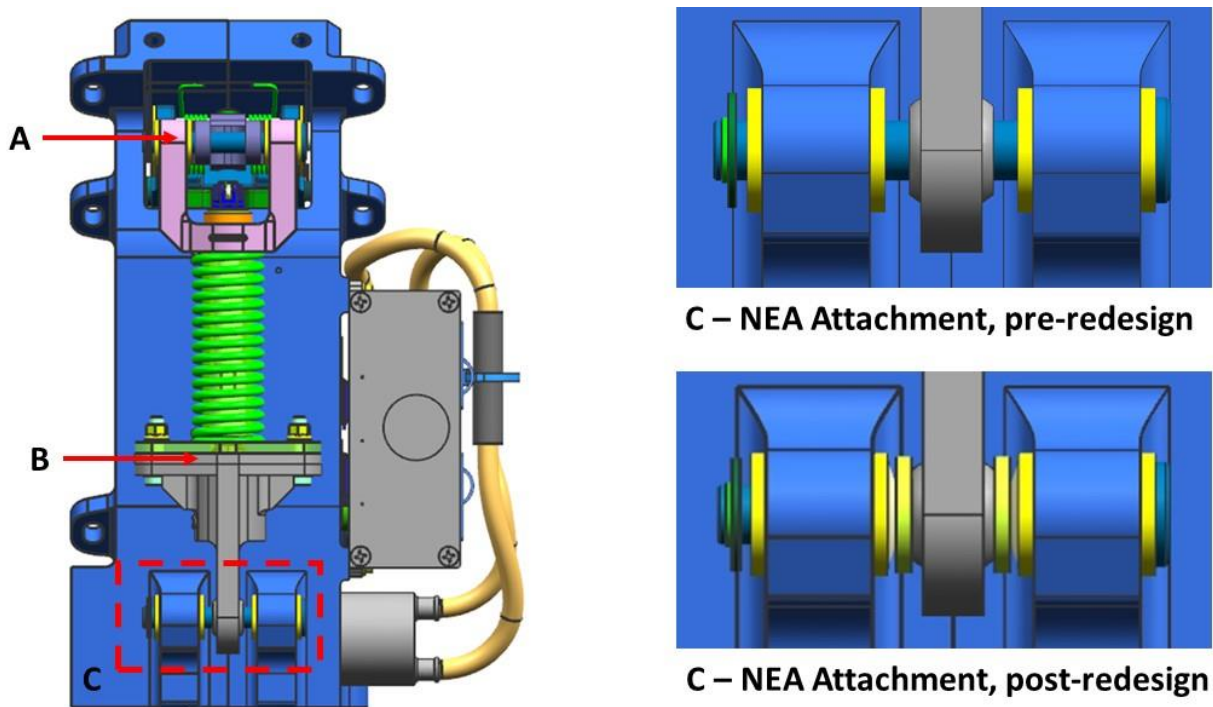
This test was informative, showing that the motion of the mechanism was extremely violent, subjecting it to nearly continuous shock loads as the mechanism shifted between the hard stops on either side of the free play. This motion was especially evident during testing in the axis parallel to the pins. Following the completion of the vibration testing, the unit was subjected to a Secondary Release Test, which it passed. The NEA was disassembled and similar wear was observed. Although the failure could not be duplicated, the excessive wear was duplicated and the test was considered successful.

Figure 11. CCLR Detail
