NASA/TM-2018-219829

A Summary of Results from Two Full-Scale Fokker F28 Fuselage Section Drop Tests

Justin D. Littell
Langley Research Center, Hampton, Virginia

May 2018

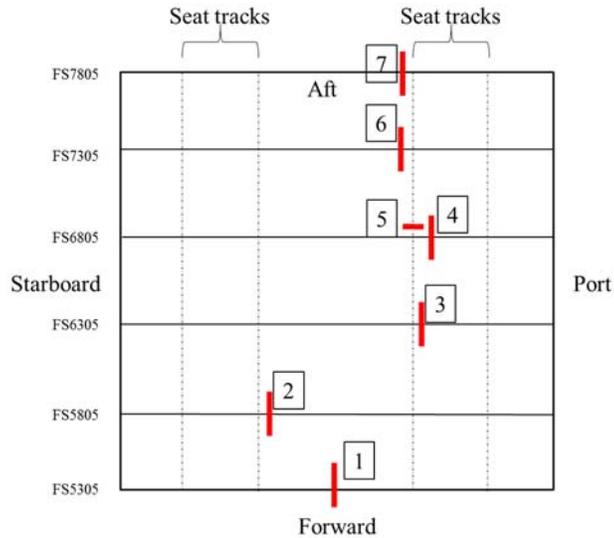
Figure 19 - Failure locations in the floor support structure and seat tracks

Post-test inspections of the airframe showed failures in all of the floor support lateral stiffeners. However they were non-uniform, and did not follow a discernable pattern. A diagram highlighting complete failures of floor support stiffeners, depicted by red dash, is shown in Figure 19. The numbered items only depict where a stiffener completely separated in half. Much of the other floor support structure buckled, bent, and partially tore as well, but, for clarity, are not labeled in Figure 19.

The failure pattern in the floor support structure at first appeared to be random and did not correlate to either a particular seating position or a place of overall stiffness discontinuity leading to high stress concentration (i.e. the cargo door). Upon closer inspection; however, it was determined that many of the specific failure locations were instead caused by the luggage interaction with the specific floor stiffener locations throughout the impact. The onboard and ground cameras were able to capture some of the exterior failures, but they were not able to cover all of the interior failures due to blockage of the failure from the luggage, floor, or both. Post-test inspections provided guidance in failure initiation and propagation for the interior members. The first interior failure inspected post-test was at location #2. A picture of failure in location #2 from Figure 19 is shown in Figure 20. Note that this failure was only visible once the floor and seats were removed.

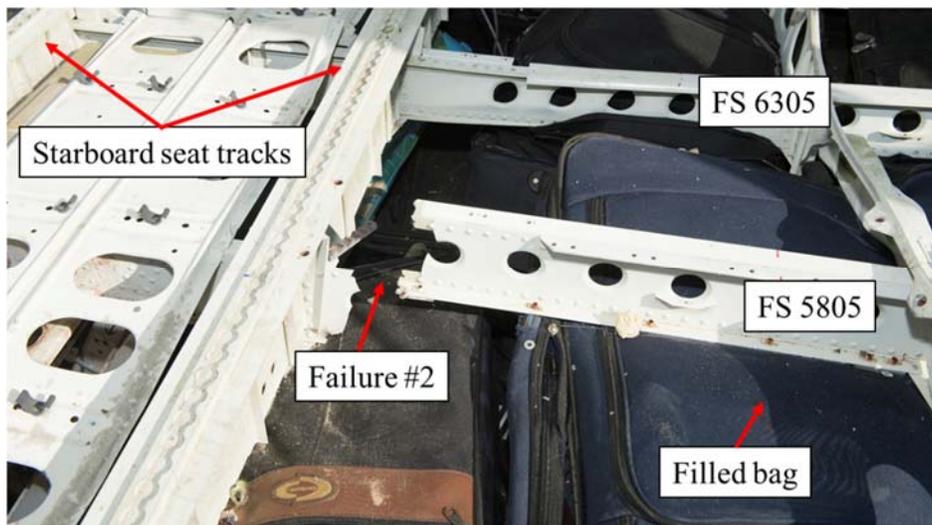
Figure 20 - Failure of FS 5805 at location #2

A detailed inspection at failure location #2 revealed a probable cause. Inboard of the starboard seat tracks, there was a fully filled dark blue bag located at the top of the underfloor luggage stack centered underneath FS 5805. To the left of the fully filled blue bag was a second black-with-brown-striped bag, stacked at a lower height than the fully filled blue bag. The difference in height was either from the black and brown striped bag not being completely filled or simply from being stacked on top of slightly shorter bags. At impact and during the maximum luggage rebound, the upward bearing of only the blue bag against FS 5805 the highest in the stack, caused the failure to occur near the seat track junction which was an area of differing localized stiffness. After the failure had occurred, the bag itself provided a surface for which FS 5805 to rest. Additionally, it is important to note that the blue bag was centered along FS 5805 and did not extend under either FS 5305, which is not shown, or FS 6305, which is shown in Figure 20. Had this bag extended into the area underneath FS 6305, it is conceivable that FS 6305 would have failed in a similar fashion. Similarly, Failures #3, #4 and #5 occurred adjacent to each other and are shown next in Figure 21.

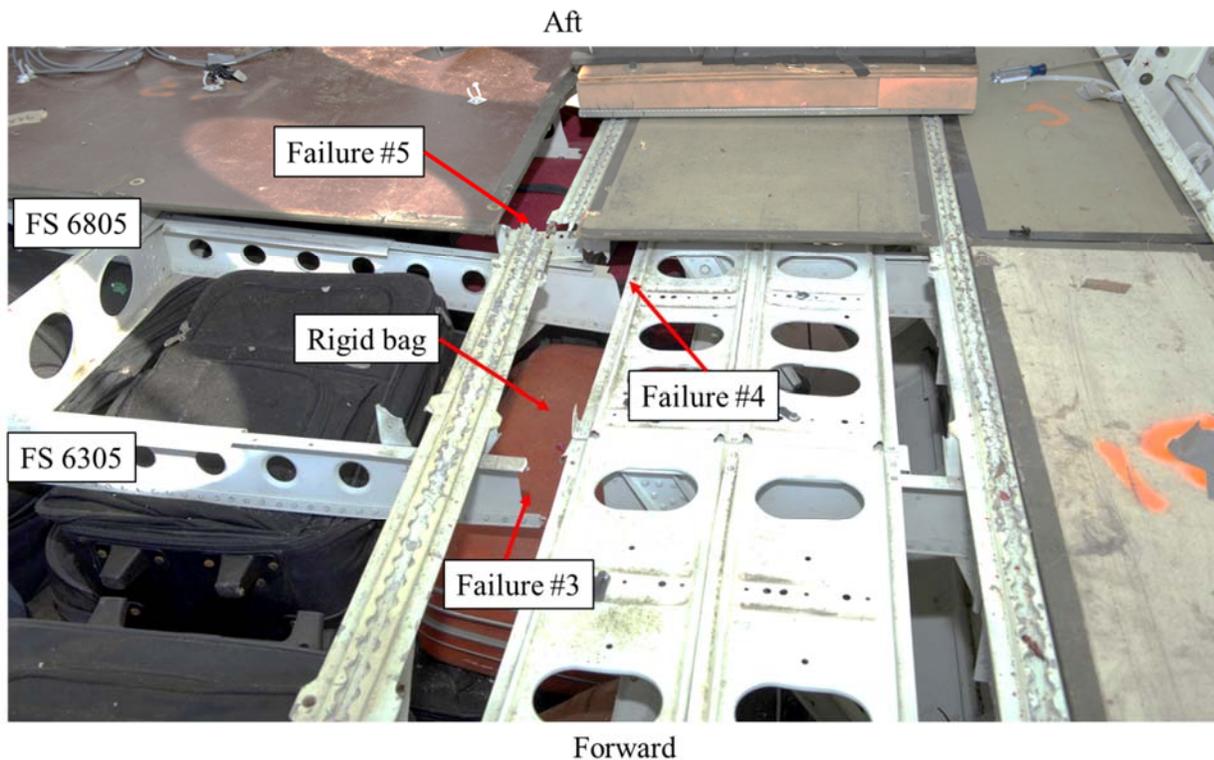
Figure 21 - Failure locations #3, #4 and #5

The root cause for the failure in FS 6305 (failure #3), FS 6805 (failure #4), and the inboard port seat track (failure #5) was attributed to the rigid brown bag underneath this area of the floor. The bag was (unintentionally) positioned such that it was centered between FS 6305 and FS 6805 at slightly outboard of the port inner seat track position. The impact and more importantly the rebound of this bag against these areas were the prime causes for the failures in these locations. The failures at FS 6305 and FS 6805 occurred at almost identical locations, which were immediately outboard of the inner seat track and positioned directly over the bag. The reason for the failure of the seat track (failure #5) was not as straightforward.

However, a combination of the failure of the two adjacent frame sections (failures #3 and #4), the added loading from the rear row double seat inboard leg attachment directly over FS 6805, and the added localized rigidity in the adjacent rear structure due to the DAS pallet attachment just aft of the seat track failure location is suspected.

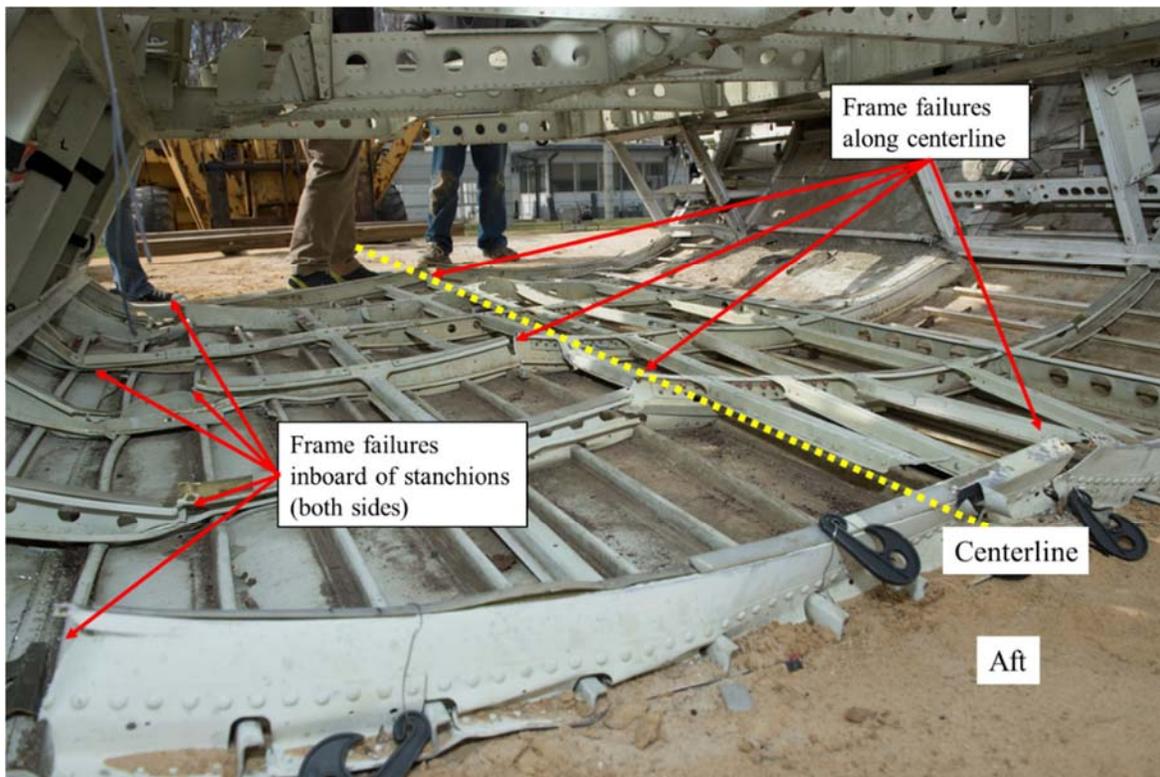
Figure 22 - Lower cavity failure locations

After the underfloor failures were thoroughly documented and photographed, the underfloor luggage was carefully removed to aid in the examination of the lower cavity and bottom skin areas of the test article. There were several failures in the lower section that are commonly seen both in previous testing, but also in in-service accident data. The first was the failure of the frame sections along the centerline at the very base of the fuselage. These failures were tensile failures at the inner end of the frame section, and were caused by the ovalization of the test article in the bottom skin region. The second prominent failure was the crushing of the frame sections immediately inboard of the lower-stanchion-to-subfloor attachment locations. This crush was caused both by subfloor deformation from the under floor luggage loading along with the outward motion of the frames themselves during the ovalization. These two failures are depicted in Figure 22.

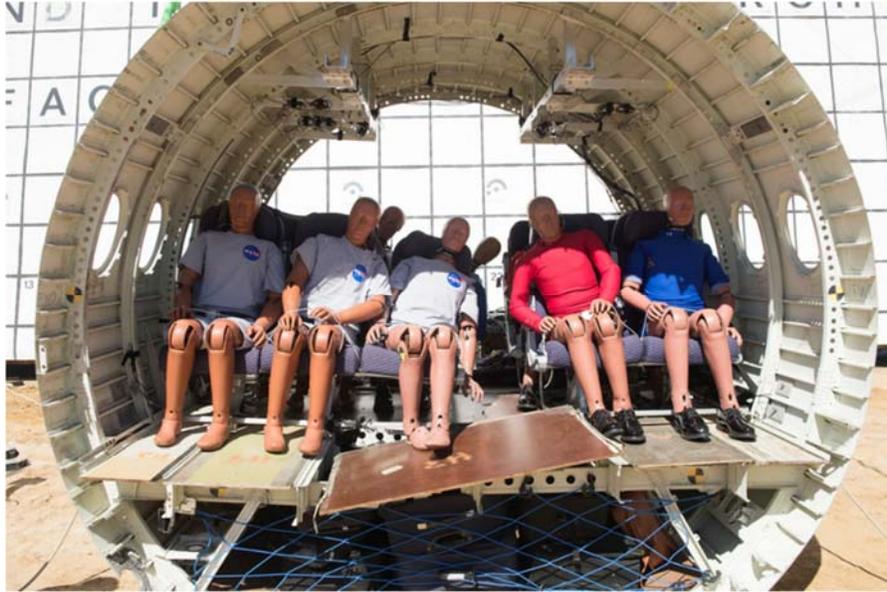
Figure 34 - Forward Section front row ATDs (Seats 6 through 10)

After the examination of the airframe deformation and responses, responses of the occupants were next evaluated to determine the magnitude of loads and likelihood of injury. Figure 34 shows the front row of occupants post-test. The ATD seated in seat 8 was leaning into the aisle, restricting any potential egress. The ATDs seated in seats 7 and 9 were also leaning toward the aisle. The outboard ATDs seated in seats 6 and 10 were upright. The inward lean in most ATDs was due to the fuselage floor supports failing primarily inboard of the lower stanchions, causing the weight of the ATDs and seats to sag onto the underfloor luggage.

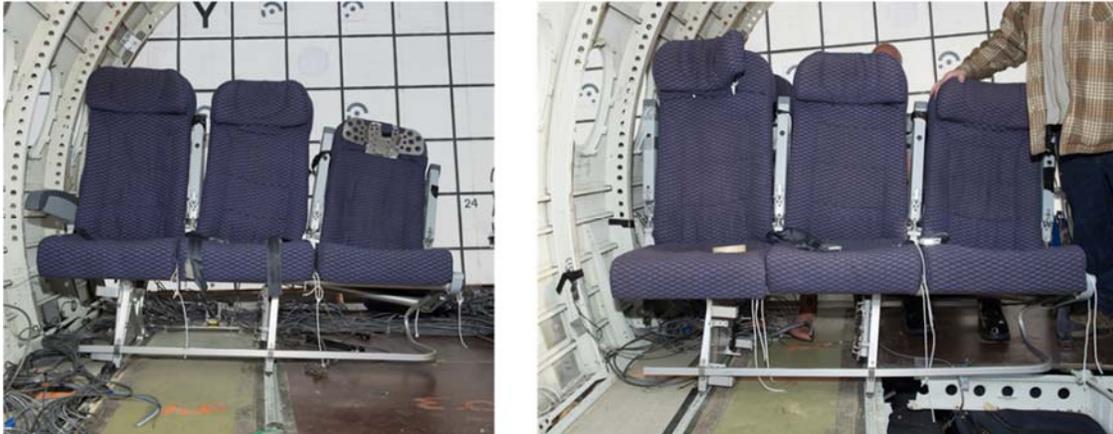
Figure 39 - Post-test triple seats. Rear (left) and front (right)

The maximum seat deformation occurred on both overhung seats - seats 3 and 8. Both seat frame rear tubes deformed to a maximum of approximately 4.5 in in the vertical direction when measured at the aisle armrest location, and the luggage guard buckled at the aisle seat rear attachment location, leading to a crack in the material. The middle and window seats and seat leg structure were undamaged for both of the triple seats. The double seats appeared undamaged when conducting post-test inspections. Figure 40 shows the underside of the triple seat in the rear row, noting the bent rear seat frame tube and the cracked luggage guard.

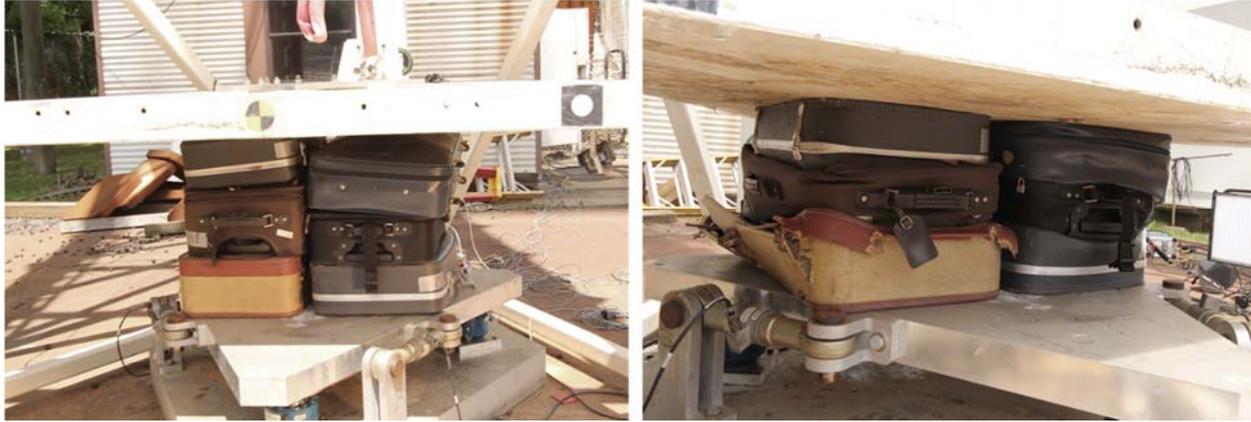
Figure 42 - Luggage test 1 pre- (left) and post-test (right)

The first test was conducted with the impact velocity of the falling mass at 18 ft/s. The total luggage weight was 128.6 lb. A pre- and post-test picture is shown in Figure 42. Post-test inspections revealed that the impact shattered the rigid bags; however, left the soft bags mostly intact. The items inside were not examined for damage.

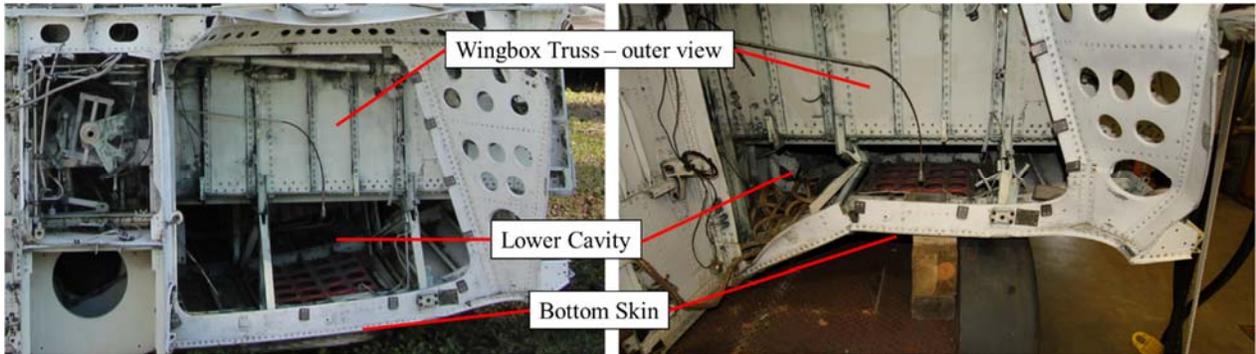
Figure 53 - Wingbox lower cavity pre- (left) and post-test (right)

Other than the aft lower cavity region, the test article did not show noticeable signs of structural damage. The wingbox truss structure appeared to be undamaged, and the seat tracks did not show signs of fracture or tearing. Similar to the Forward Section, the structure above the floor did not appear damaged. Additionally, all four emergency exit doors opened nominally post-test, which indicated no permanent deformation or warpage around the door frames. Figure 52 shows the doors pre-test and the openings post-test on the port side of the test article.

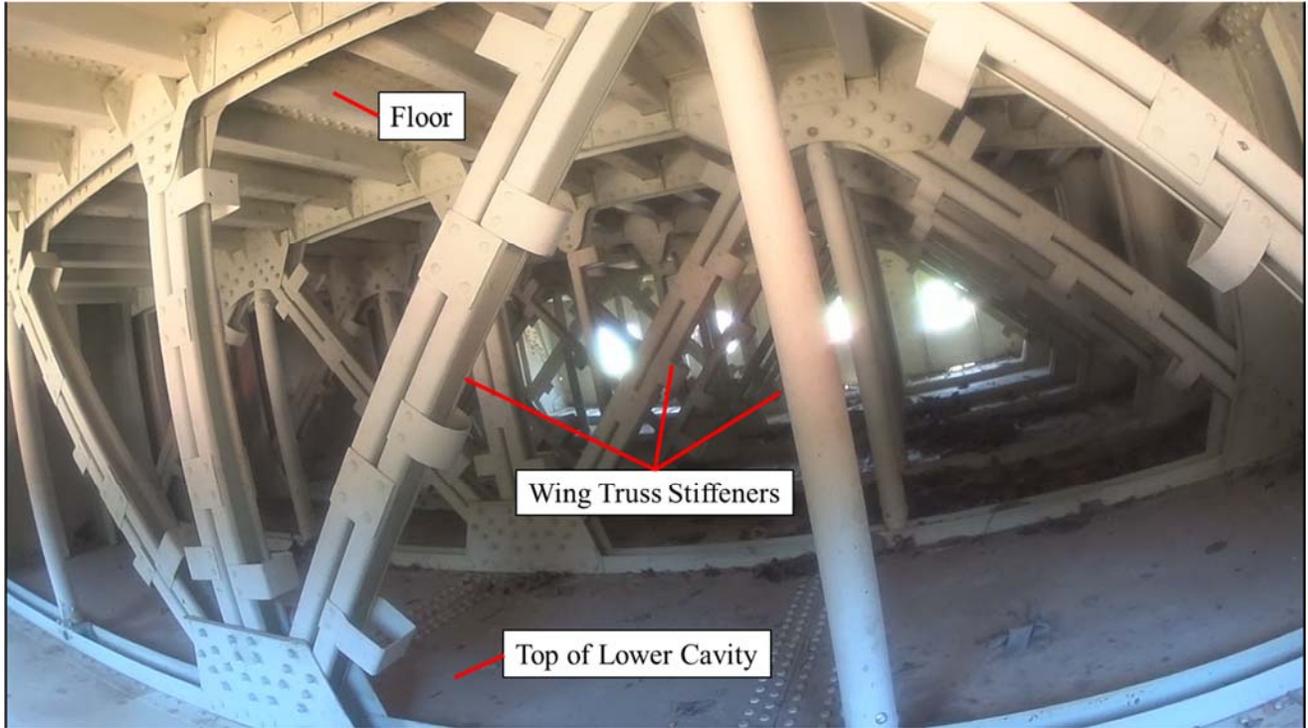
Figure 54 - Wingbox Section truss structure post-test

Additional images were taken from an onboard camera mounted inside the Wingbox truss structure. Figure 54 shows a still image from a video taken from the camera post-test, which verified that the truss structure did not exhibit deformation or failure during the test.
