Space Shuttle Stiffener Ring Foam Failure Analysis, a Non-conventional Approach.

Philip M. Howard
NASA
Kennedy Space Center
Materials Science Division

KSC-MSL-2007-0136

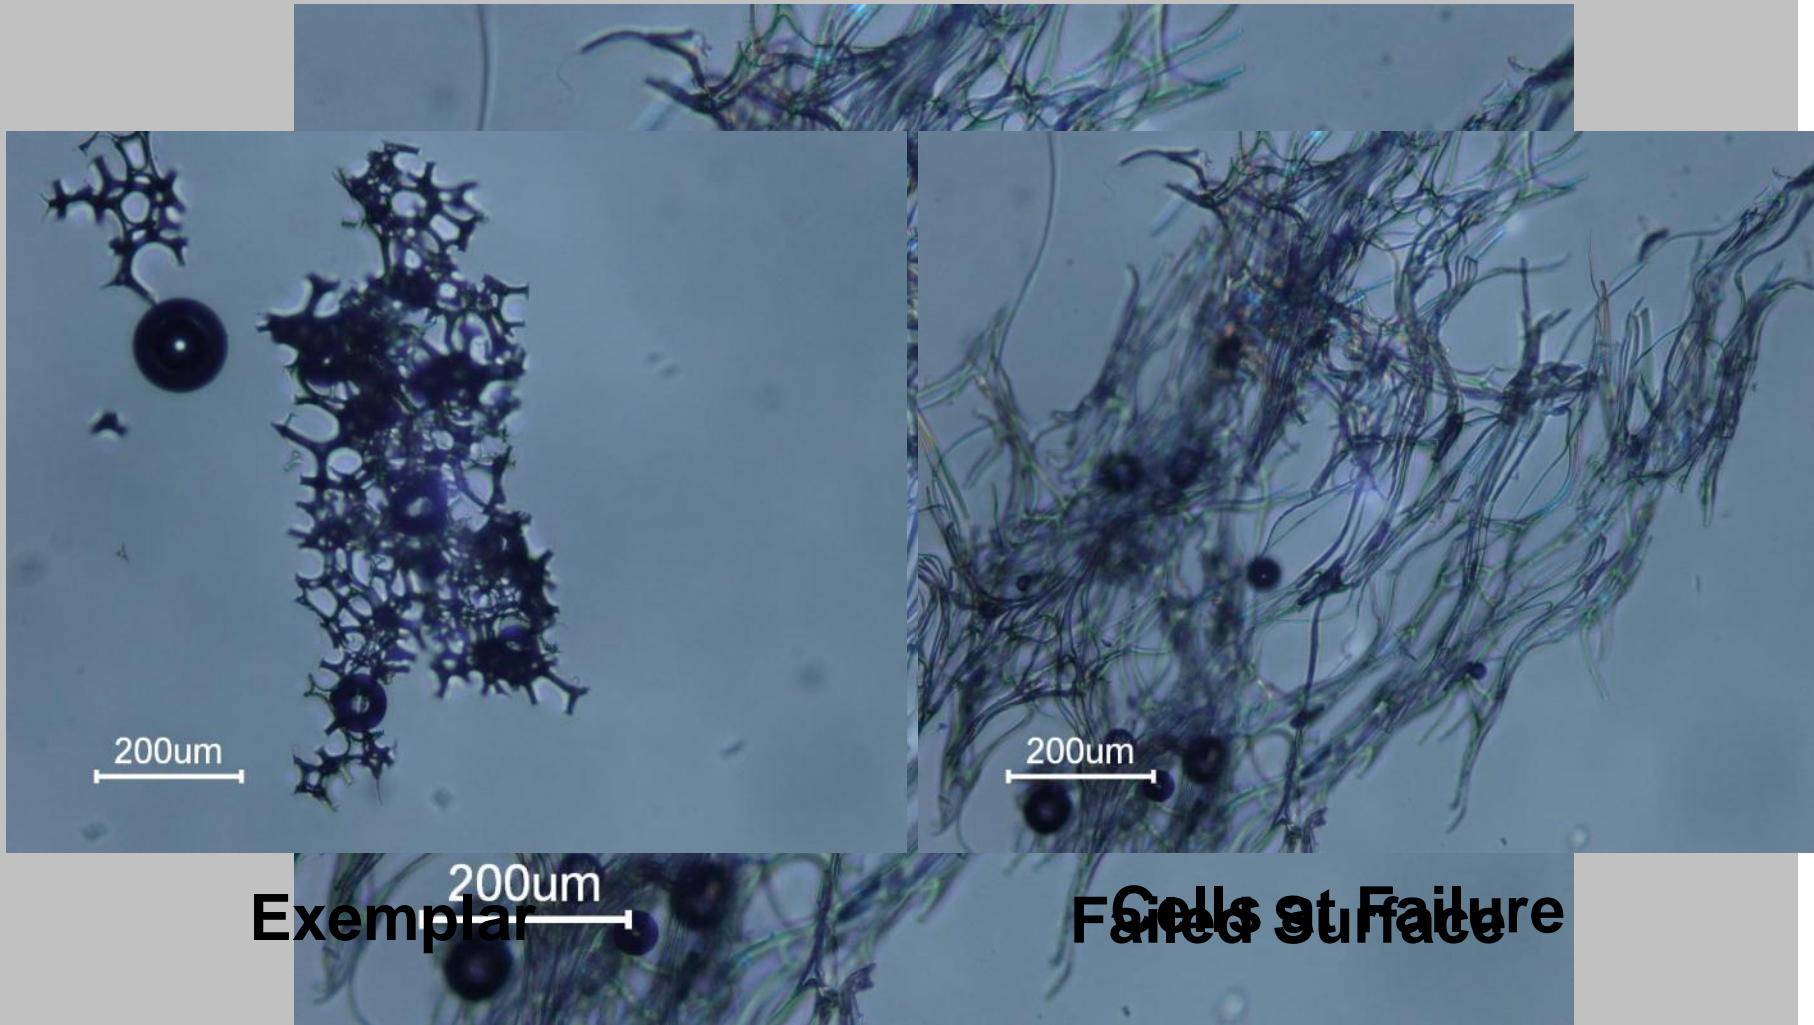
PLM of SRB Foam Failure

200um
Failed at Failure

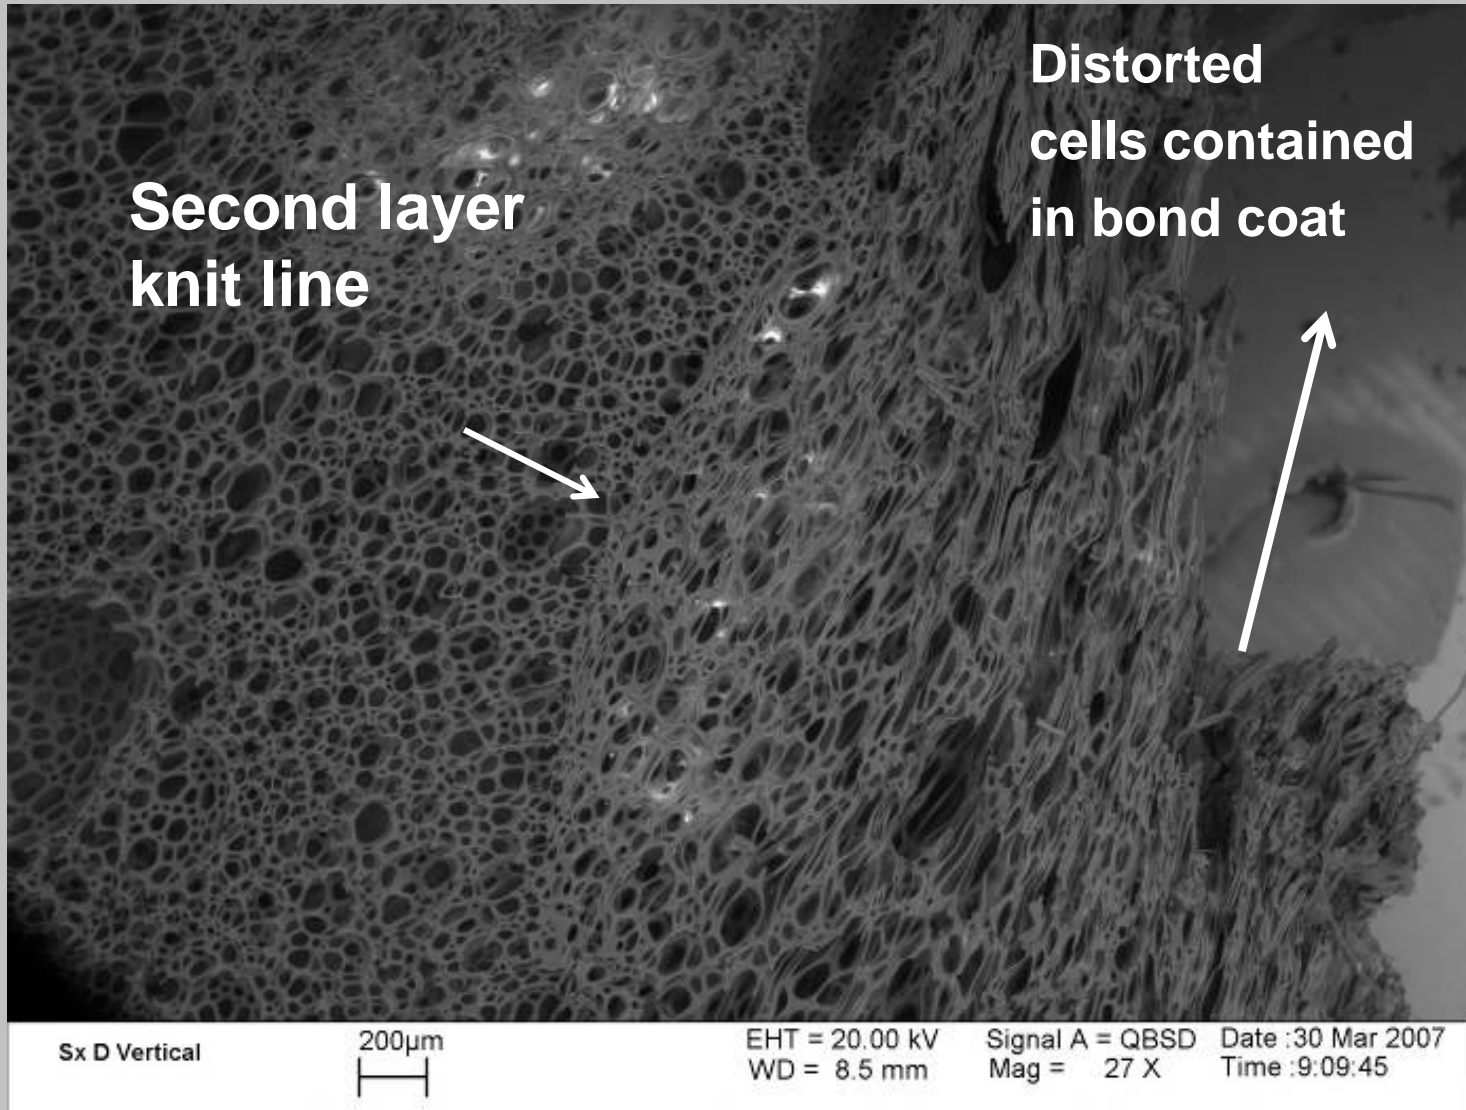
Cross Section of SRB Foam Failure

Chief SRB Engineer—we have never looked at foam like this

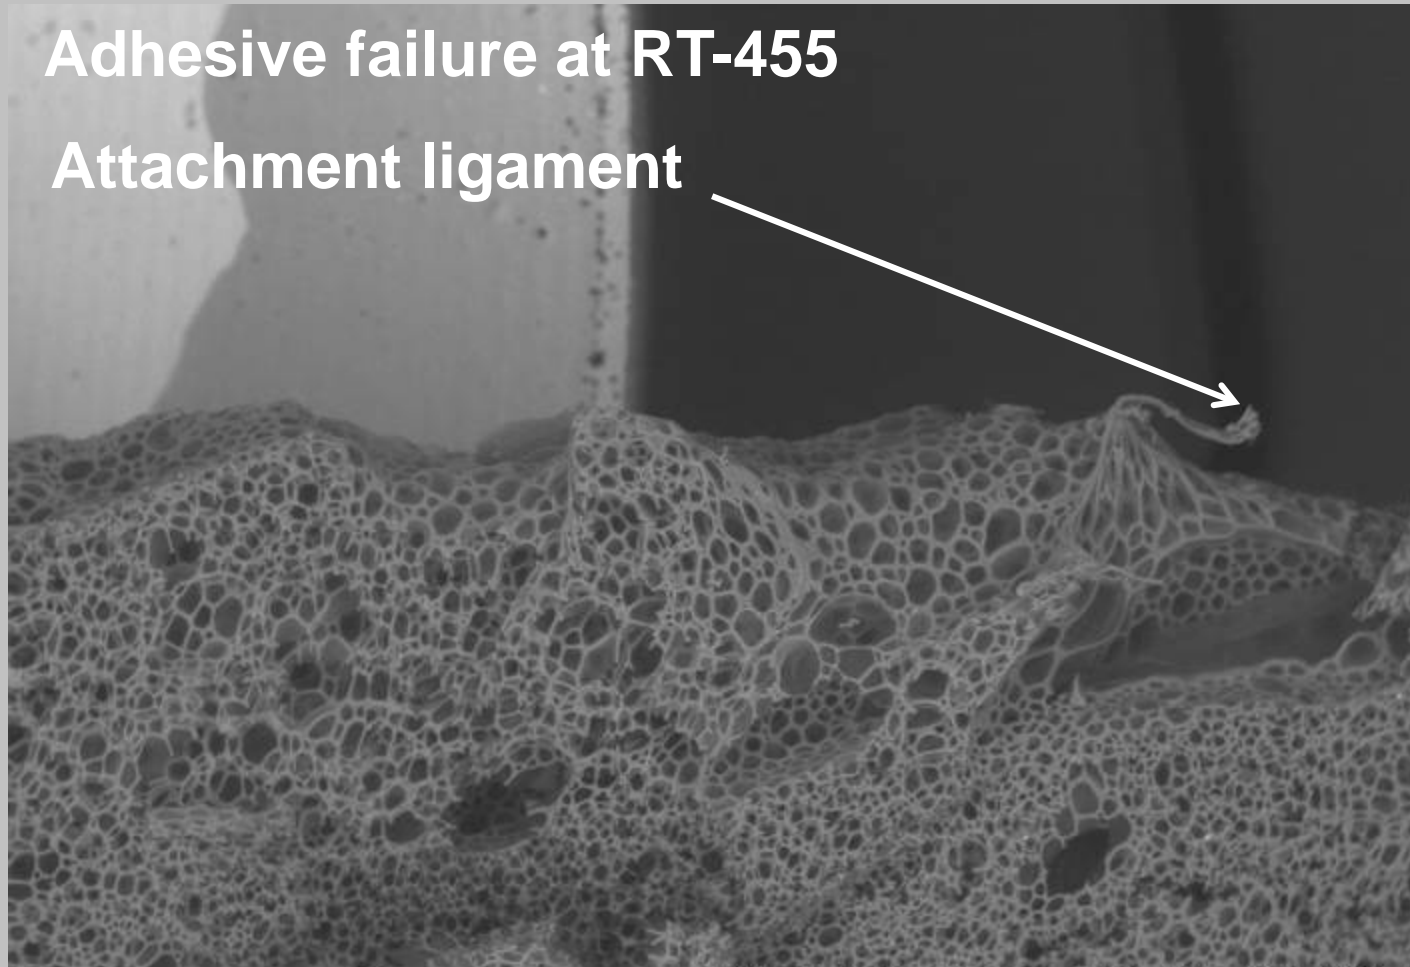
2 B Horizontal

Adhesive failure at RT-455

Attachment ligament

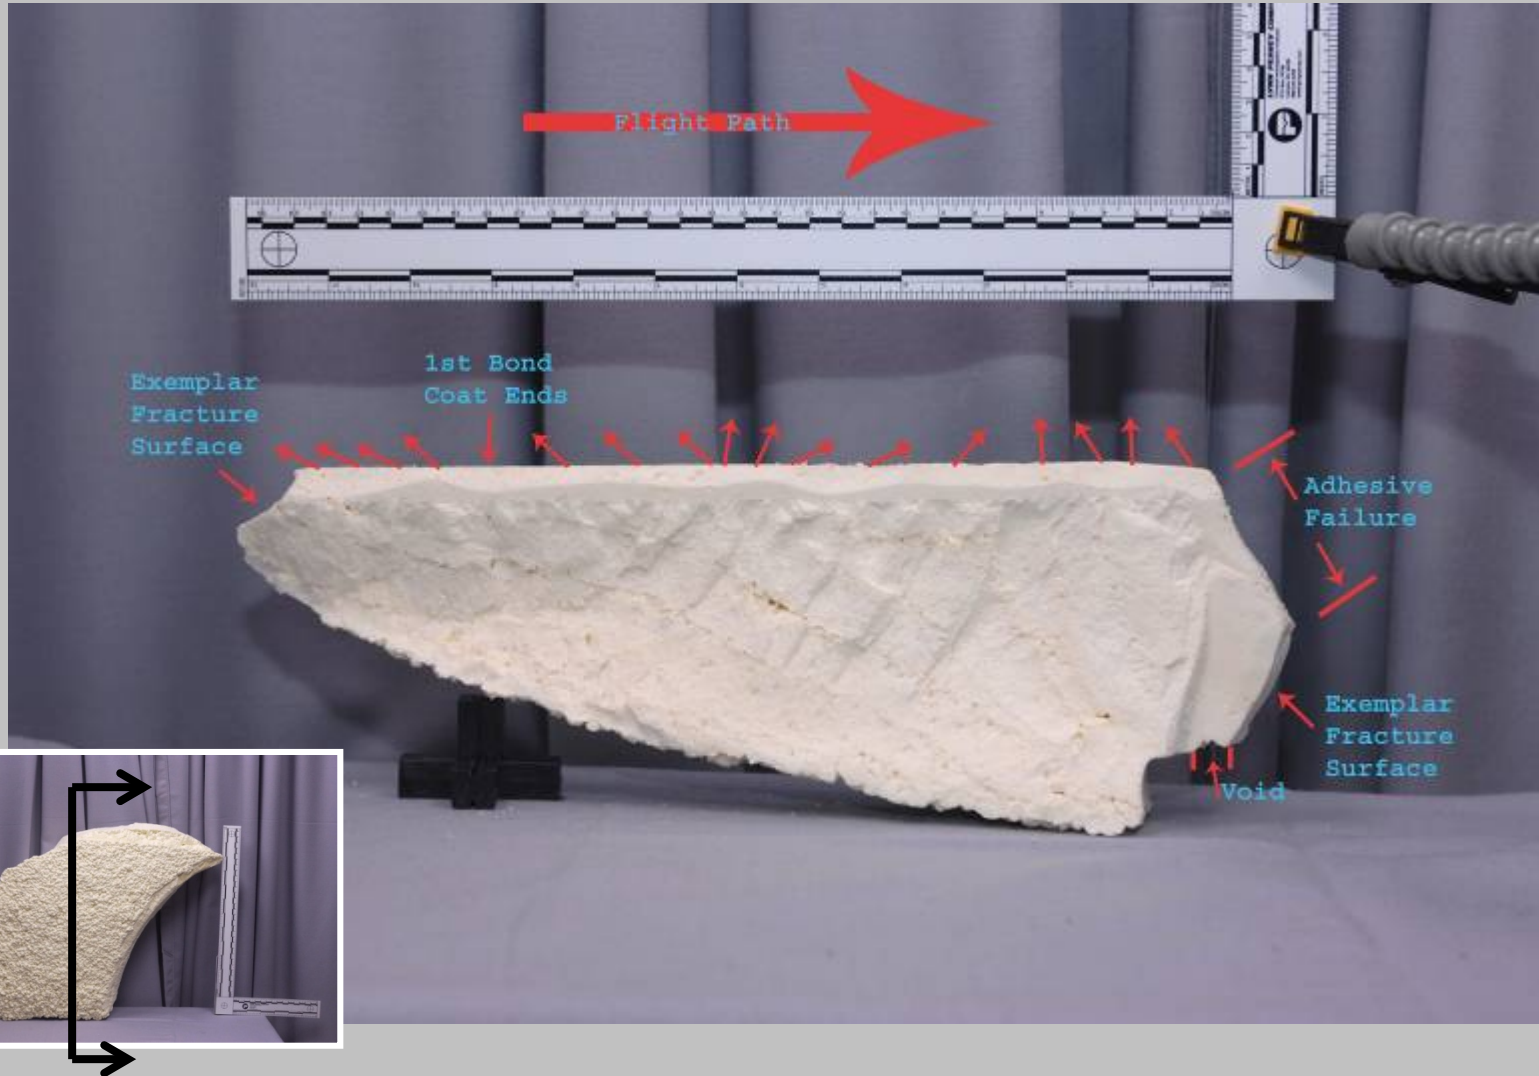
SRB Foam Failure

>80 percent application failed

The foam bond coat displayed two modes of failure:

- Cohesive failure was observed due to severely deformed foam cells in the bond coat
- Adhesive failure was observed at the RT-455 Epoxy interface.

The observed morphology indicates that the bond coat was not fully cured before other forces were applied, e.g. the expansion forces of the second coat distorted the bonding cells.

- Substrate as an infinite heat sink
- Develop spray hardware to apply micro bond layers
 << 1/8" layers
- Primer (polyurethane)
- The bond coat should be allowed to completely dry/cure
 - Never apply over wet uncured layers

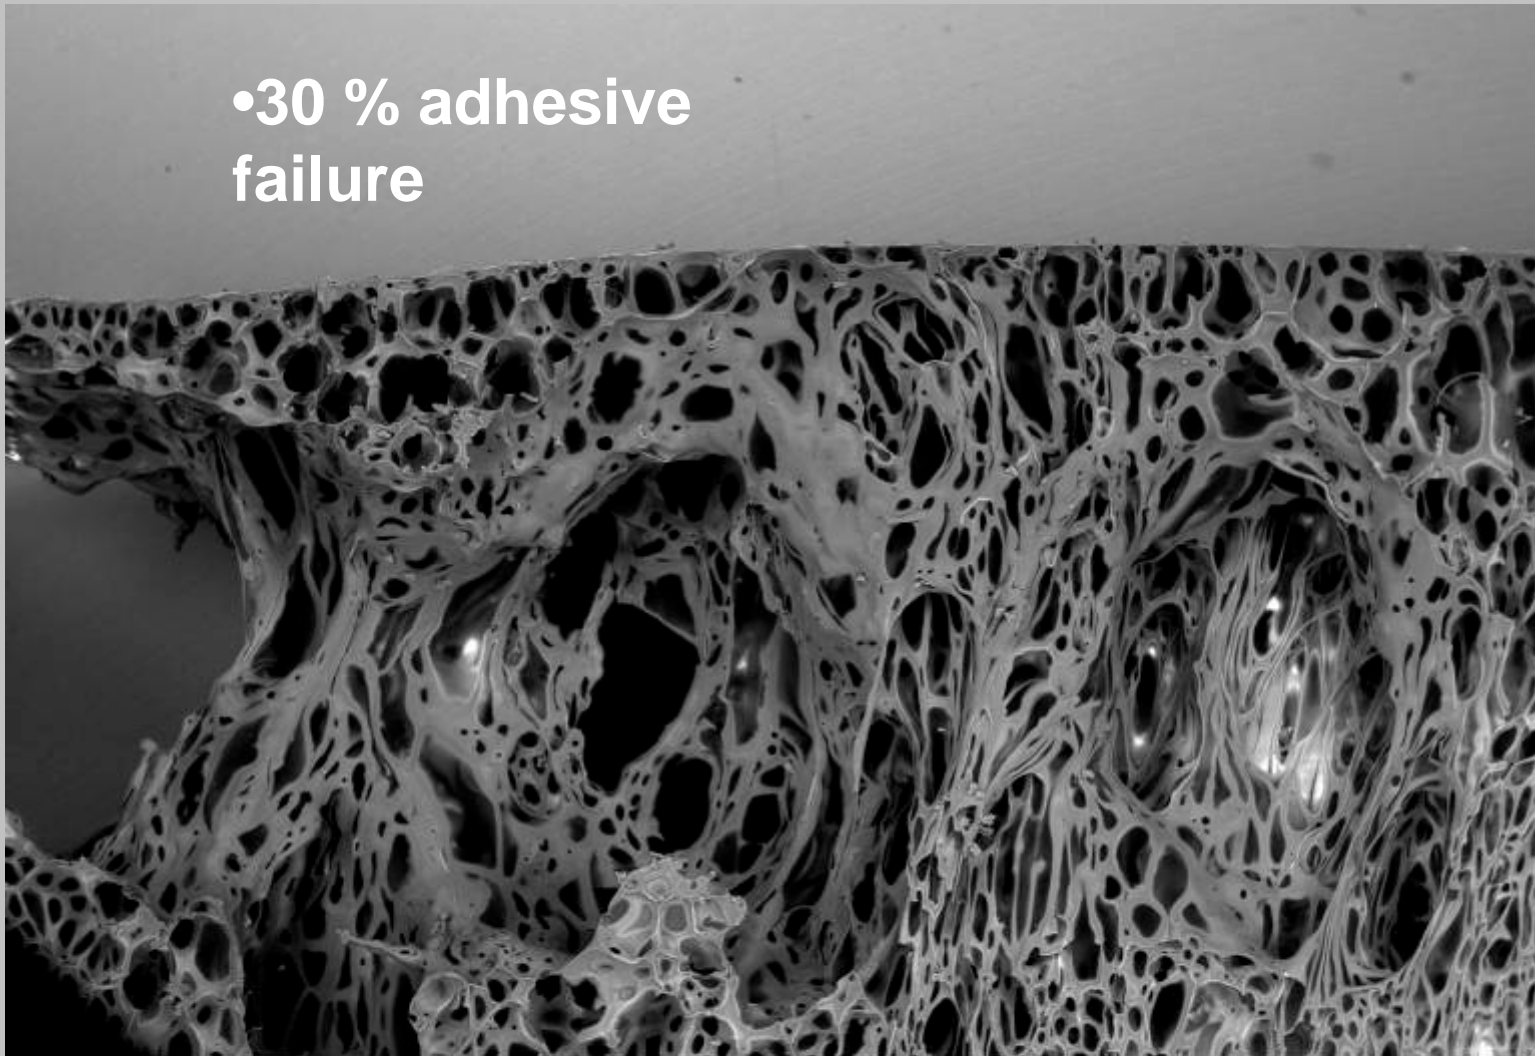
MSL-2007-0134
1

•30 % adhesive failure

50 PSI
