# Image Analysis Overview

## Multilateral Imagery Working Group Technical Interchange Meeting

NASA Johnson Space Center  
Image Science and Analysis Group (ISAG) (XI4)

May 2018

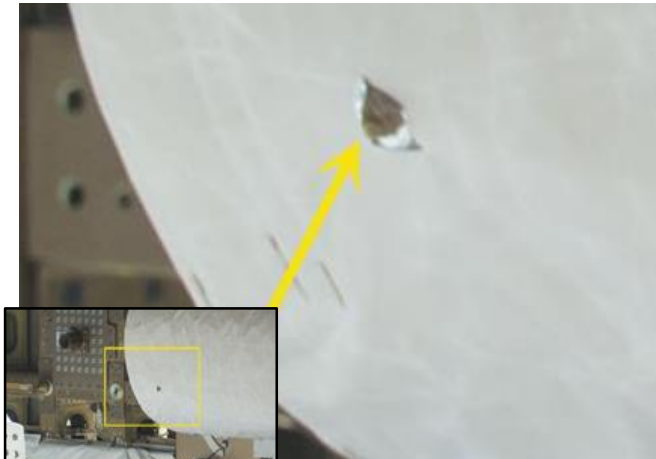
S1 CETA Light Stanchion

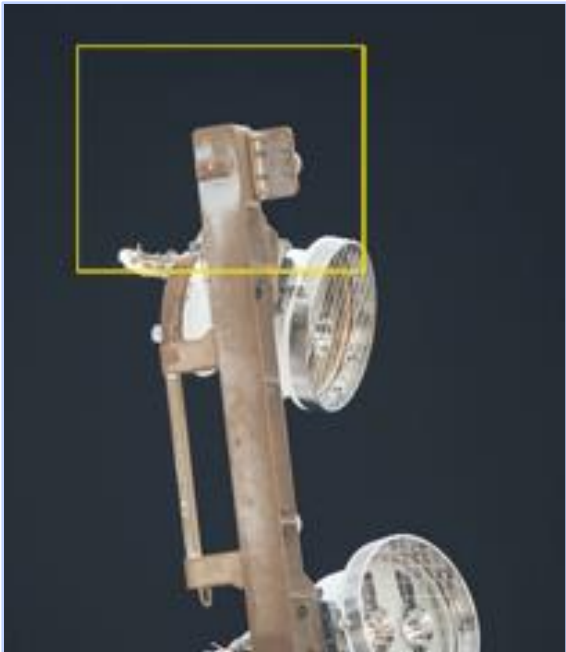
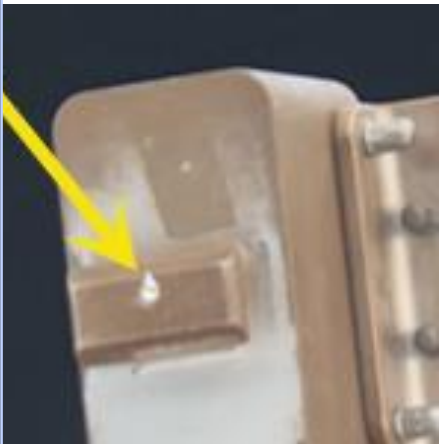
SGANT on ESP 3

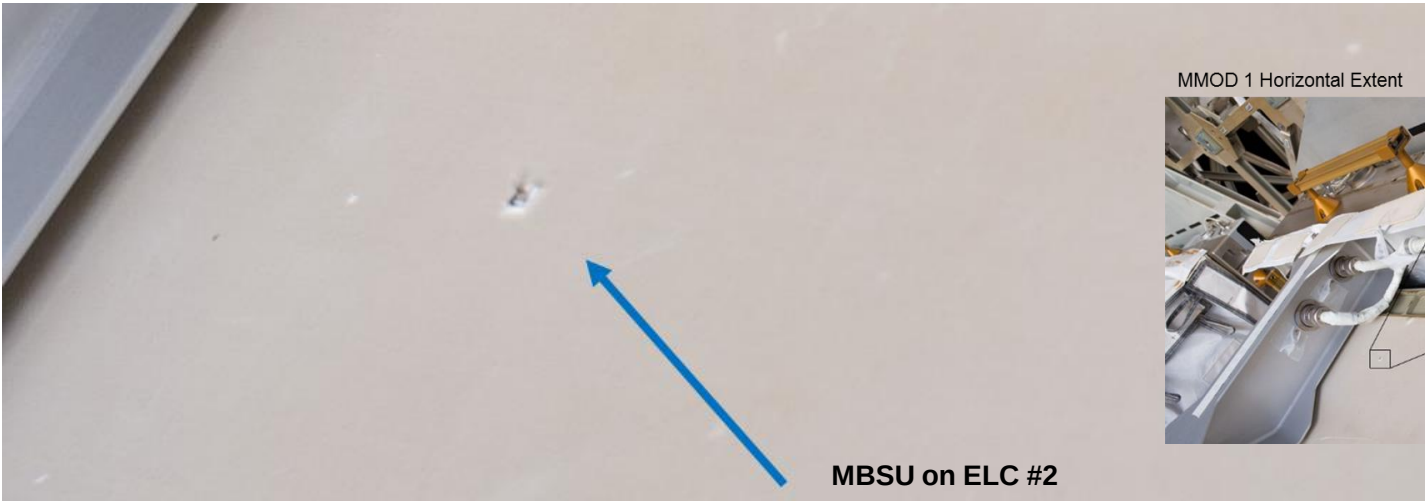
MBSU on ELC #2

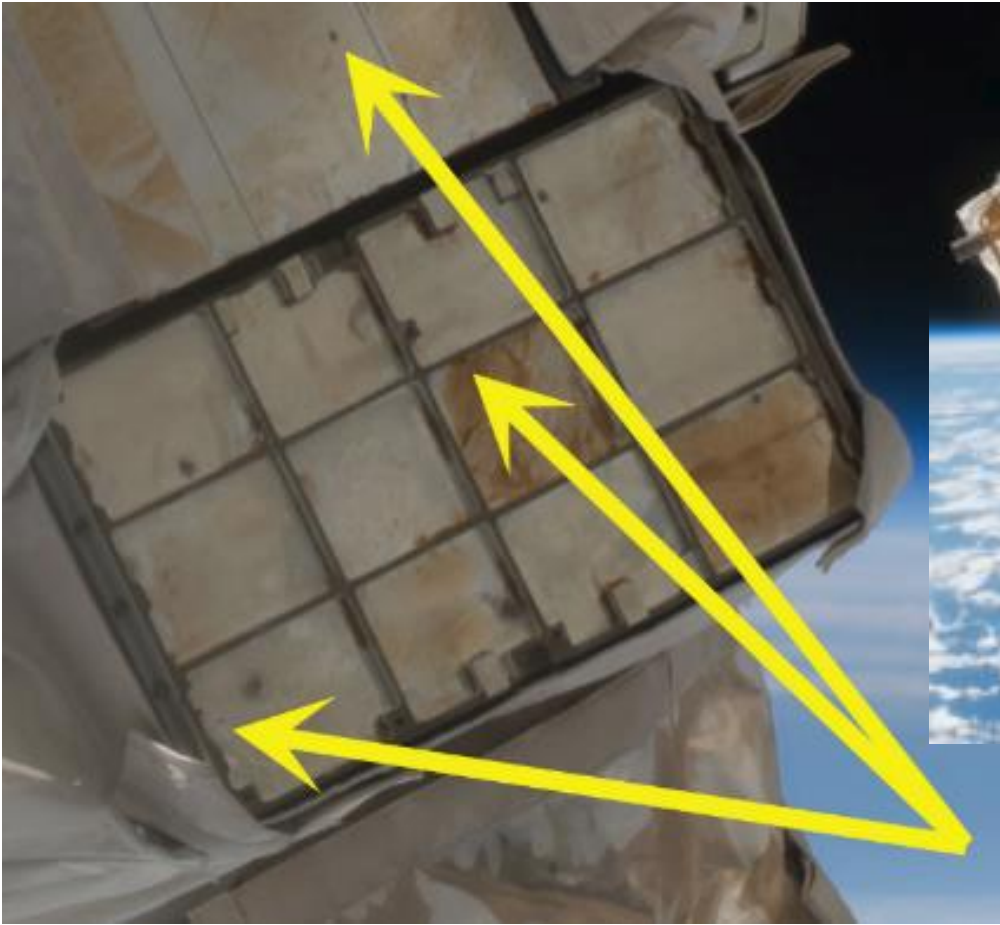
**SSRMS LEE B**

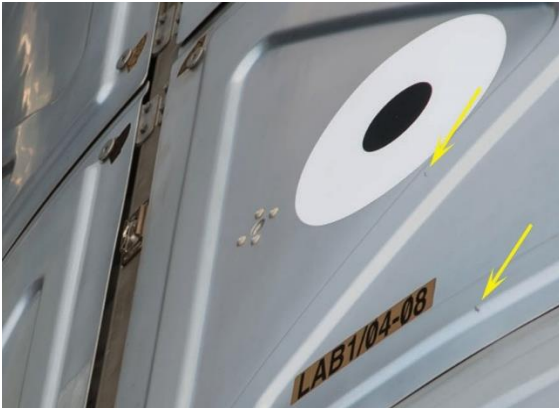
US Lab Module Nadir Side

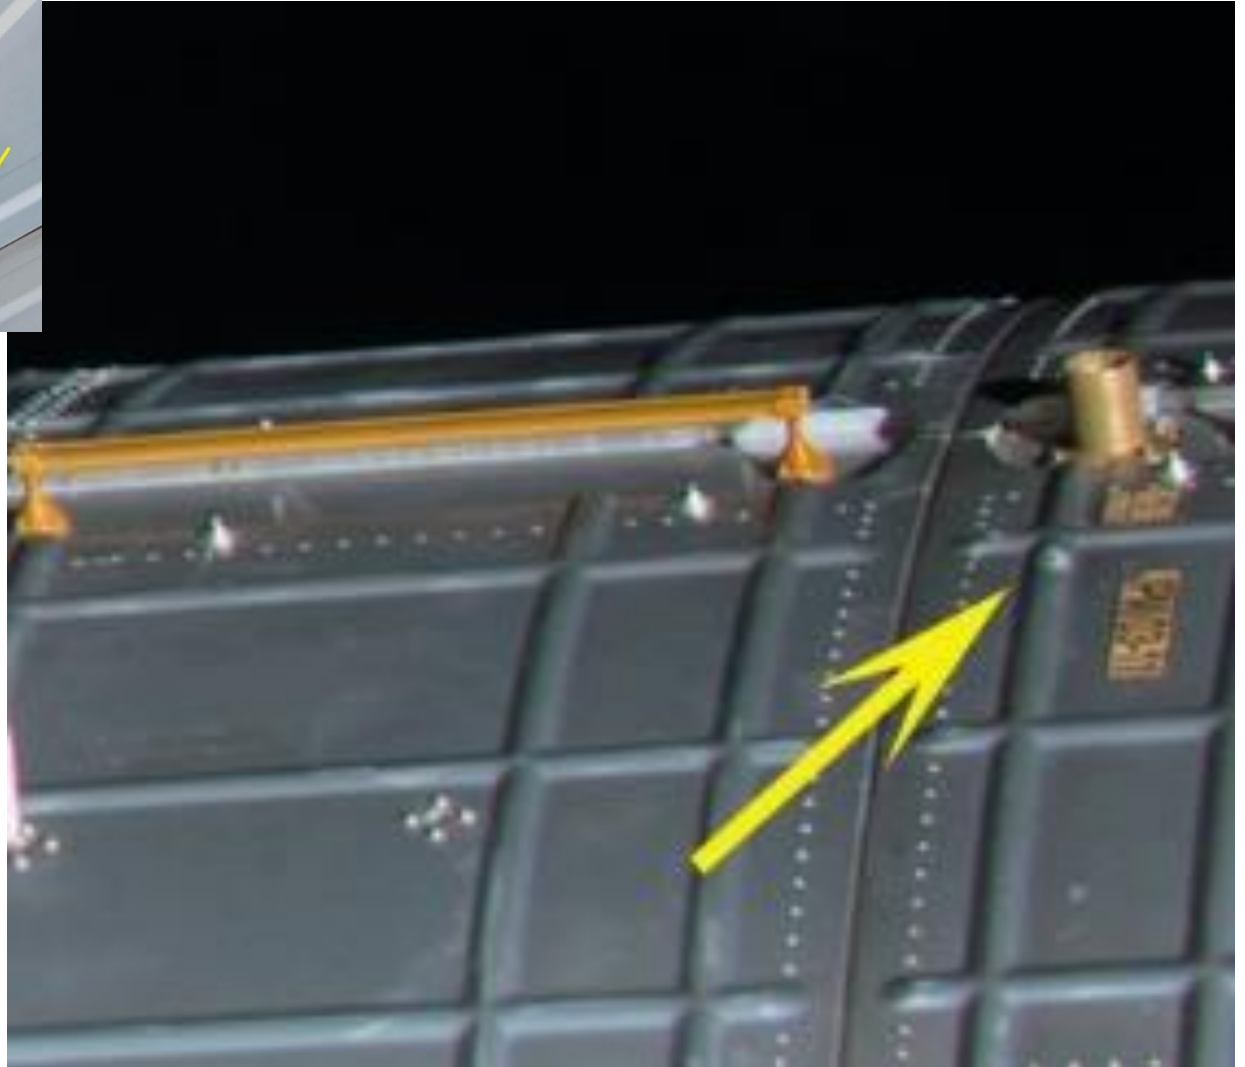
JPM Nadir MMOD Shield

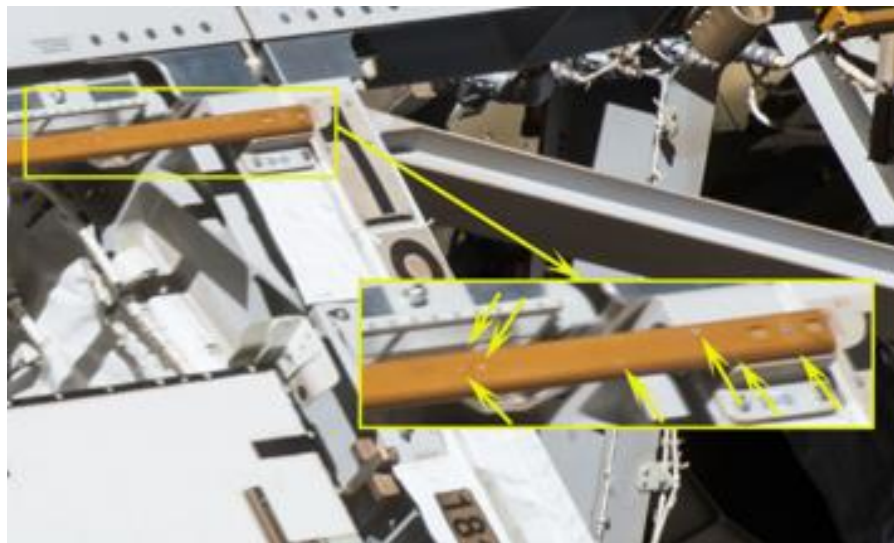
EVA Handrail Sharp Edge Risk

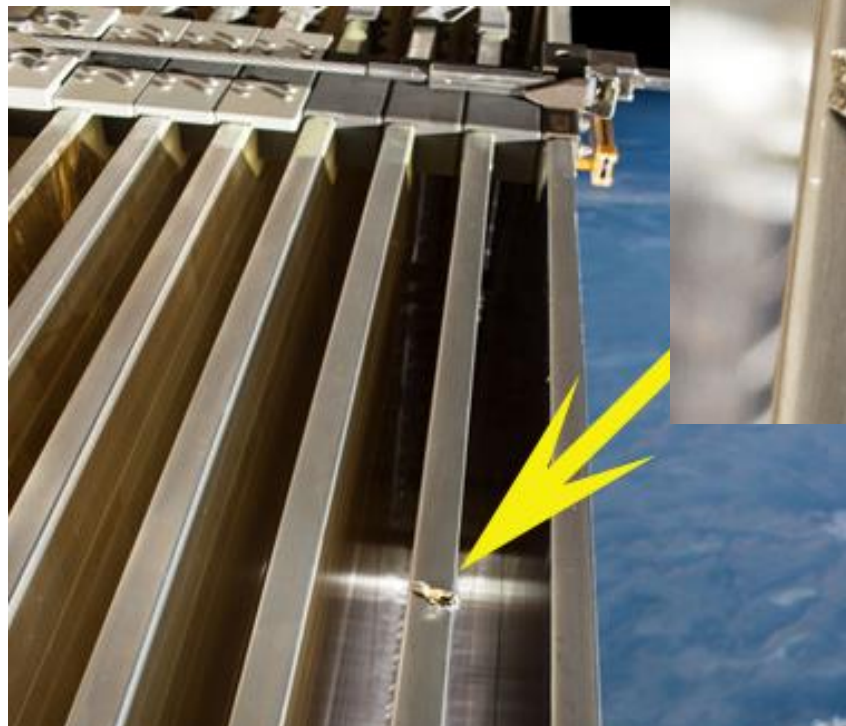
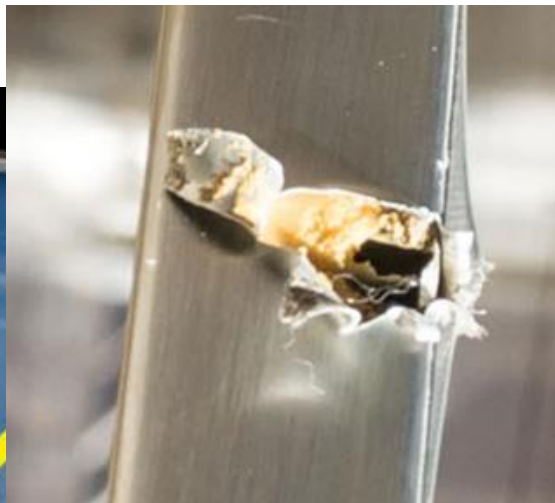
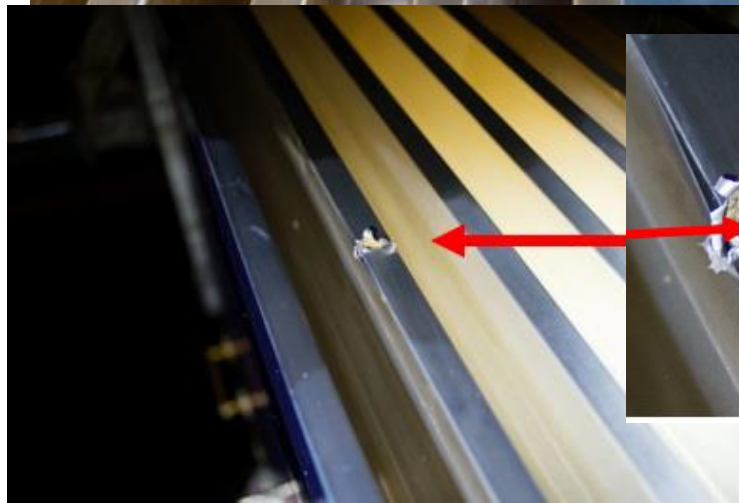
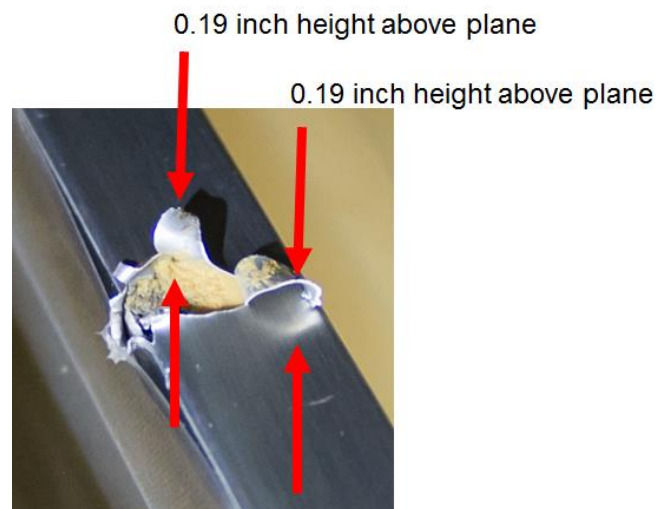
## Trailing Thermal Control Radiator (TTCR)

0.50 inch

0.19 inch height above plane

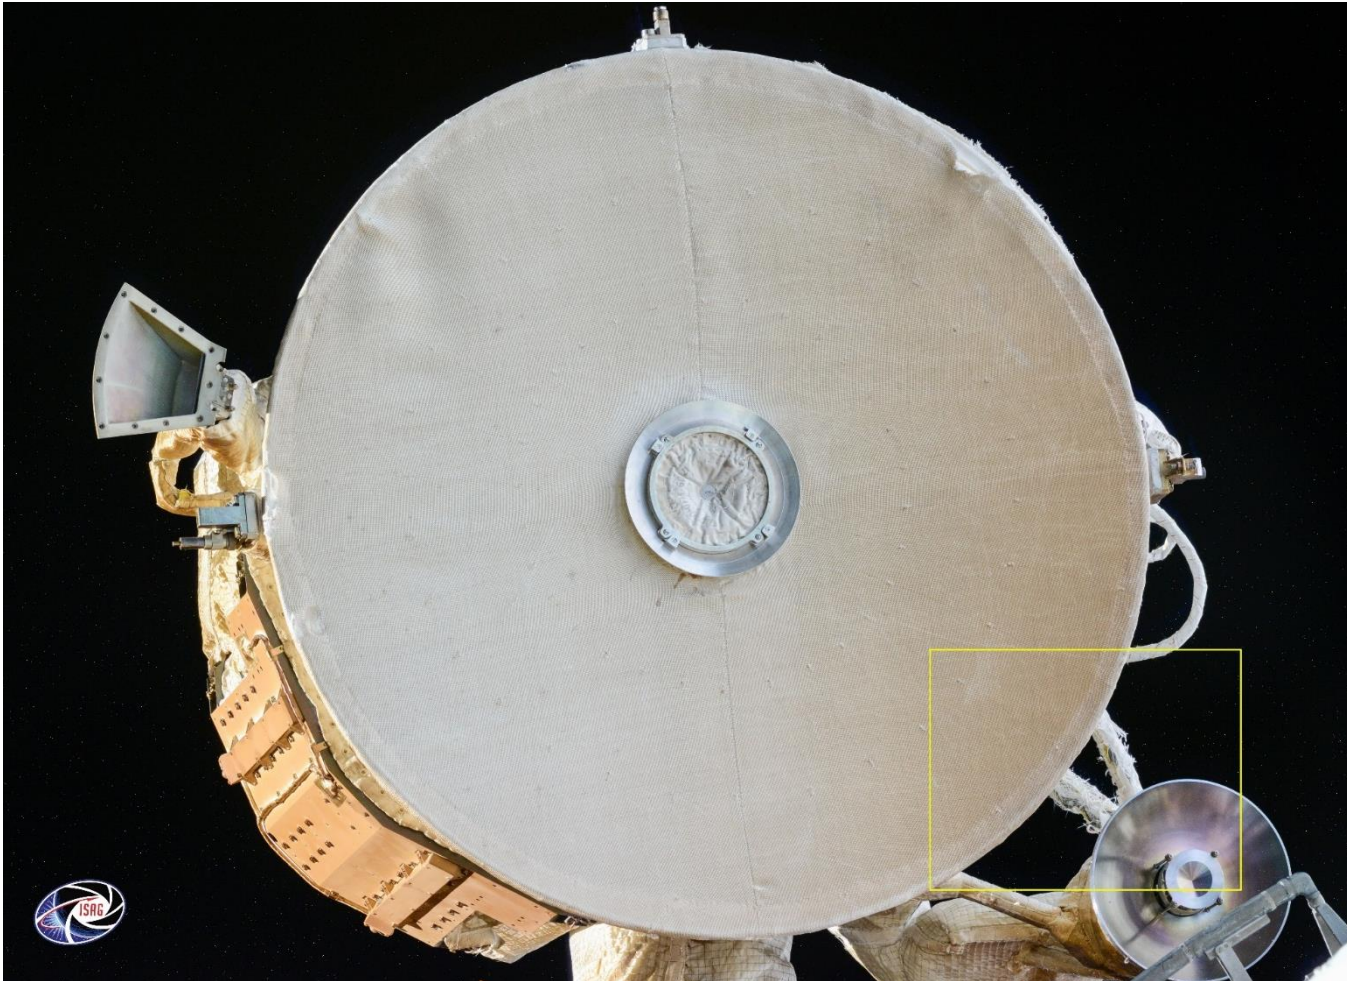
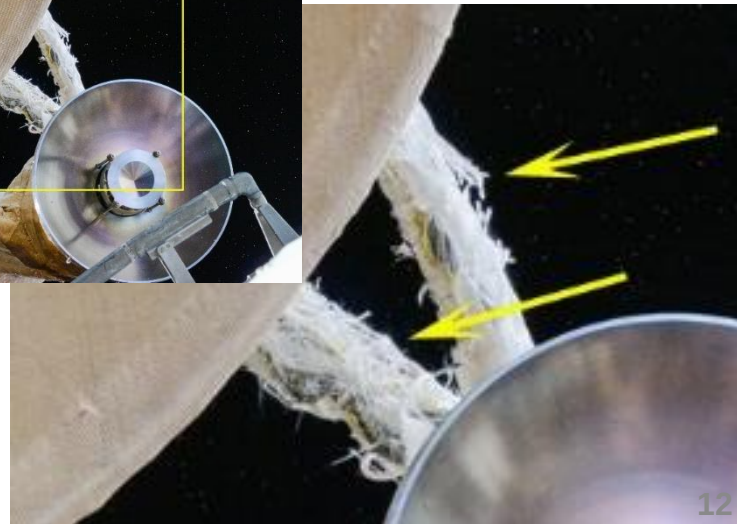
# Deterioration Observed on SM LIRA Antenna

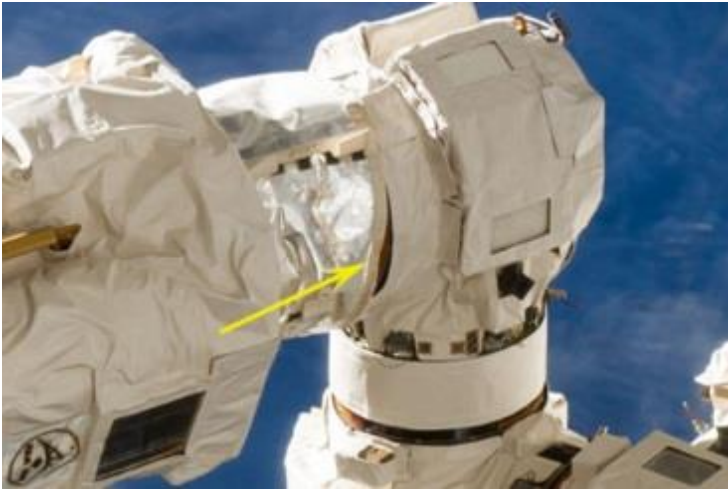
MLI Lifted on SSRMS LEE

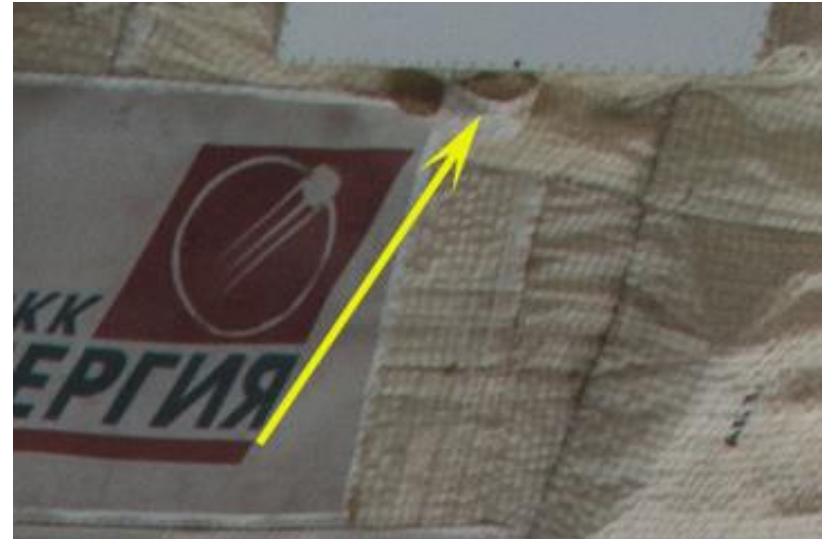
Possible Torn MLI Near Energiya Label on MRM2 Forward/Port

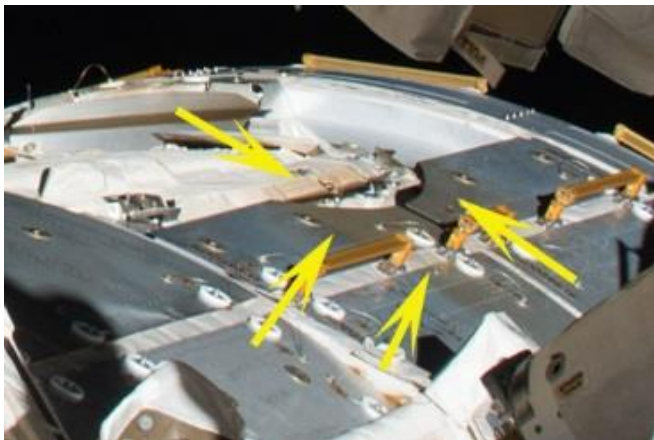
Discoloration on Node 2 Nadir CBM

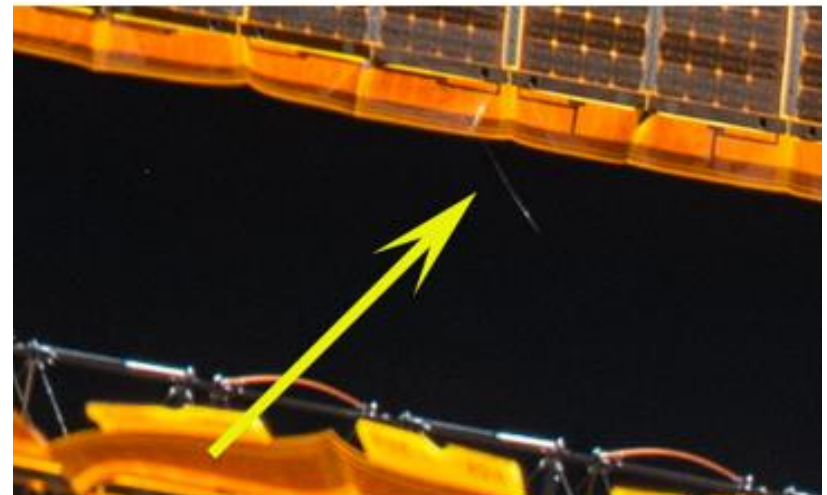
Part of P6 SAW Blanket Material or Wire Hanging From Blanket

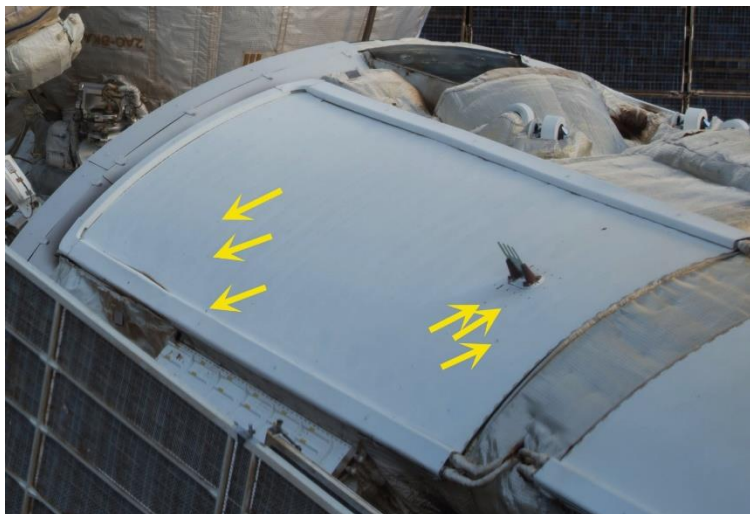
Possible MMOD Strikes or Paint Chips on FGB; Nadir

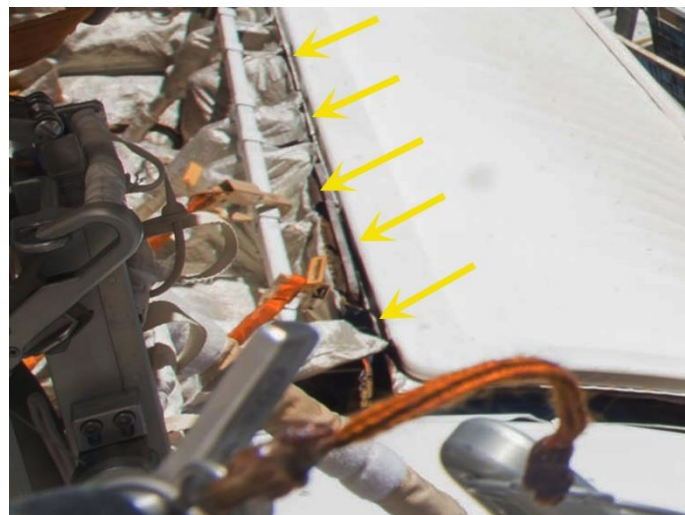
Possible MLI Lifted on FGB; Plane 3 /Zenith

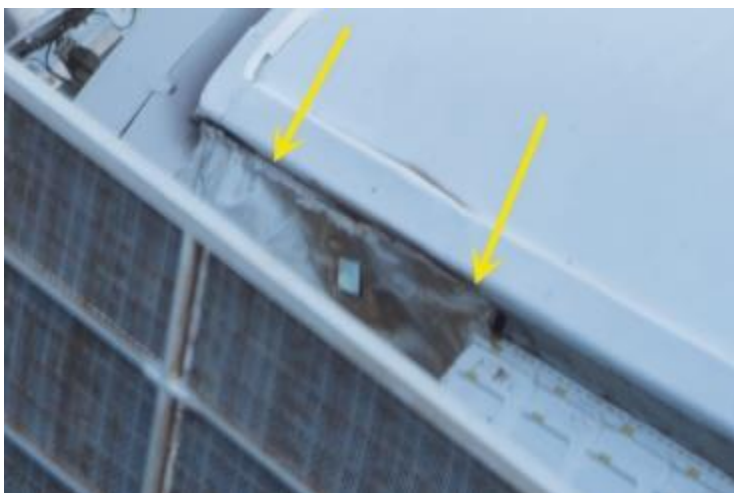
Discoloration Observed on FGB MLI Next to Radiator; Plane 1 /Nadir

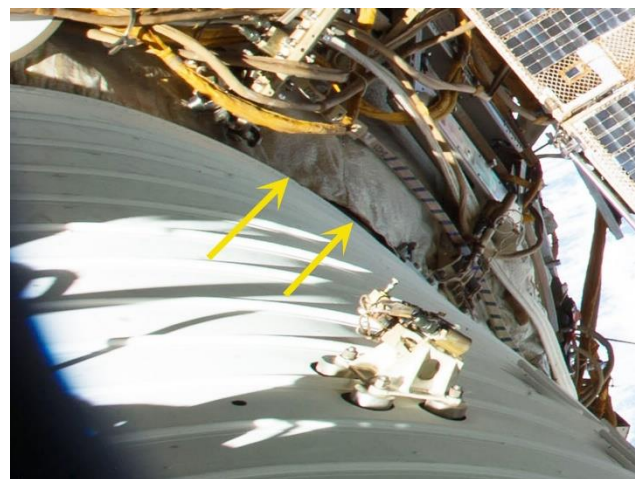
Lifted MLI on Service Module; Plane 3 /Zenith

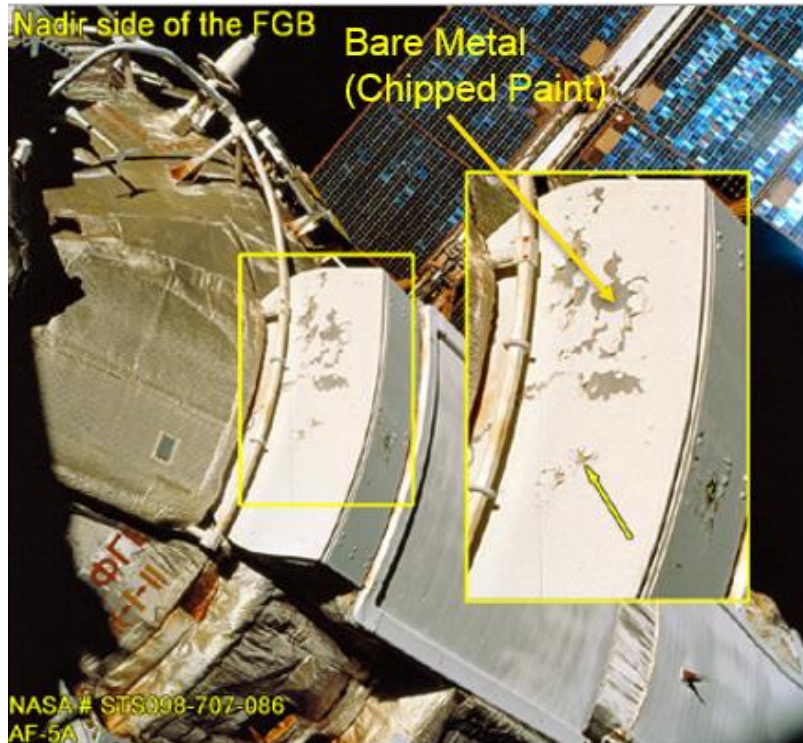
**STS-098/AF-5A Chipped Paint on FGB MMOD Shielding Panel**

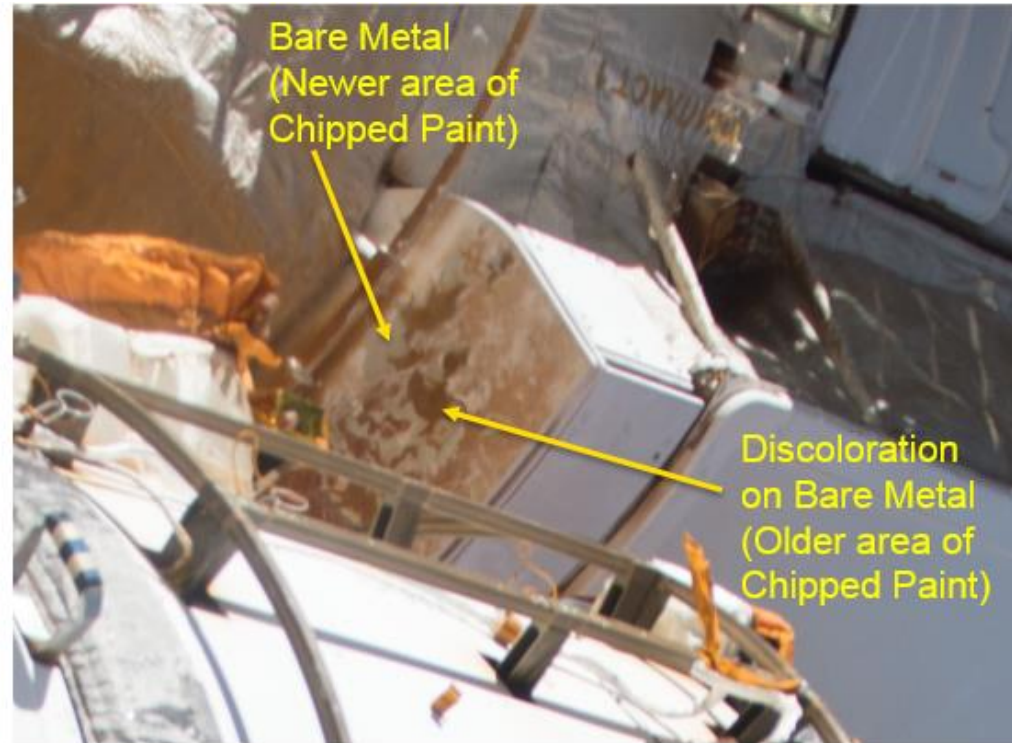
**Increment 47 Chipped Paint and Discoloration on same FGB MMOD Shielding Panel**

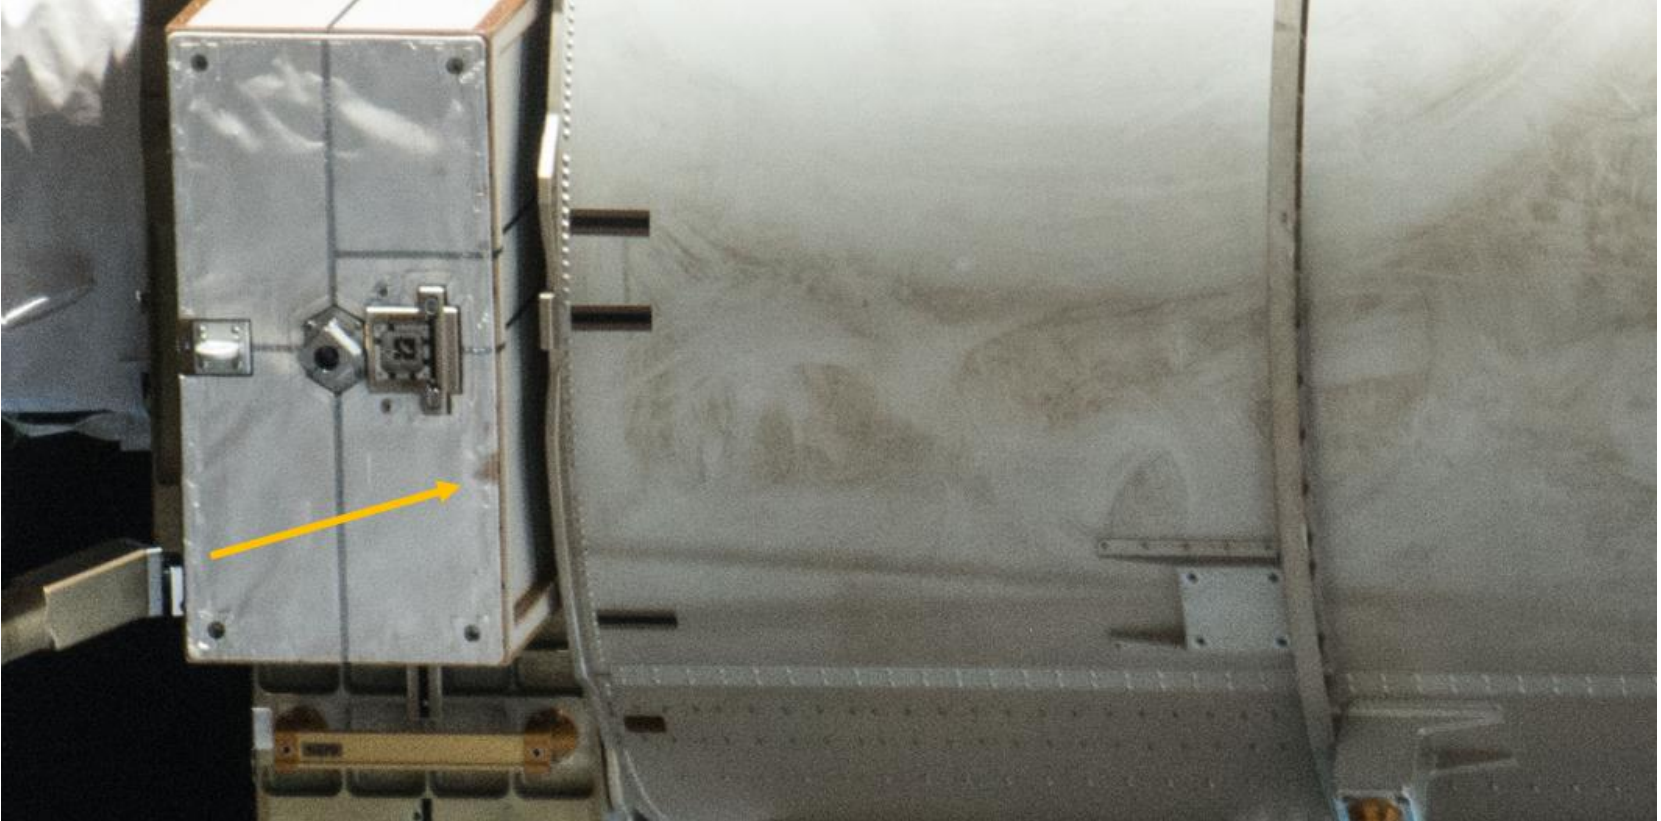
**MLI Damage and Discoloration on S6 Mast Canister**

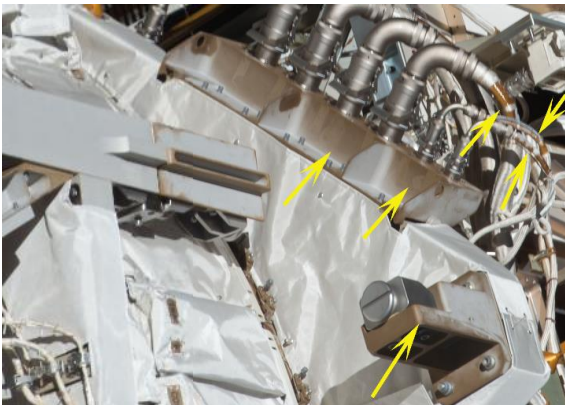
**Discolorations & Marks P4 Truss IEA**

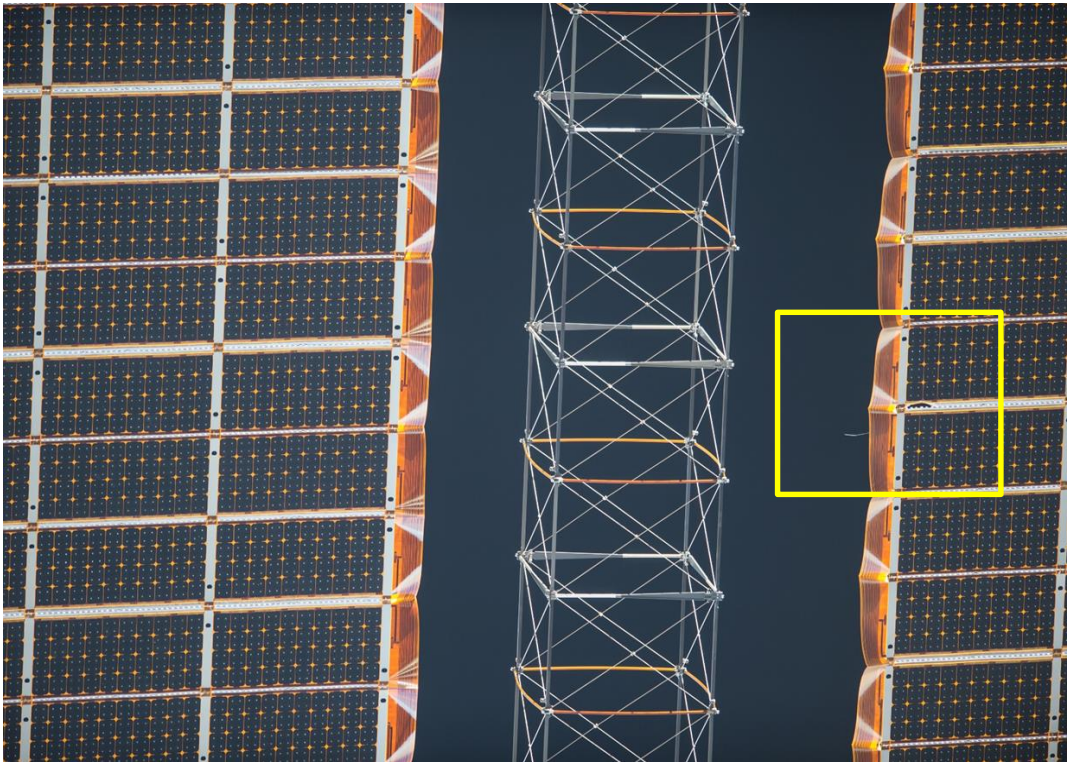
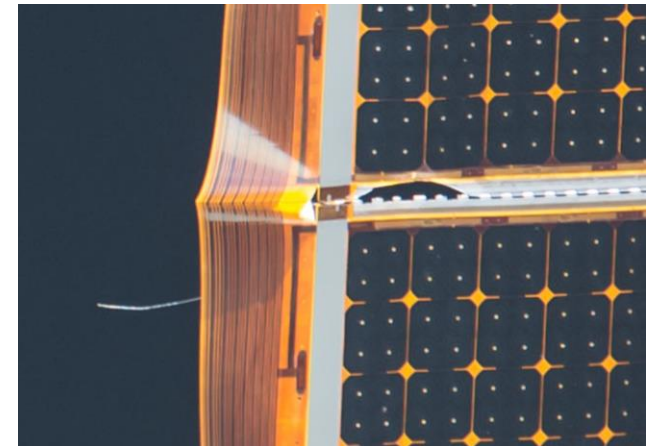
**“New” 7 inch tear is visible on Solar Array 3B.**

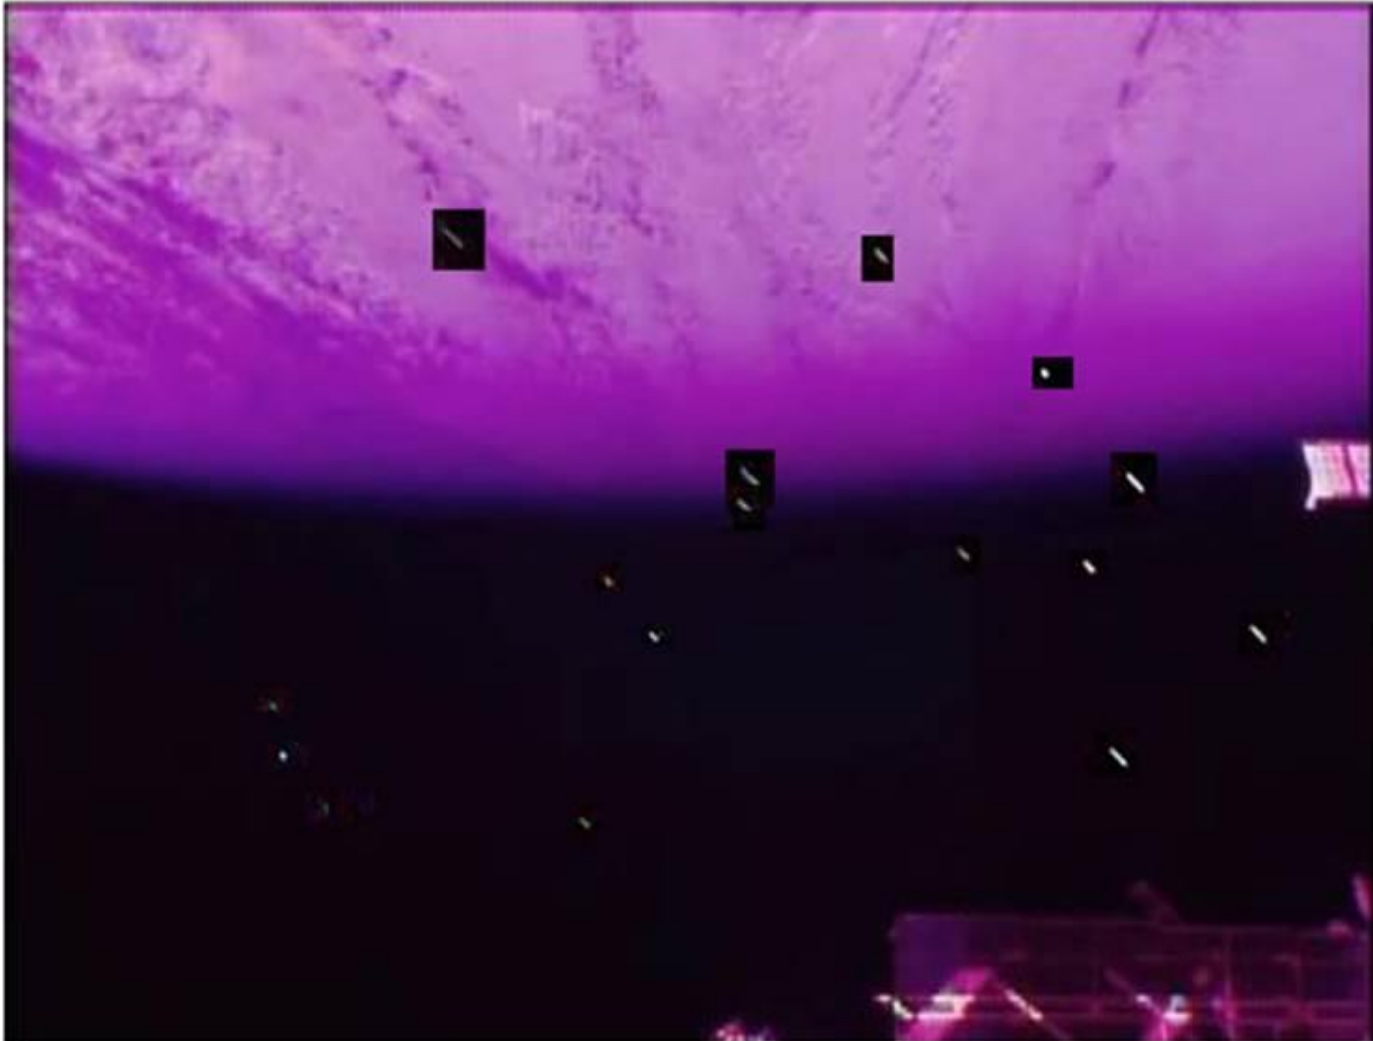
Composite Image of Ammonia Flakes With ISS Hardware

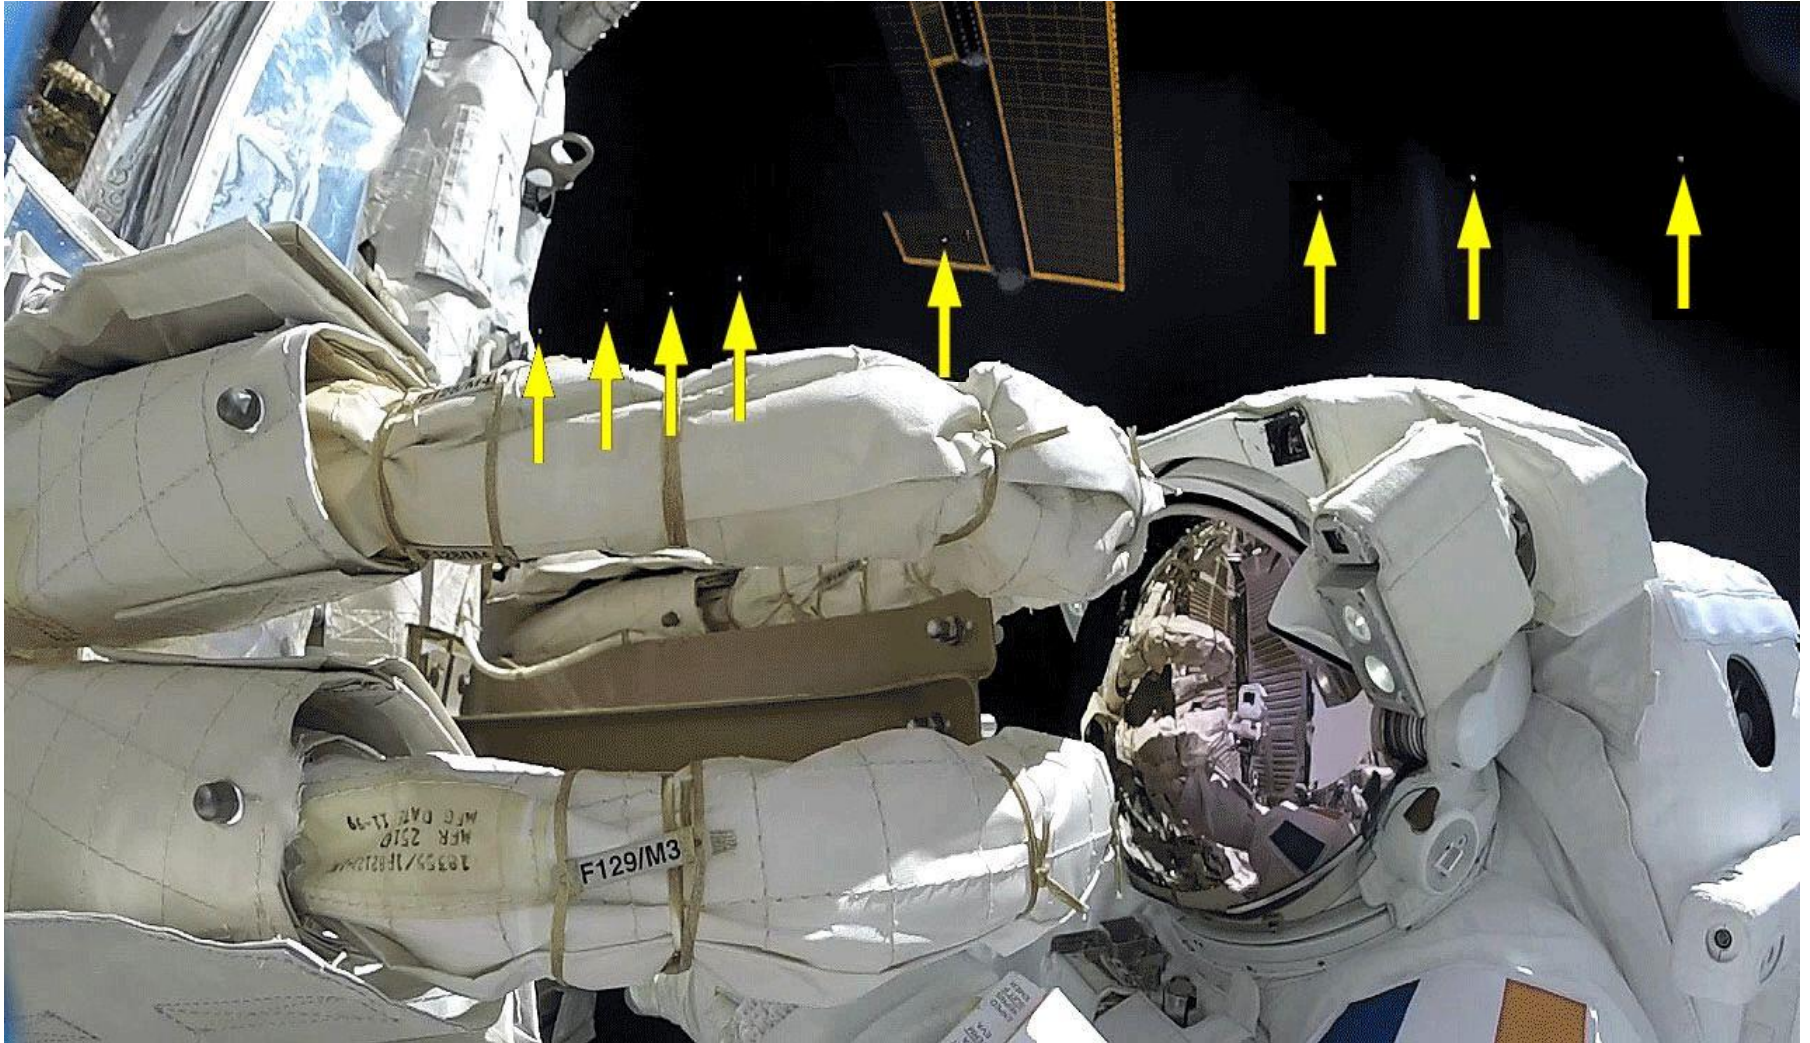
**Ammonia Flakes Observed in EVA 40 GoPro Video**

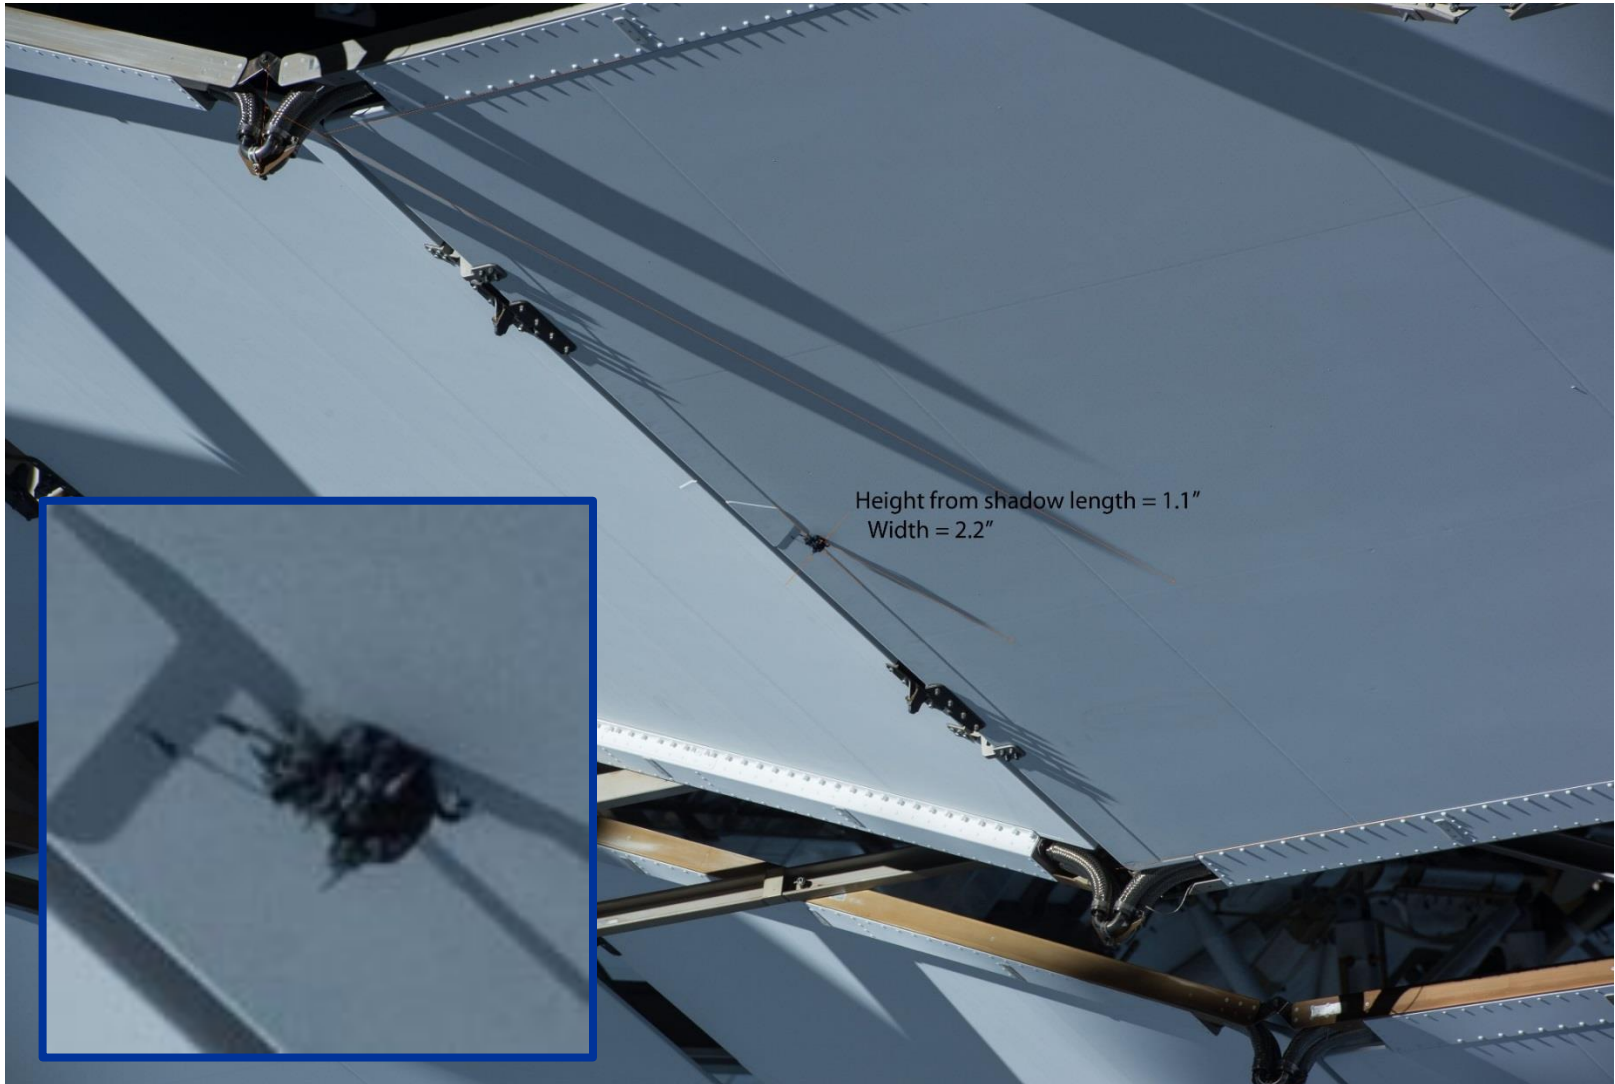
# Possible EVA Grease Ball on Thermal Radiator

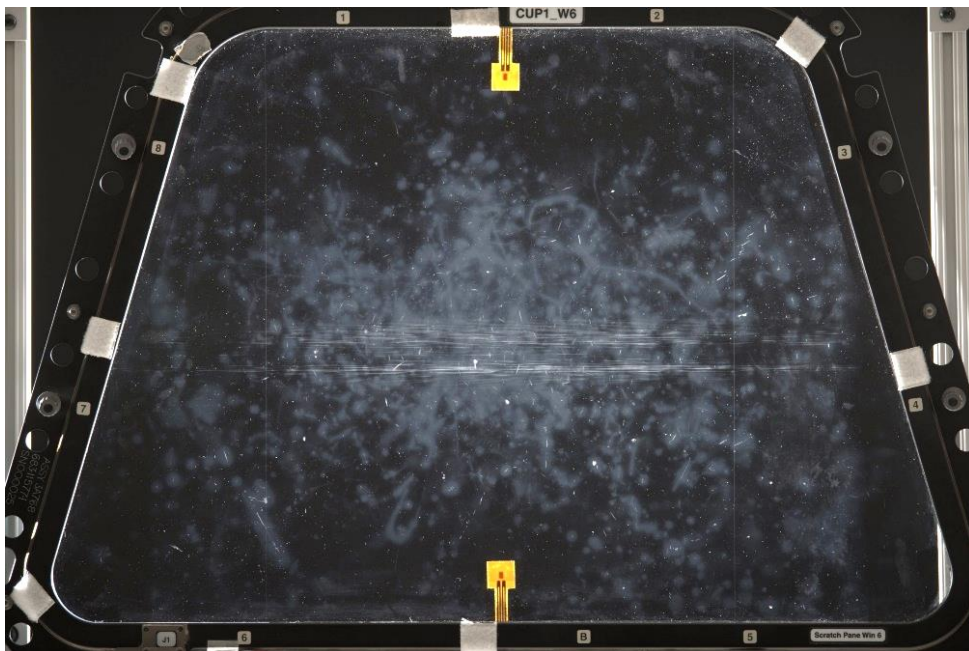
Haze and Nicks on Returned Pane
