# **Full-Scale Drop Test of a Fokker F28 Wingbox Fuselage Section**

J. D. Littell<sup>1</sup>

<sup>1</sup>NASA Langley Research Center, Research Directorate, Structural Dynamics Branch, Mail Stop 495, 14 West Bush Road, Hampton, VA 23681; PH (757) 864-5195; FAX (757) 864-8547; email: Justin.D.Littell@nasa.gov

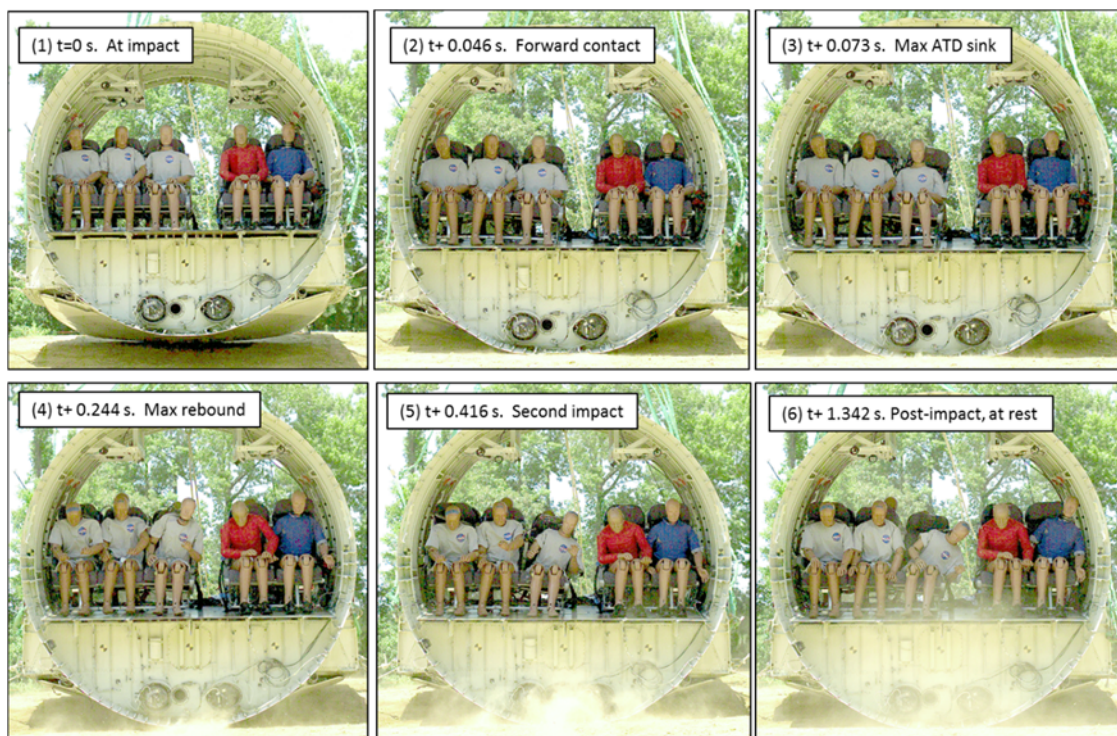
Figure 5 - Sequence of test events

The initial contact of the aft portion of the test article onto the sloped soil surface was considered to be the initial impact, and is depicted in the top left image of Figure 5. It can also be noted that at initial impact, the forward portion of the test article is still in the air. Between impact and  $t+0.046$  s, the test article rotated about the rear impact point, terminating with the forward portion of the test article initiating ground contact at  $t+0.046$  s, which is depicted in the top middle image. No sliding between impact at  $t+0.046$  s was evident from the videos, so the horizontal acceleration between these two times was presumed to be from the test article rotation only. The next notable time occurred when the onboard ATDs experienced their maximum downward vertical motion, also known as their maximum sink position, which occurred at  $t+0.073$  s, only slightly lagging the forward contact time. The test article and ATD appeared to exhibit uniform motion between  $t+0.073$  s and  $t+0.244$  s, which was the time when both test article and ATD rebounded to their maximum unloaded positions. There was a second impact of the test article that occurred at  $t+0.416$  s. During the second impact, the test article uniformly contacted the soil surface without rotational motion present. The test article came to rest shortly thereafter. A final position of the test article depicted in the lower right portion of Figure 5 shows the test article at rest, at a time well beyond where the final motion occurred during the test.

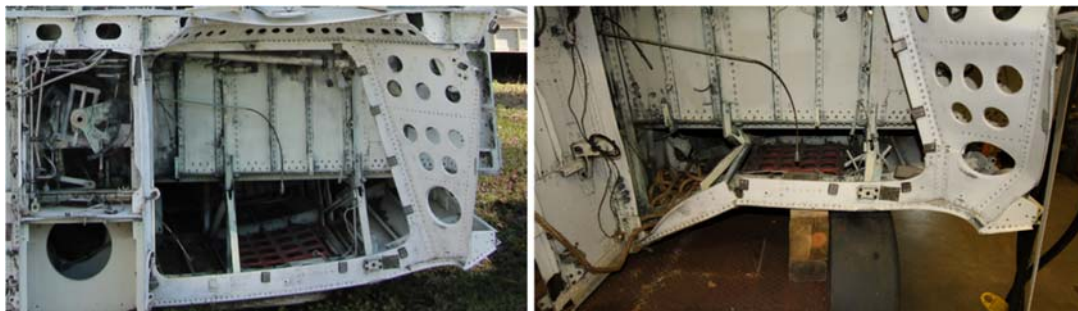
Other than the aft lower cavity, the test article did not show noticeable signs of structural damage. Additionally, all four emergency exit doors opened nominally post-test, indicating no signs of deformation or warpage on the skin or frames at the mid-cabin height. Figure 6 shows a close-up view of the aft lower cavity, pre- and post-test, which experienced the vast majority of the deformation during the test.

Figure 6 - Lower aft cavity. Before test (left) and damage post-test (right)

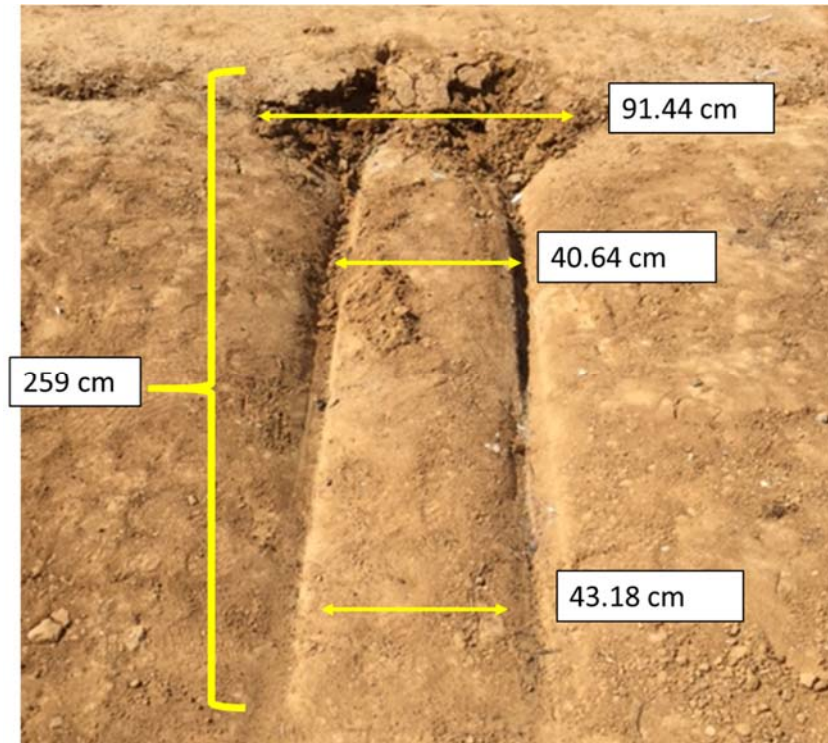
Figure 9 - Soil crater deformation with measurement overlay

The top of the image is toward the aft end of the test article. There are two distinct parallel vertical lines that show the deepest penetration near the aft of the test article and gradually become shallower when moving toward the front. The parallel lines were created by vertical stiffeners located at the bottom of the test article, approximately 22.9 cm (9 in) off the test article geometric centerline. Since the aft portion of the test article impacted first, the rear features, including the vertical stiffeners, made the deepest impression in the soil surface. Generally, the rest of the soil mound was undeformed due to the impact. The majority of the deformations appeared in the lower portion of the test article itself, which is shown previously in Figure 6. Table 1 presents the penetration measurements for three lateral locations at eight longitudinal positions in tabular form.

The soil crater measurement data marked differences between the vertical stiffener and bottom span locations. In the aft impact location, vertical stiffener penetration was 17.8 cm (7 in) into the soil on the starboard side and 18.4 cm (7.25 in) into the soil on the port side, while the location of the mid-span (not noted in Table 1 but visible in the side edges of the Figure 9) in the lower cavity of the test article penetrated very little into the soil. The difference are notable because accelerations obtained at these measured locations can provide a local loading profile. The acceleration data clearly showed difference in response between the aft subfloor accelerometer and the data logger on the cavity mid-span. Figure 10, left, shows the locations of both accelerometers in the post-test damaged view to contrast the differences in their locations. The data obtained are shown in Figure 10, right. The data logger was not time synchronized to the rest of the data so manual shifting was implemented on the data logger time data to give a more direct comparison. The data in Figure 10 are filtered using a Channel Frequency Class (CFC) 60 low-pass filter for visualization.

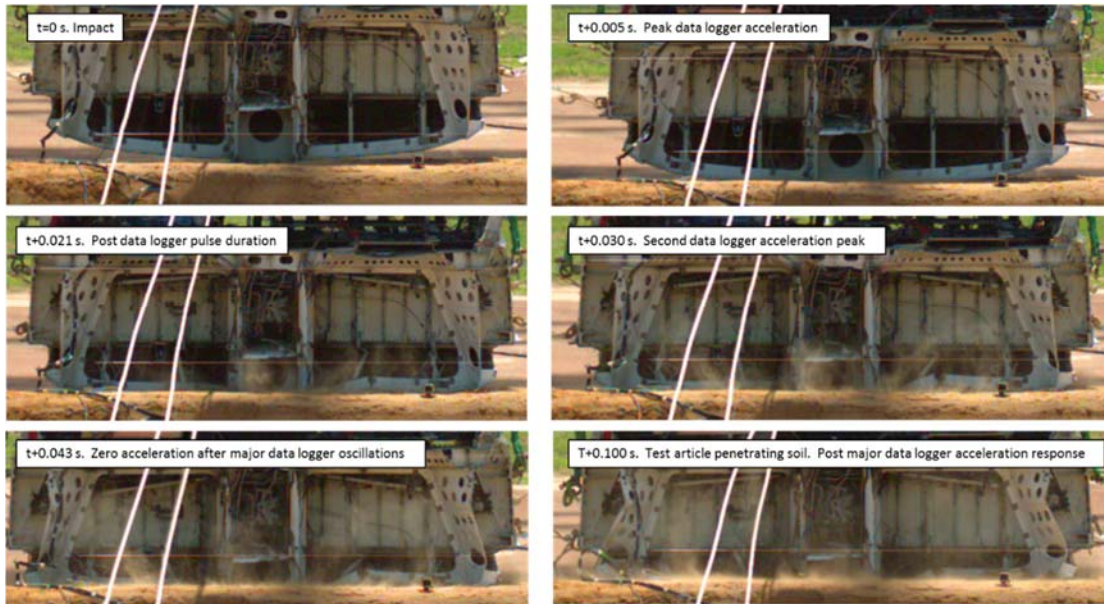
Figure 11 - Aft lower cavity deformation image series

The initial contact between the aft portion of the test article and the soil surface is shown in the upper left image in Figure 11. The peak data logger acceleration, shown in the upper right, of 106 g occurred 0.05 s later, which was before deformation initiation of the lower cavity supports occurred. The impact shape and magnitude of the acceleration response were a resultant between the bottom skin's large surface and soil contact in flat manner with no deformation. It is only after the 106 g peak that the lower cavity deformation initiated, and it was in the middle of deformation by the time the main data logger pulse finished at 0.021 s, which is shown in the middle left image. After the 0.021 s mark, large amounts of lower cavity deformation occurred, which are captured in the middle right image taken at 0.030 s after impact, and the lower left image, taken at 0.043 s after impact. At the 0.100 s mark, the major acceleration pulses for both the data logger and the accelerometer on the vertical stiffener have concluded.

The results shown in Figure 11 along with post-test inspections of the test article determined the majority of the deformation occurred in the lower cavity below the floor and wingbox truss structure, near the bottom skin of the test article. The wingbox truss structure was significantly more stiff as compared to the other parts of the fuselage and did not exhibit any noticeable deformations. Furthermore, the structure above the floor and in the mid-cabin did not show any noticeable deformations, and, as previously stated, the emergency exit doors opened nominally, also suggesting any deformation which may have occurred at the floor level or above was purely elastic in nature.
