Real Time Detection of Damage during Quasi-Static Loading of a Single Stringer Panel using Passive Thermography

Joseph N. Zalameda*^a and Michael R. Horne^b

^aNASA Langley Research Center Hampton, VA 23681-2199;

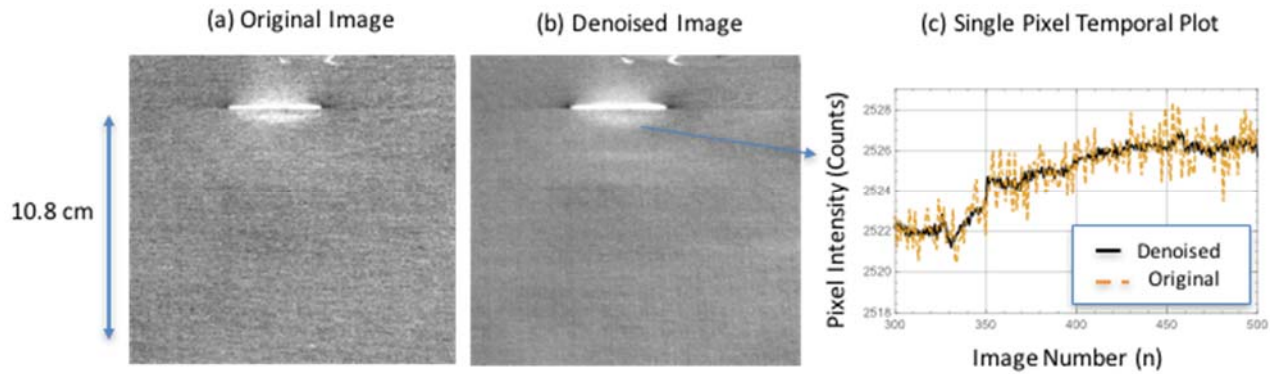
where i is the index, σ_i are the singular values of A , u_i are the columns of U , and v_i are the columns of V . N is set to 25 which gave good representation of the original data with random noise reduced. This can be seen in Figures 5a where a large heating event is detected due to the applied load. In Figure 5b the denoised image is shown with improved spatial resolution to locate the flange edge. Also shown in Figure 5c is the corresponding temporal plot for a single pixel showing noise reduced considerably. This proved helpful to remove random noise in the image data exacerbated when taking the delayed subtraction. Also shown in Figure 6 is the corresponding ultrasound inspection image showing the delamination damage growing from the flange edge toward the stringer hat. The denoising algorithm allowed for better alignment with the ultrasound inspection image.

Figure 5: Comparison of original image (a) to denoised image using singular value decomposition (b), and corresponding temporal plot at a single pixel (c).

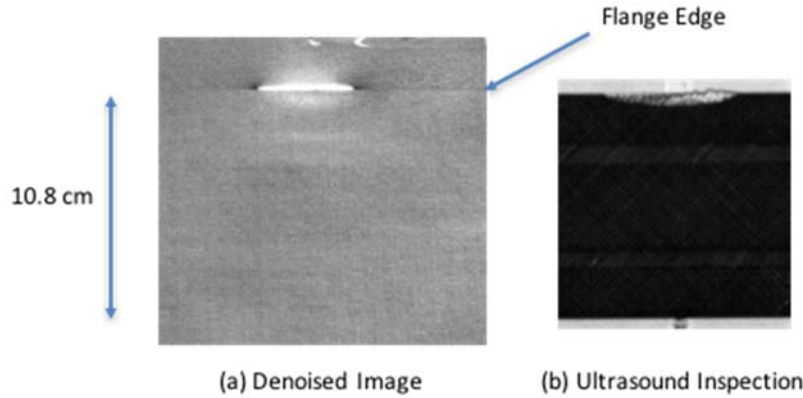
Figure 6: Comparison of denoised image (a) to corresponding ultrasound inspection image (b).

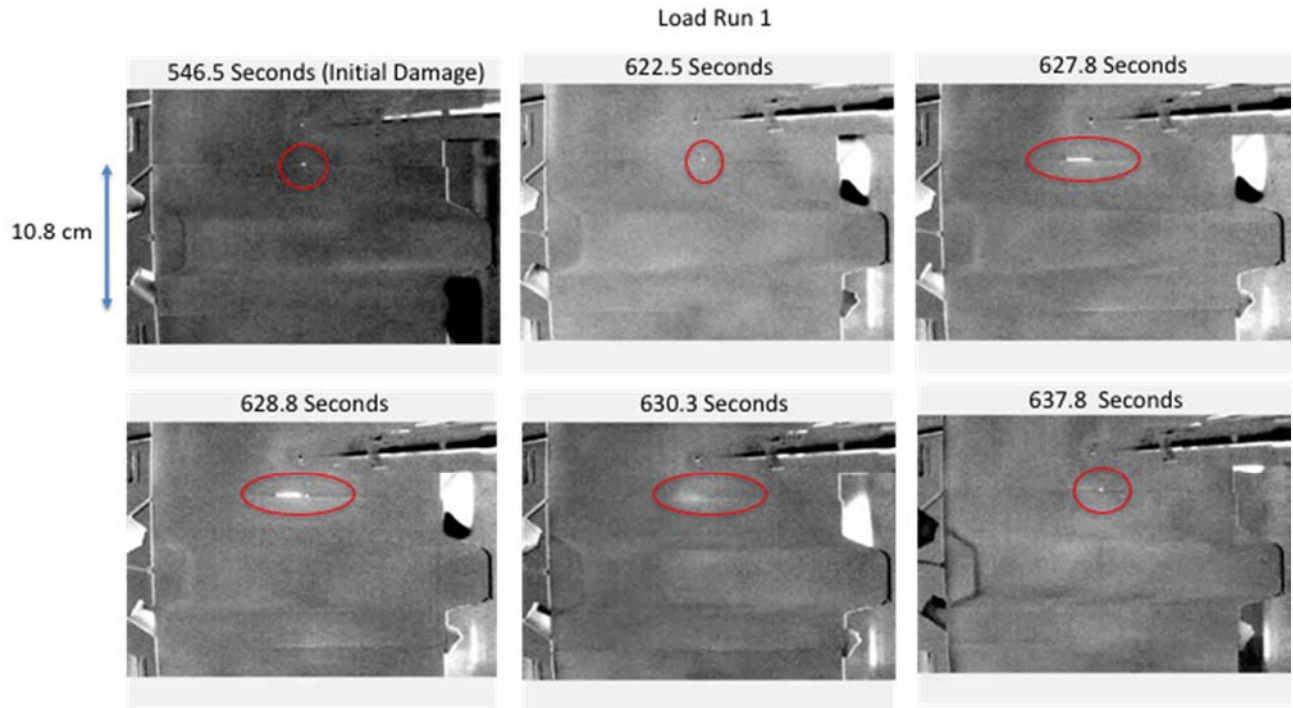
Examples of detected damage progression for a given sample during consecutive load runs are shown in Figures 7, 8, 9 and 10. The thermal damage was identified over camera noise and background reflections using three criteria: observing a bright area that appears suddenly, stays in one location, and then slowly decays in intensity over time. Using these criteria, the thermal damage is clearly identified for load runs 1 and 2 shown in Figures 7 and 9 respectively. Shown in Figures 8 and 10 are the corresponding ultrasonic inspection images. The ultrasonic inspection results show a very small edge delamination growing inward toward the stiffener hat. The thermal indications, shown in Figure 7, prove passive thermography is able to successfully detect the formation of small edge delaminations for this test setup. The thermal

Figure 7: Processed thermal inspection images for quasi-static load run 1.

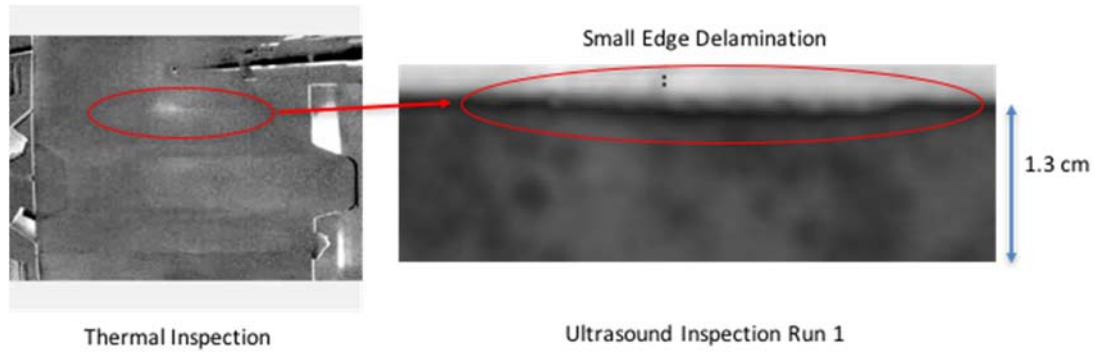
Figure 8: Comparison of thermal to ultrasonic inspection image for quasi-static load run 1.

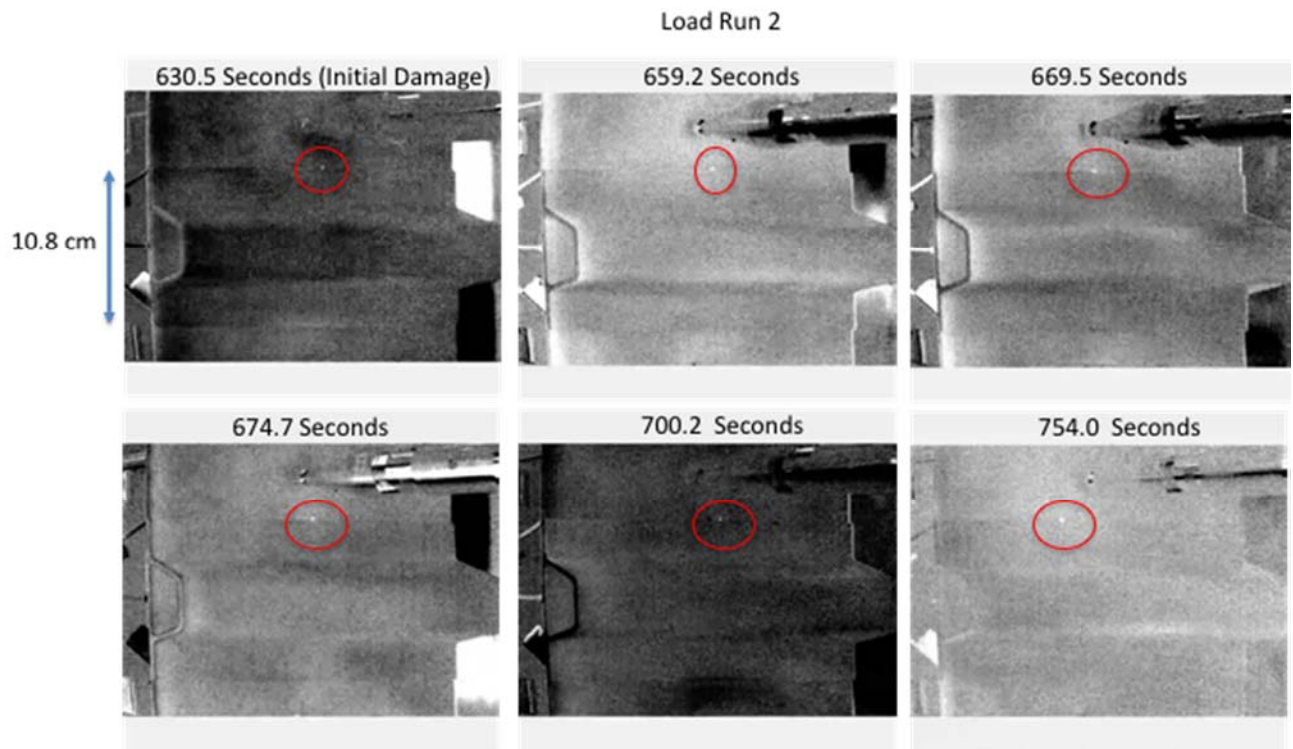
Indications from run 2 are not as pronounced as run 1, however, the small indications reveal the delamination has only grown minimally. This was confirmed with the ultrasonic inspection results shown in Figure 10. The passive thermography is able to provide the necessary information needed to control the growth of the damage thus allowing documentation with another inspection technique to determine the damage progression modes.

Figure 9: Processed thermal inspection images for quasi-static load run 2.

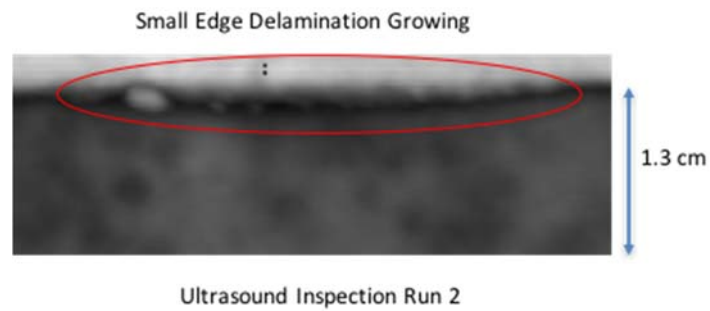
Figure 10: Ultrasonic inspection image for quasi-static load run 2 showing small delamination growth.

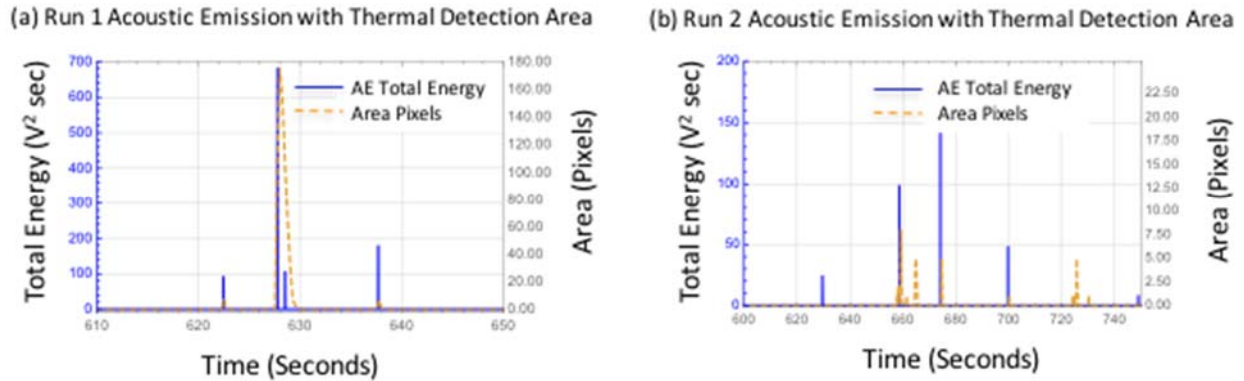
The acoustic emission data were compared to thermal data by aligning the recorded load profiles from each system. Shown in Figures 12a and 12b the acoustic emission events are compared to thermally detected area pixel count above a threshold of 9 counts for a given processed thermal image in time. As can be seen in Figures 12a and 12b for most of the detected acoustic emission events there is a corresponding thermal indication. Acoustic emission is sensitive to fiber break and matrix crack damage and this is expected to release some thermal energy. Acoustic emission is expected to be less dependent of damage depth, whereas for passive thermography, deeply buried damage would be more difficult to detect. Damage out of the field of view of the camera, such as damage formation under the stringer would be impossible to detect and this might account for acoustic emission events not detected thermally. For this test configuration, the array of acoustic emission sensor data was not able to provide damage location, whereas, passive thermography was able to provide damage location as shown previously in Figures 7 and 9.

Figure 12: Detected acoustic emission events compared to thermally detected area pixels above a threshold for runs 1 and 2.
