# Fractographic Analysis of 60-Nitinol Bearing Races

*Malcolm K. Stanford*  
*Glenn Research Center, Cleveland, Ohio*

Fracture surfaces on a failed bearing race made from 60-Nitinol (60 wt% Ni – 40 wt% Ti) were analyzed. The bearing had experienced excessive localized heat due to an issue during machining that may have resulted in dimensional distortion. However, the classical fracture features that were identified by scanning electron microscopy and the fracture origins coincided with high concentrations of TiC-based contamination. Lessons learned for processing and quality control are discussed. An attempt to use x-ray diffraction to directly measure residual stresses imparted from the required heat treatment is also discussed.

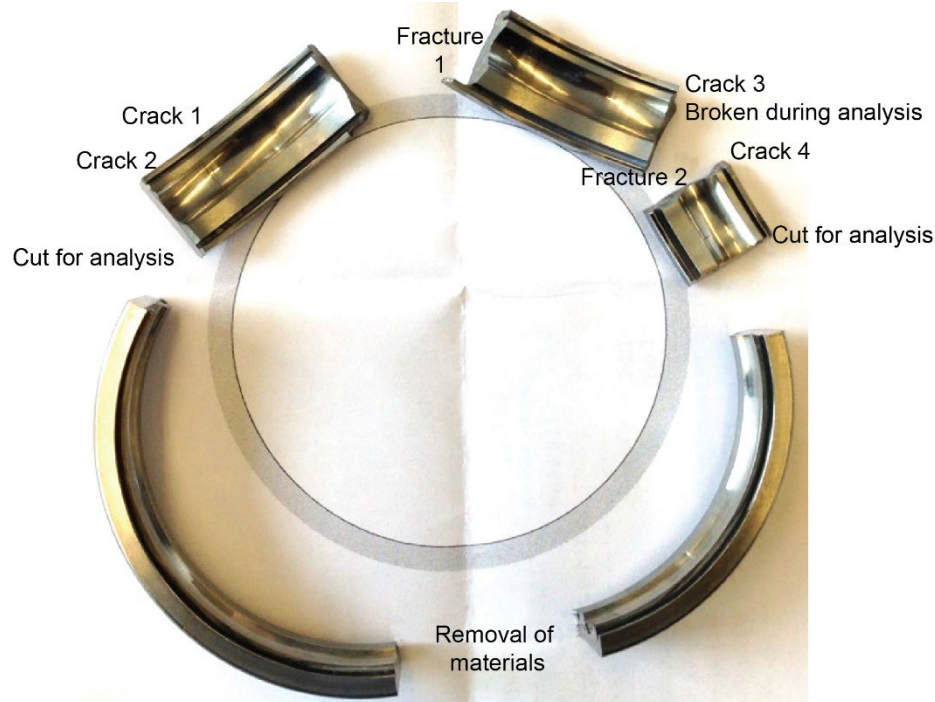
Fractures were observed in some early prototype 60-Nitinol bearings after testing. These fractures originated on the inner diameter of the outer race and propagated outward radially. Some of the fractures appeared to propagate into the surface for only a short distance, but some went completely through the bearing races. One such bearing was disassembled, as shown in Figure 1. The manufacturing and processing history for this bearing was reviewed and a few possible causal factors for the fractures were considered (Ref. 4). It was thought that localized heating due to nonuniform contact with a grinding wheel during a machining operation led to warping of the bearing race. 60-Nitinol has also been found to warp due to the high levels of residual stress that are imparted to the material during its heat treatment process (Ref. 5). As the outer layers of material are removed, a part can warp as the residual stresses attempt to maintain equilibrium. Whatever caused the warping, the race was thought to have become dislodged from the machining fixture during the grinding process. This would have led to uneven grinding of the inner diameter later in the machining process. It was also thought that the bearing blank could have started out undersized such that there was not enough material to grind the bearing to its designed dimensions. In either case, the resulting out-of-round condition of the bearing was thought to have led to failure by fatigue, due to the cyclic loading of the asymmetrical part. The purpose of this study was to examine the microstructure of the failed bearing to better understand factors that could have influenced these fractures.

Figure 1.—Failed bearing sections with fracture surfaces for further analysis labeled 1 and 2. In addition to the fractures, the bearing has been sectioned in a few locations to aid disassembly while preserving the fracture surfaces.

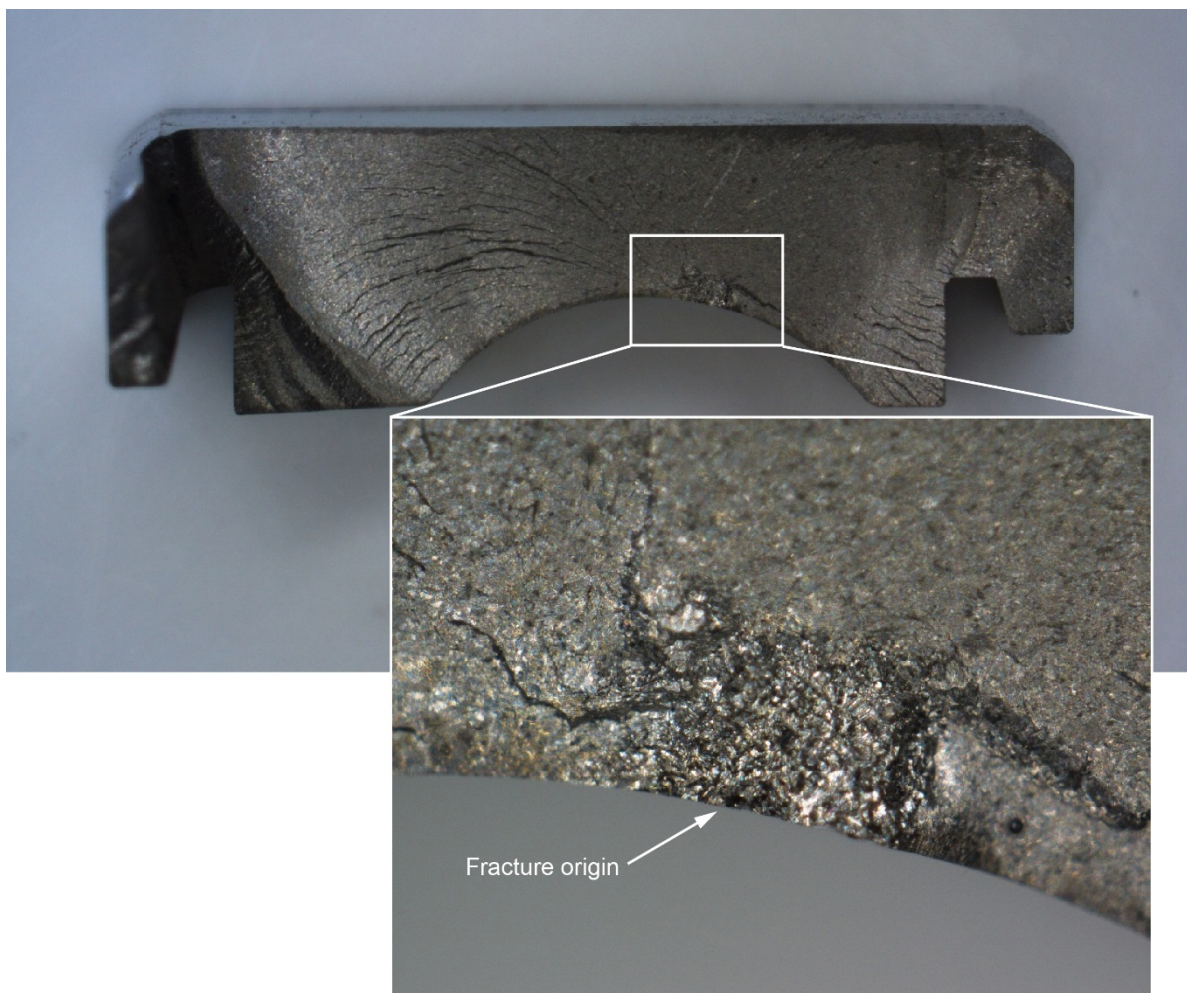
Figure 4 shows a macroscopic view of a fractured bearing surface with hackle (also known as “river patterns”) indicating the location of the fracture initiation site. The inset shows the fracture initiation site at higher magnification. This fracture surface is from the fracture labeled “Fracture 1” in Figure 1. The mating half of the fracture surface shown in Figure 4 is shown in Figure 5, where the topography of the fracture surface can be observed with better resolution. Using backscattered electron imaging, as shown in Figure 6, the chemical difference between the bulk material and what is clearly an inclusion can be observed. Figure 7 shows EDS analysis of this inclusion, which indicates that it is composed of titanium, carbon and possibly nitrogen. A nitrogen peak appeared in the surrounding bulk material as well so, based on this analysis, it is not possible to determine if the inclusion is a compound of Ti, C and N (TiCN) or just Ti and C (TiC). There is also an interference between Ti and N peaks at roughly 0.5 keV that makes detection of N difficult in this material.

Figure 4.—Macroscopic image of fracture surface 1 with inset showing the fracture initiation site. Though the location of the fracture origin is easily identified by following the classical features identified in Figure 2, more depth of field is needed to further investigate the fracture origin.

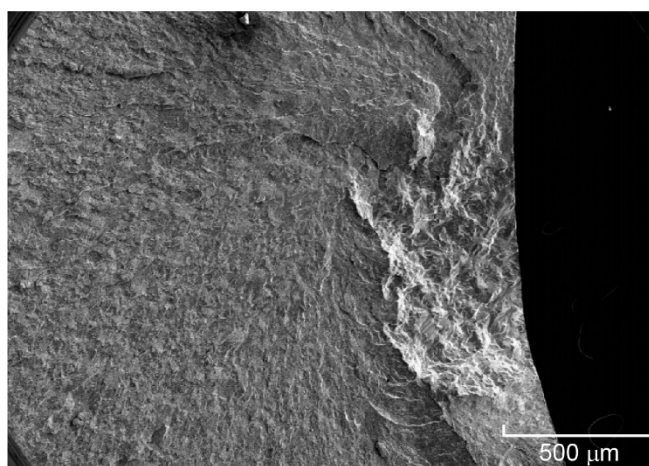
Figure 5.—SEM micrograph of the mating fracture surface to that shown in Figure 4. The topography of the surface is more clearly resolved with electron microscopy than with optical microscopy.

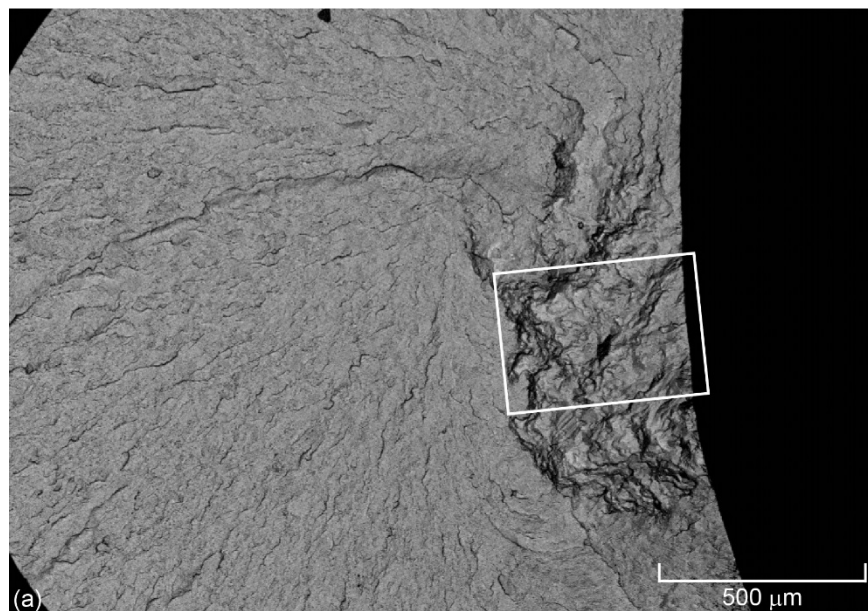
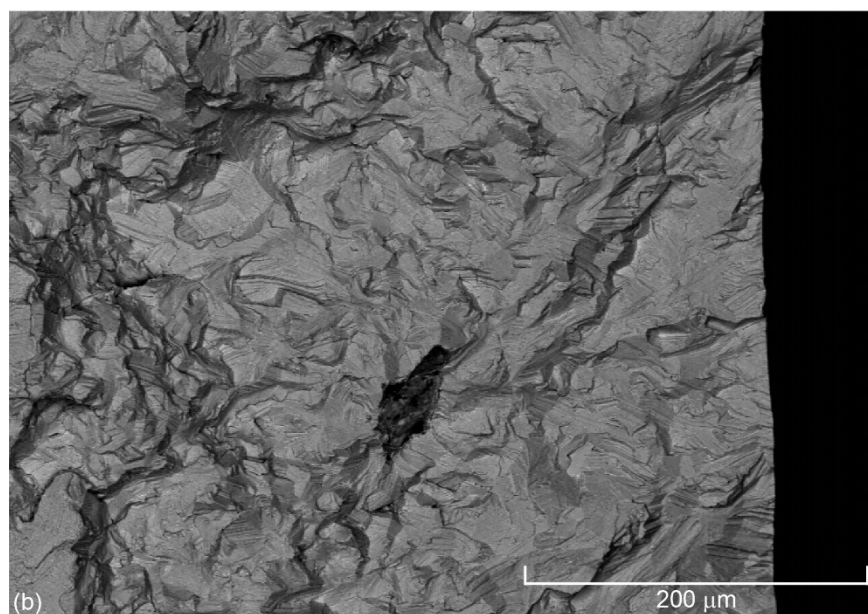
Figure 6.—Backscattered electron image SEM micrographs of the fracture initiation site from Figure 4 at (a) low and (b) high magnification, showing a large (approximately 75  $\mu\text{m}$  in length) inclusion.

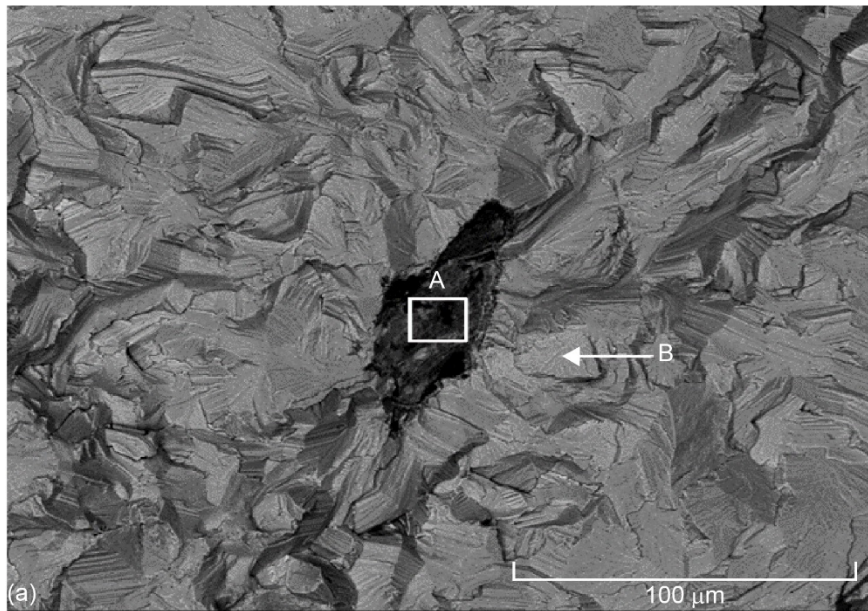
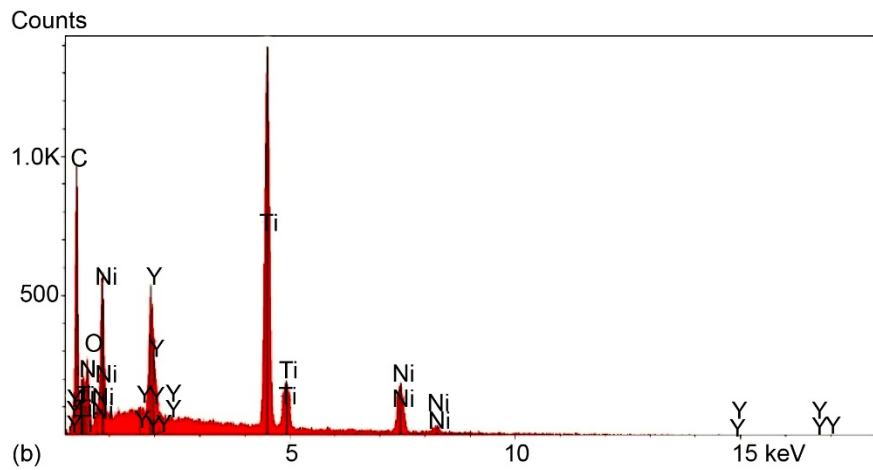
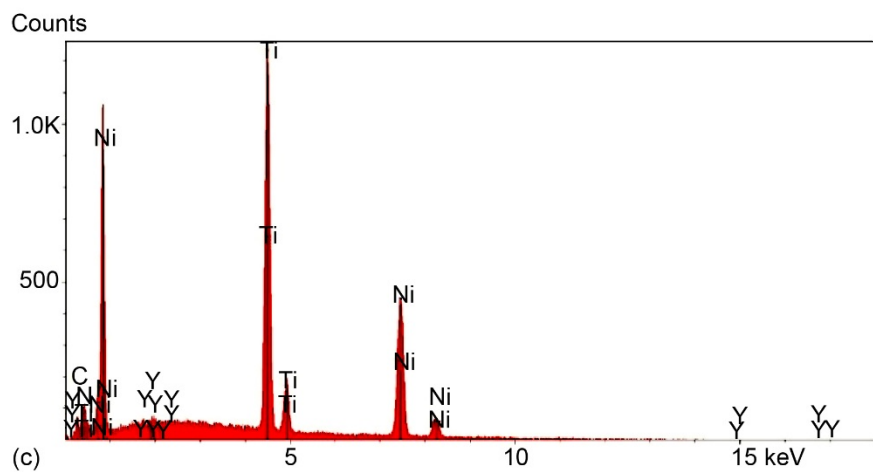
Figure 7.—SEM micrograph of the inclusion noted in Figure 6(b) and EDS spectra (b) at area A and (c) at point B indicating that the inclusion is composed of Ti, C and N within NiTi.

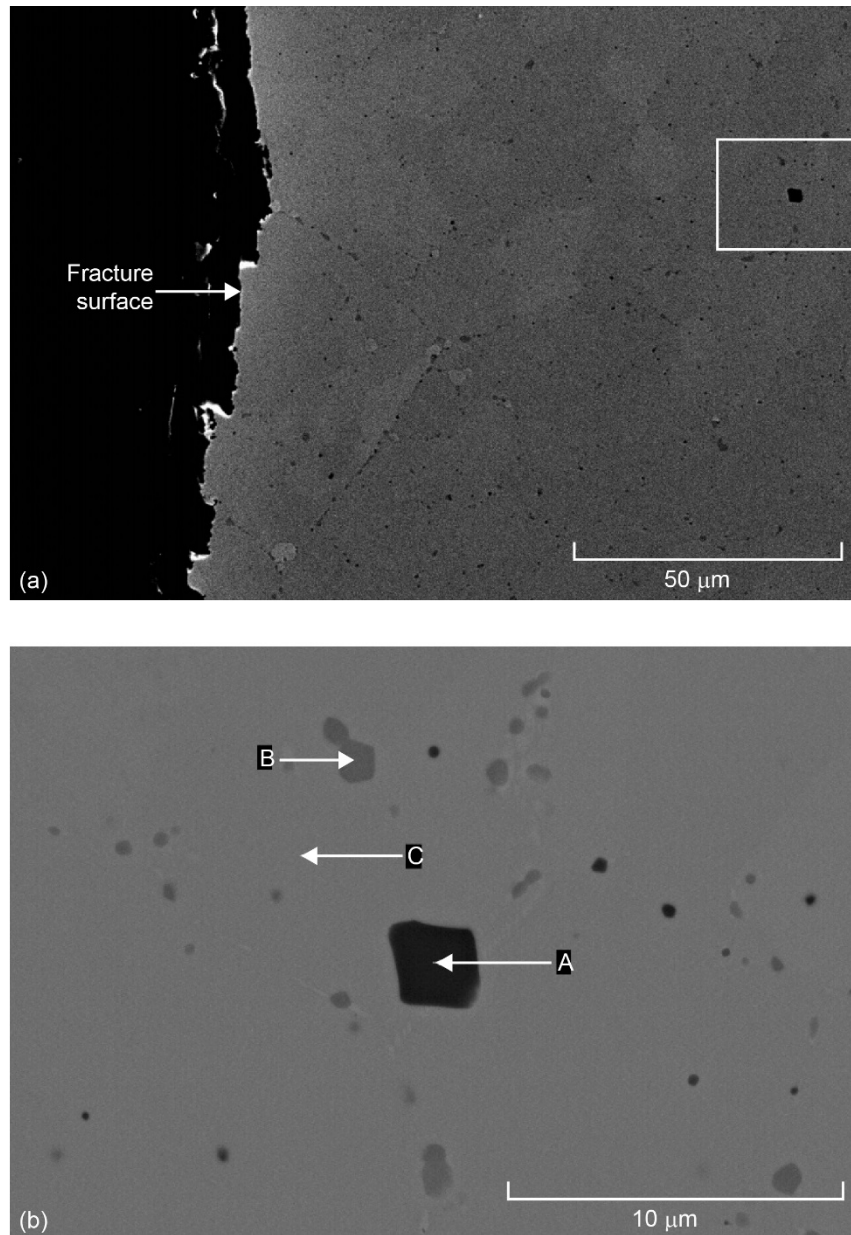
Figure 8.—SEM micrographs at (a) low and (b) high magnification of the bulk material perpendicular to the fracture surface shown in Figure 4 to Figure 7, showing a small ( $\sim 2\ \mu\text{m}$ ), angular inclusion at A.

A section was made perpendicular to the fracture surface, approximately 1 mm away from the inclusion. This was done because metallographic preparation removes about a millimeter of material during grinding and polishing. The goal was to examine the material as close as possible to the fracture initiation site. SEM micrographs of the resulting cross section are shown in Figure 8. Another chemical inhomogeneity was observed approximately 100  $\mu\text{m}$  from the fracture surface. Based on EDS analysis, as shown in Figure 9, the inclusion was composed of Ti and C and was, therefore, likely TiC. The same specimen used for this cross section was polished approximately 1 mm further into the bulk of the material. This cross section was then also examined by SEM and another angular inclusion was detected, as shown in Figure 10 and Figure 11. Hard, angular inclusions such as these would clearly serve as stress-risers within the bulk material enabling fracture initiation.

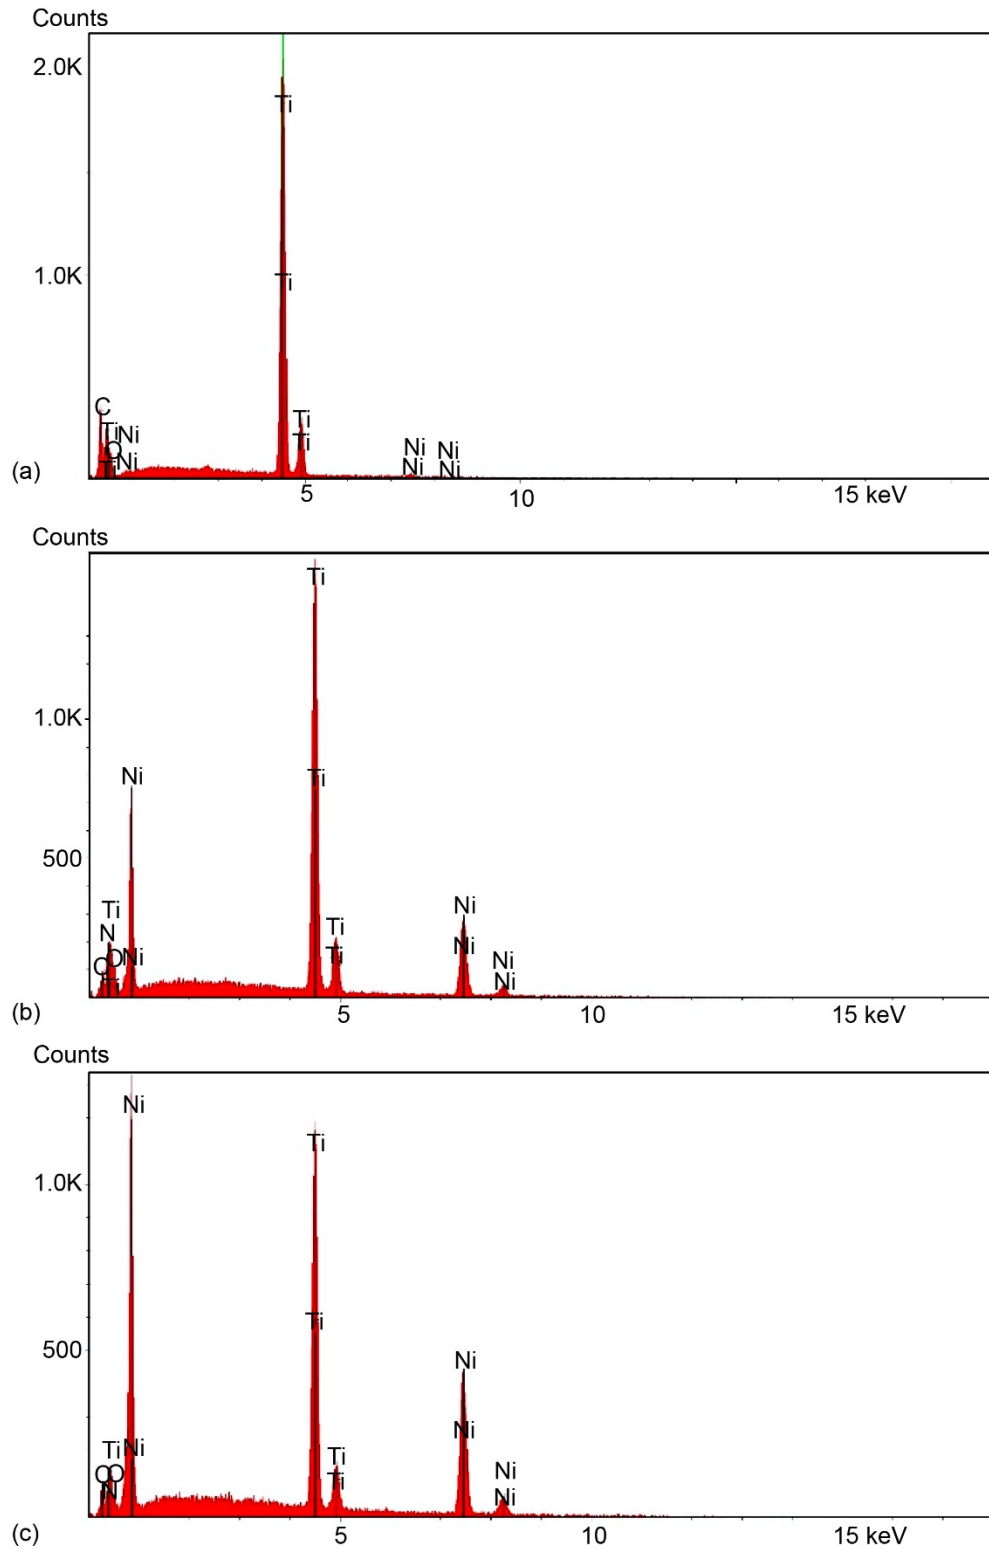
Figure 9.—Chemical analysis of the inclusion noted in Figure 8. The elements present (a) at point A are Ti, C, O and Ni, (b) at point B are Ti, Ni, C, O and N and (c) at point C are Ni, Ti, C and O.

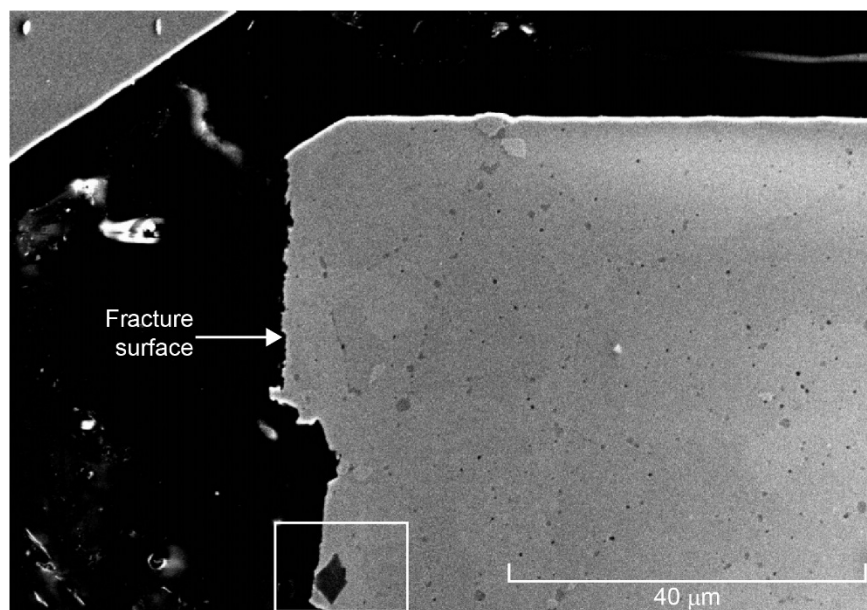
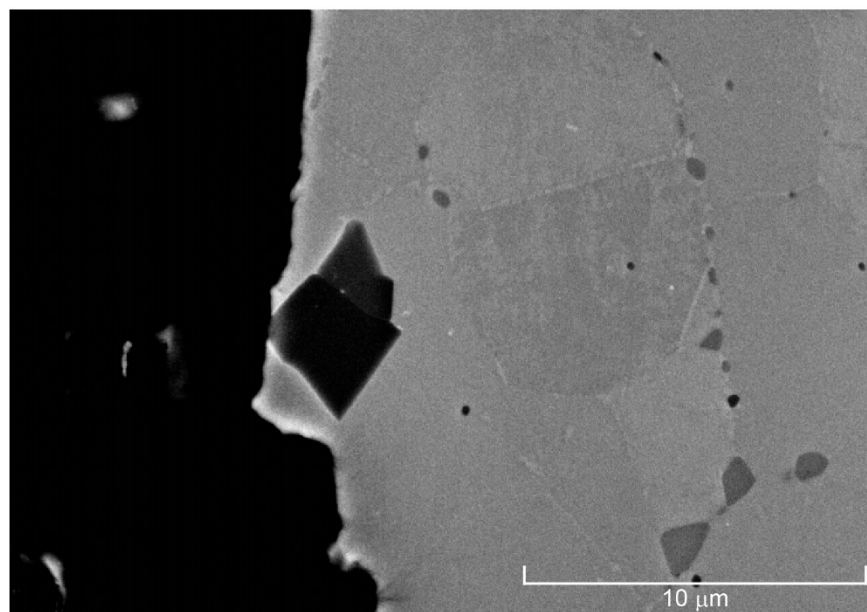
Figure 10.—SEM micrographs at (a) low and (b) high magnification of the bulk material perpendicular to the fracture surface shown in Figure 3 to Figure 6 and parallel to the surface shown in Figure 8 after additional polishing, showing another small (3 to 5  $\mu\text{m}$ ), angular inclusion.

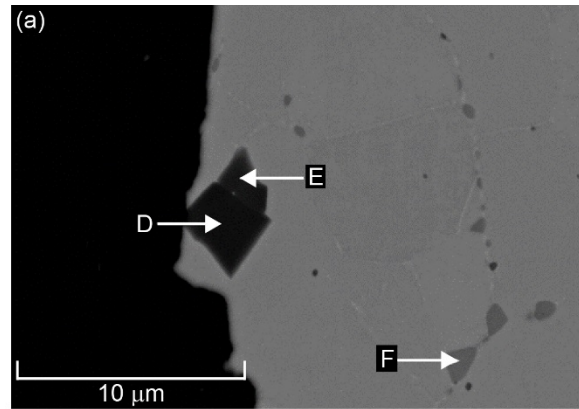
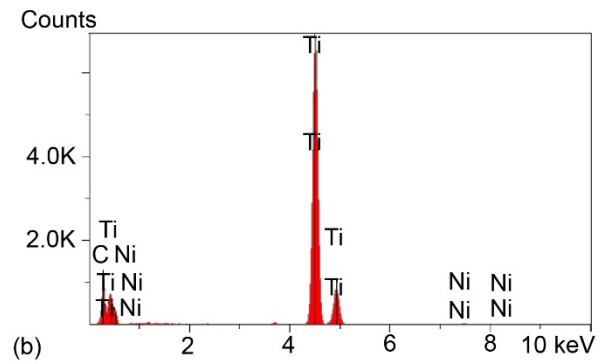
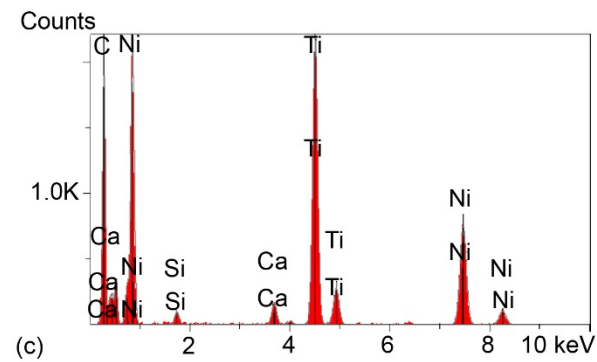
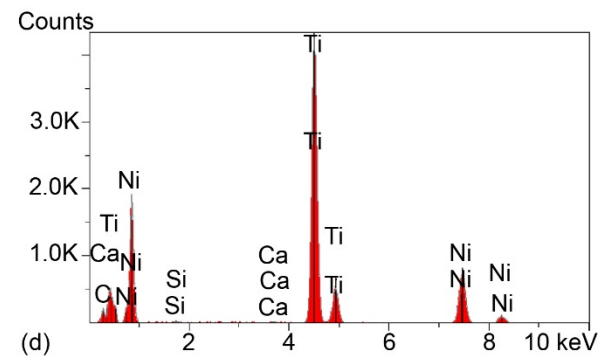
Figure 11.—Chemical analysis of the inclusion noted in Figure 10 (shown in a), indicating a composition of Ti and C. The spectra shown are for (b) location D, (c) location E, and (d) location F.

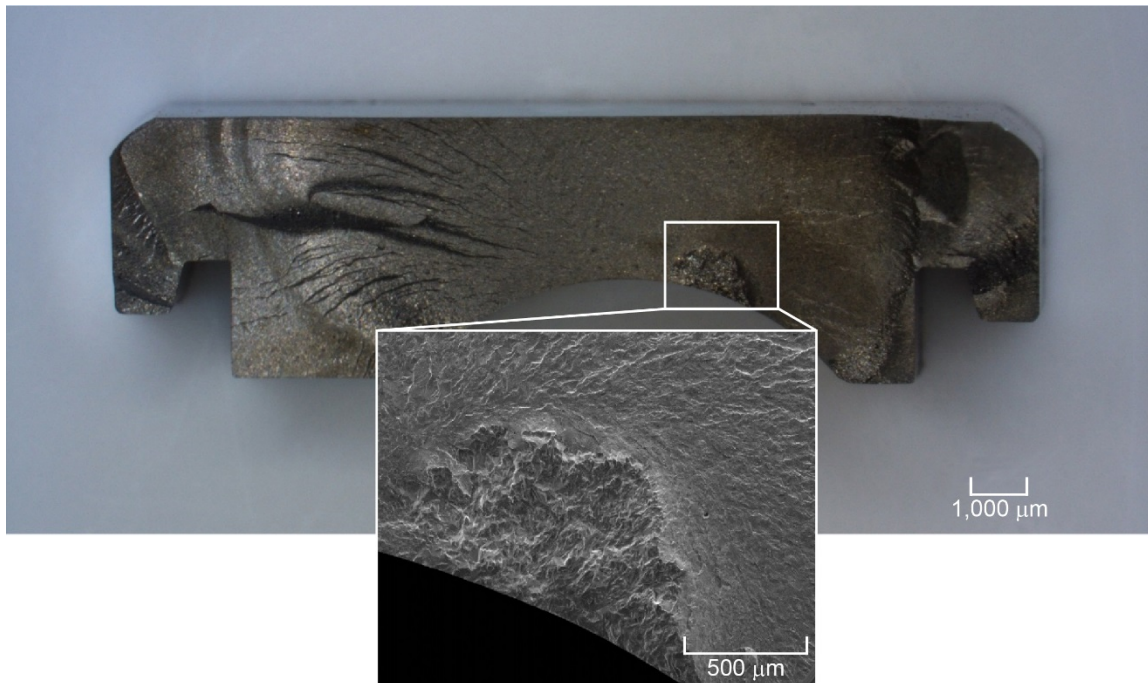
Figure 12.—Macroscopic image of a segment of the fractured bearing surface with the inset showing higher-magnification SEM image of the fracture origin.

A second fracture surface (from the fracture labeled “Fracture 2” in Figure 1) is shown in Figure 12. The fracture initiation site and the flaw within it are identified in Figure 13. Analysis of the flaw, shown in Figure 14, revealed that it was filled with particles with high concentrations of Ti, C and N, as with the inclusion that was previously discussed.

The location of these fracture origins may also be noteworthy. The fractures originated from the inner diameter of the outer bearing race, approximately 30° from top dead center. The mechanics of the state of stress at the fracture origins during bearing operation are beyond the scope of this investigation but may have an important role in these fractures.

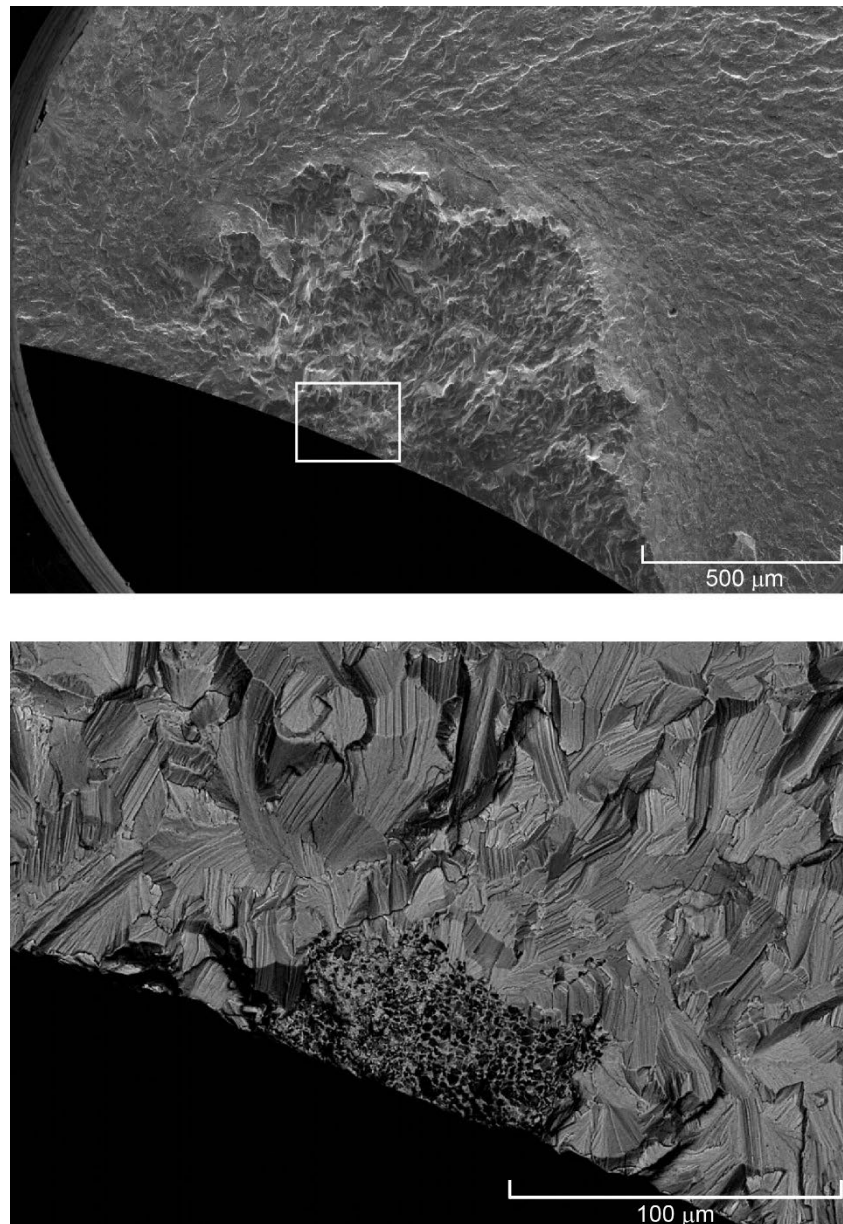
Figure 13.—SEM micrographs of the fracture initiation site shown in Figure 12 at (a) low and (b) high magnification, showing a cluster of inclusions ( $\sim 100\ \mu\text{m}$  in size).

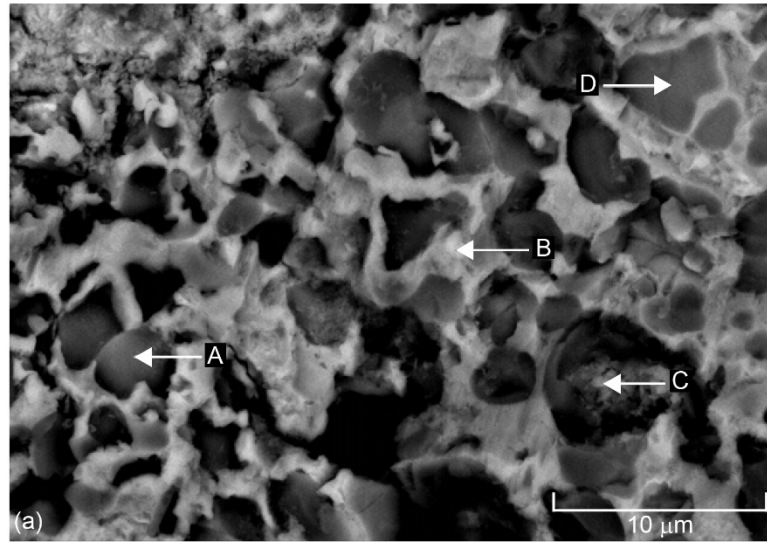
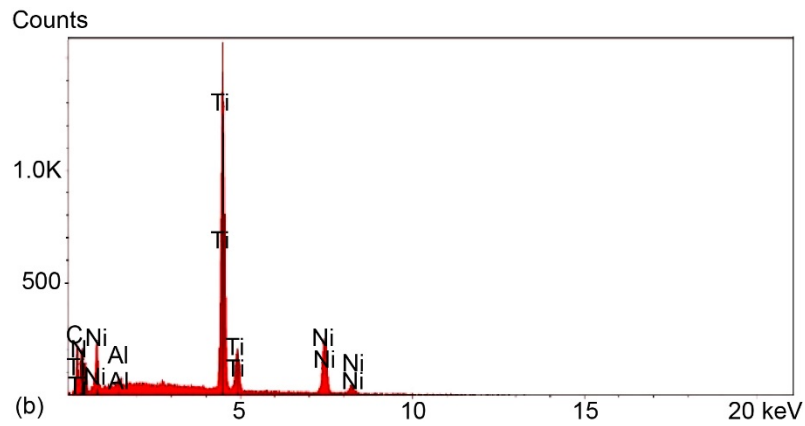
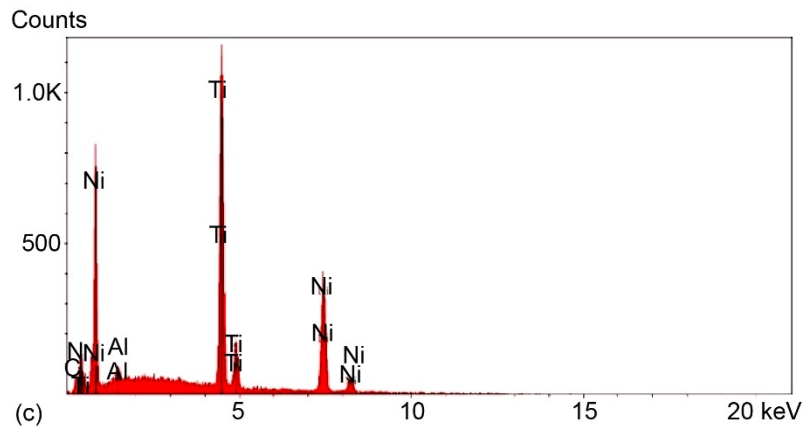
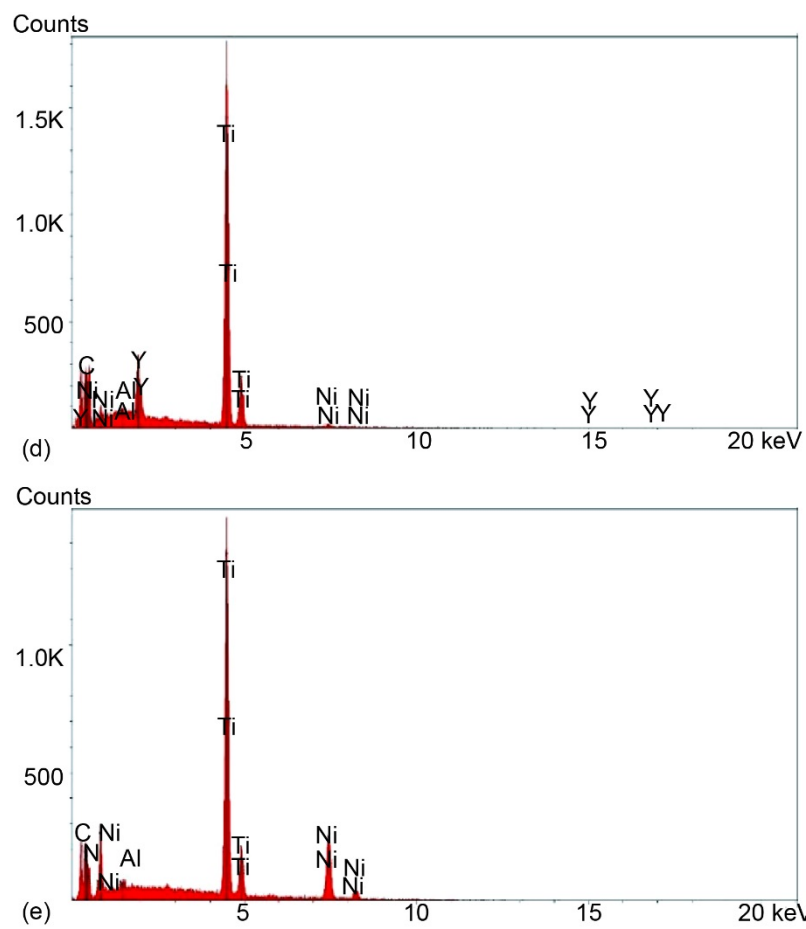
Figure 14.—(a) SEM of inclusions at fracture origin shown in Figure 13 with EDS chemical analyses indicating the presence of Ti-C-N based inclusions at (b) location A, (c) location B, (d) location C and (e) location D.

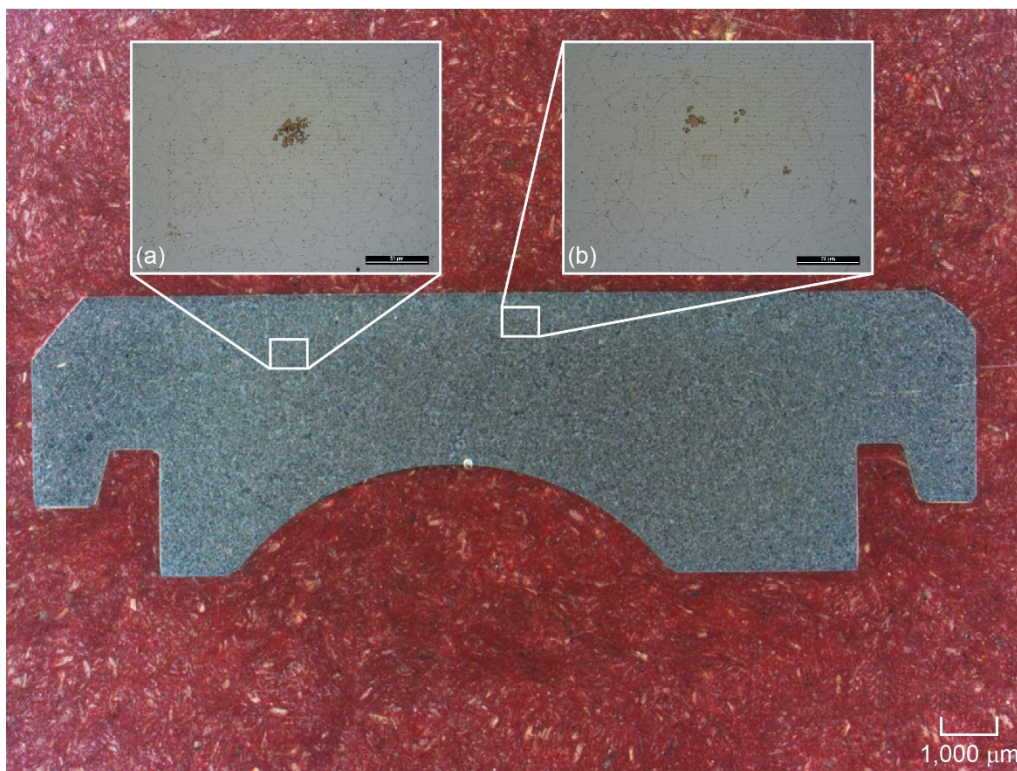
A section of the bearing more than a centimeter away from any fractures was also selected for examination. This cross section was polished for metallographic examination. A macroscopic image of this cross section is shown in Figure 15. Inspection by optical microscopy revealed clusters of inclusions that had a golden appearance under the optical microscope in contrast to the typical bright white hue of the metallic Nitinol. Since pure TiN is known to have a golden hue and pure TiC is black, the visual appearance is further evidence that the inclusions are not pure TiC. They are likely TiCN or possibly TiN. EDS analyses of the inclusions, shown in Figure 16 and Figure 17, indicated that the composition of the inclusions were TiC, though the presence of N could not be excluded due to the peak interference between Ti and N mentioned previously. Regardless of the exact composition of the inclusion, it is a contaminant that is unexpected due to the cleanliness of the starting materials. Also, although this contamination appears to be present throughout the material, its presence coincides with both of the studied fracture initiation sites in this material. So, while contamination appears to play a critical role in these fractures, the presence of the contamination alone was not sufficient to cause fractures in the studied bearing. It is likely that the location (and, possibly, the concentration) of the contamination has the greatest effect on the initiation of the studied fractures since clusters of inclusions were found on the inner diameter of the bearing race at the fracture origins. The influence of the machining operation mentioned previously along with the likely combination of residual stresses in the part caused by heat treatment also cannot be ruled out as a possible additional factor in the initiation of the studied fractures.

Figure 15.—Macroscopic image of random cross-section through the other race with insets (a) and (b) showing higher-magnification images of areas with additional inclusions, which have a golden hue under the optical microscope.

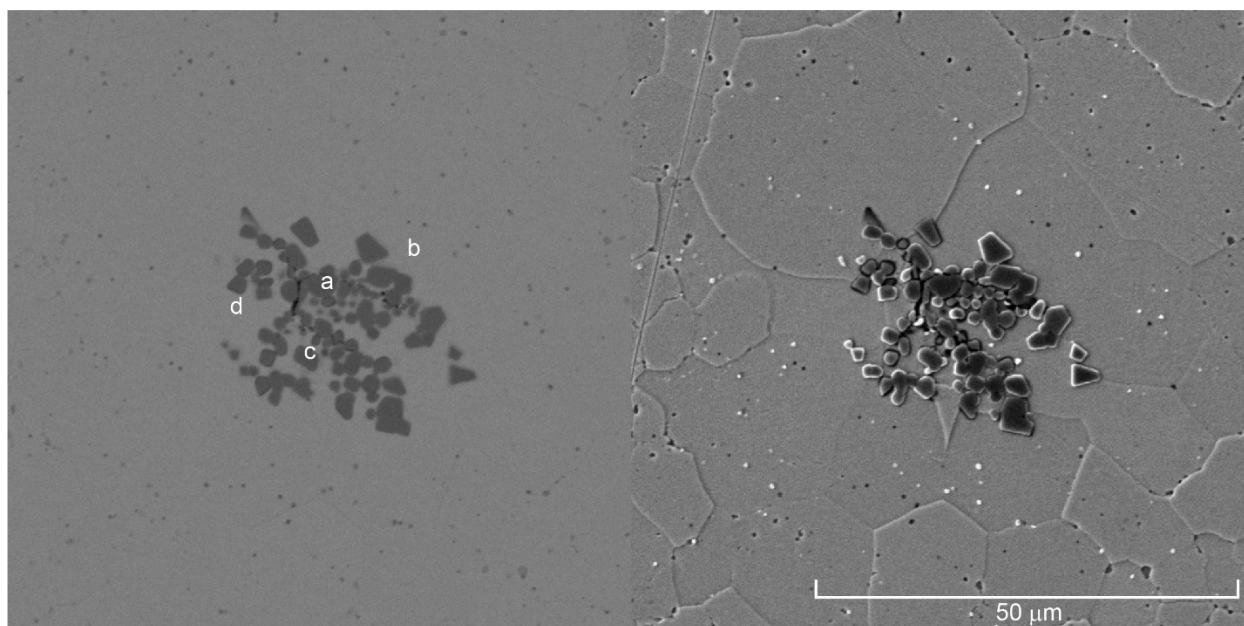
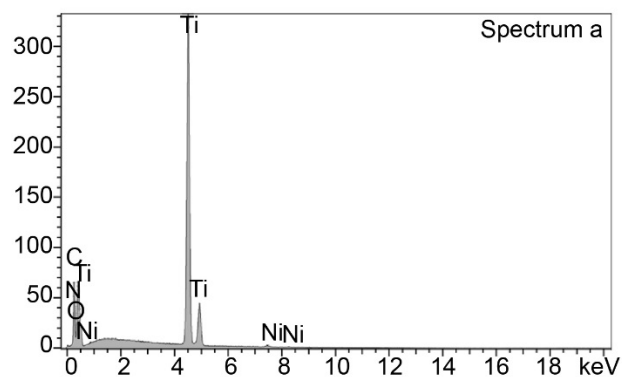
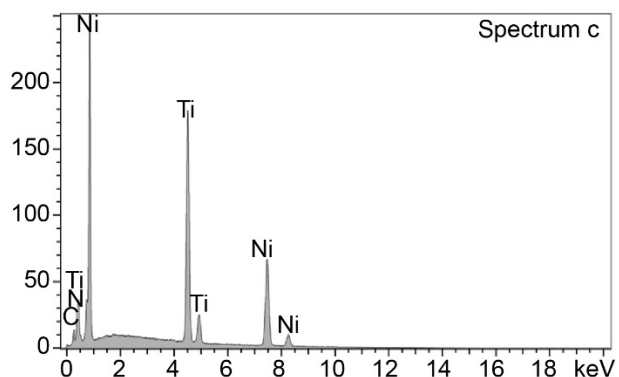
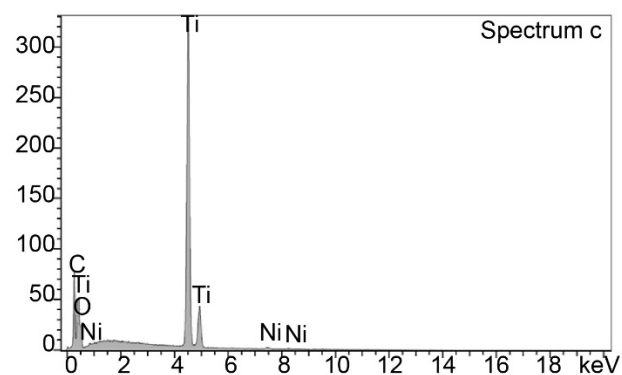
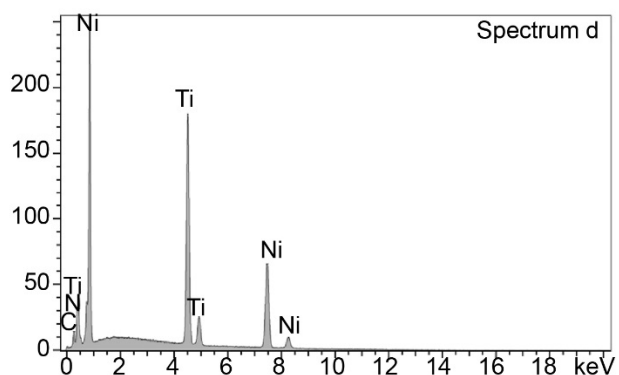
Figure 16.—Scanning electron micrographs and corresponding EDS spectra of inclusions shown in Figure 15(a) (the careful reader may notice that the optical image is inverted across the vertical axis compared to the SEM image). The image on the left is the backscattered electron image, which emphasizes atomic number contrast, and the image on the right is the secondary electron image, which emphasizes surface topography. Spectra correspond to the chemical compositions at locations labeled on the backscattered electron image.

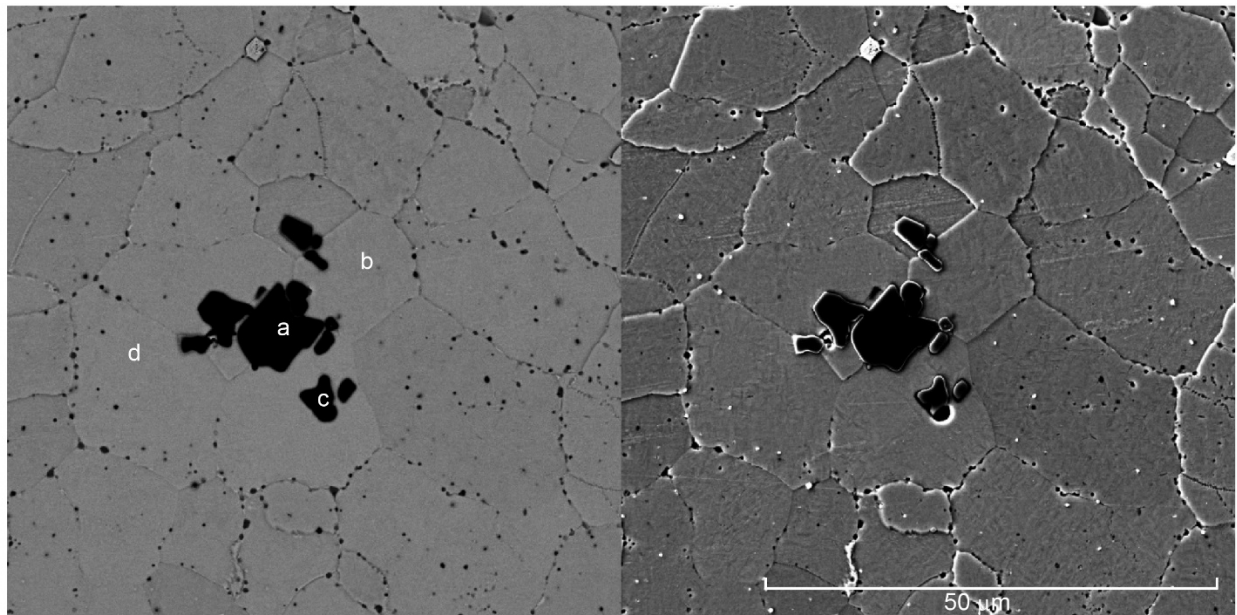
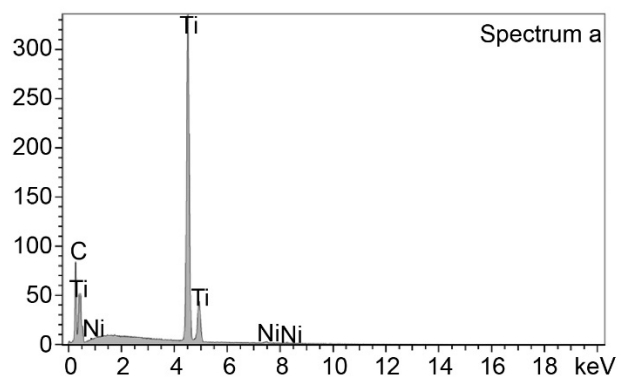
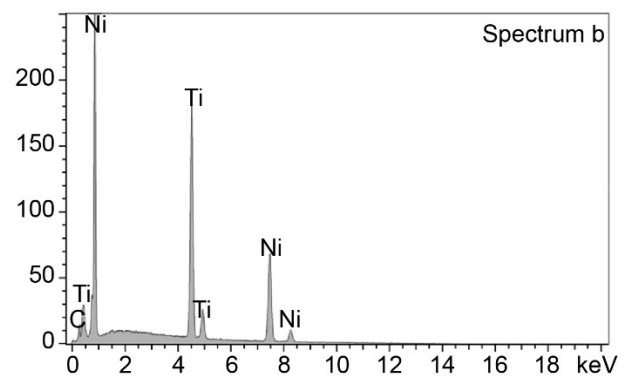
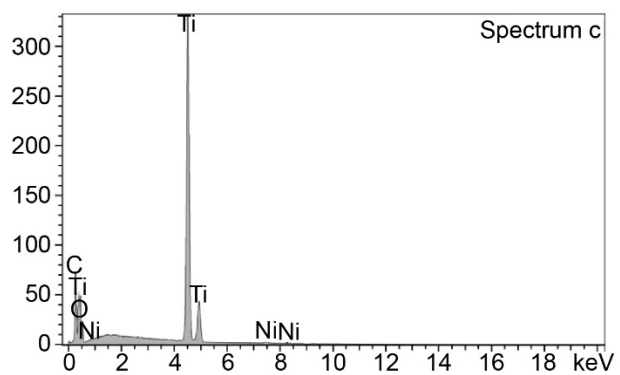
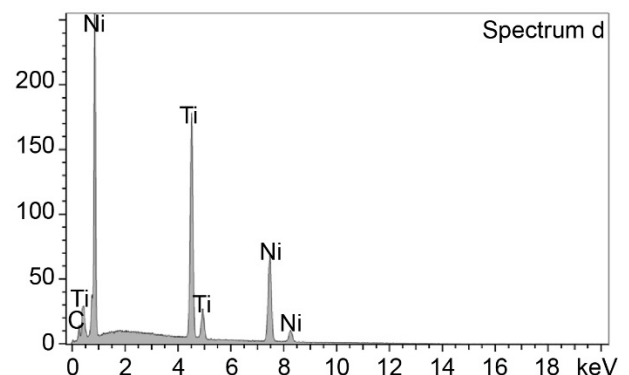
Figure 17.—Scanning electron micrographs and EDS spectra of inclusions shown in Figure 15(b) (the careful reader may notice that the optical image is inverted across the vertical axis compared to the SEM image). The image on the left is the backscattered electron image and the image on the right is the secondary electron image.
