# A Screening Method Using Pulsed-Power Combined with Infrared Imaging to Detect Pattern Defects in Bulk Metal Foil or Thin Film Resistors

Jay Brusse<sup>(1)</sup>, Lyudmyla Panashchenko<sup>(2)</sup>

<sup>1</sup> ASRC AS&D at NASA Goddard Space Flight Center Code 562  
Greenbelt, MD 20771 USA  
[Jay.A.Brusse@nasa.gov](mailto:Jay.A.Brusse@nasa.gov)

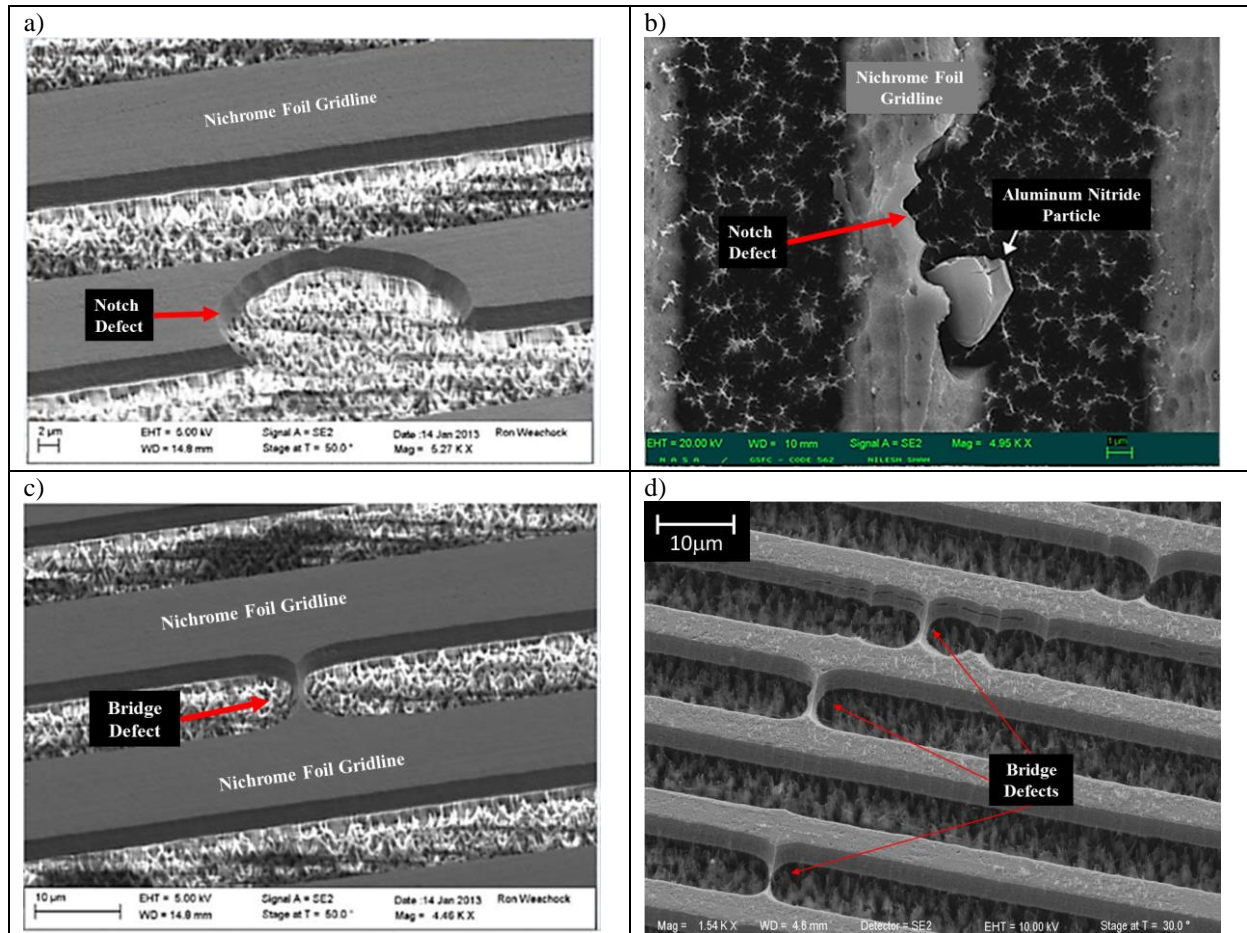
Notch defects are localized holes in the resistor gridline that reduce the gridline cross sectional area below the original design intent. Notches that take away >75% of the nominal resistor line width are considered to be unacceptable by some workmanship inspection criteria [3, 11] when the pattern is inspected at 30x magnification. The causes of notch defects include pre-existing pin holes in the foil sheet prior to etching, photolithography/etching-related anomalies and non-conductive particles (e.g., aluminum nitride) embedded in the foil [5]. If a notch defect breaks, then the electrical continuity of the gridline pattern is interrupted usually resulting in an open circuit failure mode. If the disrupted section of the resistor pattern has an associated parallel pathway, then a positive resistance shift occurs.

Bridge defects, as the name suggests, are sections of foil resistor material that interconnect two or more adjacent gridlines. Bridges whose narrowest width is <10% of the nominal resistor line width are considered to be unacceptable [3, 11]. The primary causes of bridge defects are related to photolithography/etching anomalies that result in a failure to completely remove foil material from the spaces between adjacent lines as intended. Bridges form unintentional parallel resistor pathways within the serpentine pattern. If during the trimming operation the manufacturer cuts a shorting tab associated with a section of the pattern containing bridge defects, then these bridges and the parallel resistance pathways they produce become essential features of the overall resistance value. Any disruption of the bridge would result in removal of the parallel path and an associated increase in resistance value.

Fig 3. Destructive Physical Analysis (DPA) Examples of Constriction Defects in Foil Resistors  
 a) Large Notch Defect in Gridline,  
 b) Notch Defect Associated with an Aluminum Nitride Particle Embedded in the Foil,  
 c) and d) Bridge Defects Between Adjacent Gridlines

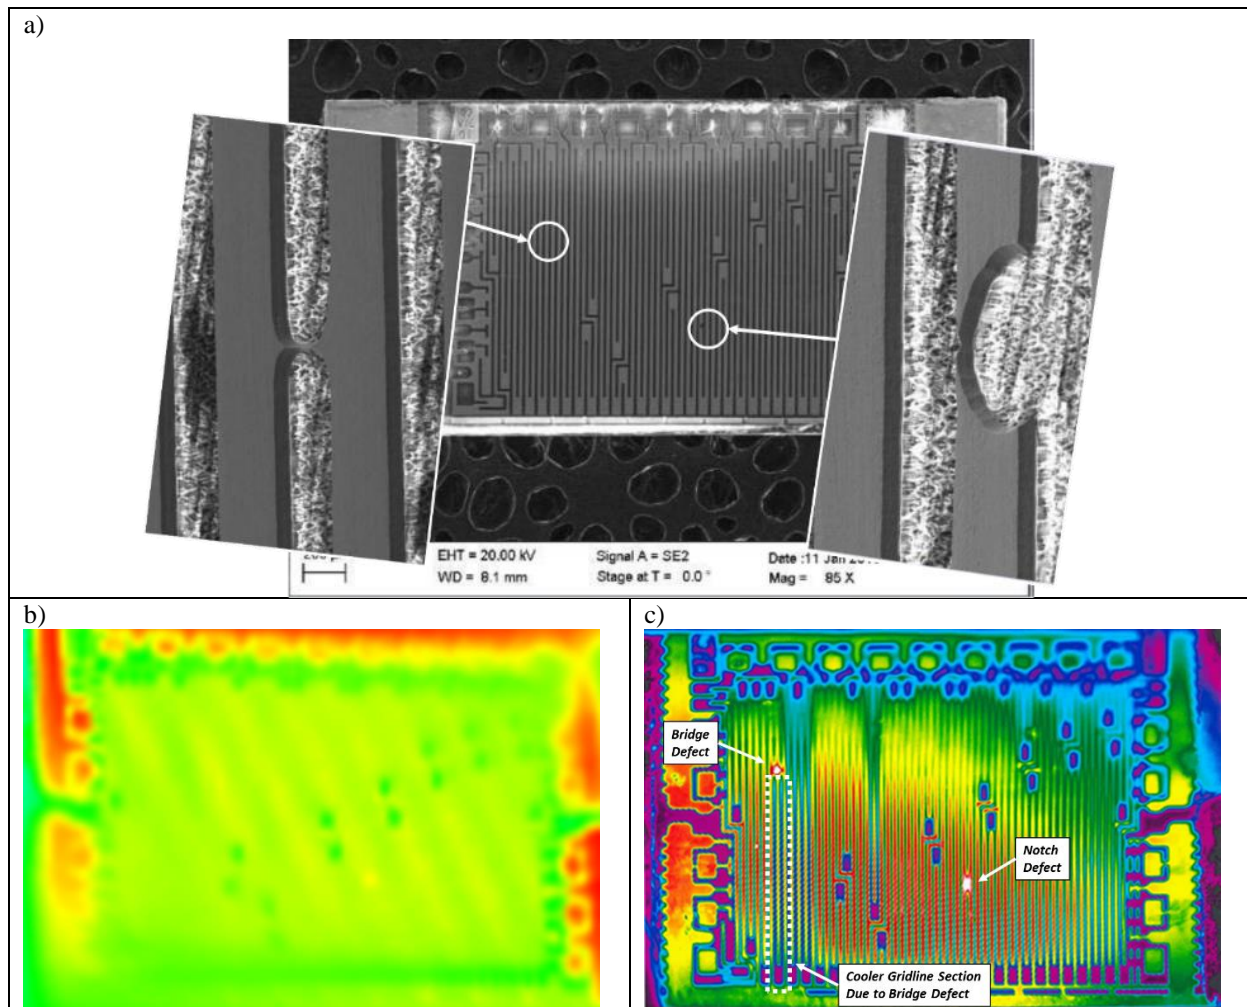
Fig 6. Inspection of a Single DPA Sample Foil Resistor Having 1 Notch and 1 Bridge Defect  
a) SEM Images, b) Low Resolution Infrared FLIR SC660, and c) High Resolution Infrared FLIR SC8300

The difference in resolution of the images acquired by the two infrared cameras was remarkable. Hot spots associated with both the notch and bridge defects (seen as white in this color palette) were readily identified by the FLIR SC8300 whereas the same defects were not discernable with the SC660. Even without a-priori knowledge from high-magnification SEM inspection, the high-resolution infrared image can be used to identify the constriction defect type. For example, the notch defect shown in Fig. 6 is revealed as a hot spot contained within a single gridline run. The notch is also identifiable by noting that the temperatures of the gridline runs entering and exiting the notch are approximately the same magnitude since the current flowing in each is the same and therefore, so too is the Joule heating. The bridge defect in Fig. 6 appears as a hot spot between two adjacent gridlines. The bridge can also be recognized by the much cooler temperature of the gridline section beyond the bridge defect where less current is flowing due to the bypass provided by the bridge. These initial results provided the motivation to pursue the use of the FLIR SC8300 as a non-destructive, post-procurement screening inspection tool.

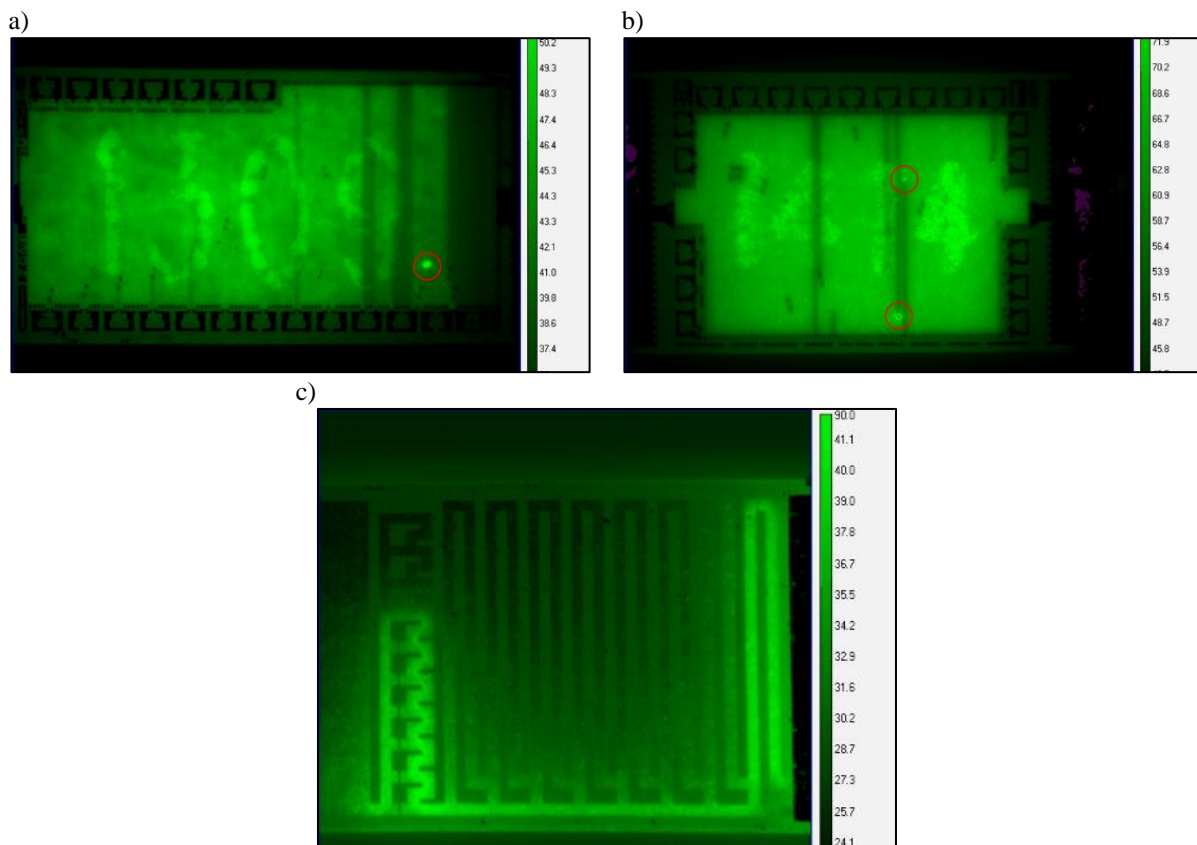
Fig. 8 – Examples of Pulsed-Power Infrared Images of  
 a) Foil Resistor with a Notch Type Defect, b) Foil Resistor with 2 Bridge Type Defects and  
 c) Thin Film Resistor with No Defects

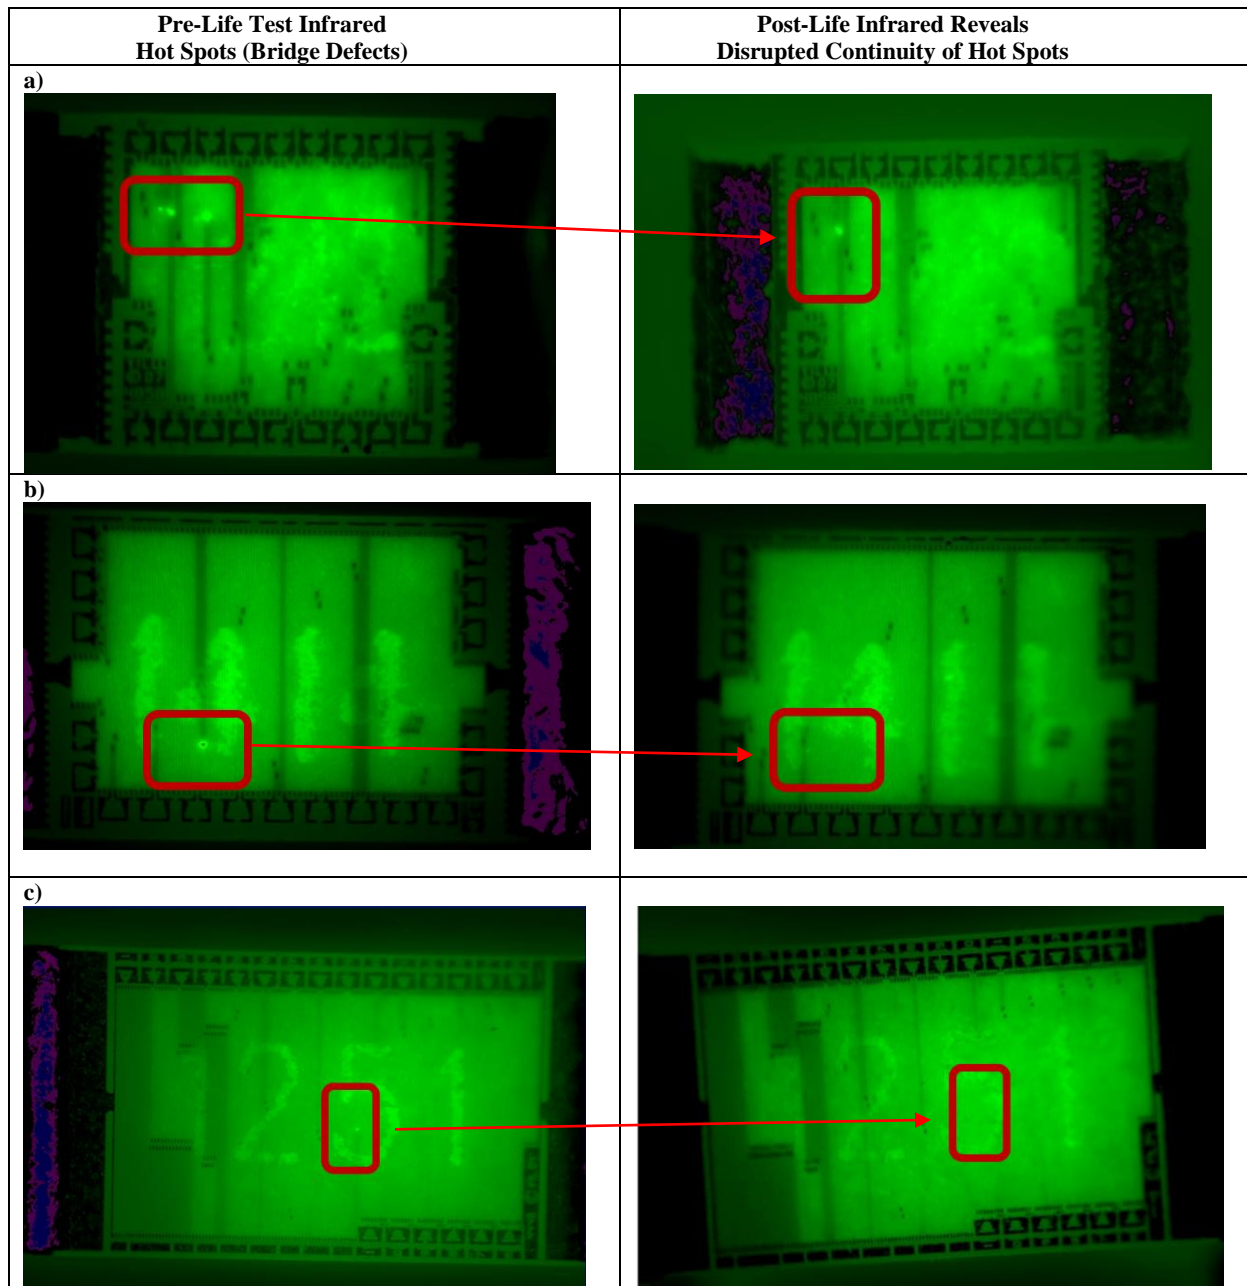
Fig. 12. Pre-Life Test and Post-Life Test Infrared Comparison Images of the Three Life Test Failures

The pre-life test and post-life test infrared images for each of the three life test failures are shown in Fig. 12. These comparison images show that each of these three resistors had ‘significant’ hot spots identified prior to life test and by the conclusion of life test either 1 or 2 bridge defects per resistor had lost electrical conductivity as evidenced by the disappearance of the hot spots in the post-life test infrared images.

Since S/N 12 (0805 - 5.1k $\Omega$ ) exhibited two distinct and large positive resistance shifts (see Table 5), it is a good example to discuss the correlation between the resistance shifts and the infrared signature changes during life test. Fig. 12a shows that prior to life test S/N 12 contained 4 distinct hot spots each consisting of a bridge defect between adjacent gridlines. After life test, only 2 of the original 4 hot spots remained indicating that the other 2 bridge defects had become electrically open (i.e., non-conducting) during life test. As described earlier, the disruption of a bridge defect results in a positive resistance shift due to the removal of the parallel resistance pathway created by the bridge.

- a) Size 0805, 5.1k $\Omega$ , S/N12, Type C,
- b) Size 1206, 20k $\Omega$ , S/N 28, Type A,
- c) Size 2010, 50k $\Omega$ , S/N 48, Type B

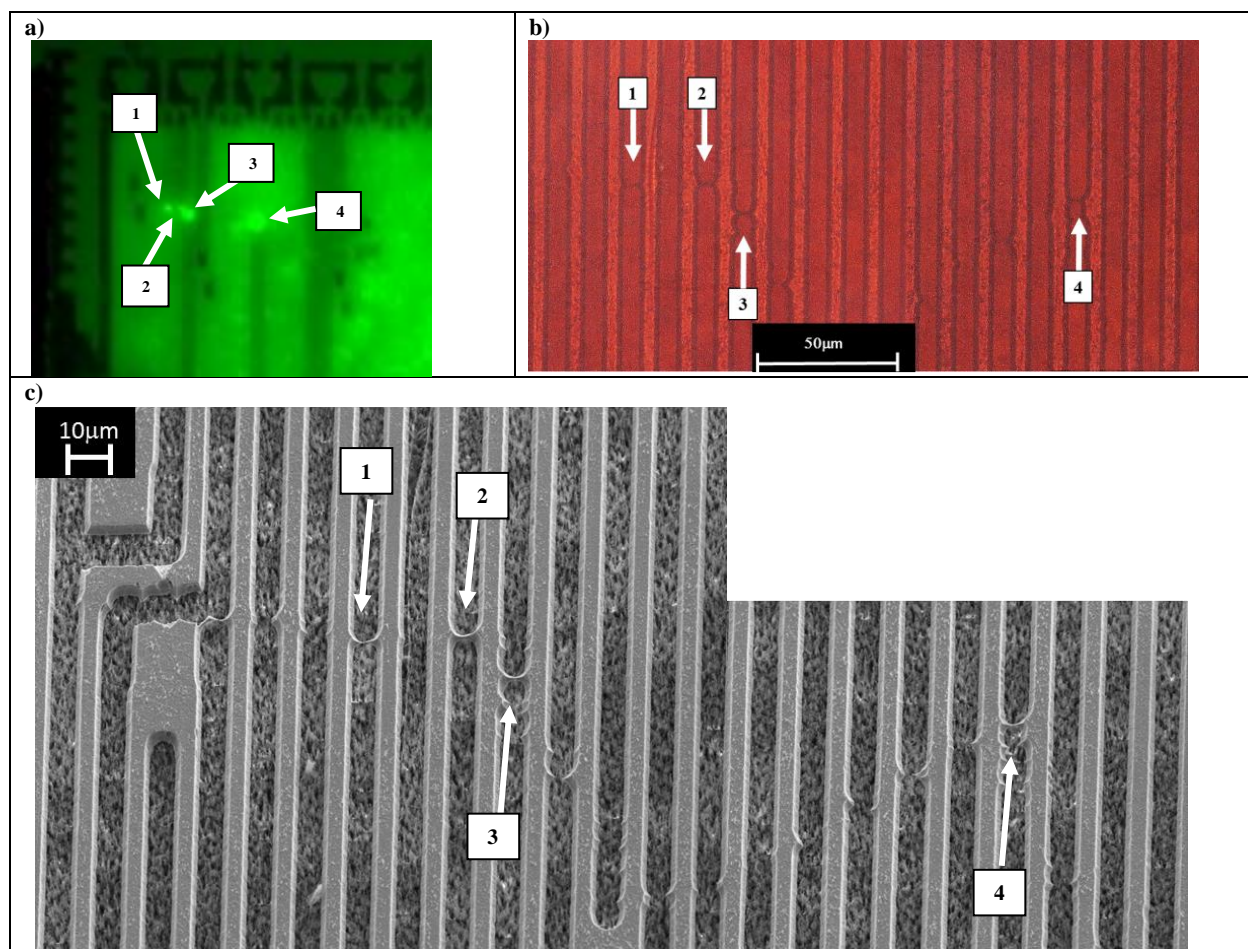
Fig 13. Failure Analysis Size 0805, 5.1k $\Omega$ , S/N 12

The results of these inspections are shown in Figs. 13 and 14. Fig. 13a shows the pre-life test infrared image of a resistor that had 4 significant hot spots each associated with a bridge defect. Fig. 13b is an optical microscopy image of the same resistor after removal of the opaque epoxy coating. Optical inspection through the translucent polymer coating that protects the resistor element shows certain aspects of these 4 bridge defects. However, especially at higher magnifications, factors such as focal range and optical reflections from the complicated shapes of the constrictions make it exceedingly difficult to quantify the dimensions of such defects. Fig. 13c shows a SEM view of the same region from Fig. 13b after complete removal of the polymer coating. The SEM, with its superior focal depth and magnification capabilities, reveals enhanced details of constriction defects not possible with optical microscopy.

- a) Infrared Image Showing 4 Hot Spots Associated with Bridge Defects
- b) Transmitted Light Microscopy Montage Image Highlighting Bridge Defects in a),
- c) SEM Image of Region Shown in b)

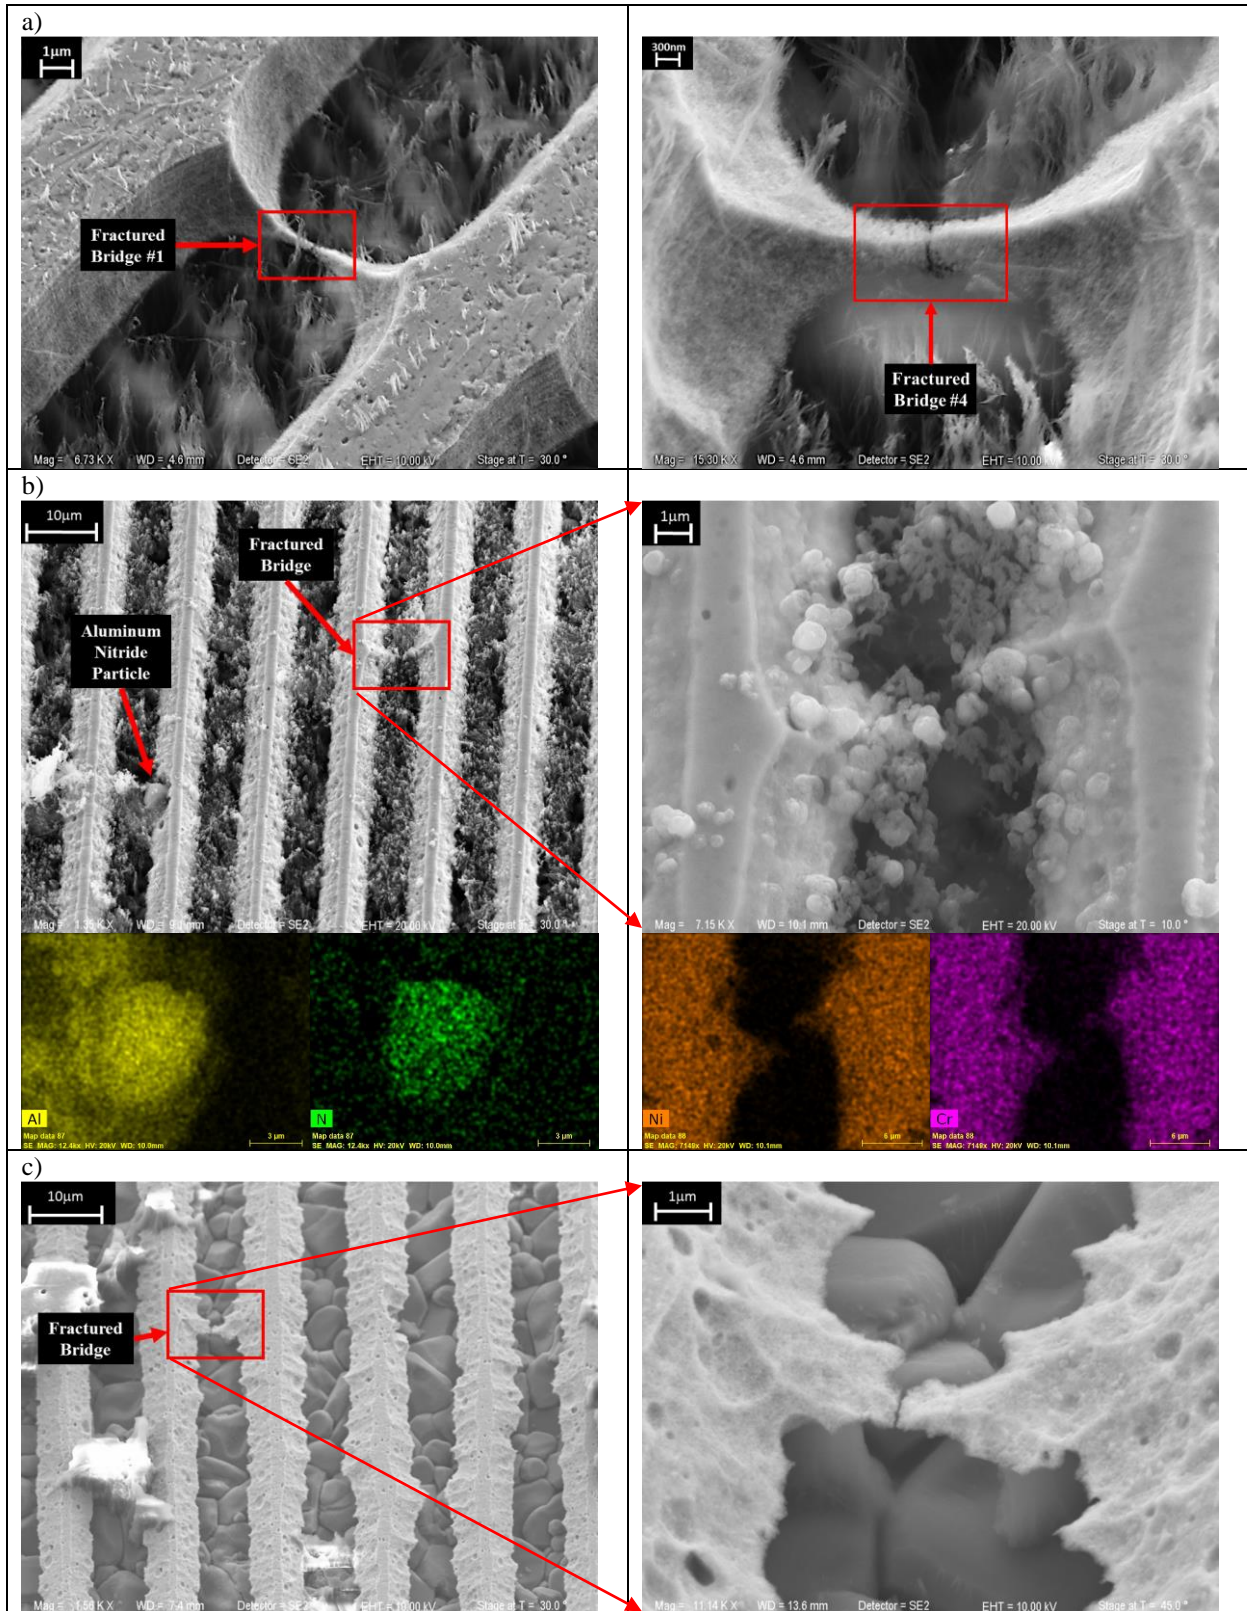
Fig. 14 shows that the failure sites for all 3 life test failures were identified and confirmed to be fractured bridge defects consistent with the locations of the pre-life test hot spots that had disappeared at discrete time intervals during life test. Each of these previously-conducting bridge defects fractured at the approximate mid-point in their span producing an open circuit condition in the bridge. The fractured bridges resulted in the removal of parallel resistance pathways in each resistor pattern thus producing the observed positive resistance shift failure modes. Detailed inspection of the fractured bridges shows no evidence of melting nor tensile stretch-to-break failure. Instead, the fractures are all consistent with cyclical fatigue fracture. The source of cycling was thermomechanically-induced by the on/off power cycling that resulted in hot spot expansion and contraction during the life test.

Fig. 14 – SEM and EDS Images of Once-Conducting Bridge Defects that Fractured During Life Test  
 a) Size 0805, 5.1kΩ, S/N12, Type C, Showing the Fractured Bridges Labeled “1” and “4” in Fig. 13,  
 b) Size 1206, 20kΩ, S/N 28, Type A Fractured Bridge and EDS of an Embedded Aluminum Nitride Particle  
 c) Size 2010, 50kΩ, S/N 48, Type B, Fractured Bridge Defect

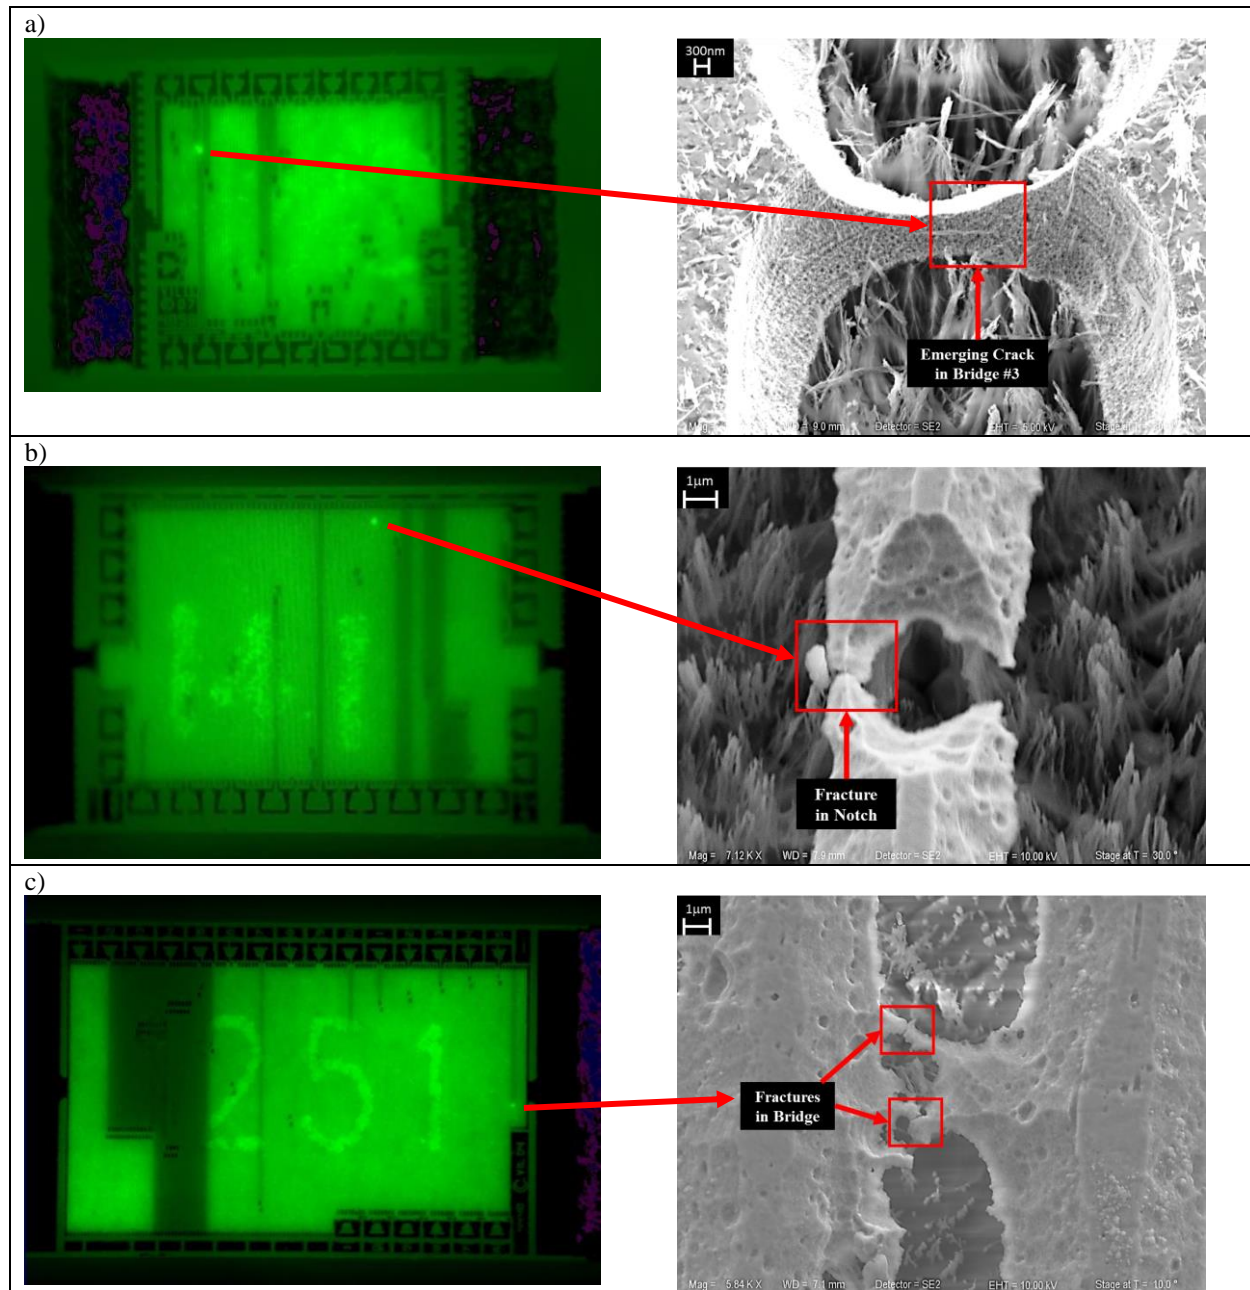
Three resistors with significant hot spots that persisted after life test were also deprocessed as described above to enable detailed SEM inspection (see fig. 15). High magnification SEM inspection of these three resistors showed evidence of emerging (fig. 15a) and/or near-complete fracture of the constrictions associated with these hot spots. In particular figs. 15b and 15c show evidence of near-complete fracture of the constriction. It is possible resistors in this condition will exhibit intermittent resistance changes caused by small displacements of the fractured ends that make and break pressure contact between the ends of the constriction. Such displacements may be produced by changes in ambient temperature leading to expansion and contraction of the resistor materials. Intermittent behavior like this would be very difficult to detect during life test since continuous resistance monitoring is not used.

Fig. 15. Infrared and Corresponding SEM Images of Constriction Defects that Remained Intact Through Life Test  
a) Size 0805, 5.1kΩ, S/N12, Type C, Bridge Defect (see Fig. 13 bridge #3) with Emerging Fracture  
b) Size 1206, 20kΩ, S/N 25, Type A, Notch Defect with Near-Complete Fracture  
c) Size 2010, 50kΩ, S/N 33, Type B, Bridge Defect with Two Near-Complete Fractures
